REMEDIAL EXCAVATION REPORT DEQ Site No. 03-93-0008

April 3, 2000

Project Number 990621-A4

DELCO PETROLEUM CO. LLC 17873 SE McLoughlin Blvd. Milwaukie, Oregon

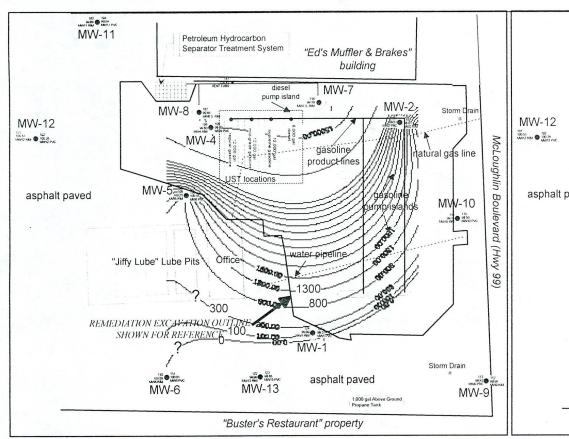
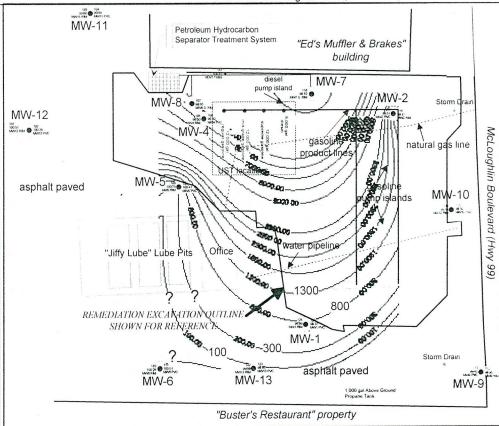
1/24/95

Benzene concentrations in groundwater contours appear to peak in late 1994 and early 1995 (Figures 10E and 10F). Benzene contours for January 24, 1995 (Figure 10E) indicate a large concentration increase along the gasoline pipeline, indicating that the replacement gasoline pipeline may have leaked, and/or the elbows (or pipeline bends) may have leaked. An area of high concentration of gasoline contaminated soil was excavated from around MW-2, as well as, around the gasoline pipeline elbows/bends as they turned southward toward the pump islands. Benzene to toluene groundwater concentration ratios from samples collected in 1995 through 1998 indicates an apparent gasoline pipeline leak near the southwesternmost pump island (Figure 11).

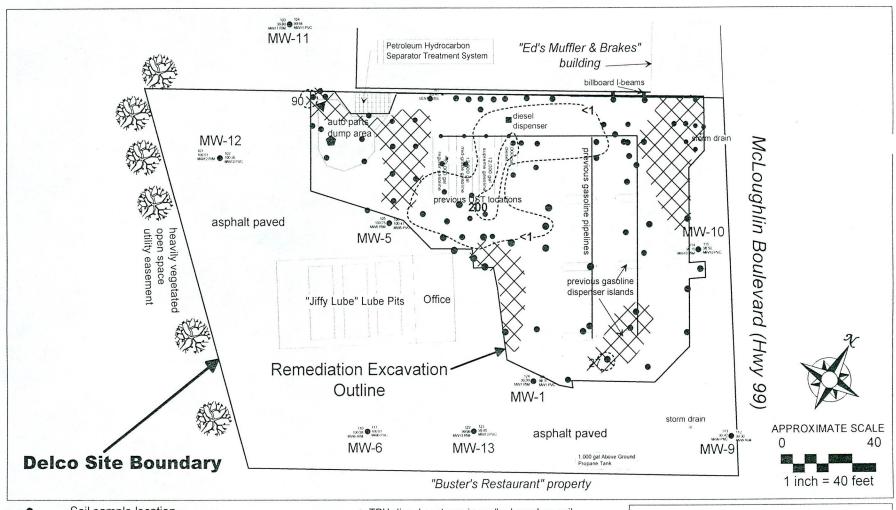
Figure 23B - TPH DIESEL CONTOUR MAP

The TPH diesel concentration contour (Figure 23B) indicates that leakage may have been near the fill pipe of the UST. No visible holes or fractures were seen in the diesel UST that was excavated. The higher concentrations of diesel contaminated soil extends north of the location of the prior diesel tank and southward toward the service station office. This pattern, as well as the similar pattern for gasoline, may be related to the higher permeability of the UST backfill.

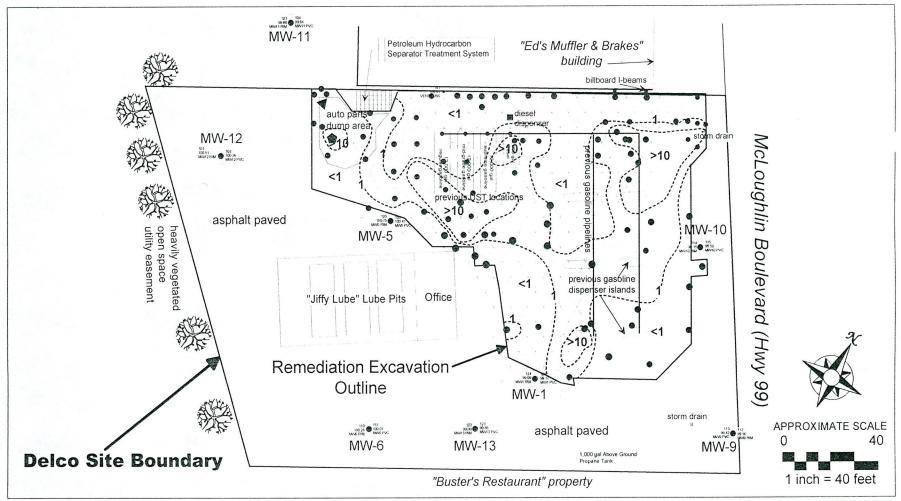
Figure 23F - TOTAL XYLENES CONTOUR MAP

These three areas of probable sources of gasoline leakage are further indicated by the Total Xylenes contours (Figure 23F) since the xylenes would be the least rapidly depleted by groundwater dissolution or biodegradation and would have the higher concentrations over time. These patterns are also consistent with those found for groundwater contamination (see discussion Section 2.7.4).

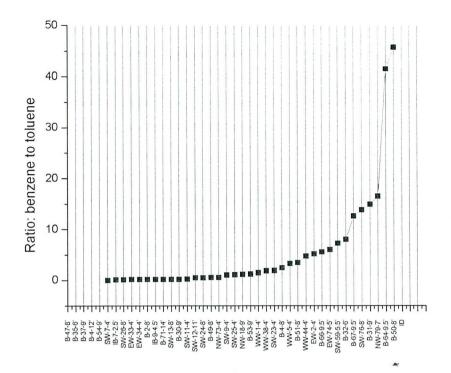
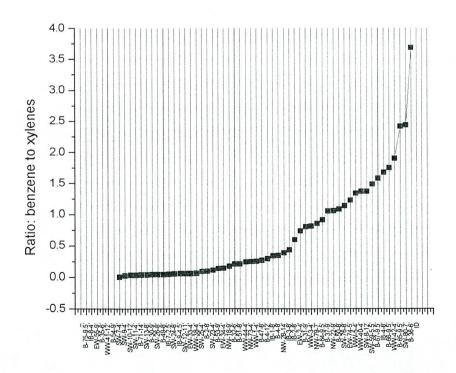
Figure 26 - CONCENTRATION RATIOS (SOIL)

Based on Figure 26, the highest benzene to toluene ratios occur in soil samples B-67-9.5', SW-76-8', B-31-9', NW-79-7', B-64-9.5', and B-50-8'. The second highest grouping of ratios appears to include samples WW-44-4', EW-2-4', B-66-9.5', EW-74-5', SW-59-5.5', and B-32-6'. These two groups appear as breaks in the slope and could indicate separate leakage events.
