**RE: THIRD QUARTERLY 2024 TEMPORARY PROTECTIVE CAP INSPECTION
NAVIGATION CENTER CAP INSPECTIONS
1111 NORTHWEST NAITO PARKWAY
PORTLAND, OREGON
FARALLON PN: 2395-017**

THIRD QUARTERLY 2024 TEMPORARY PROTECTIVE CAP INSPECTION
Navigation Center Cap Inspections
1111 Northwest Naito Parkway
Portland, Oregon

Farallon PN: 2395-017

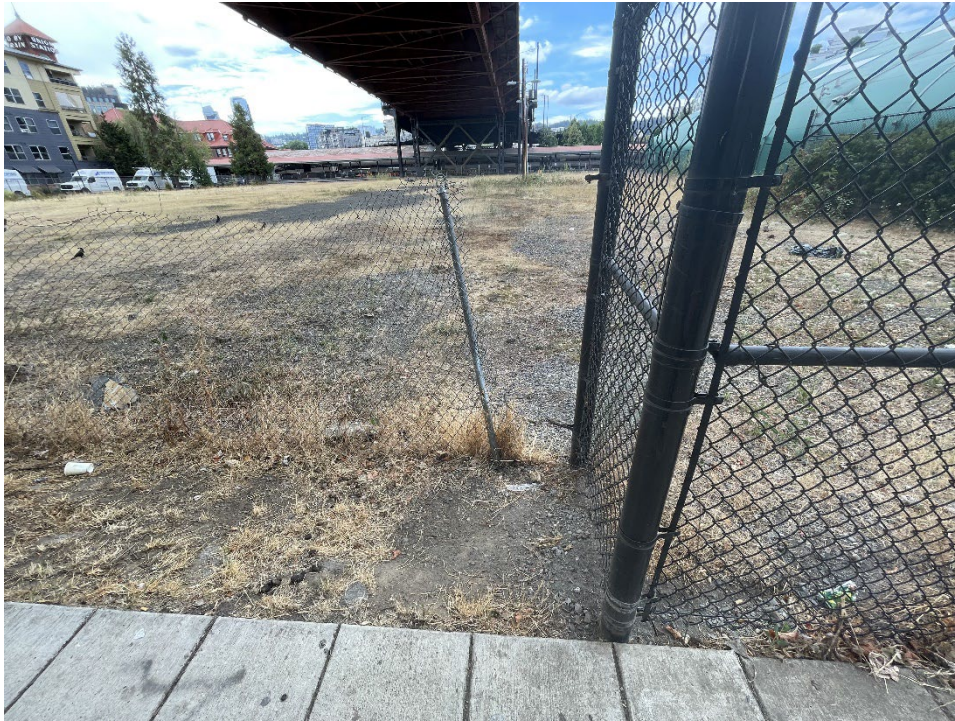
- Visual inspection of the protective fencing around the Navigation Center was performed for evidence of damage or removal such that the fencing would no longer be a viable barrier to control access to the Navigation Center and prevent public access to adjoining uncapped areas. Farallon observed damage to fencing southeast of the Navigation Center (Photo 17). The fencing surrounding the Navigation Center facility was observed to be intact during the site inspection; the damage consists of a fencing post bent to allow access from Naito Parkway into the undeveloped field southeast of the Navigation Center (Multnomah County Tax Lot No. 1N1E34BD-00805). Although the observed fencing damage does not provide an access point to or from the Navigation Center facility, Farallon recommends coordinating with the southeast-adjointing property owner to repair the fencing to prevent the public from accessing the adjoining uncapped areas.

Photograph 17. Damaged fencing on adjoining property.

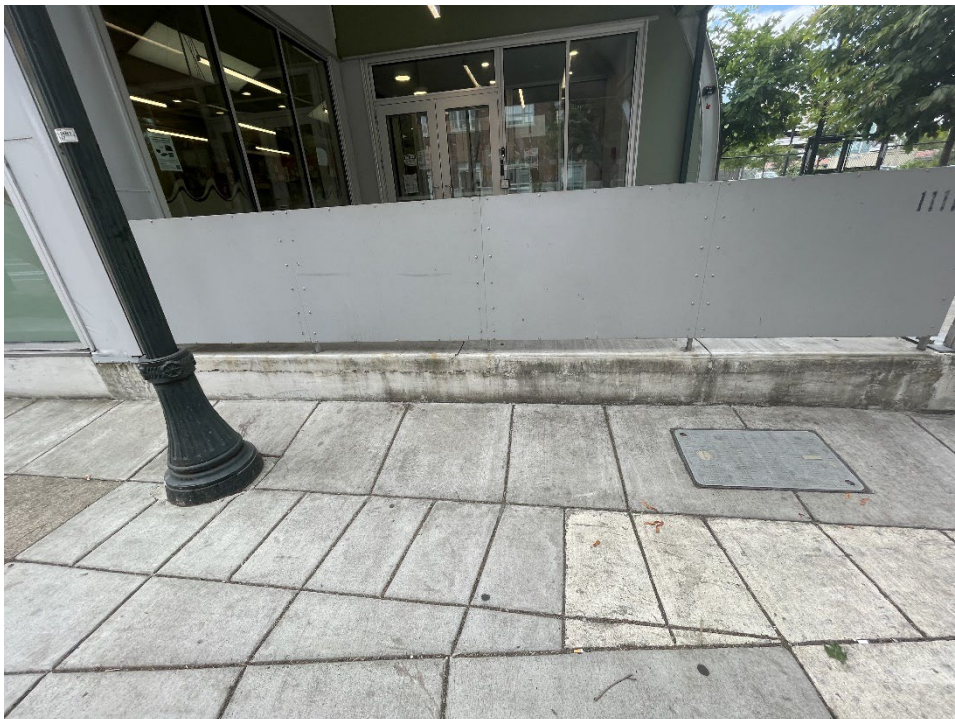
feet long in the vertical face of the concrete platform leading to the entrance of the Navigation Center (Appendix B, Photograph No. 18). Because the crack is superficial and on the vertical platform, it is not considered a point of exposure to underlying contaminated soil. Farallon will continue to monitor the crack during upcoming quarterly monitoring events to ensure conditions remain protective of human health.

Photograph 18. Superficial crack concrete in building vertical exterior.

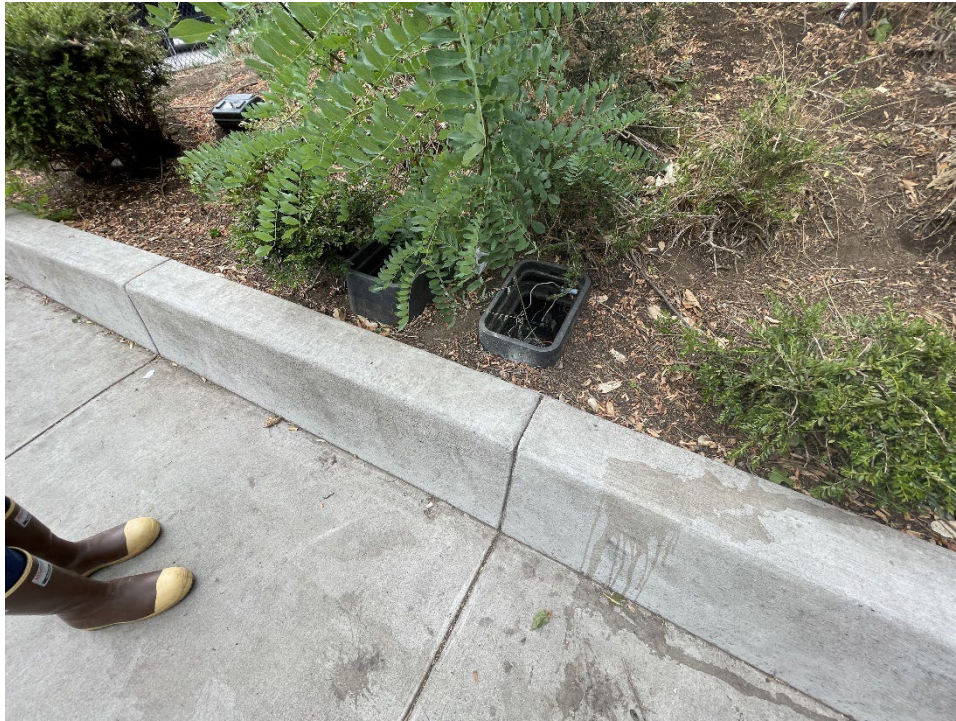
- Visual inspection of at-grade stormwater control system features was performed for evidence of degradation or blockage that may result in erosion of the temporary protective cap; visual inspection of stormwater overland flow pathways was performed for evidence of blockage as a result of traffic, falling debris, or other occurrences; and visual inspection of surfaces was performed for evidence of improper grading that may prevent stormwater from flowing toward control system features such as catch basins. No such conditions were observed, apart from Farallon observing that two of the irrigation utility boxes, located in the garden bed west of the Navigation Center building, were missing covers (Appendix B, Photograph No. 19). The missing box covers are not considered a point of exposure to underlying contaminated soil, as the soil in the garden and utility boxes are uncontaminated. However, to protect the soil cap, Farallon recommends replacing the utility box covers.

Photograph 19. Uncovered irrigation utility boxes.
