RE: Annual Inspection for Parcel AP  
North Ridge Estates Superfund Site  
ECSI No. 5998

Operations and Maintenance Inspection Form

2023 Annual Inspection Summary Report  
North Ridge Estates - Operable Unit 1  
Klamath Falls, Oregon

Figure  
AP.3

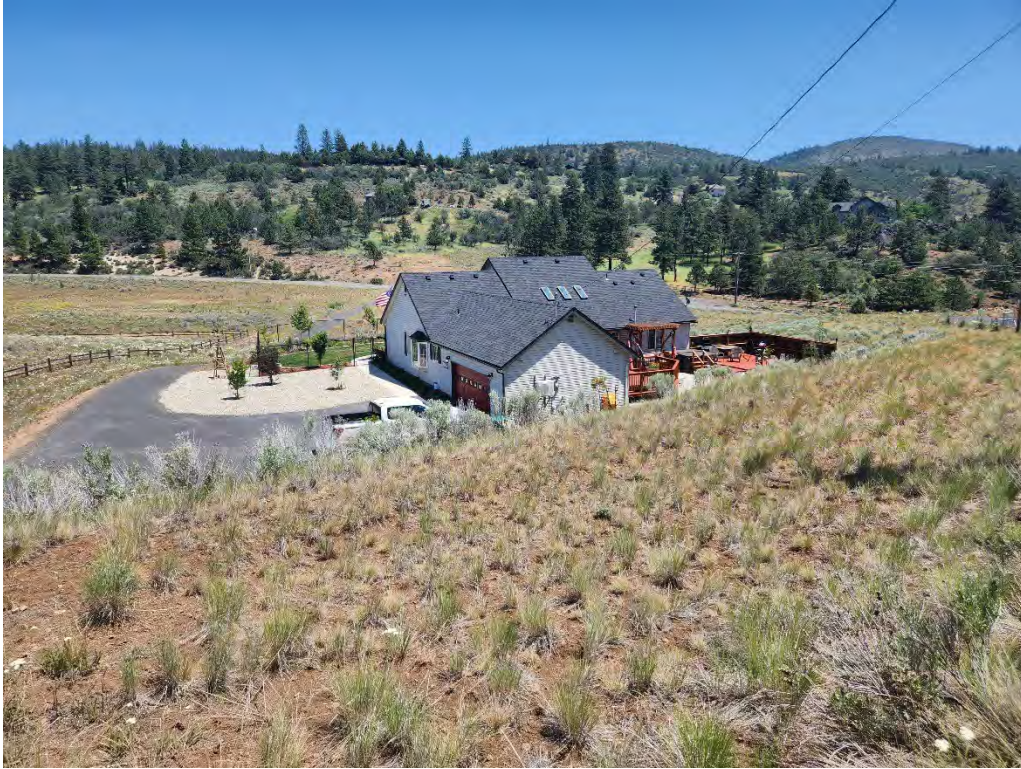
Parcel AP – View from Northwestern corner of Parcel.

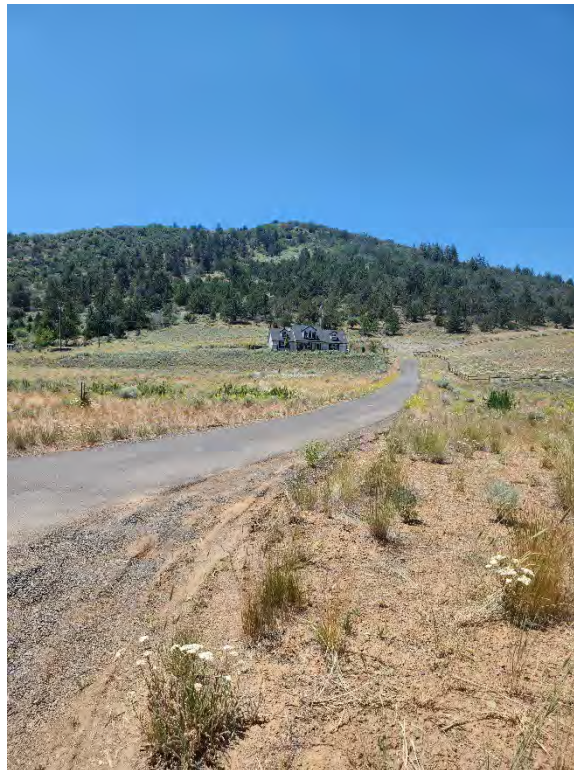
Parcel AP – View from Northeastern corner of Parcel.

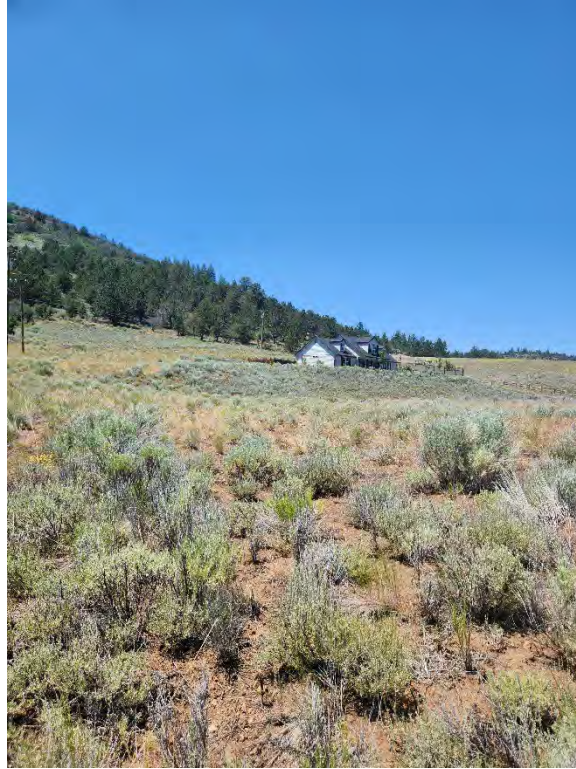
Parcel AP – View from Southeastern corner of Parcel.

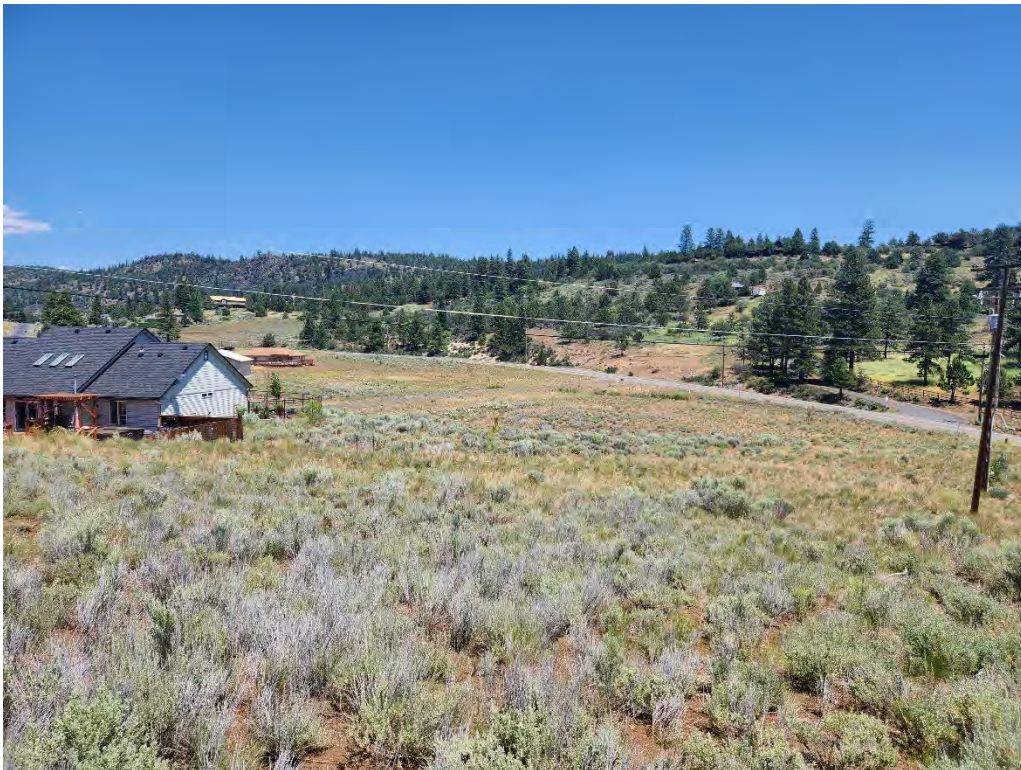
Parcel AP – View from Southwestern corner of Parcel.

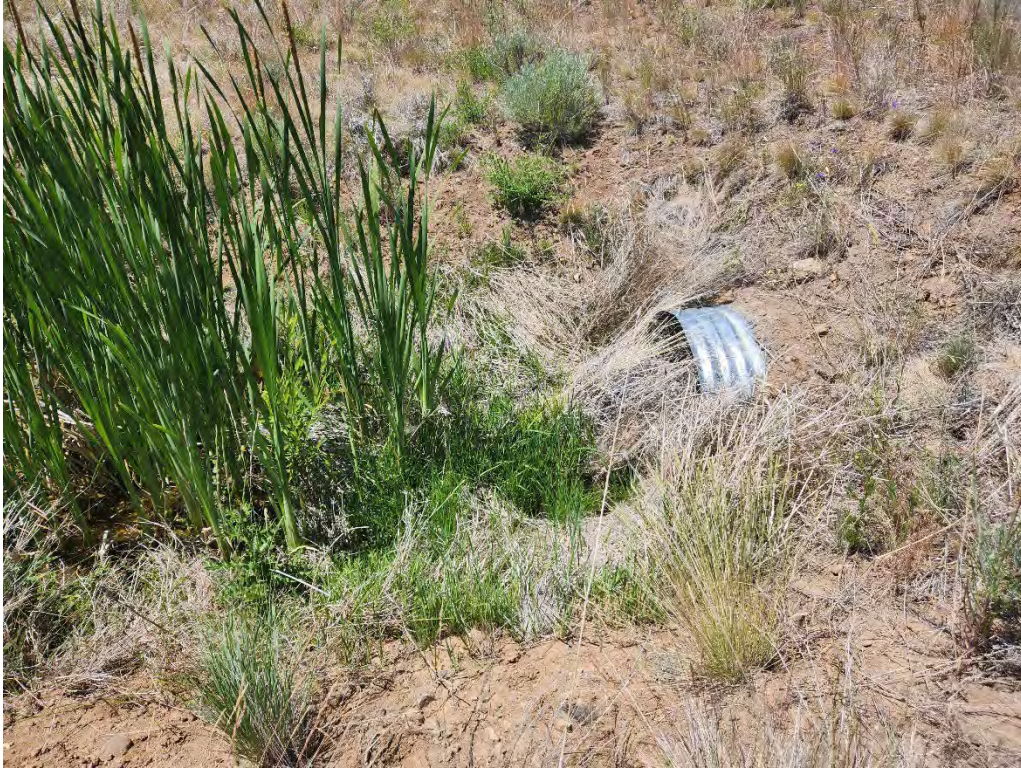
1. **Blocked culvert.** The end of the culvert located below your driveway remains partially obstructed (see enclosed figure).

Ditches and Culverts	Obstructions observed in ditches or culverts that may impede conveyance of stormwater?	<input checked="" type="checkbox"/>	<input type="checkbox"/>	<input type="checkbox"/>	<input type="checkbox"/>	Culverts near the northeast area of parcel were observed to be obstructed; standing water observed near culverts.	Remove vegetation obstructing culverts to enable stormwater flow.
	Damaged observed to riprap surface? Note if riprap is not intact or not effectively providing armor protection.	<input type="checkbox"/>	<input type="checkbox"/>	<input checked="" type="checkbox"/>	<input type="checkbox"/>		
	Are there any areas that show signs of excessive scour? (i.e., gullies forming along centerline of ditch)	<input type="checkbox"/>	<input type="checkbox"/>	<input checked="" type="checkbox"/>	<input type="checkbox"/>		
	Are culvert inlets and outlets damaged?	<input type="checkbox"/>	<input type="checkbox"/>	<input checked="" type="checkbox"/>	<input type="checkbox"/>

Parcel AP – View of Blocked Culvert located on Northeast area of Parcel.

**Corrective Action.** Remove the material obstructing the culvert to allow the unrestricted flow of stormwater by November 12, 2023.

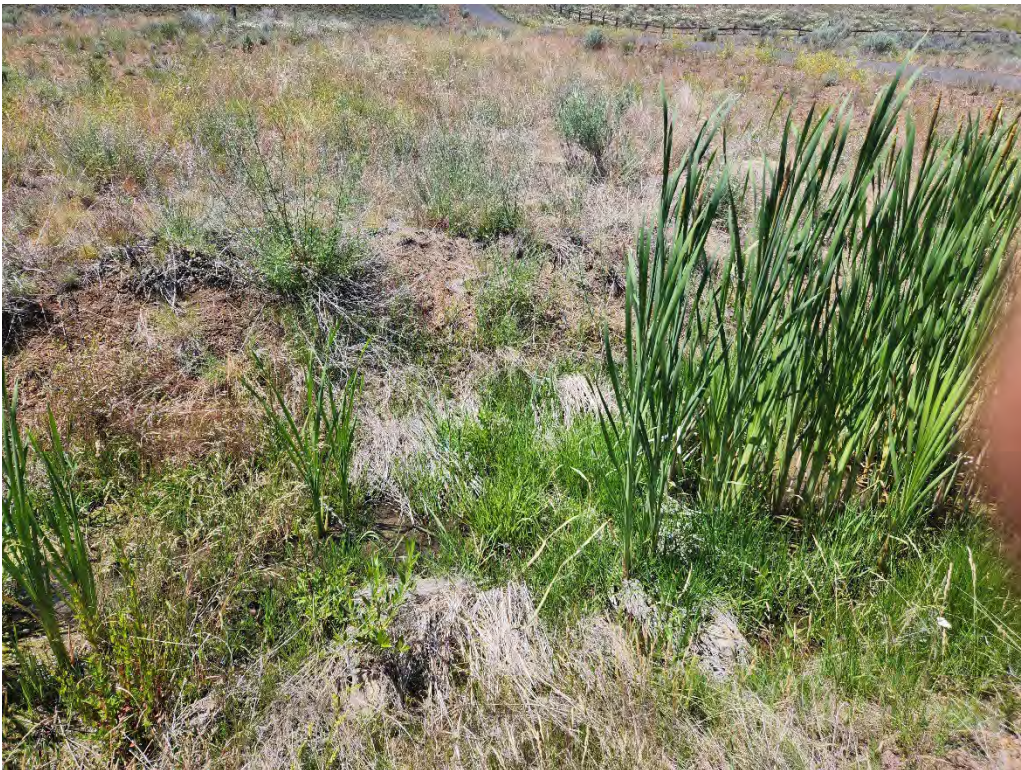
Parcel AP - View of Standing water near blocked culverts located on Northeast area of Parcel.
