RE: Annual Inspection for Parcel AQ
North Ridge Estates Superfund Site
ECSI No. 5987

Operations and Maintenance Inspection Form

2023 Annual Inspection Summary Report
North Ridge Estates - Operable Unit 1
Klamath Falls, Oregon

Figure
AQ.3

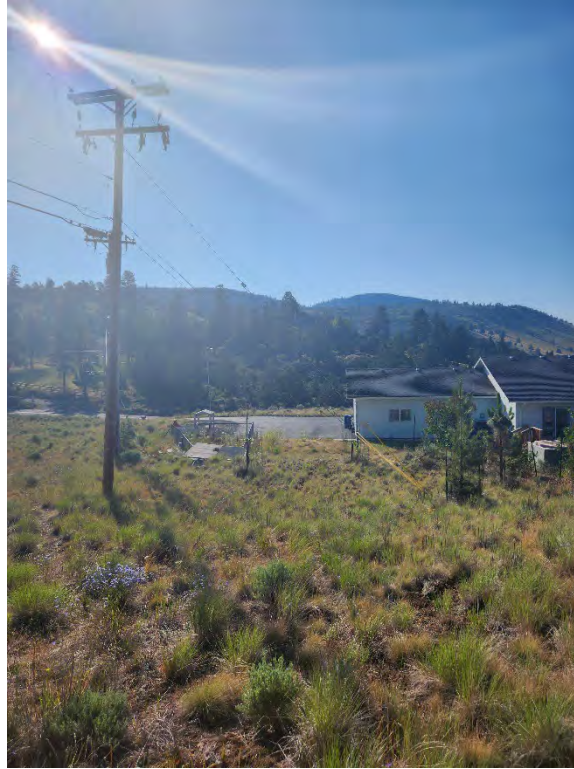
Parcel AQ – View facing Southeast from Northwest corner.

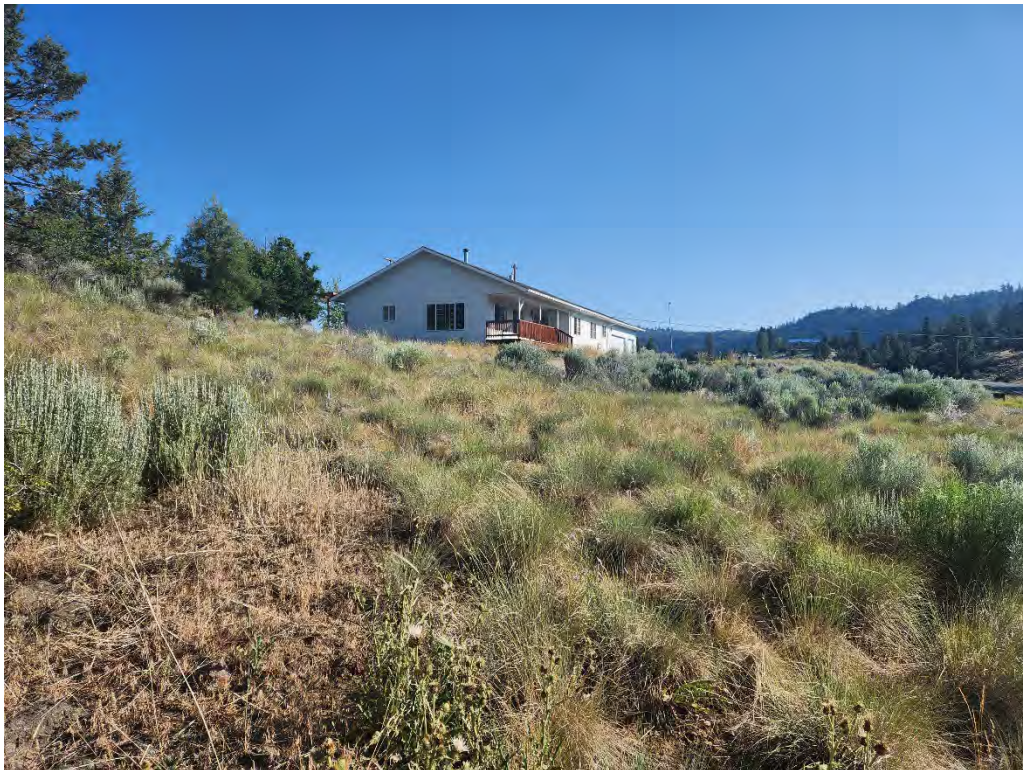
Parcel AQ – View facing North from Southern corner.

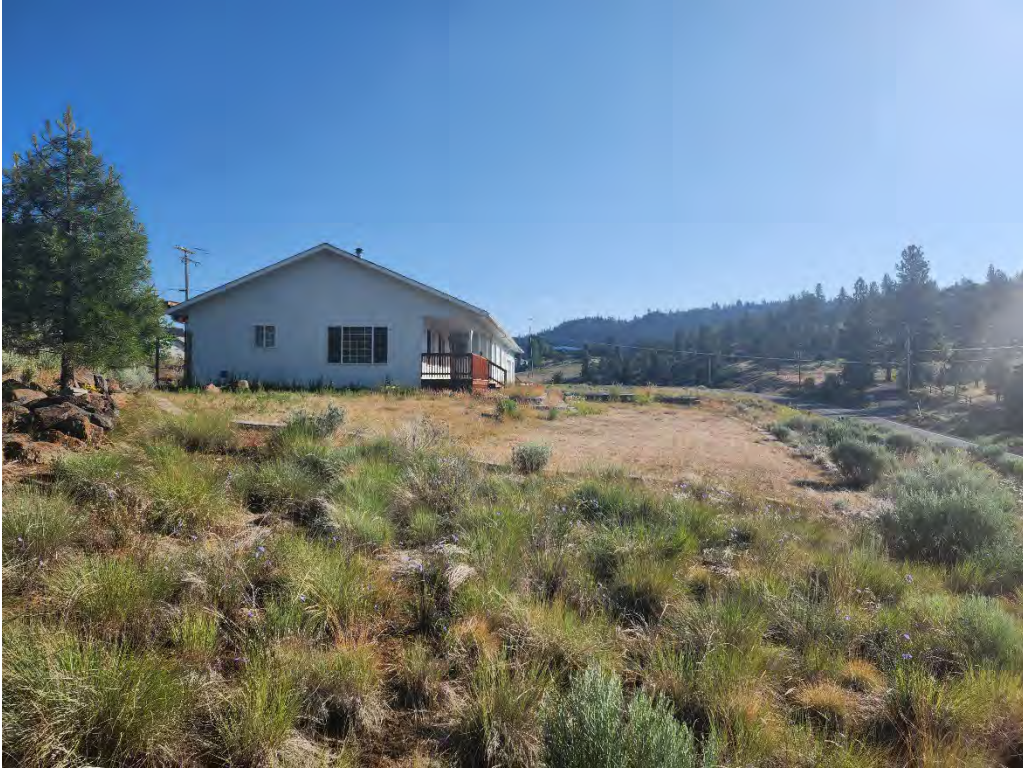
Parcel AQ – View facing Northeast from Southwest corner; sparse vegetation observed.

Recommendations: 1) Seal asphalt cracks in driveway; 2) repair rills and tire tracks (armor as needed); and 3) seed area of sparse vegetation.

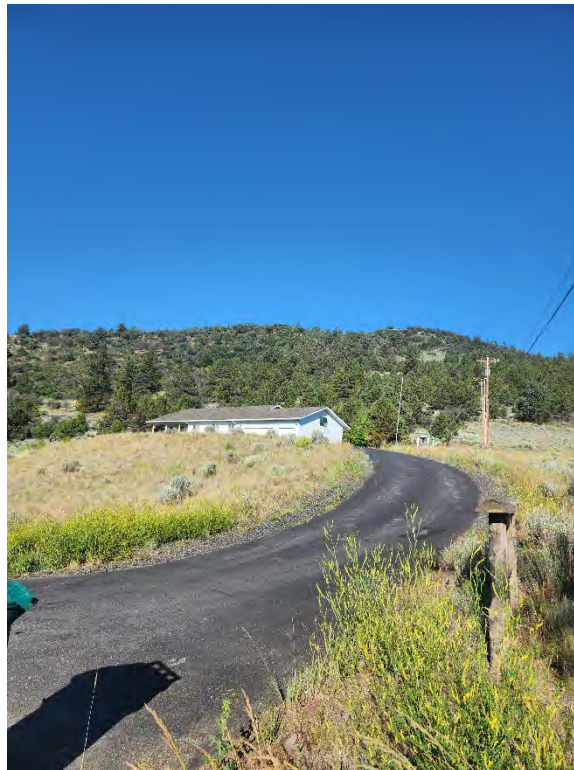
Parcel AQ – View facing Southwest from Northeast corner.

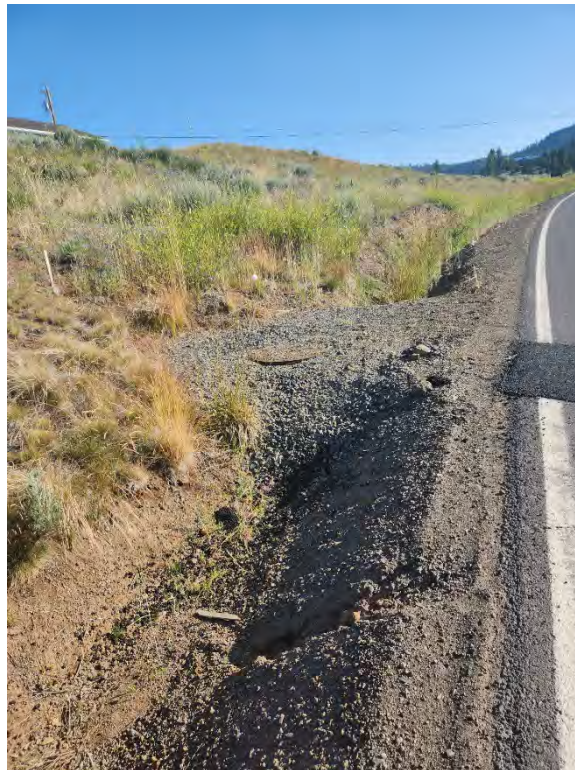
Ditches and Culverts	Obstructions observed in ditches or culverts that may impede conveyance of stormwater?	<input checked="" type="checkbox"/>	<input type="checkbox"/>	<input type="checkbox"/>	<input type="checkbox"/>	All culverts on Parcel AQ are obstructed with soil and gravel, ranging from 10 to 100%. Culvert located on southernmost portion of parcel is 100% covered by gravel. The placing of gravel was likely related to previous repair work.	Remove obstructions from culverts to enable stormwater flow.
	Damaged observed to riprap surface? Note if riprap is not intact or not effectively providing armor protection.	<input type="checkbox"/>	<input type="checkbox"/>	<input checked="" type="checkbox"/>	<input type="checkbox"/>		
	Are there any areas that show signs of excessive scour? (i.e., gullies forming along centerline of ditch)	<input type="checkbox"/>	<input type="checkbox"/>	<input checked="" type="checkbox"/>	<input type="checkbox"/>

Parcel AQ – View of Gravel Area and blocked Culvert.
