RE: Annual Inspection for the Swimming Pool and Memorial Park Repositories
North Ridge Estates Superfund Site
ECSI Nos. 5989, 5990

Operations and Maintenance Inspection Form

Lot SPR Inspection
2023 Annual Inspection Summary Report
North Ridge Estates - Operable Unit 1
Klamath Falls, Oregon

Memorial Park Repository (Parcel MBK-D and L)

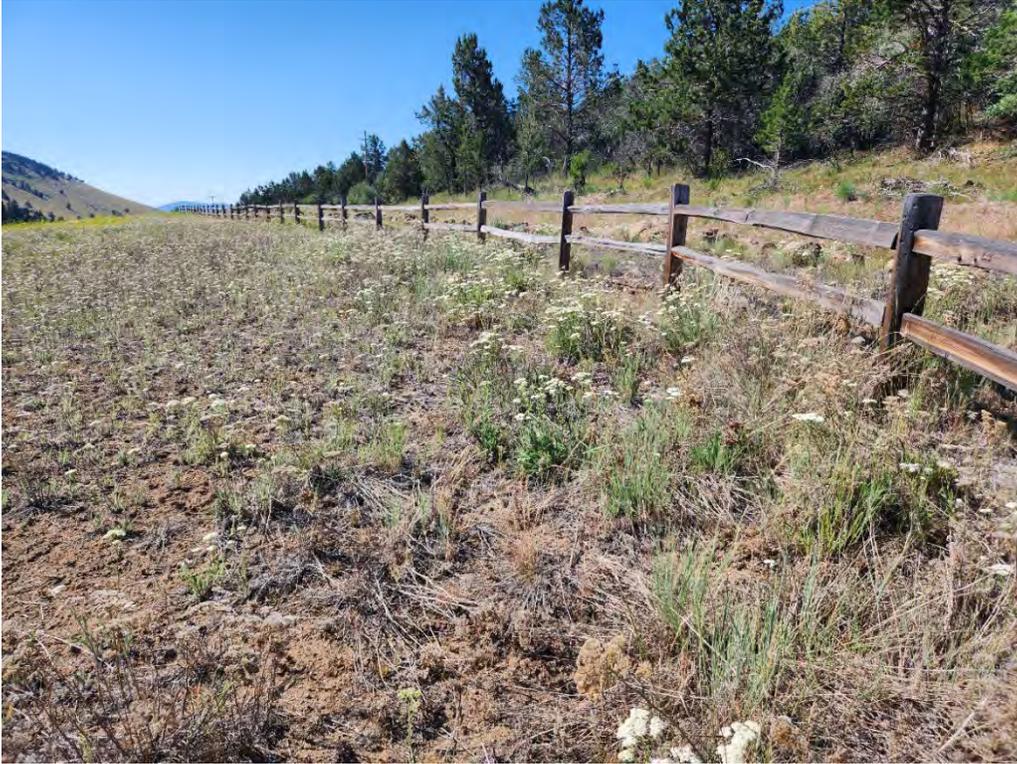
Parcel AL – View facing Northeast of broken split rail fence on Parcel.

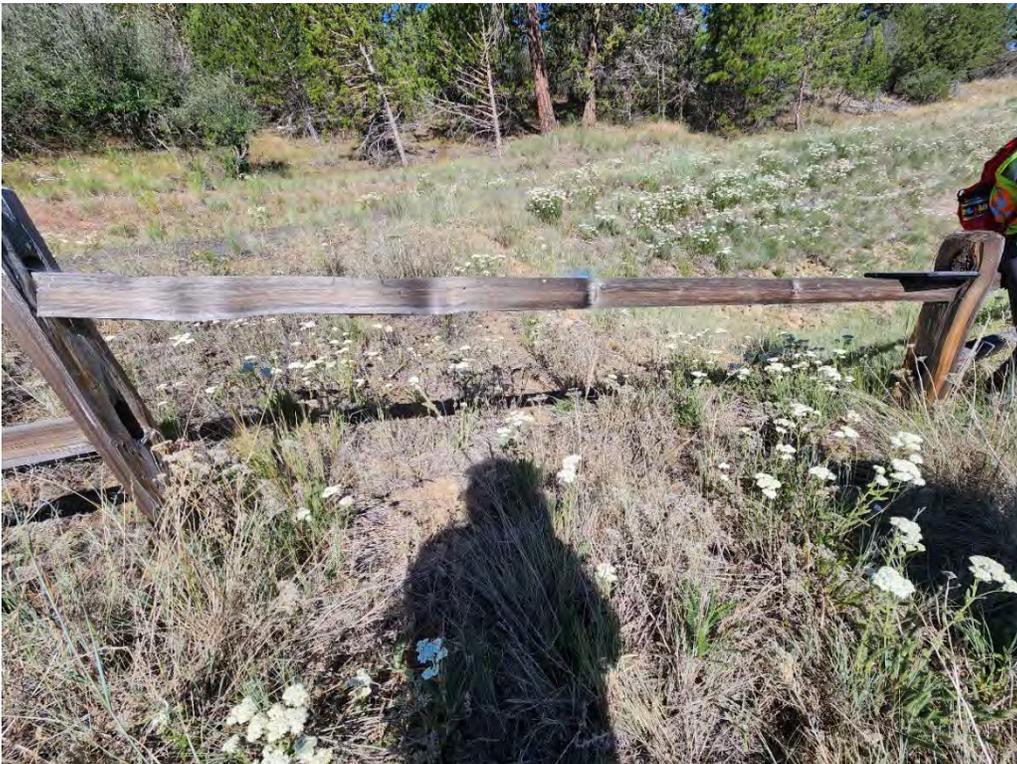
Parcel AL – View facing Southwest of broken split rail fence on Parcel.

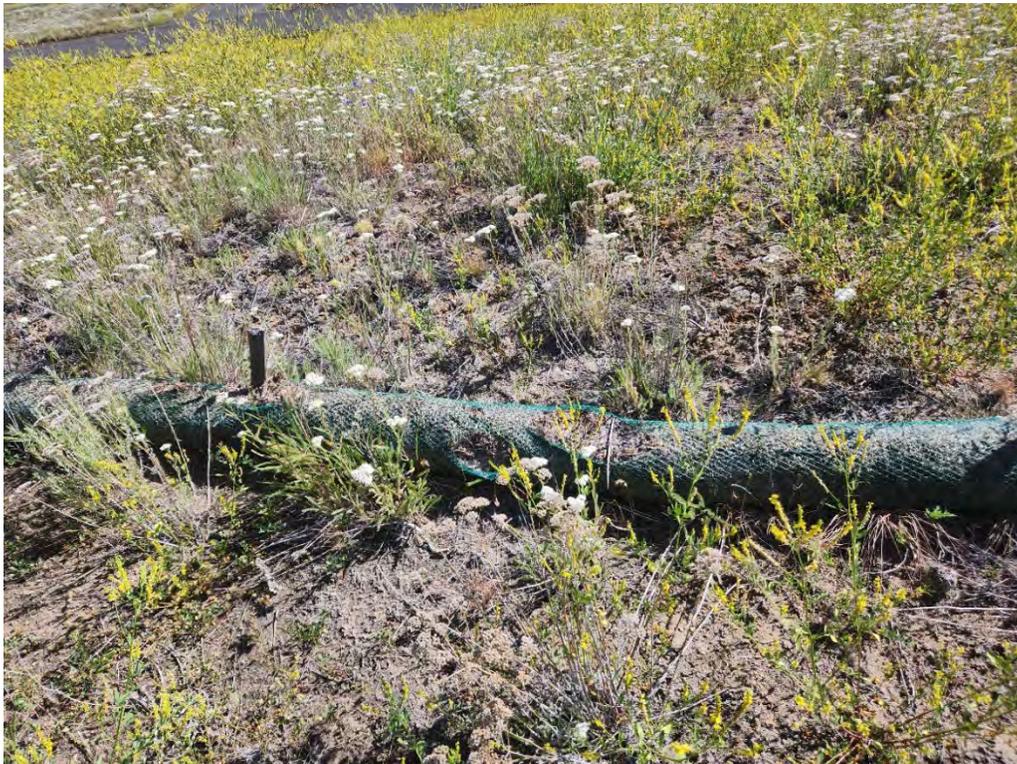
Parcel AL – View of Straw Wattle observed on Parcel.

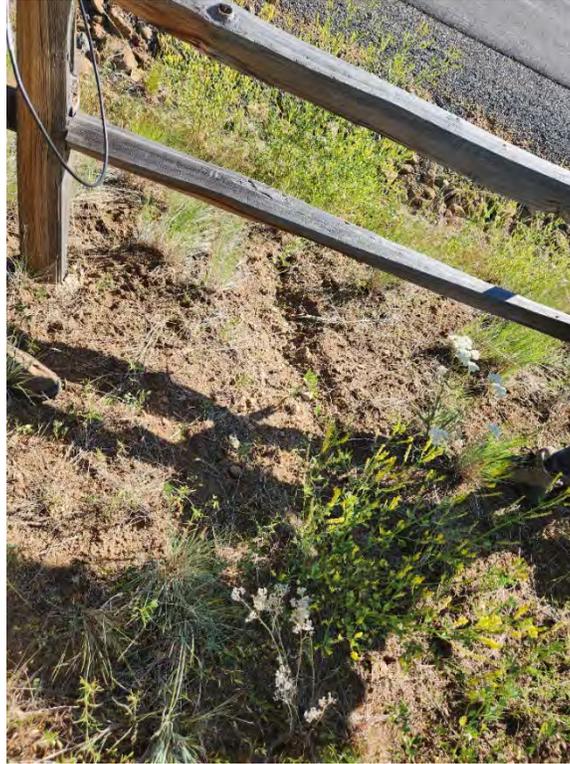
Parcel MBK-E – Rills observed connecting downslope to southern ditch along North Ridge Drive.

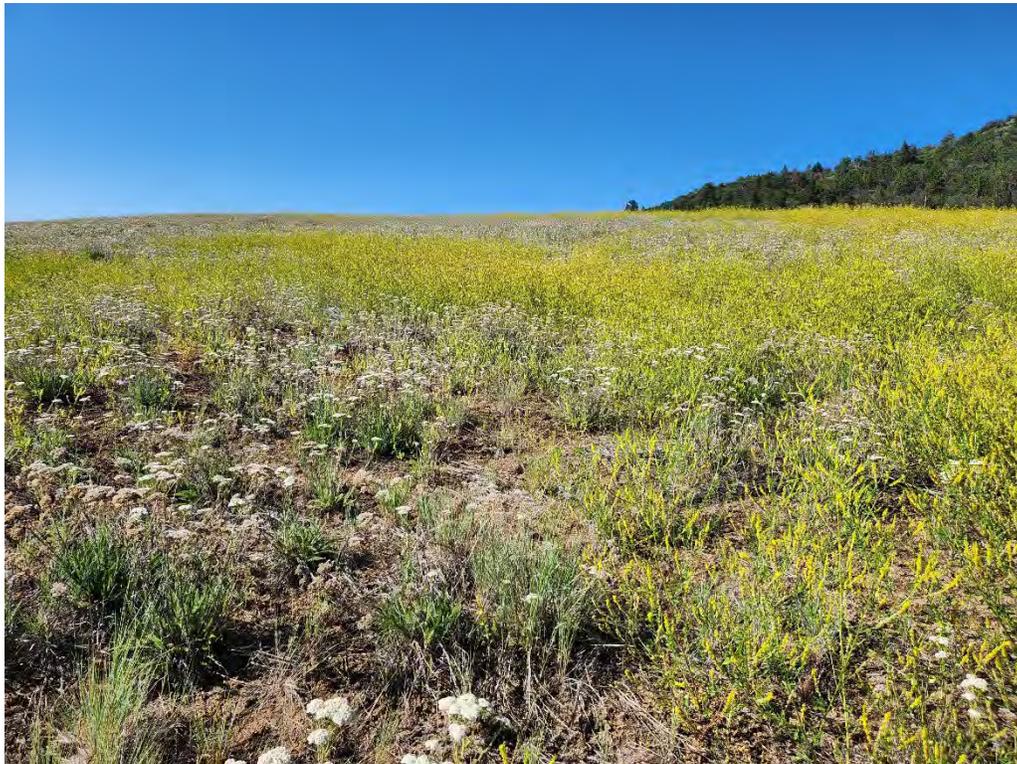
Parcel MBK-E – View facing South from North corner of Parcel; increased vegetation coverage.

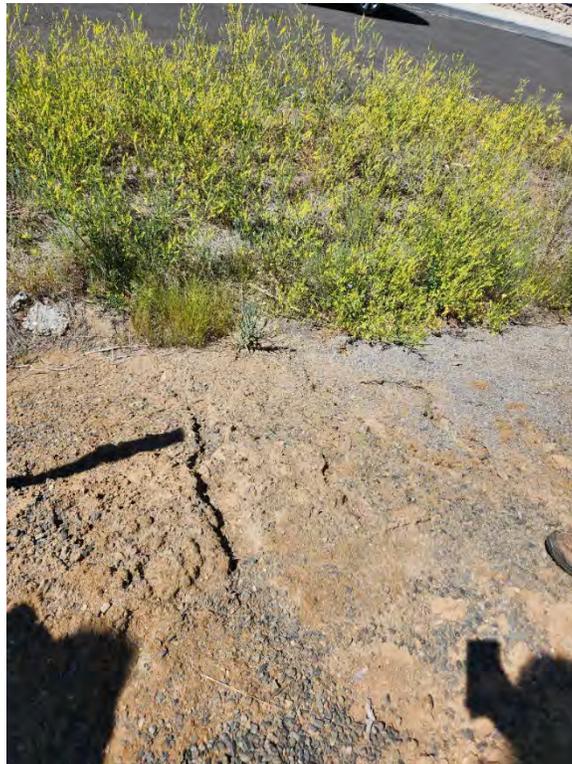
Parcel AG – View of Rills across from Pavilion near culvert along North Ridge Drive.

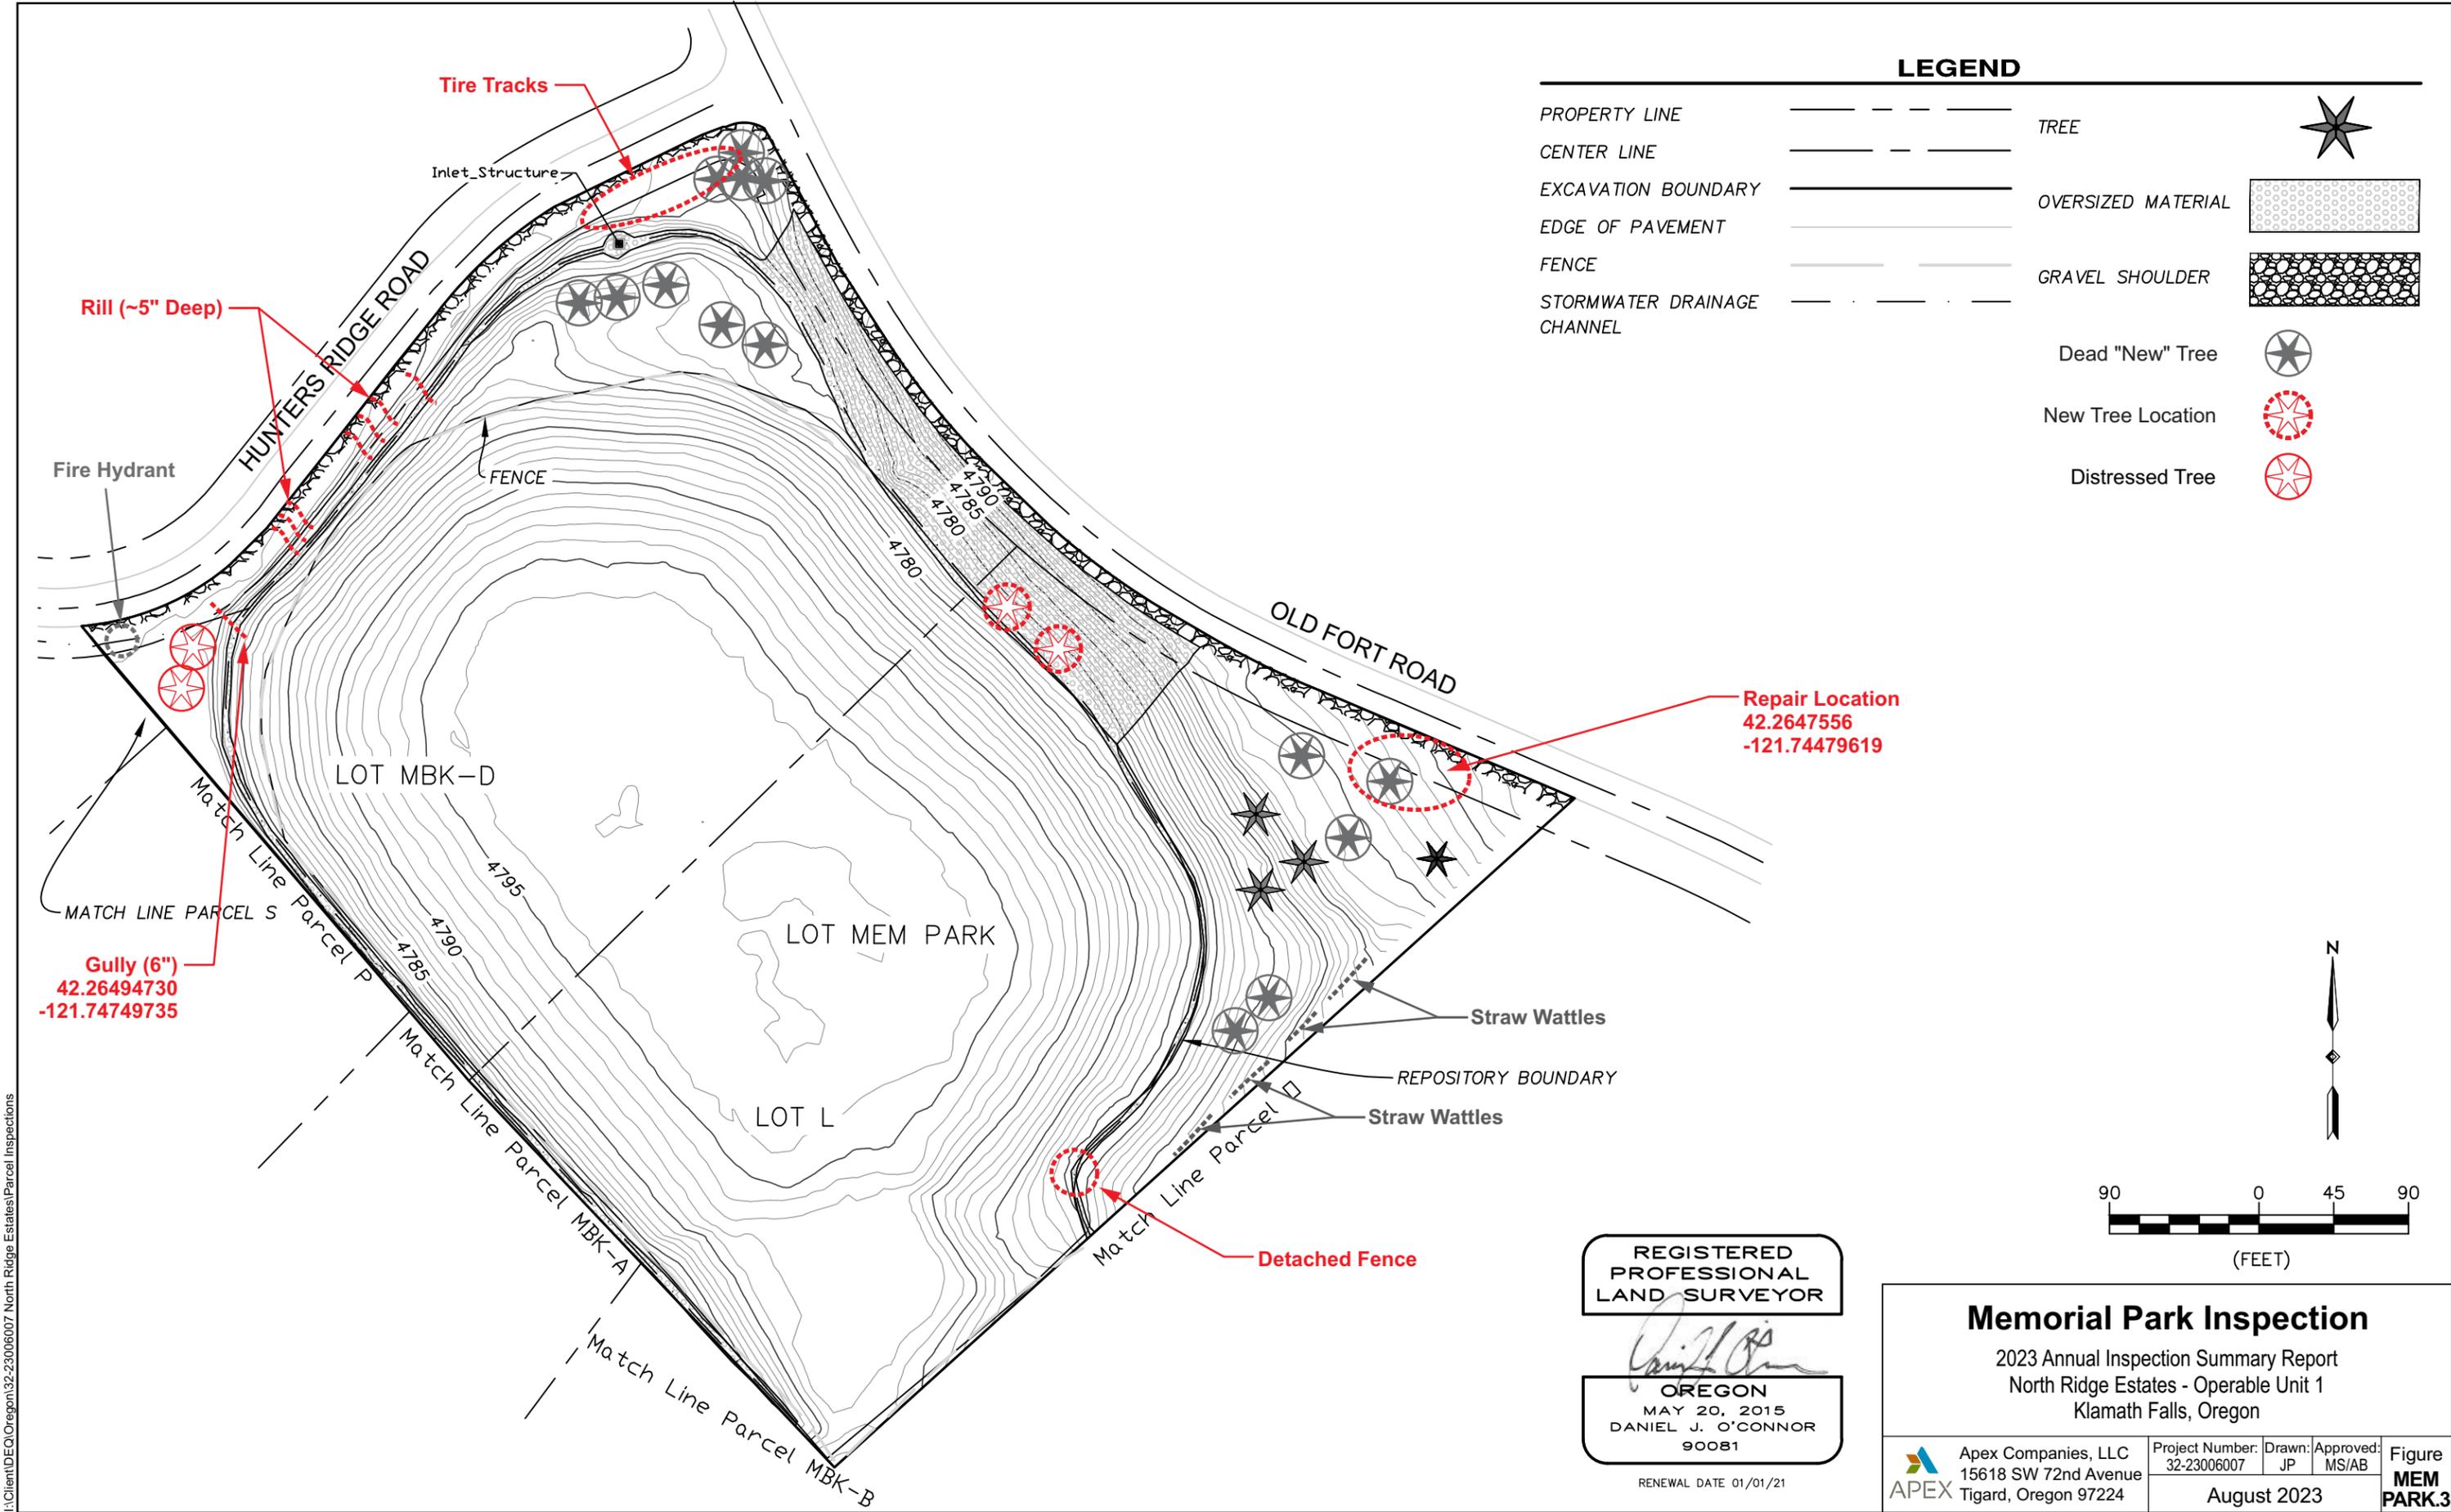
Figure
**MEM
PARK.3**

Evidence of trees and shrubs in distress?	<input type="checkbox"/>	<input checked="" type="checkbox"/>	<input type="checkbox"/>	<input type="checkbox"/>	A total of two new trees observed to be in healthy condition; two trees observed to be in distress.	
	Are there any stressed or dying trees that may impact or damage the protective cap when felled?	<input type="checkbox"/>	<input type="checkbox"/>	<input checked="" type="checkbox"/>	<input type="checkbox"/>

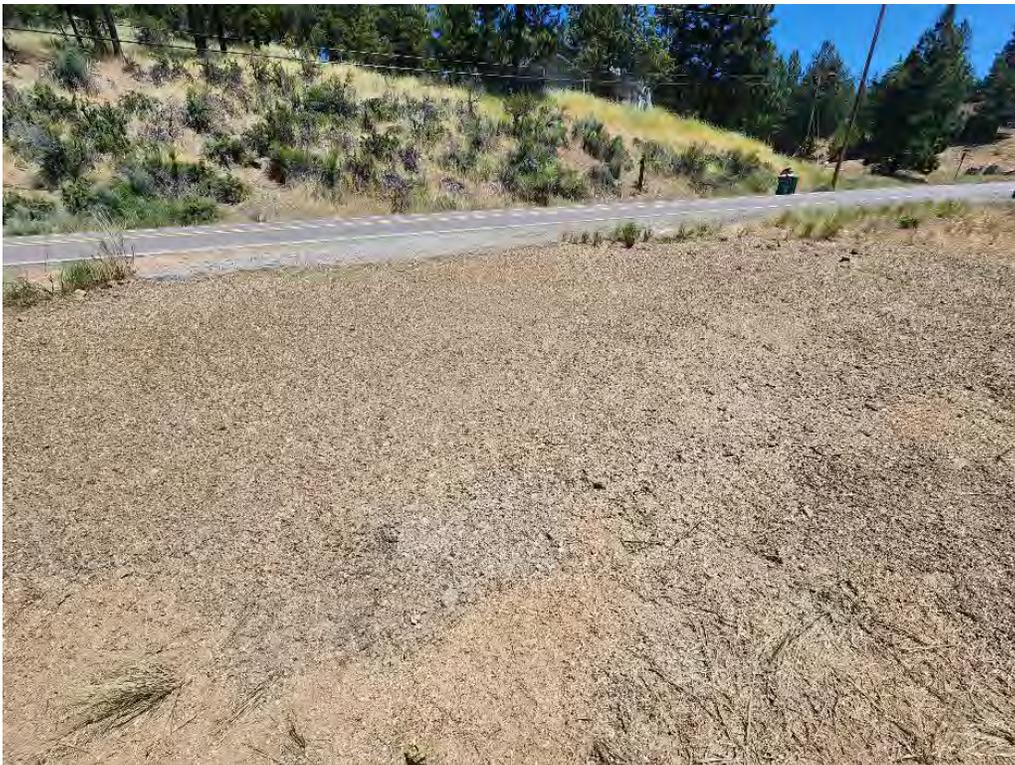
Parcel L – View of recent repairs along Northeast side of Parcel adjoining North Fort Road.

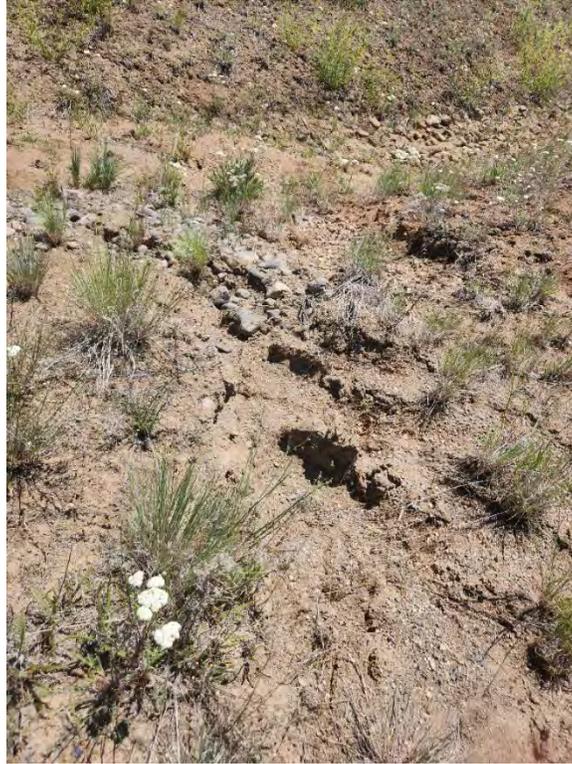
Parcel MBK-D – View of gully located near West side of Parcel.
