RE: Annual Inspection for Parcel D
North Ridge Estates Superfund Site
ECSI No. 5991

Lot D Inspection

2023 Annual Inspection Summary Report
North Ridge Estates - Operable Unit 1
Klamath Falls, Oregon

Figure
D.3

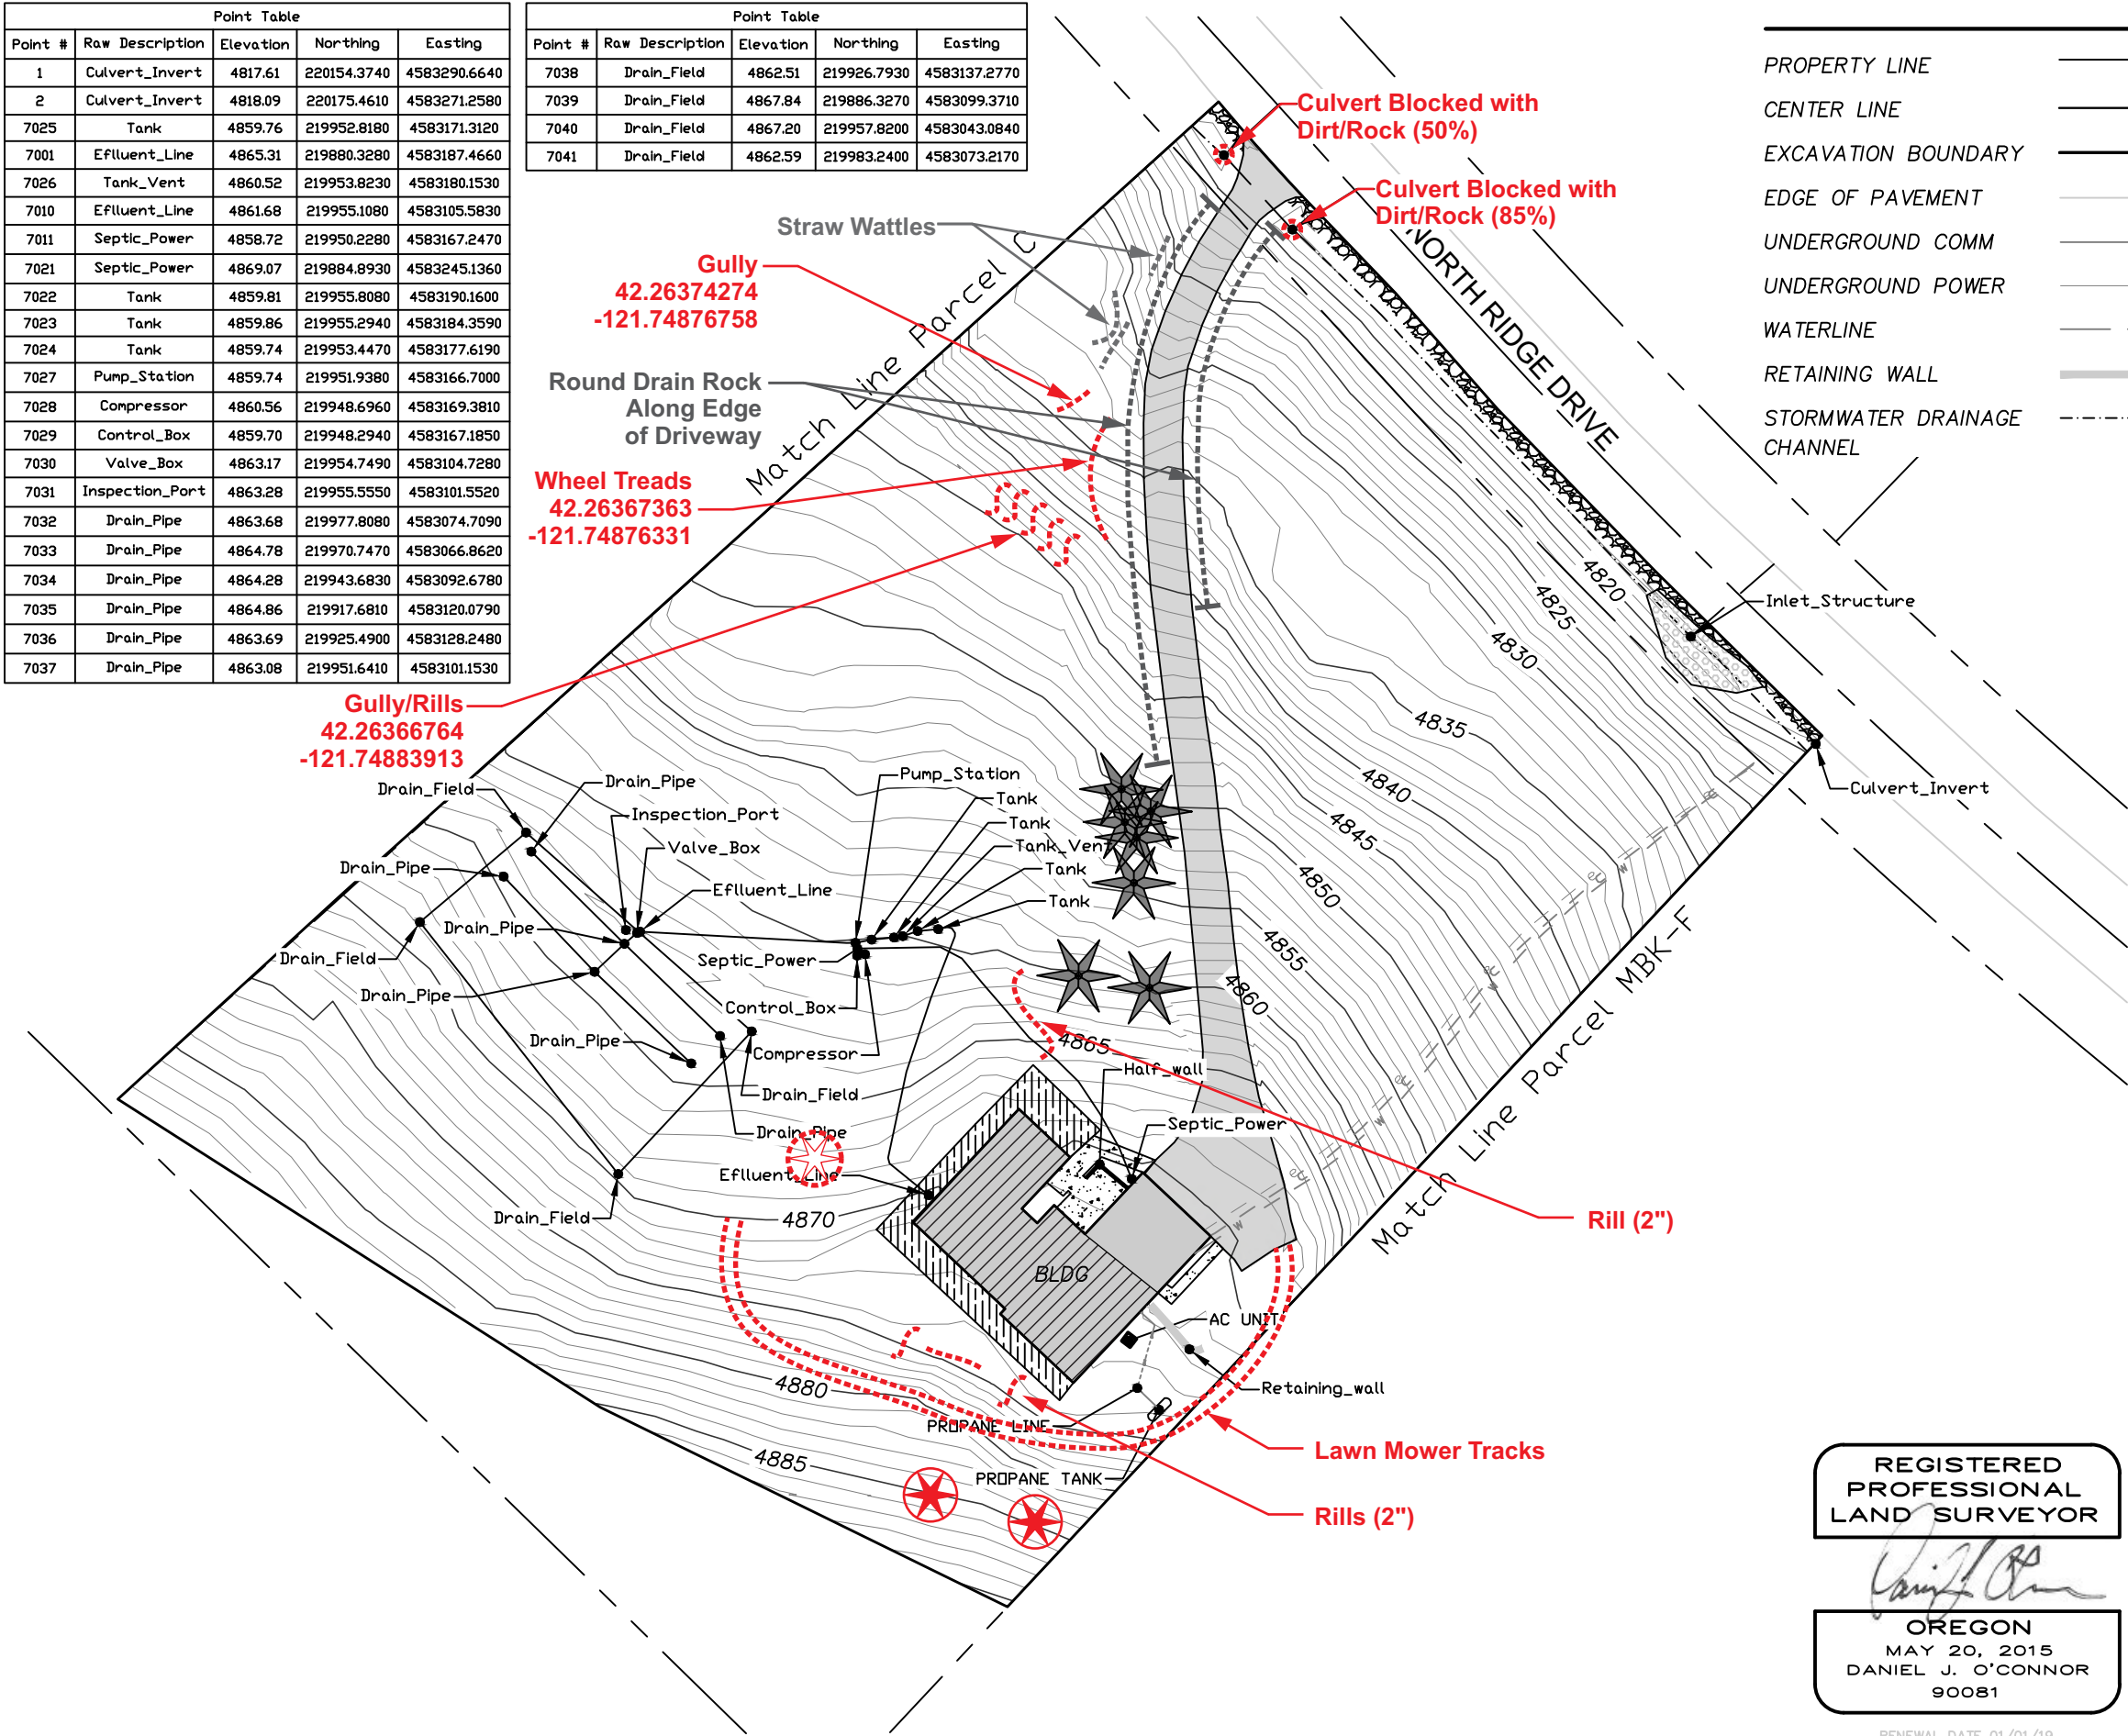
1. **Cap Damage.** Areas of damage (gullies, rills) to the soil protective cap have been noted (see enclosed figure).

Part I. General Site Information							
Site Name:		North Ridge Estates		State/County:		Oregon (Klamath County)	
EPA Point of Contact		Linda Meyer (206) 553-6636		ODEQ Point of Contact		Katie Daugherty (503) 860-3943	
Inspection Date:		7/4/2023		Person(s) Performing Inspection:		Ben Echt (Apex Companies, LLC)	
				Person(s) Performing Inspection:			
Part II. Remedy Performance Assessment							
Remedy Component	Potential Problem	Yes (Repair Needed)	Yes (Monitor/ No Repair)	No	N/A	If Yes, Describe Extent of Problem	Describe Potential Repair Solution
Protective Cap	Have rills developed deeper than 2 inches?	<input type="checkbox"/>	<input checked="" type="checkbox"/>	<input type="checkbox"/>	<input type="checkbox"/>	Rills were noted to the west of the residence and in the grass on the north corner of the residence. (same as 2022)	
	Are the rills within a 10-foot interval?	<input type="checkbox"/>	<input checked="" type="checkbox"/>	<input type="checkbox"/>	<input type="checkbox"/>	Approximately eight rills were present in the northwest portion of the parcel.

Have gullies developed deeper than 6 inches?	<input type="checkbox"/>	<input checked="" type="checkbox"/>	<input type="checkbox"/>	<input type="checkbox"/>	Gullies present in the west side of the driveway in the ditch.	
	Have animals created burrows in the protective cap?	<input type="checkbox"/>	<input type="checkbox"/>	<input checked="" type="checkbox"/>	<input type="checkbox"/>		
	Have vehicles damaged the protective cap?	<input type="checkbox"/>	<input checked="" type="checkbox"/>	<input type="checkbox"/>	<input type="checkbox"/>	Mower tracks were noted 4 to 6 inches deep on several portions of the parcel. (Same as 2022)	
	Any evidence of ACM on Site including areas where the protective cap is less than 2 feet (see as-built drawings) or within the dripline of the legacy trees?	<input type="checkbox"/>	<input type="checkbox"/>	<input checked="" type="checkbox"/>	<input type="checkbox"/>

Corrective Action. Fill in the damaged areas. Armor as needed to prevent reoccurrence by November 12, 2023.

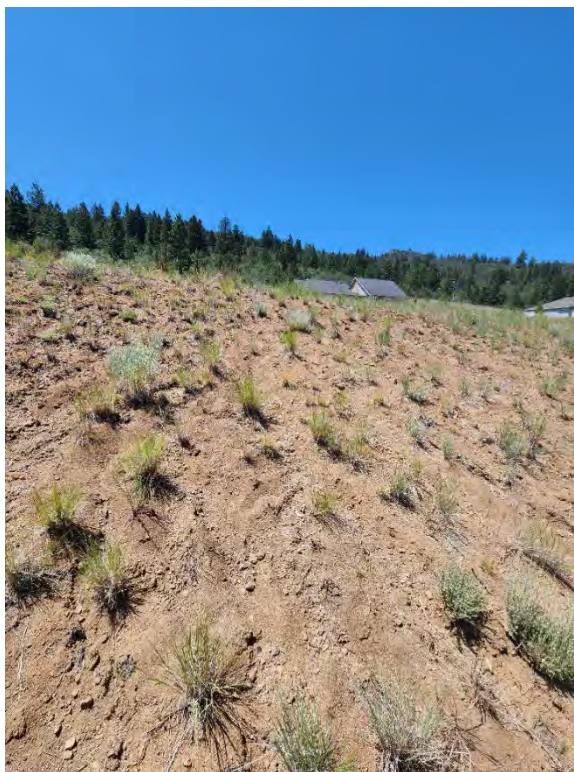
Parcel D – View of new additional Rills and Gullies on Northern portion of Parcel.

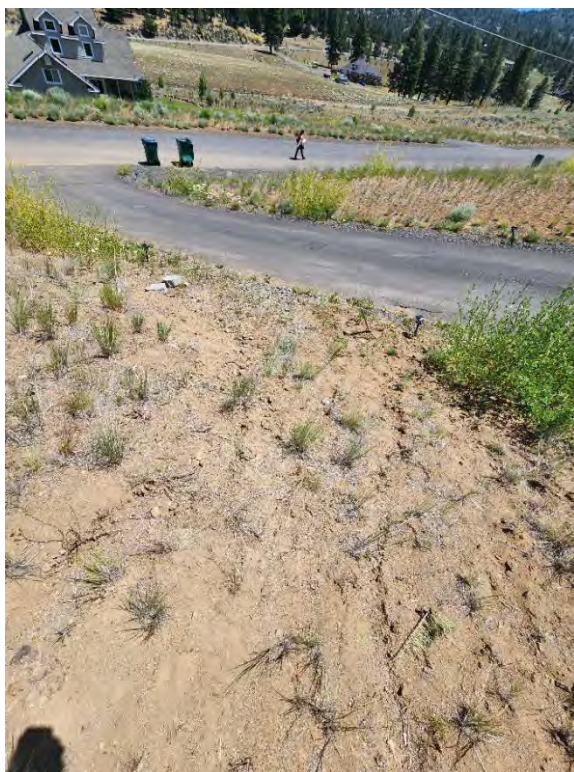
Parcel D – Gully observed on Northern area of Parcel, near driveway.

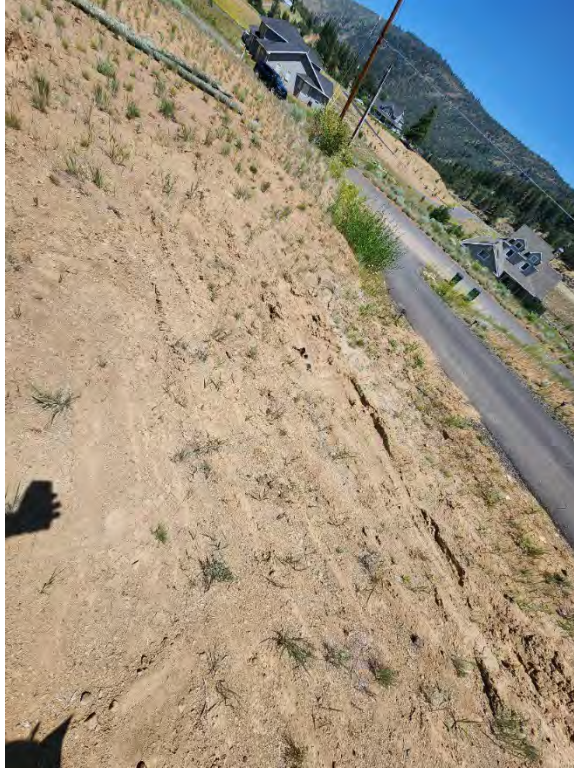
Parcel D – Tire Tracks observed west of driveway.
