RE: Annual Inspection for Parcel C  
North Ridge Estates Superfund Site  
ECSI No. 5992

The Oregon Department of Environmental Quality (DEQ) completed an annual inspection of the protective cap on your property located at 3508 North Ridge Drive during the week of July 3, 2023. Enclosed for your information is a summary of the inspection and recommended actions.

***Parcel C***

Operations and Maintenance Inspection Form

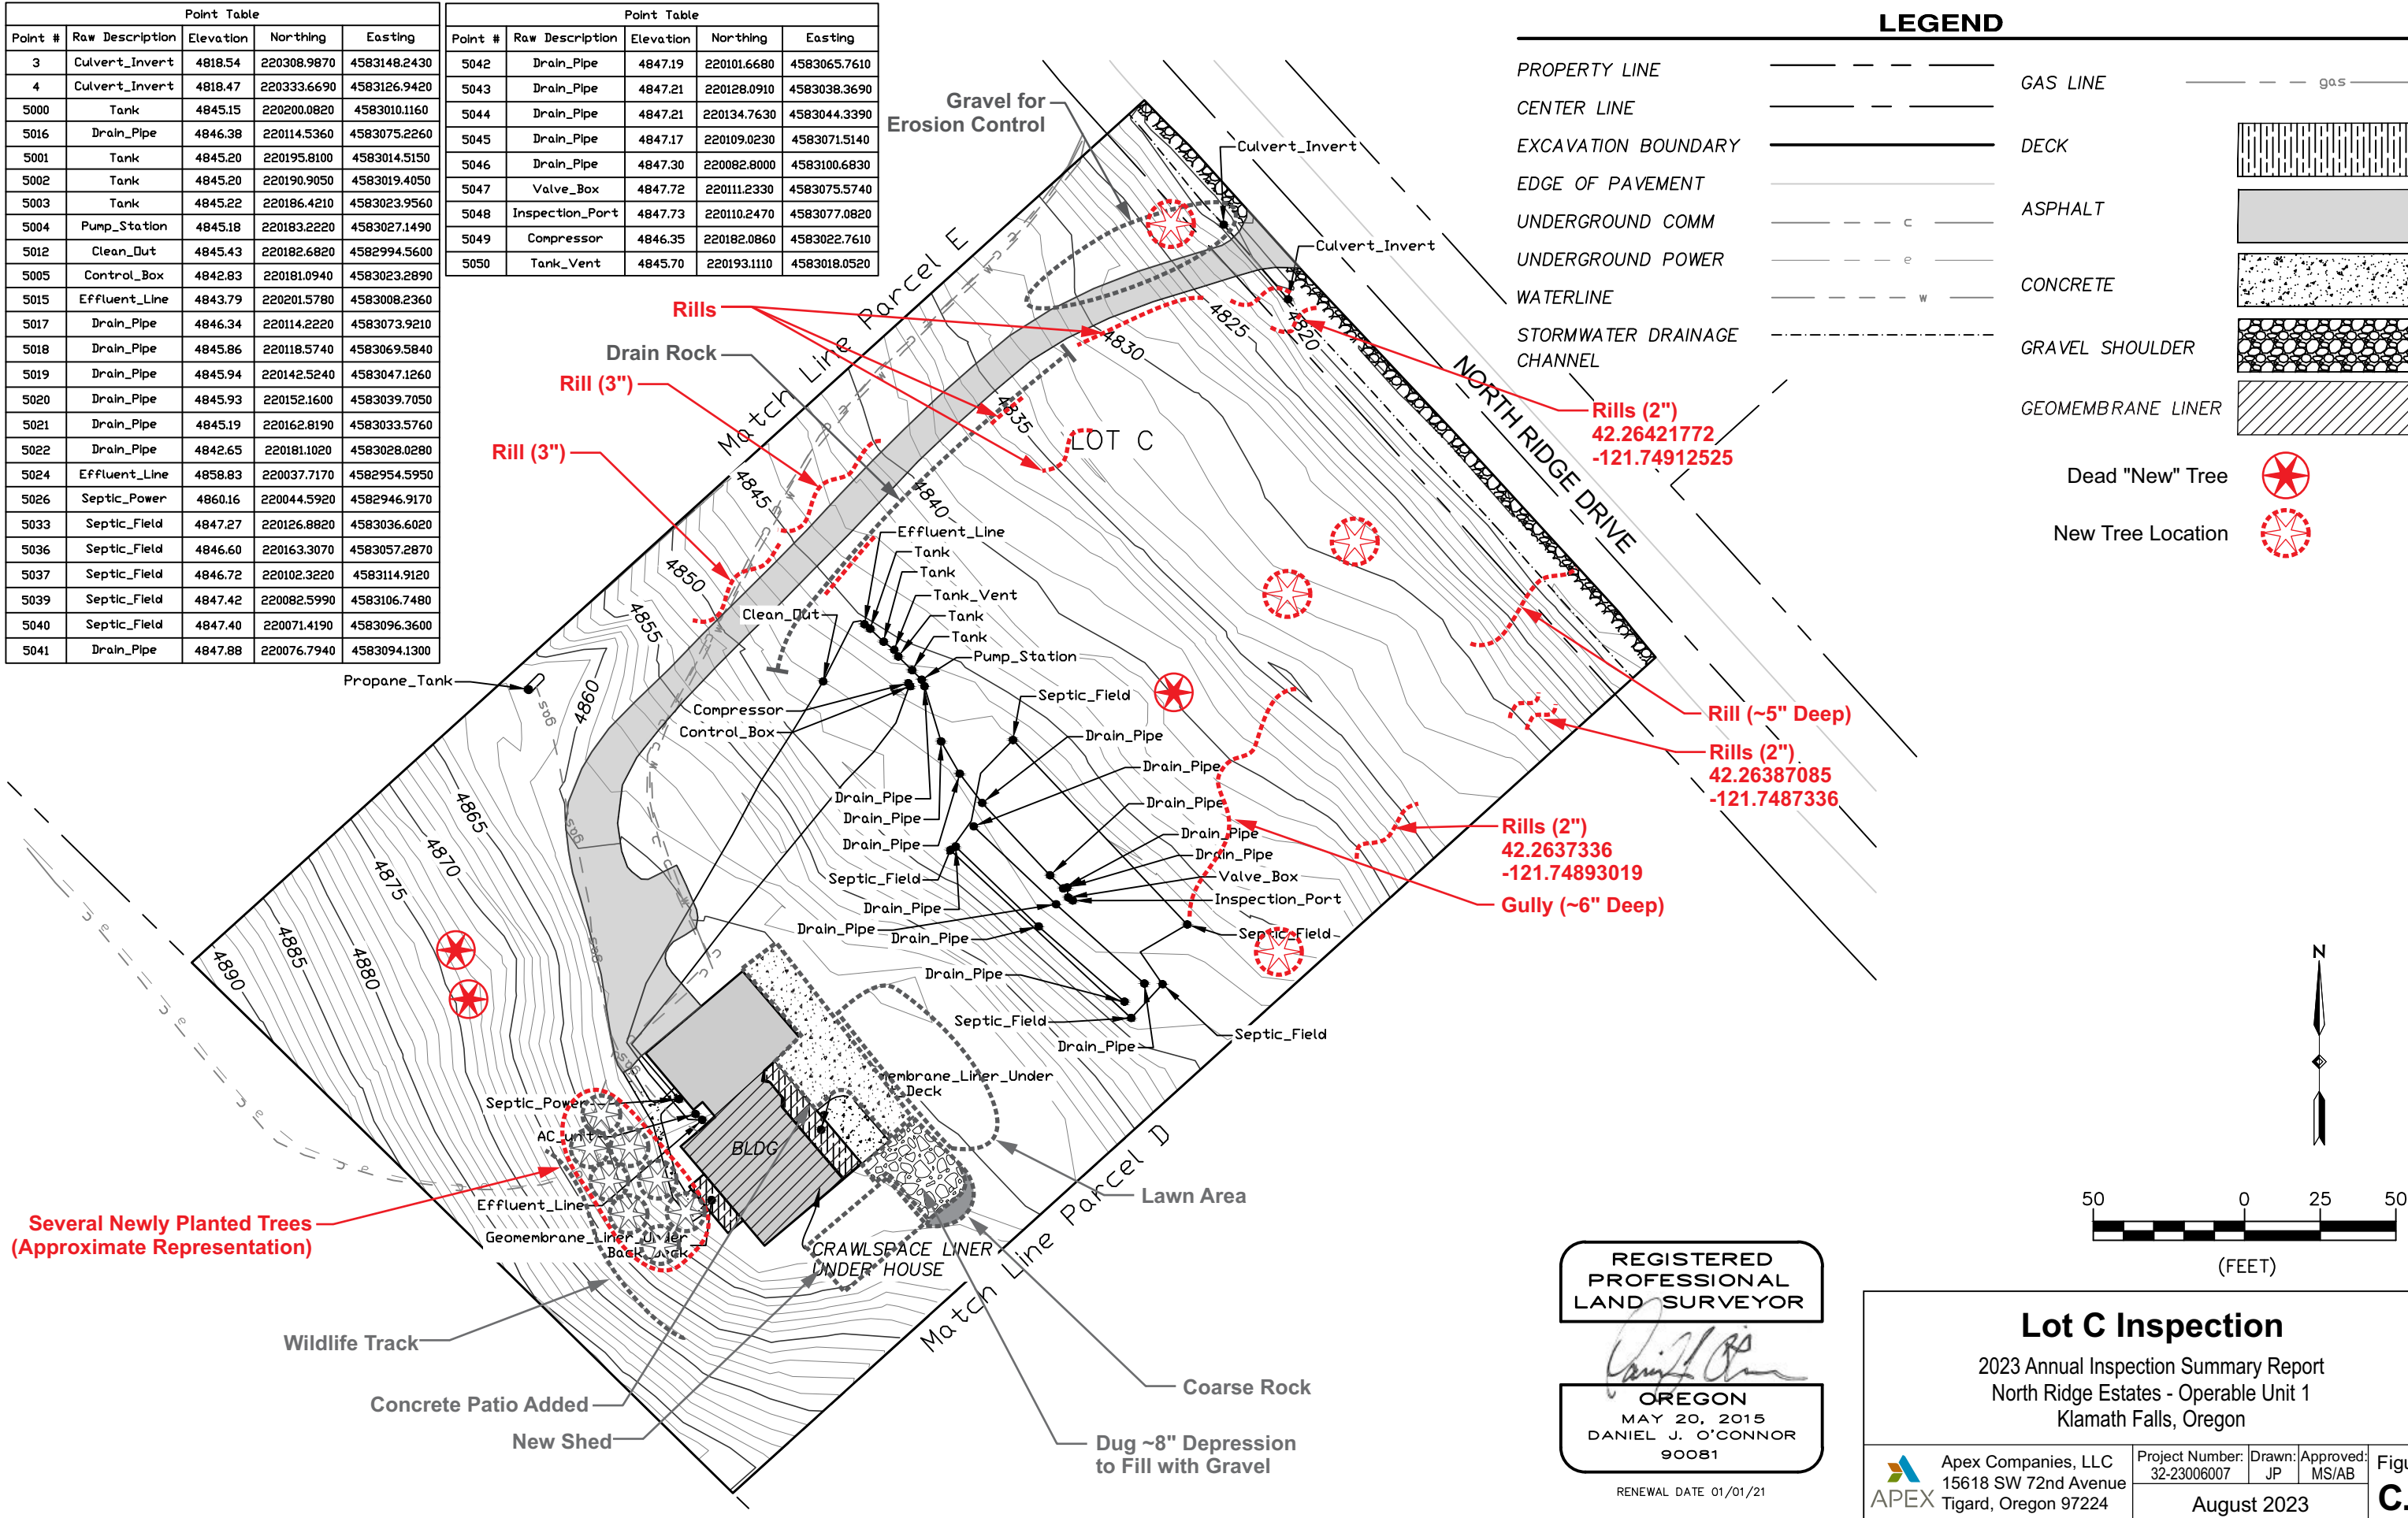
- 1 **Cap Damage.** Areas of damage (gully, rills) to the soil protective cap have been noted (see enclosed figure).

**Corrective Action.** Fill in the damaged areas. Armor as needed to prevent reoccurrence by November 12, 2023.

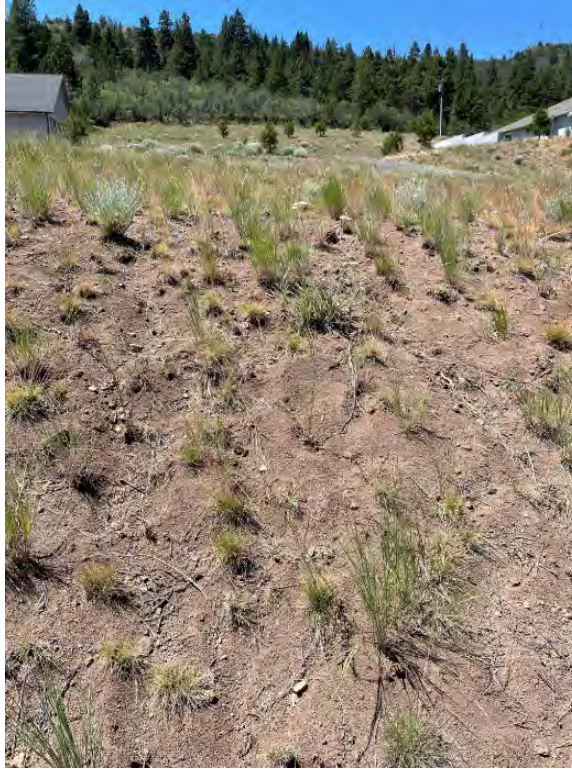
Parcel C – New Rill present in the Northwest corner of the Parcel on the East side of the driveway.

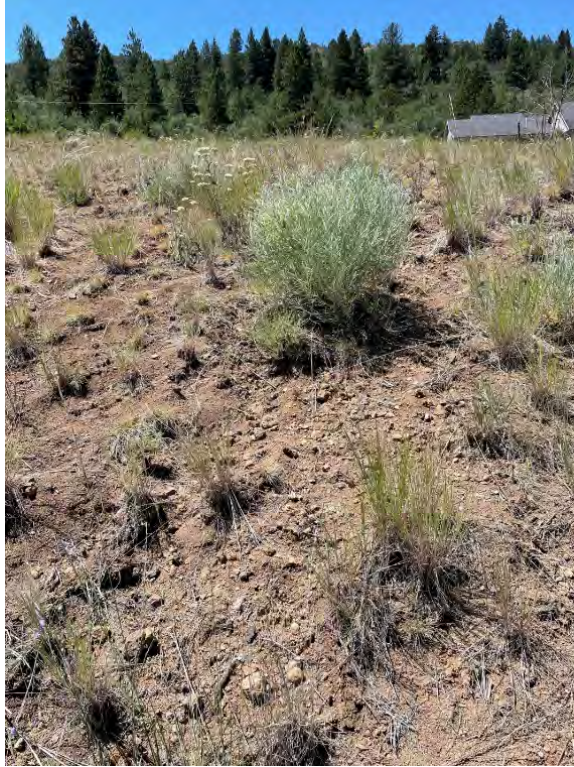
Have gullies developed deeper than 6 inches?	<input type="checkbox"/>	<input checked="" type="checkbox"/>	<input type="checkbox"/>	<input type="checkbox"/>	Gullies were noted on the south side of the driveway and in the eastern portion of the parcel. (Same as 2022)	
	Have animals created burrows in the protective cap?	<input type="checkbox"/>	<input type="checkbox"/>	<input checked="" type="checkbox"/>	<input type="checkbox"/>		
	Have vehicles damaged the protective cap?	<input type="checkbox"/>	<input type="checkbox"/>	<input checked="" type="checkbox"/>	<input type="checkbox"/>		
	Any evidence of ACM on Site including areas where the protective cap is less than 2 feet (see as-built drawings) or within the dripline of the legacy trees?	<input type="checkbox"/>	<input type="checkbox"/>	<input checked="" type="checkbox"/>	<input type="checkbox"/>		
	Are there areas that show evidence of unstable slopes, subsidence, or slope failure? Are there signs of active bank erosion and/or lateral cutting?	<input type="checkbox"/>	<input type="checkbox"/>	<input checked="" type="checkbox"/>	<input type="checkbox"/>

Parcel C – Gully present, likely caused by stormwater from drainage pipe.
