Department of Environmental Quality
Northwest Region
700 NE Multnomah Street, Suite 600
Portland, OR 97232
(503) 229-5263
FAX (503) 229-6945
TTY 711

RE: Annual Inspection for Parcel C
North Ridge Estates Superfund Site
ECSI No. 5992

North Ridge Estates Remedy Performance Assessment

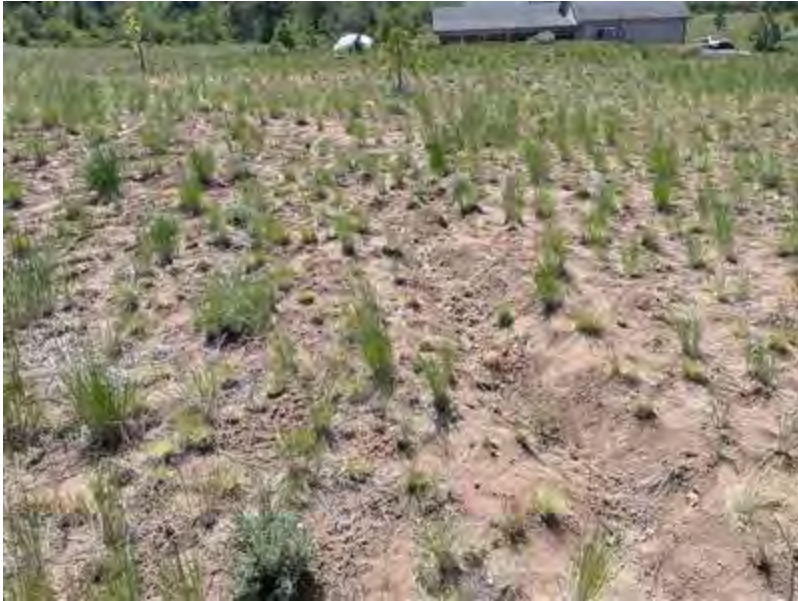
Have gullies developed deeper than 6 inches?

Yes (Repair Needed)

Gully near east corner of parcel

- 1 **Cap Damage.** Areas of damage (gully, rills) to the soil protective cap have been noted (see enclosed figure). **Corrective Action.** Fill in the damaged areas. Armor as needed to prevent reoccurrence by October 31, 2024.
- 2 **Vegetation.** An area of sparse vegetation was noted. **Corrective Action.** Vegetate this area prior to May 2025.

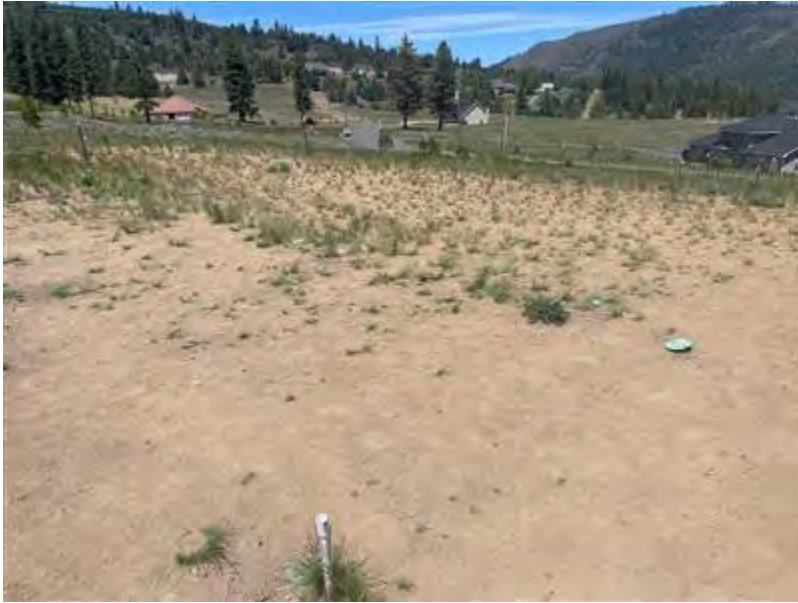
Evidence of distressed or sparse vegetation? (sparse vegetation no greater than 10 percent of area and bare areas no greater than 100 square feet)

Yes (Repair Needed)

Sparse vegetation (~1,500 SF)

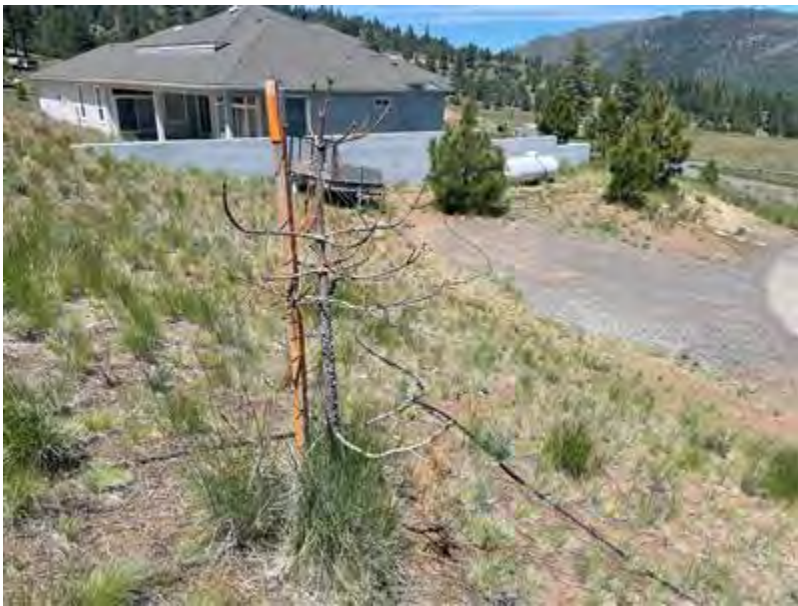
Evidence of trees and shrubs in distress?

Yes (Repair Needed)

Dead tree

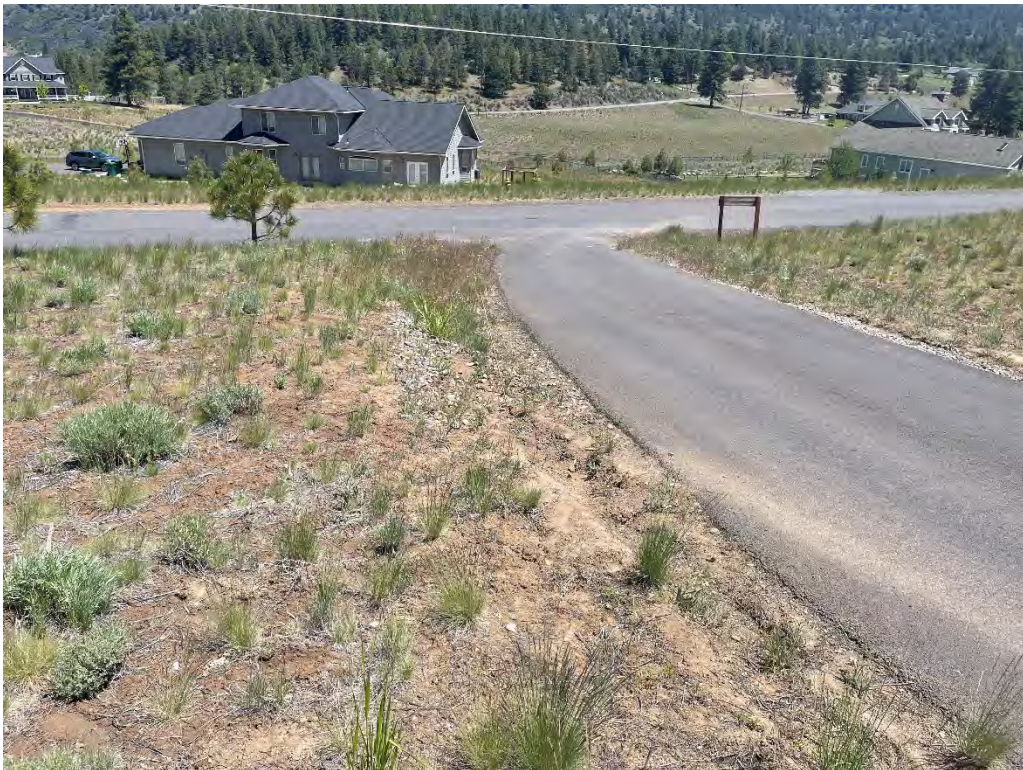
Parcel C – Minor gully forming along edge of driveway, facing Northeast.
