RE: Annual Inspection for Parcel B
North Ridge Estates Superfund Site
ECSI No. 5993

Operations and Maintenance Inspection Form

2023 Annual Inspection Summary Report
North Ridge Estates - Operable Unit 1
Klamath Falls, Oregon

Figure
B.3

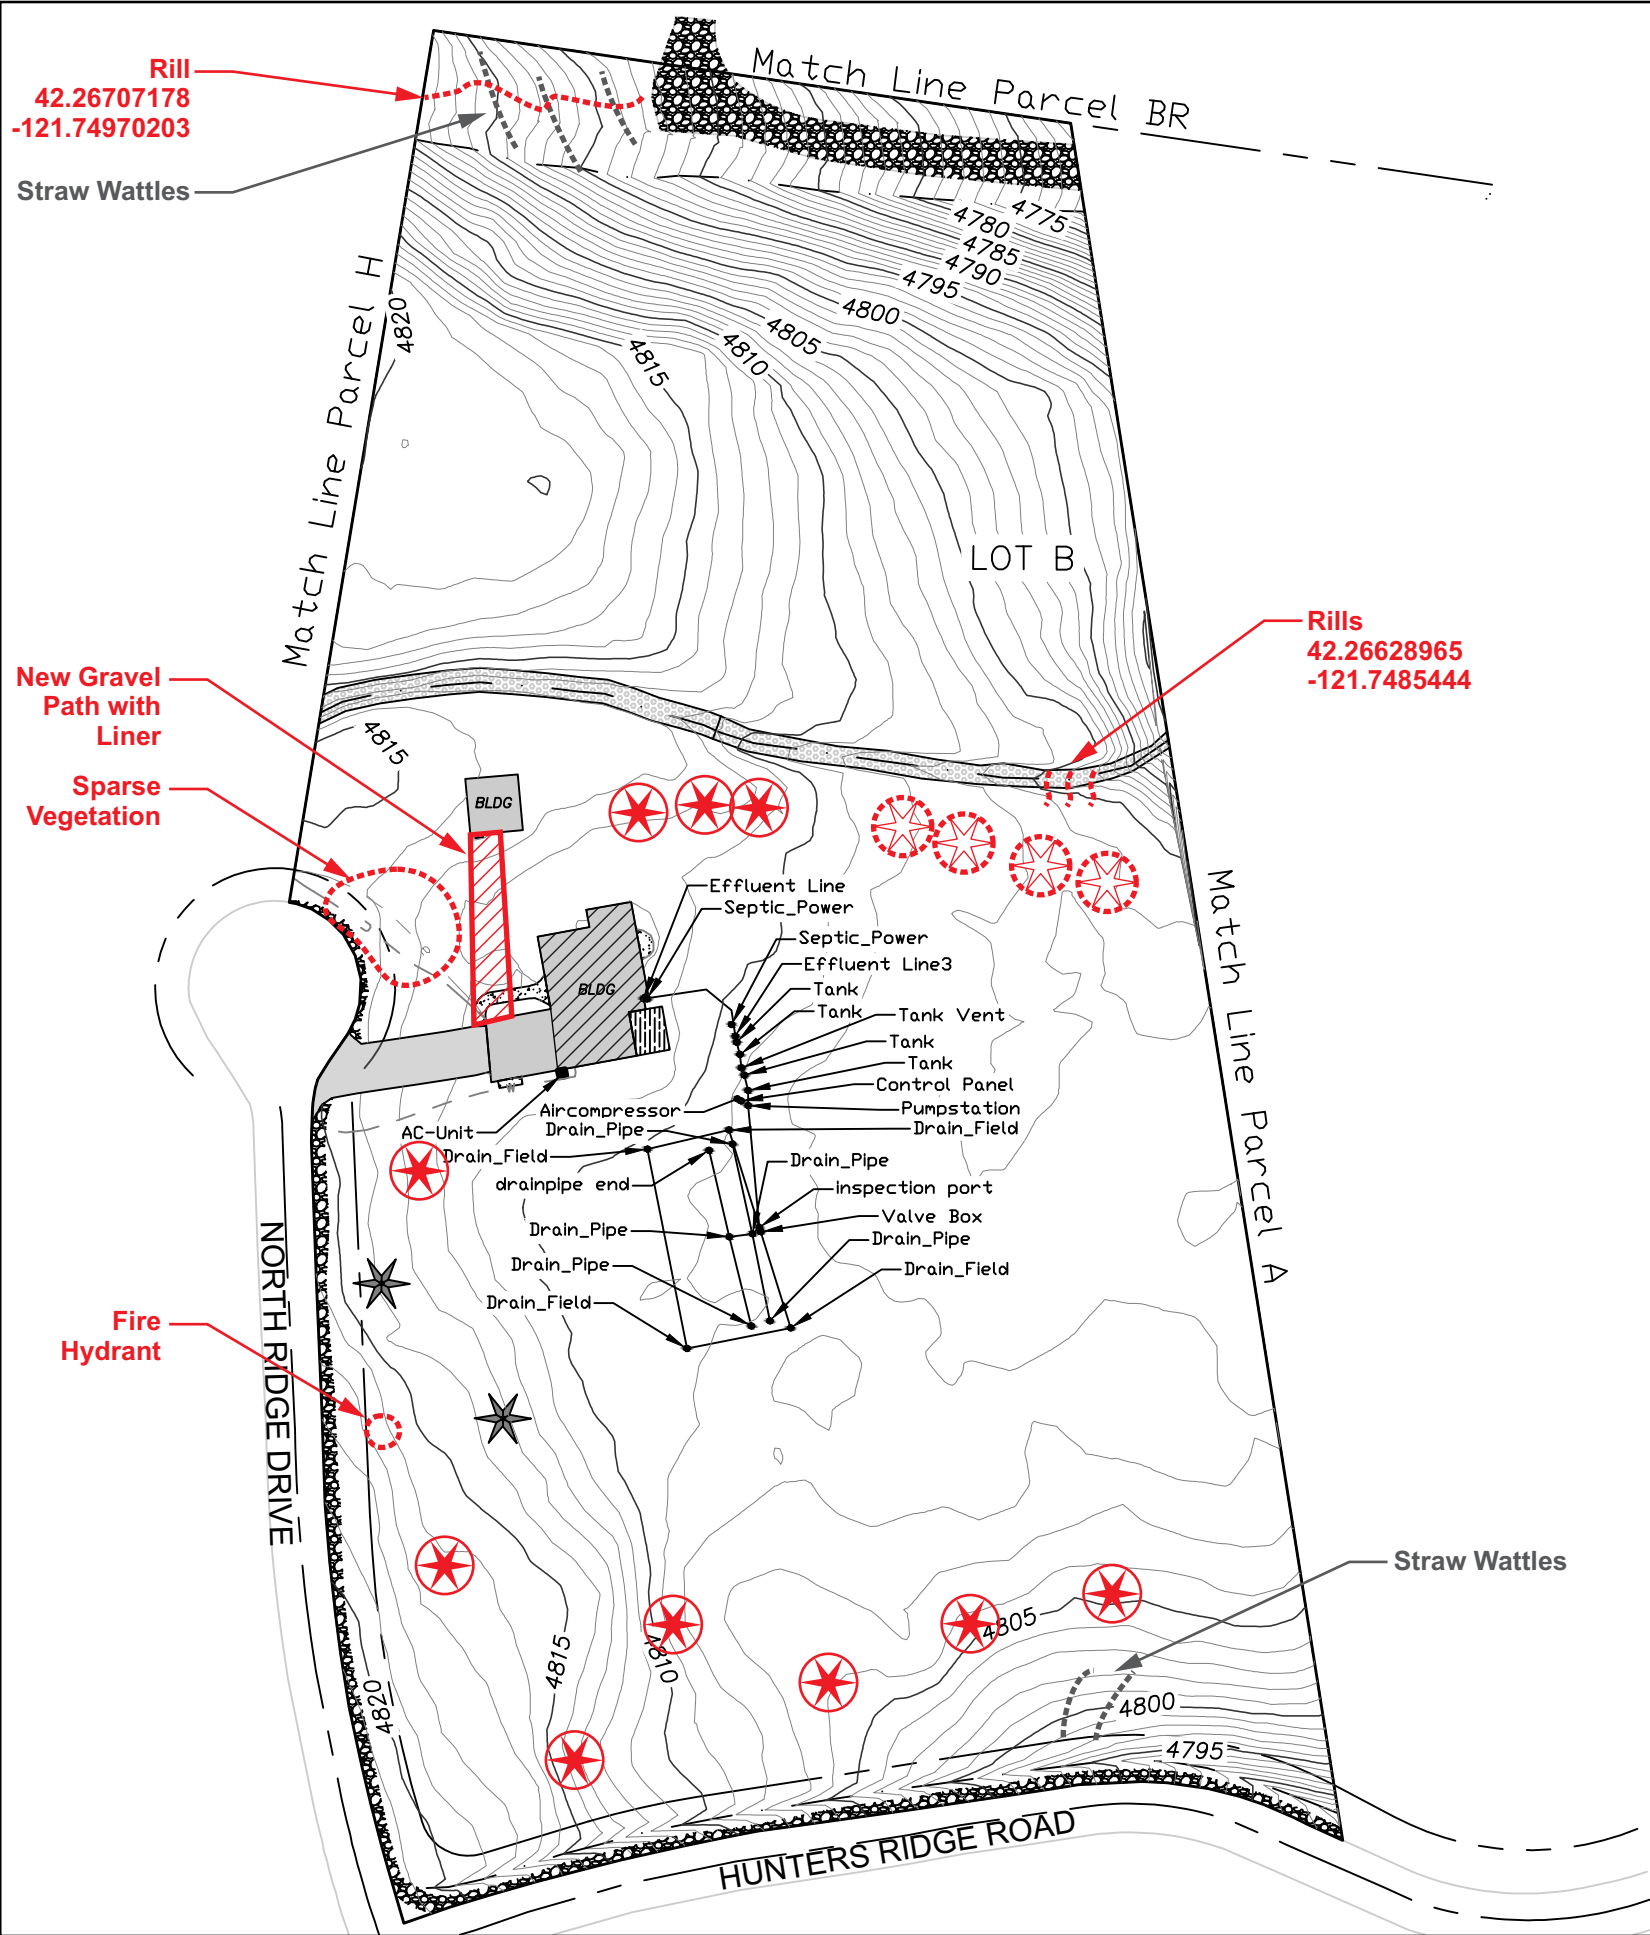
2. **Cap Damage.** Areas of damage (rills) to the soil protective cap have been noted (see enclosed figure).

Corrective Action. Fill in the damaged areas. Armor as needed to prevent reoccurrence by November 12, 2023.

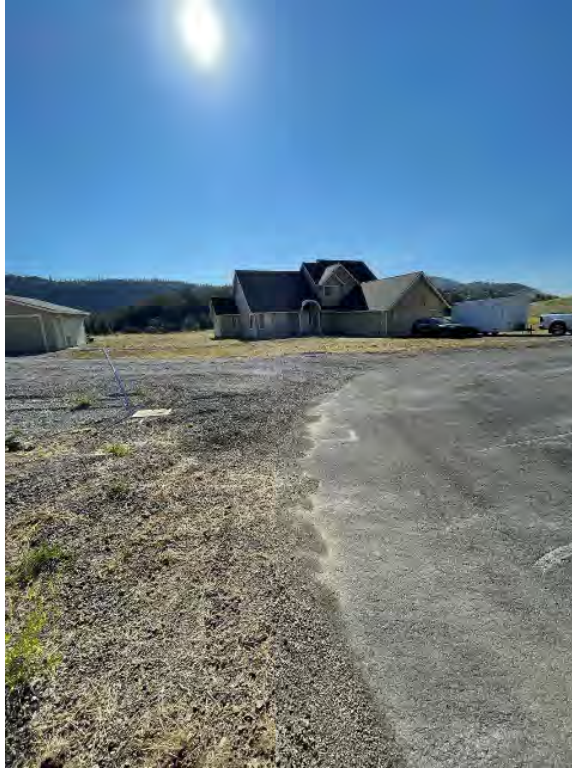
Parcel B – Central corner of Parcel, facing East.

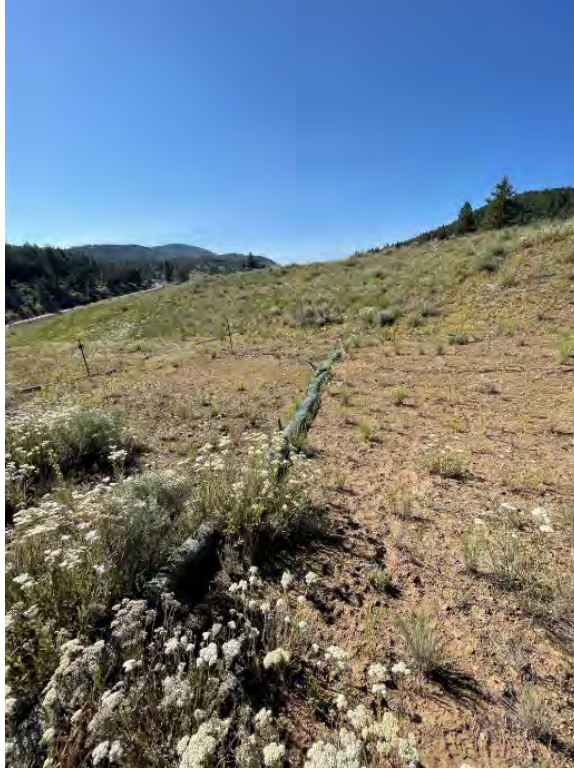
Parcel B – Northwest corner of Parcel, facing Southeast.

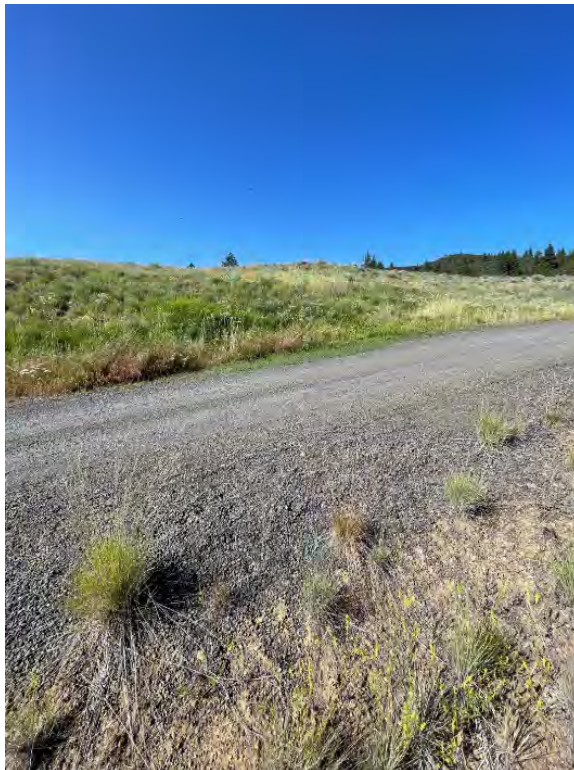
Parcel B – Northeast corner of Parcel, facing Southwest.

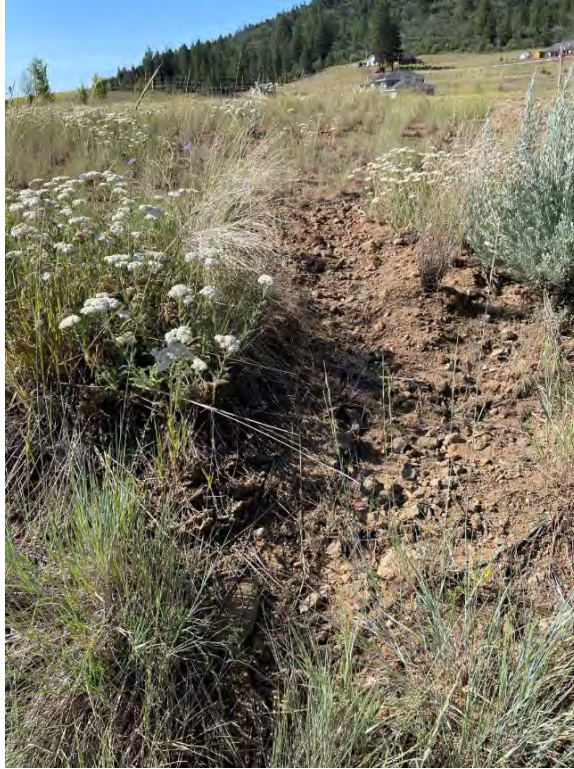
Part I. General Site Information							
Site Name:		North Ridge Estates		State/Country:		Oregon (Klamath County)	
EPA Point of Contact		Linda Meyer (206) 553-6636		ODEQ Point of Contact		Katie Daugherty (503) 860-3943	
Inspection Date:		7/4/2023		Person(s) Performing Inspection:		Alex Evernden (Apex Companies, LLC)	
Parcel/Tax ID:		Parcel B					
Part II. Remedy Performance Assessment							
Remedy Component	Potential Problem	Yes (Repair Needed)	Yes (Monitor/ No Repair)	No	N/A	If Yes, Describe Extent of Problem	Describe Potential Repair Solution
Protective Cap	Have rills developed deeper than 2 inches?	<input type="checkbox"/>	<input type="checkbox"/>	<input checked="" type="checkbox"/>	<input type="checkbox"/>		
	Are the rills within a 10-foot interval?	<input type="checkbox"/>	<input checked="" type="checkbox"/>	<input type="checkbox"/>	<input type="checkbox"/>	A set of rills approximately 6 inches apart were located along the downslope channel on the east side of the parcel.

Parcel B – New Rill at channel on East side of Parcel.

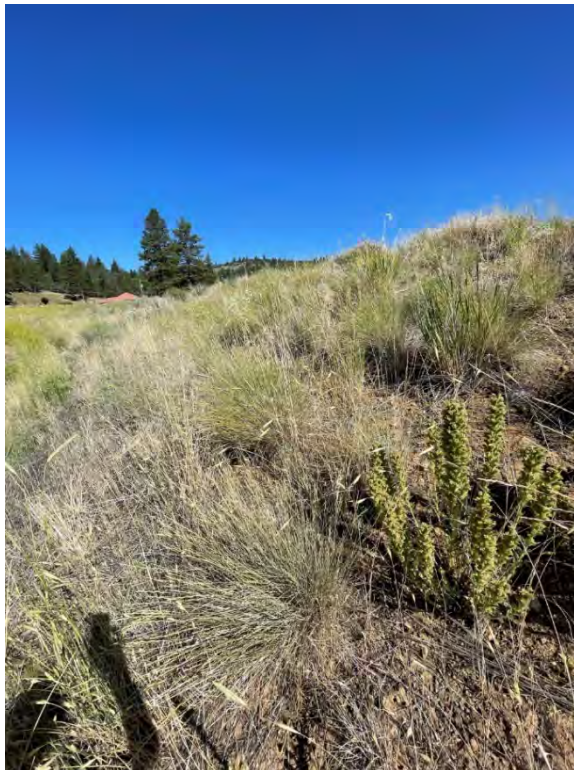
Parcel B – Southeast corner of Parcel, facing Northwest.

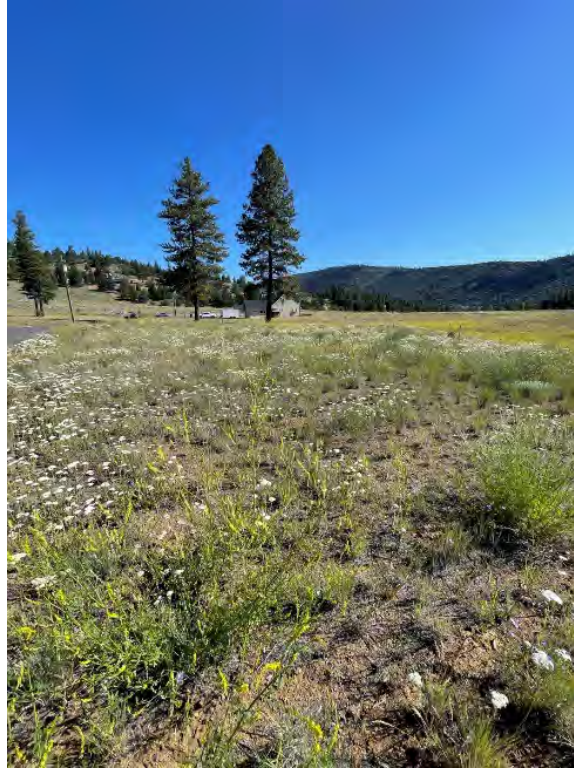
Parcel B – Southwest corner, facing Northeast.
