RE: Annual Inspection for Parcel A
North Ridge Estates Superfund Site
ECSI No. 5994

The Oregon Department of Environmental Quality completed an annual inspection of the protective cap on your property located at 3637 Hunters Ridge Road during the week of July 3, 2023. Enclosed for your information is a summary of the inspection and recommended actions.

Part I. General Site Information							
Site Name:		North Ridge Estates		State/County:		Oregon (Klamath County)	
EPA Point of Contact		Linda Meyer (206) 553-6636		ODEQ Point of Contact		Katie Daugherty (503) 860-3943	
Inspection Date:		7/4/2023		Person(s) Performing Inspection:		Alex Evernden (Apex Companies, LLC)	
Parcel/Tax ID:		Parcel A					
Person(s) Performing Inspection:							
Part II. Remedy Performance Assessment							
Remedy Component	Potential Problem	Yes (Repair Needed)	Yes (Monitor/ No Repair)	No	N/A	If Yes, Describe Extent of Problem	Describe Potential Repair Solution
Protective Cap	Have rills developed deeper than 2 inches?	<input type="checkbox"/>	<input type="checkbox"/>	<input checked="" type="checkbox"/>	<input type="checkbox"/>		
	Are the rills within a 10-foot interval?	<input type="checkbox"/>	<input checked=

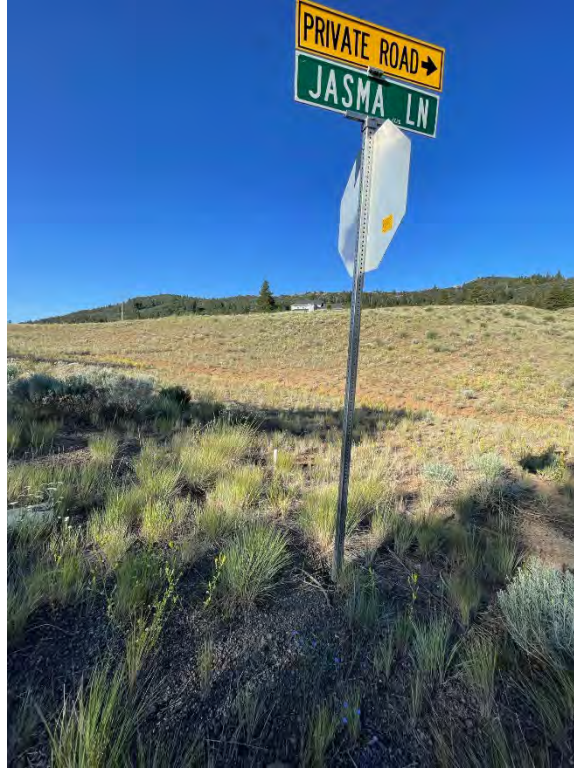
Parcel A – Northeast corner of Parcel, facing Southwest.

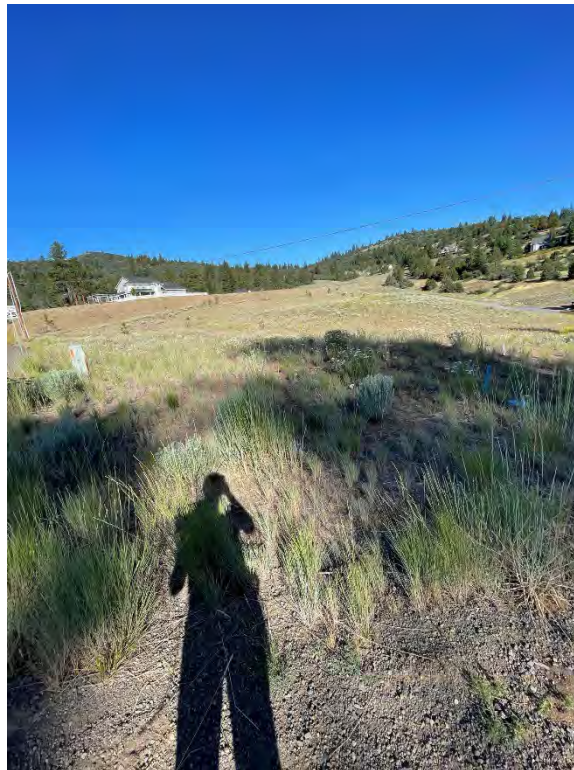
Parcel A – Southeast corner, facing Northwest.

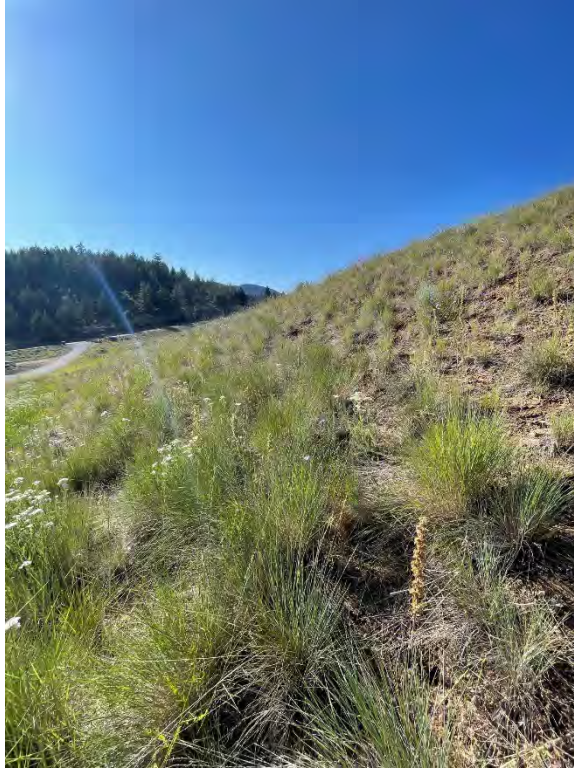
Parcel A – Northwest corner of Parcel, facing Southeast.

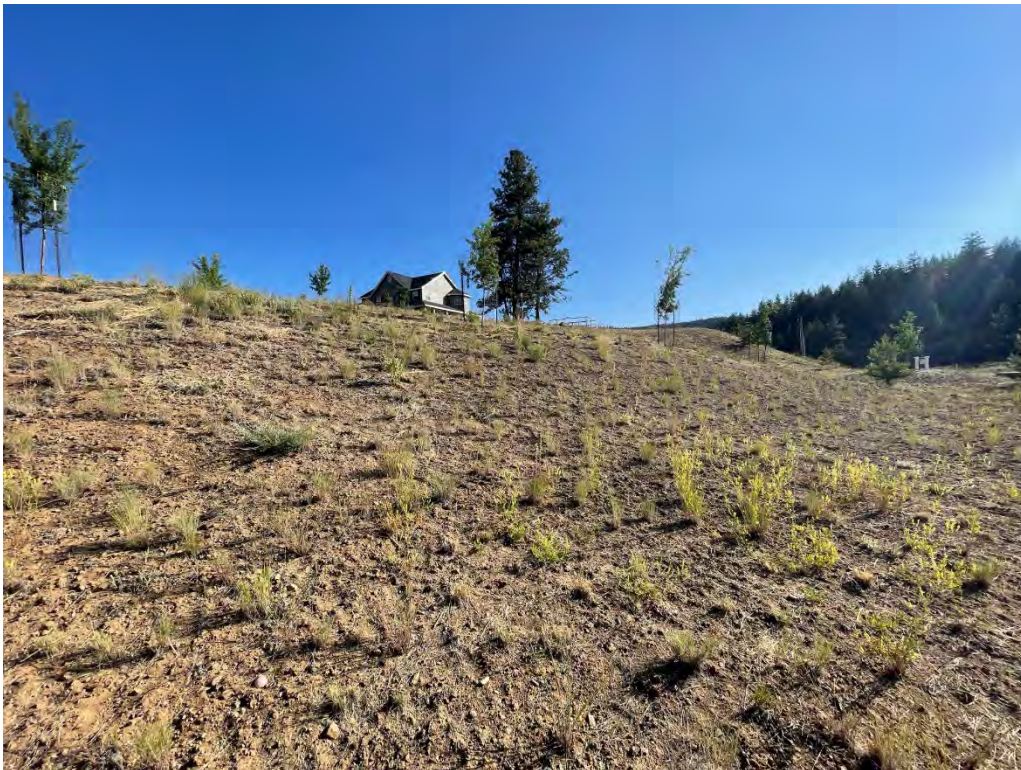
Parcel A – Southwest corner of Parcel, facing Northeast.

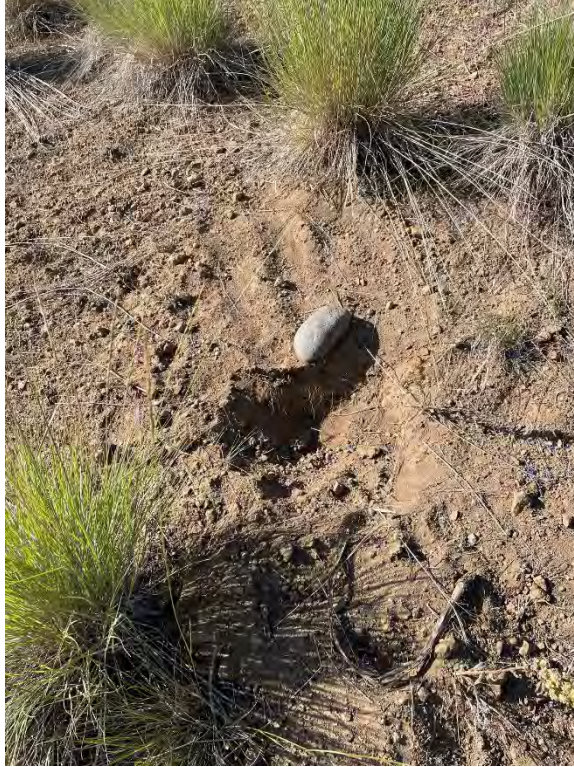
2. **Cap Damage.** Areas of damage (rills, tire tracks, burrows) to the soil protective cap have been noted (see enclosed figure).

Parcel A – New animal burrow (4 inches deep) located on the North side of the parcel.

Corrective Action. Fill in the damaged areas. Armor as needed to prevent reoccurrence by November 12, 2023.

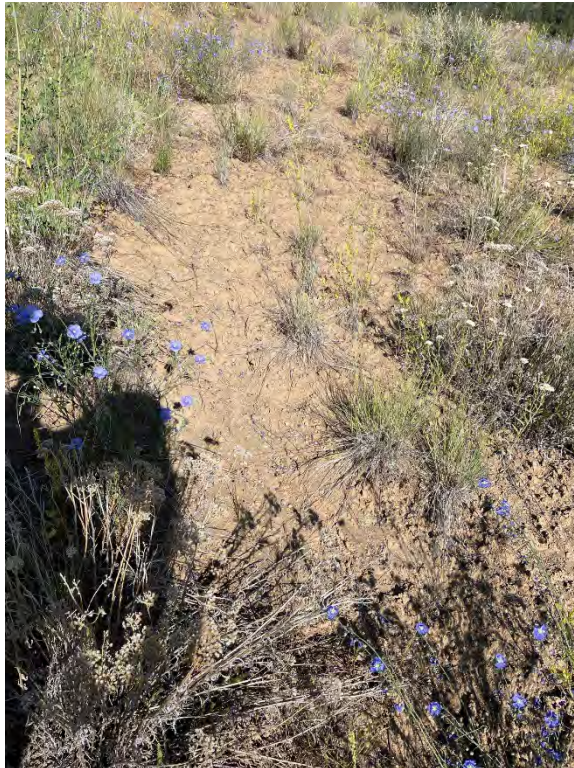
Parcel A – New rill location on the North side of the Parcel.

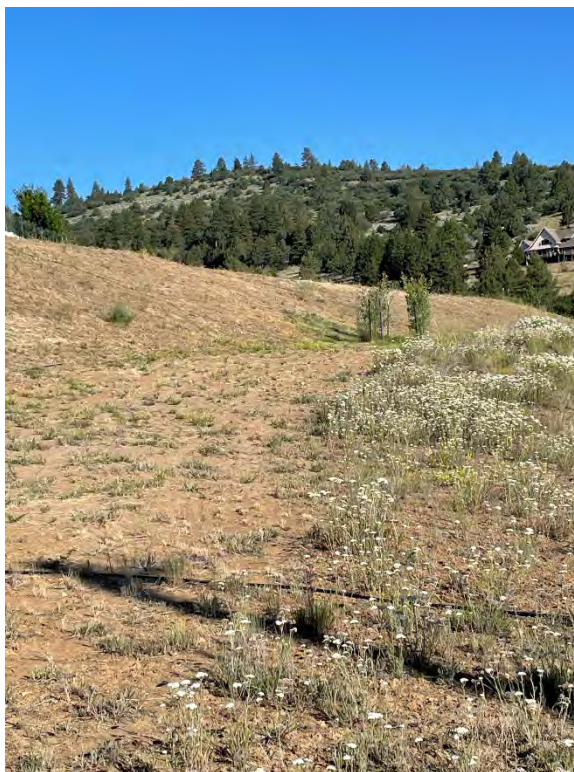
1. **Vegetation.** Areas of sparse vegetation were noted, similar to previous inspection.

Parcel A – Sparse vegetation along the Southeast side of the Parcel.

Corrective Action. Seed and water these areas to promote vegetation growth prior to June 2024.
