RE: Annual Inspection for Parcel E
North Ridge Estates Superfund Site
ECSI No. 5995

Parcel E

Operations and Maintenance Inspection Form

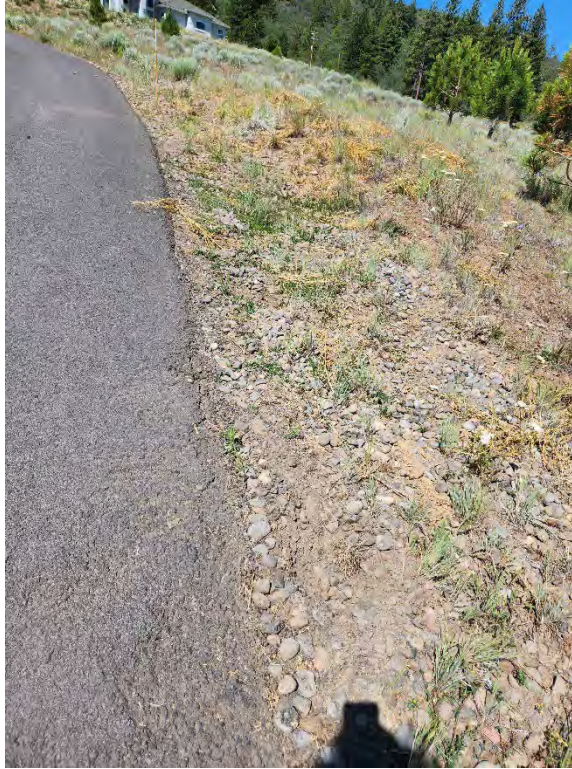
Are there any other signs of considerable damage to paved surfaces, other than normal wear and use?	<input type="checkbox"/>	<input type="checkbox"/>	<input checked="" type="checkbox"/>	<input type="checkbox"/>		
Crawlspace and Decks	Are the liners inside crawlspaces and under covered decks damaged or punctured?	<input type="checkbox"/>	<input type="checkbox"/>	<input checked="" type="checkbox"/>	<input type="checkbox"/>	No liners were observed.	
	Are the liners exposed to UV radiation?	<input type="checkbox"/>	<input type="checkbox"/>	<input checked="" type="checkbox"/>	<input type="checkbox"/>		
Access Controls	Are access controls damaged?	<input type="checkbox"/>	<input type="checkbox"/>	<input type="checkbox"/>	<input checked="" type="checkbox"/>		
	Are changes to the access controls needed?	<input type="checkbox"/>		<input type="checkbox"/>	<input checked="" type="checkbox"/>		
Miscellaneous Features / Changes in Site Conditions / Misc.	Are there any new site features installed that have damaged the protective cap?	<input type="checkbox"/>	<input type="checkbox"/>	<input checked="" type="checkbox"/>	<input type="checkbox"/>	Small retaining wall present along the east side of the driveway. Grass landscaping has been added to the east side of the residence. A small gravel shoulder and round rock were noted on the eastern corner of the parcel by North Ridge Drive.

Parcel E – Divots in shoulder of road on Northeast portion of Parcel.
