RE: Annual Inspection for Parcel F  
North Ridge Estates Superfund Site  
ECSI No. 5996

***Parcel F***

## Operations and Maintenance Inspection Form

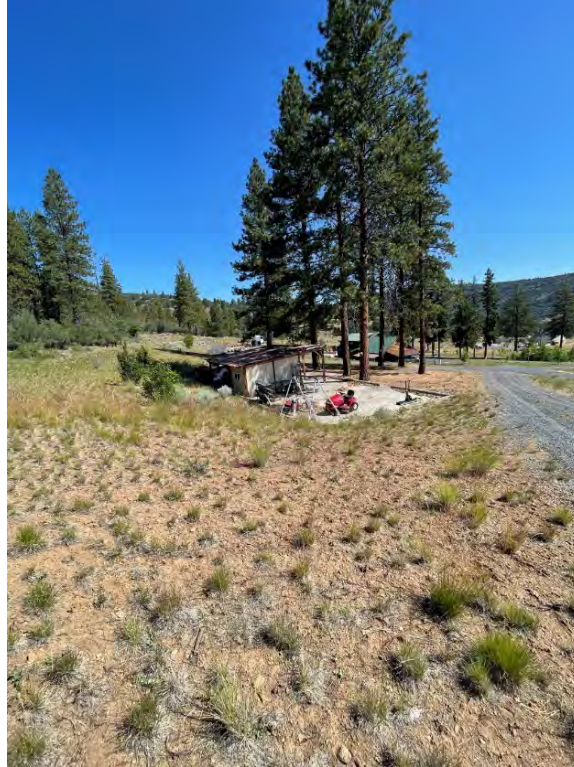
Parcel F – Southwest corner of Parcel, facing Northeast.

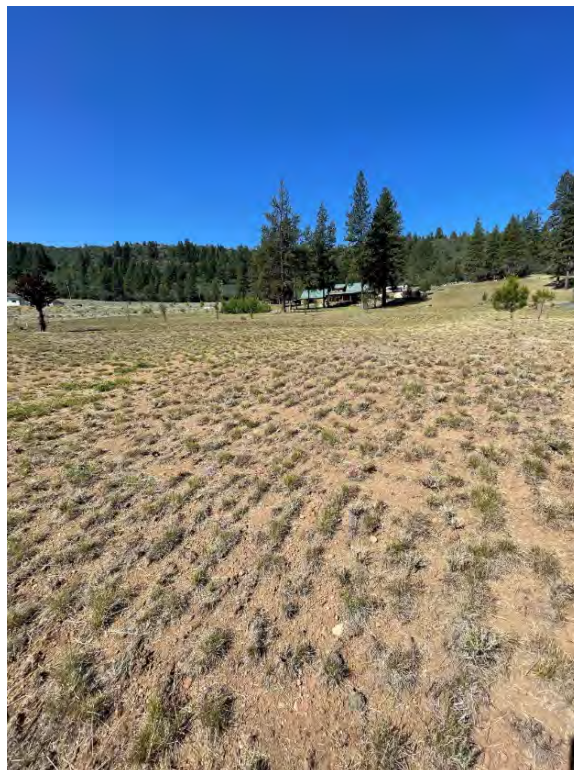
Parcel F – Northeast corner of Parcel, facing Southwest.

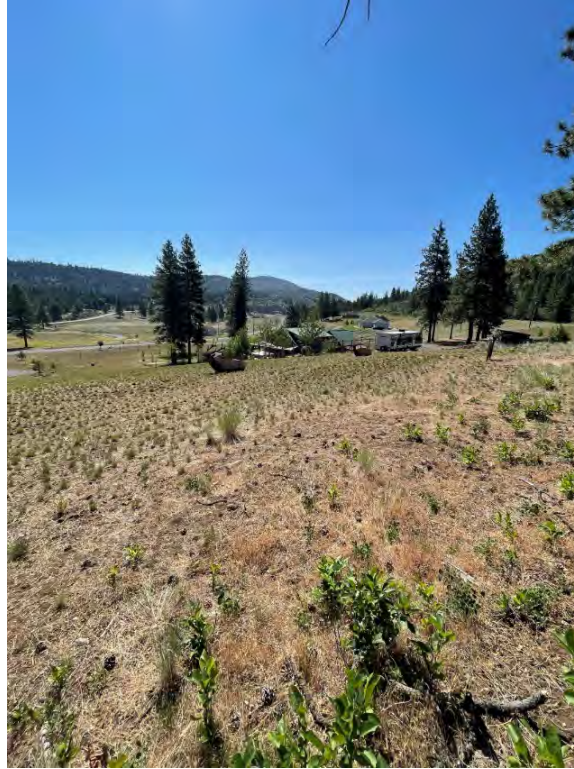
Parcel F – Northwest corner of Parcel, facing Southeast.

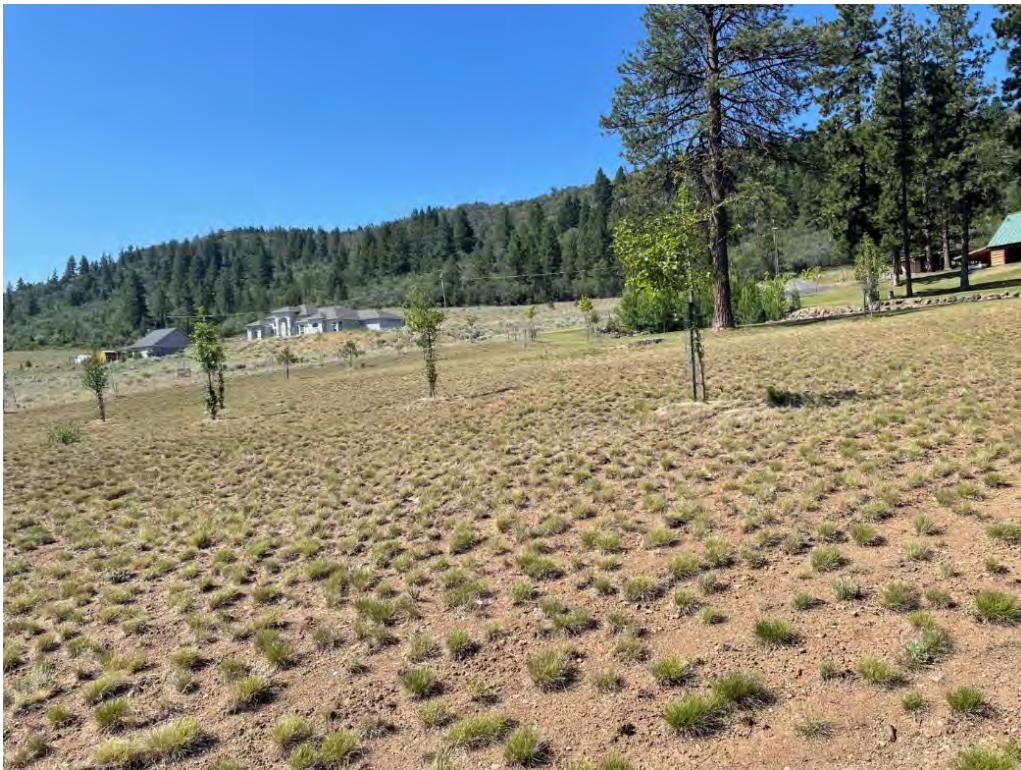
Parcel F – Newly planted Trees on the East side of the Parcel.

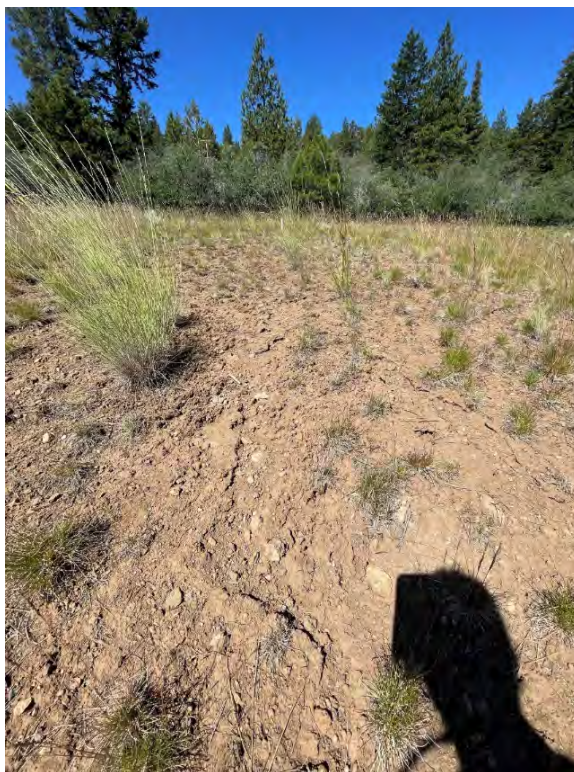
Parcel F – New Rill on the Southwest side of the Parcel.

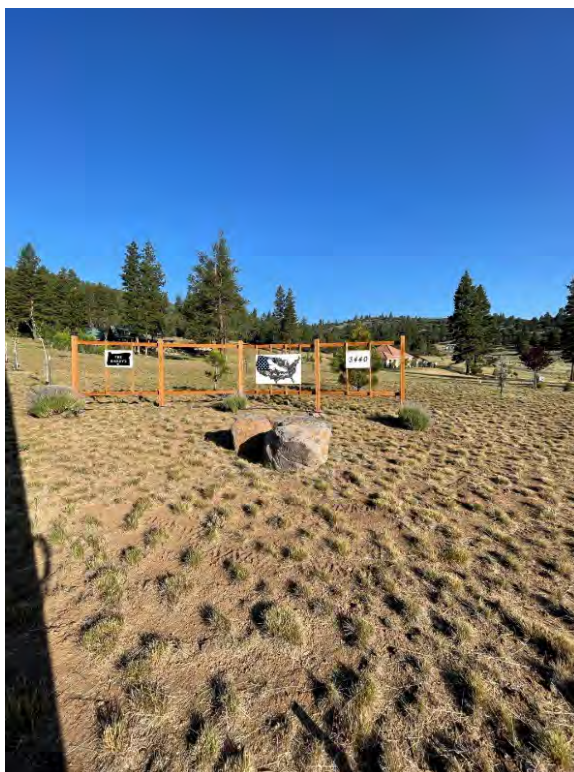
Parcel F – Southwest corner, facing Northeast.
