RE: Annual Inspection for Parcel G  
North Ridge Estates Superfund Site  
ECSI No. 5997

***Parcel G***

2023 Annual Inspection Summary Report  
North Ridge Estates - Operable Unit 1  
Klamath Falls, Oregon

Figure  
G.3

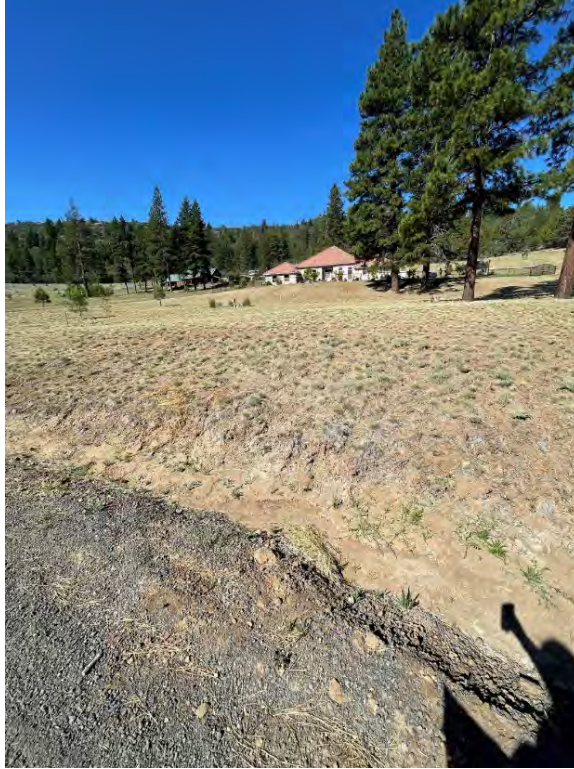
Parcel G – Northeast corner of Parcel, facing Southwest.

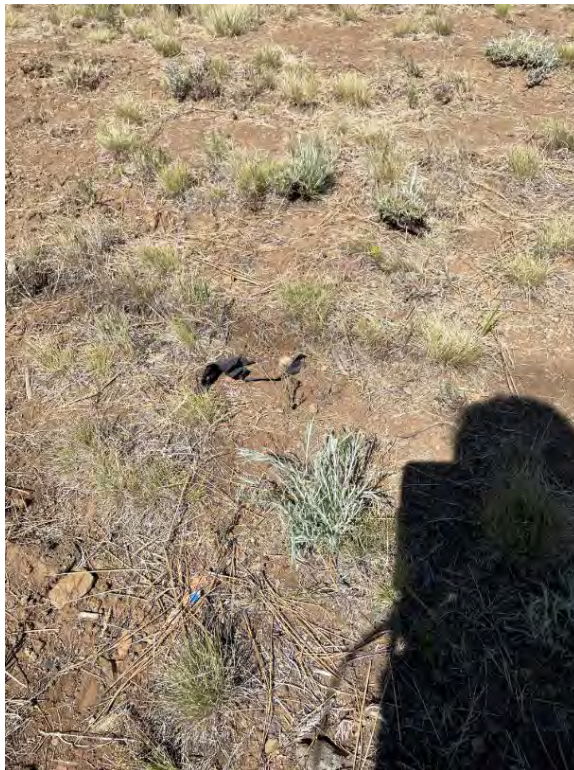
Exposed Liner  
42.26588152  
-121.74987479

Parcel G – Geomembrane Filter exposed on the East side of the Parcel.

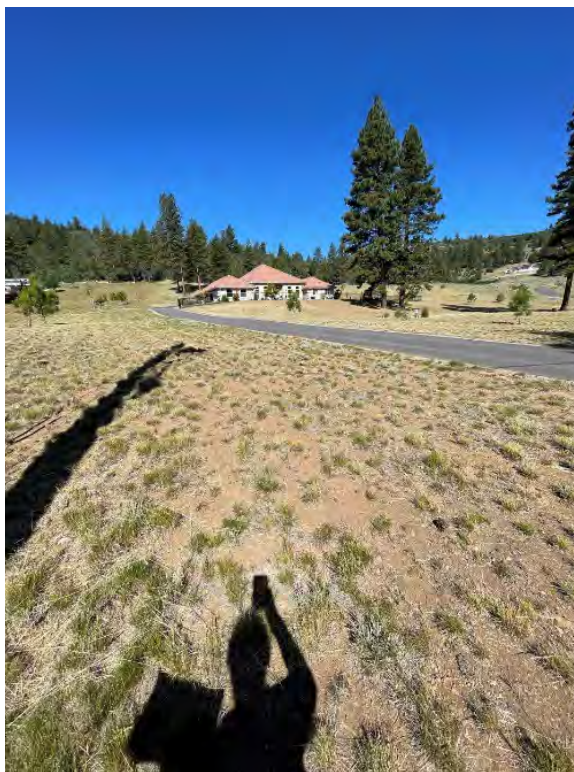
Parcel G – Northeast corner, facing Northwest.

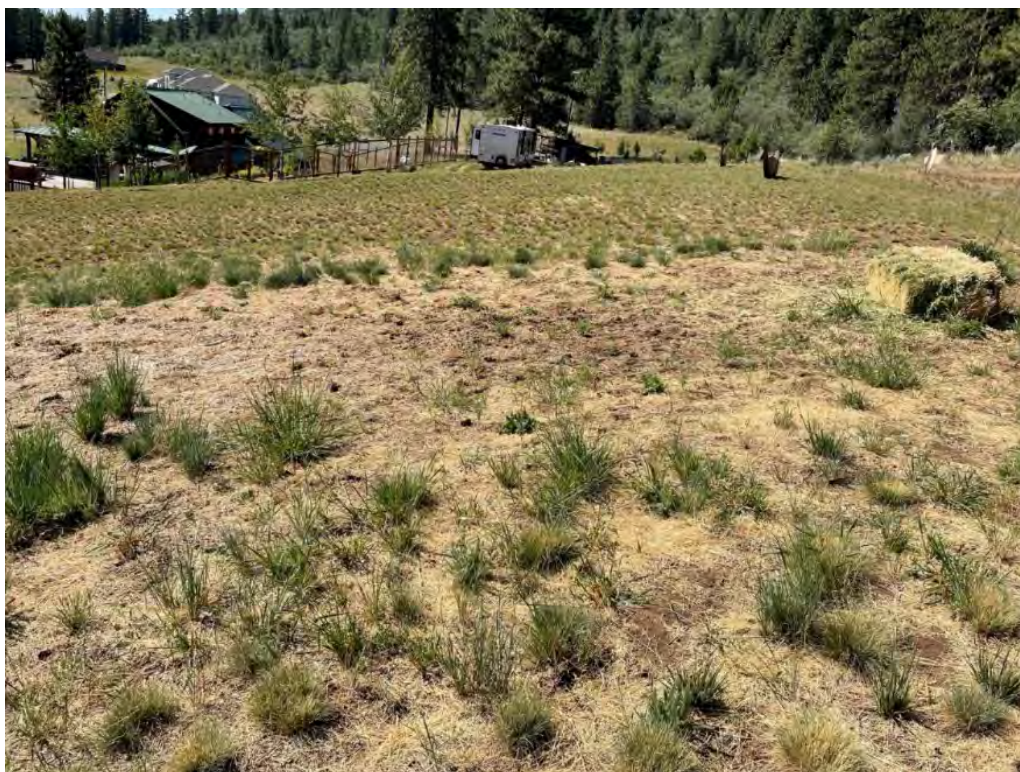
Sparse Vegetation  
Covered in Hay  
42.2651567  
-121.75159224

Parcel G – Hay covered patch of sparse vegetation.

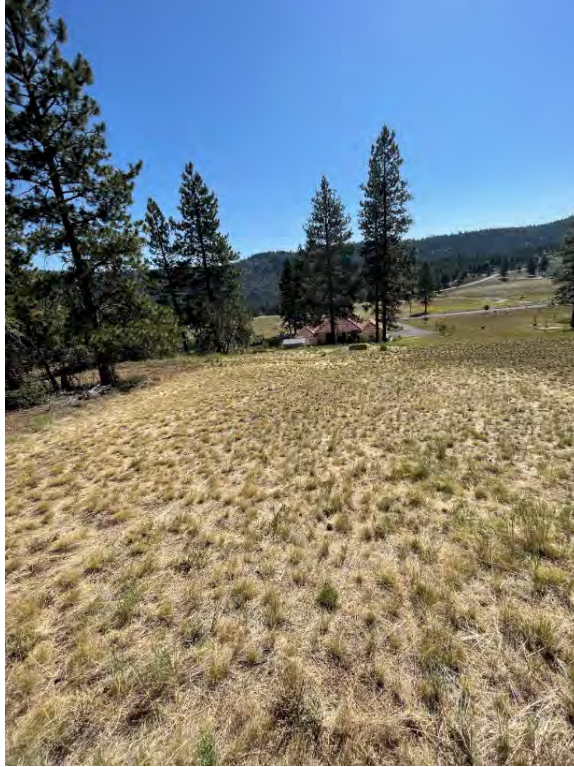
Parcel G – Southwest corner of Parcel, facing Northeast.

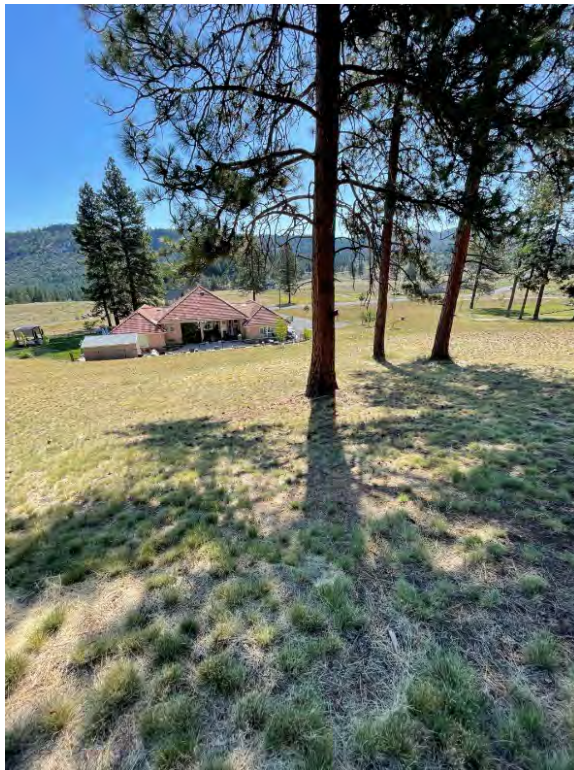
Parcel G – South Central area, facing East.

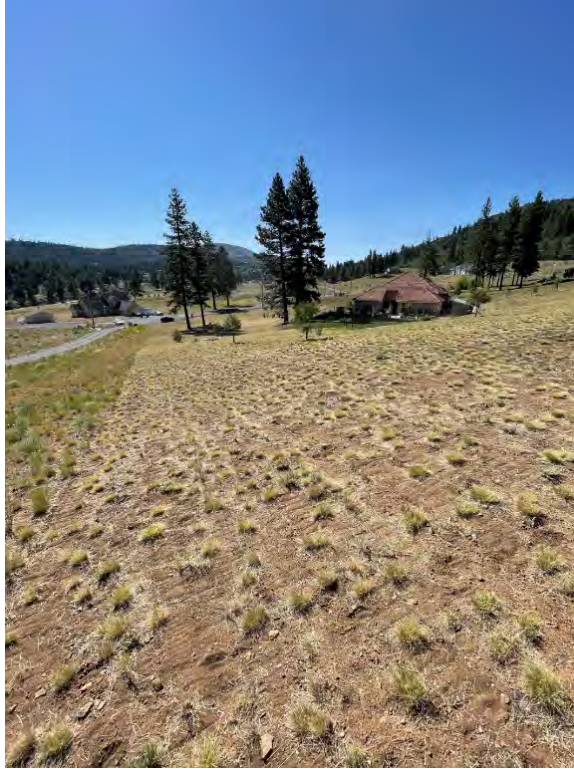
Parcel G – Northwest corner, facing Southeast.
