RE: Annual Inspection for Parcel H (part of)
North Ridge Estates Superfund Site
ECSI No. 5998

Parcel H

Operations and Maintenance Inspection Form

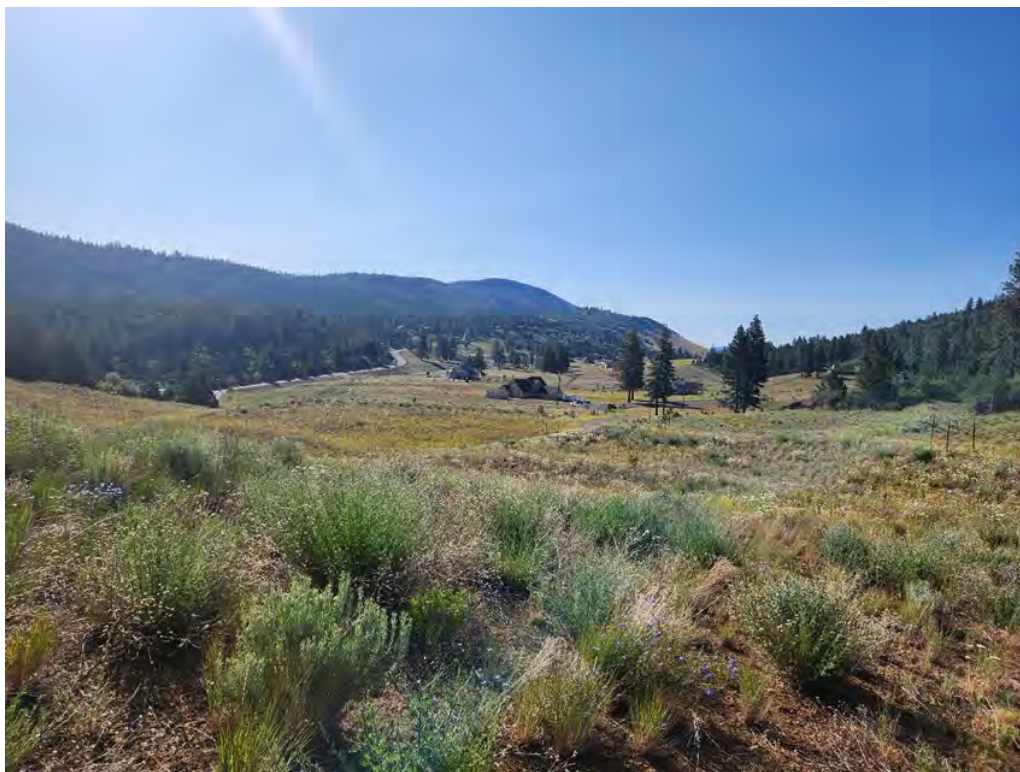
Parcel H – View facing South from North Corner.

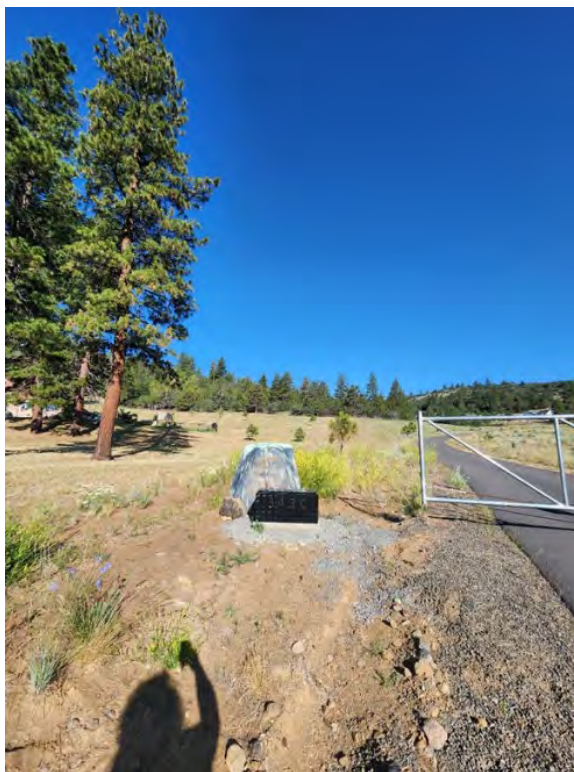
Parcel H – View facing North from Southeast Corner.

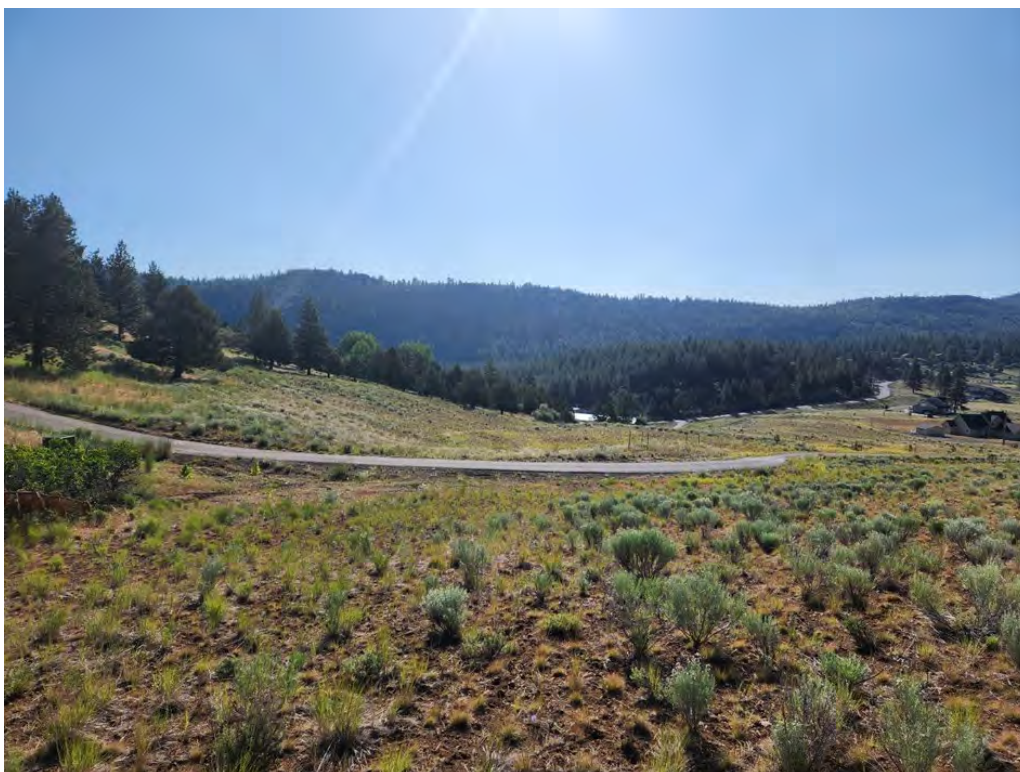
Parcel H – View facing Southeast from Northwest corner; vegetation growth since trenching (2021).

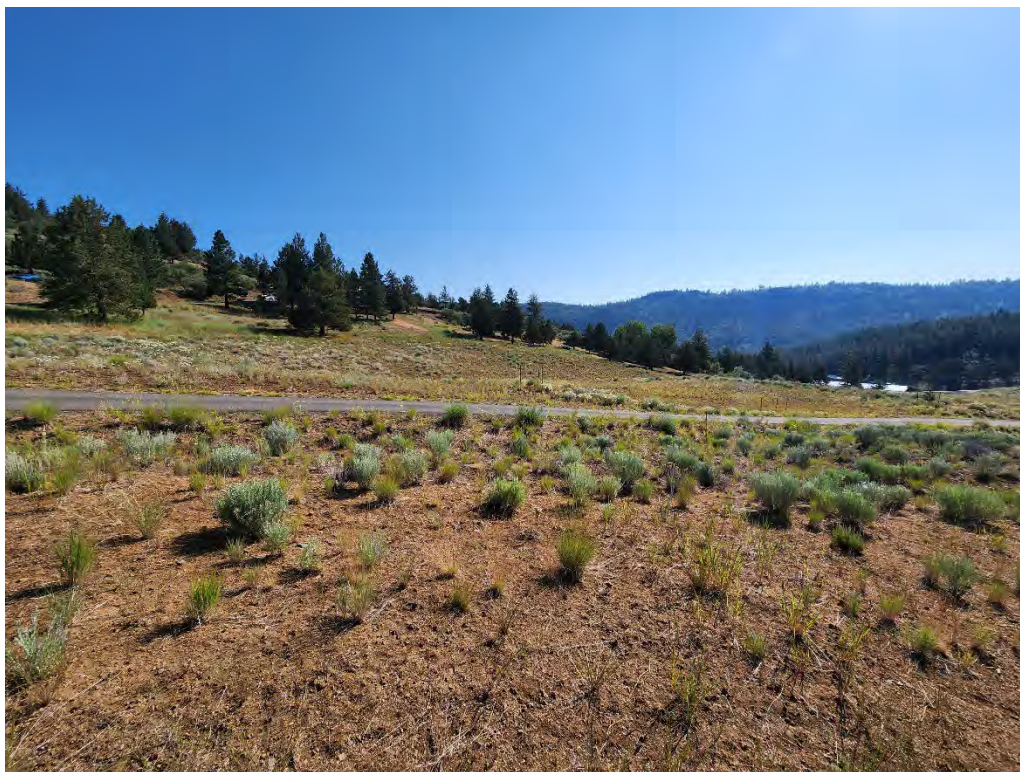
Parcel H – View facing East from West corner.

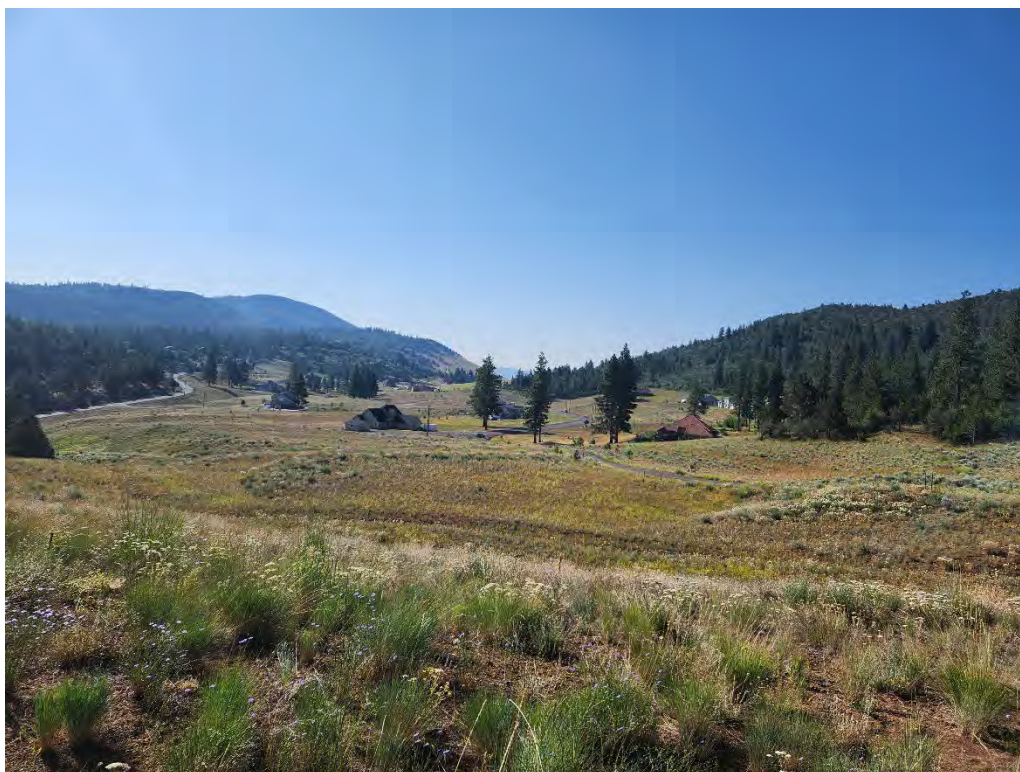
Parcel H – View facing Southwest from Northeast corner.
