RE: Annual Inspection for Parcel H (part of)
North Ridge Estates Superfund Site
ECSI No. 5998

Parcel H

Operations and Maintenance Inspection Form

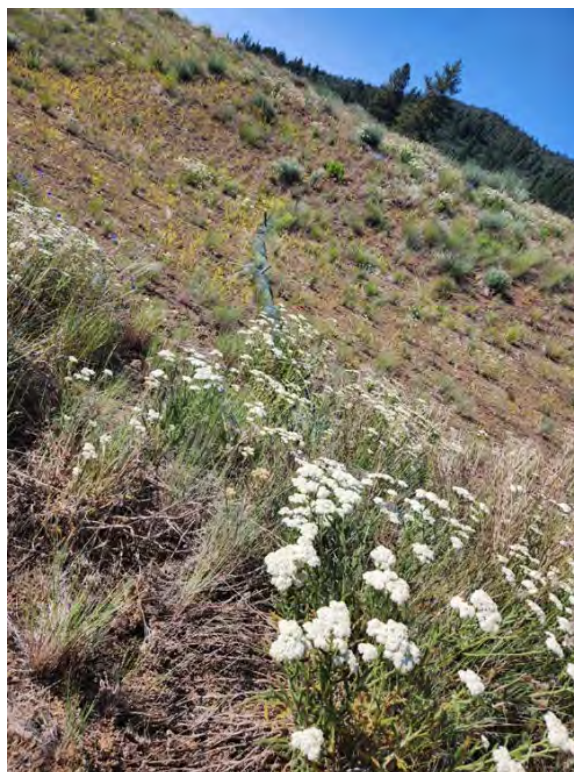
Parcel H – View of Straw Wattle seen on Parcel.

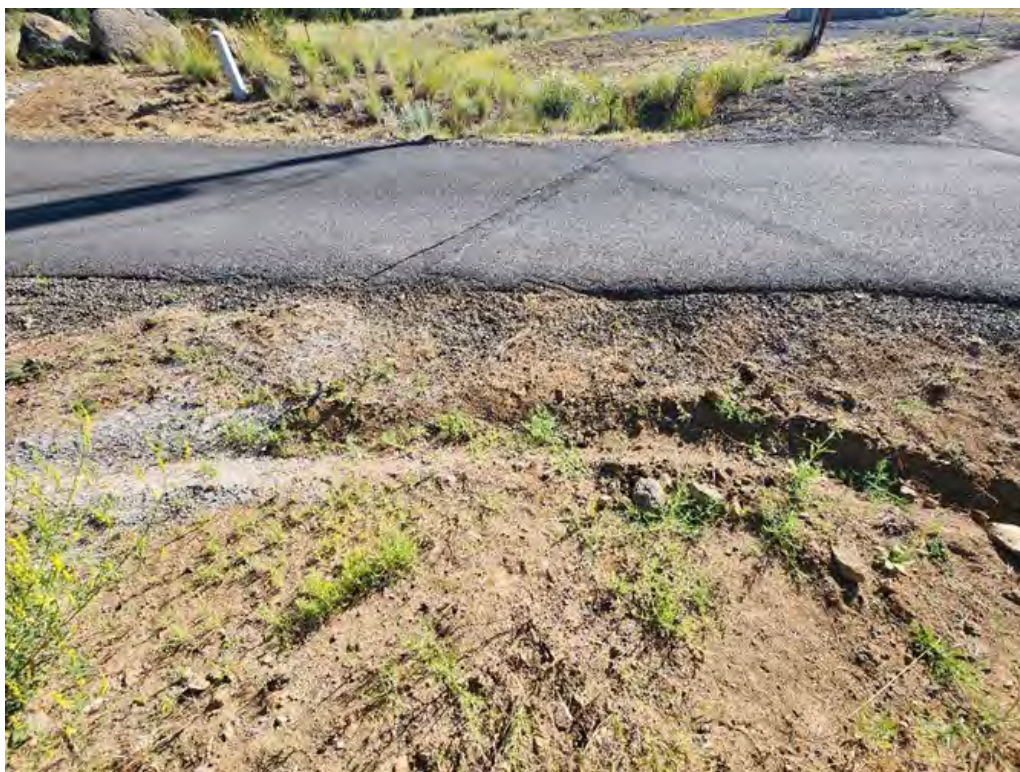
Parcel H – View of Rills located at the Southernmost corner of the Parcel.

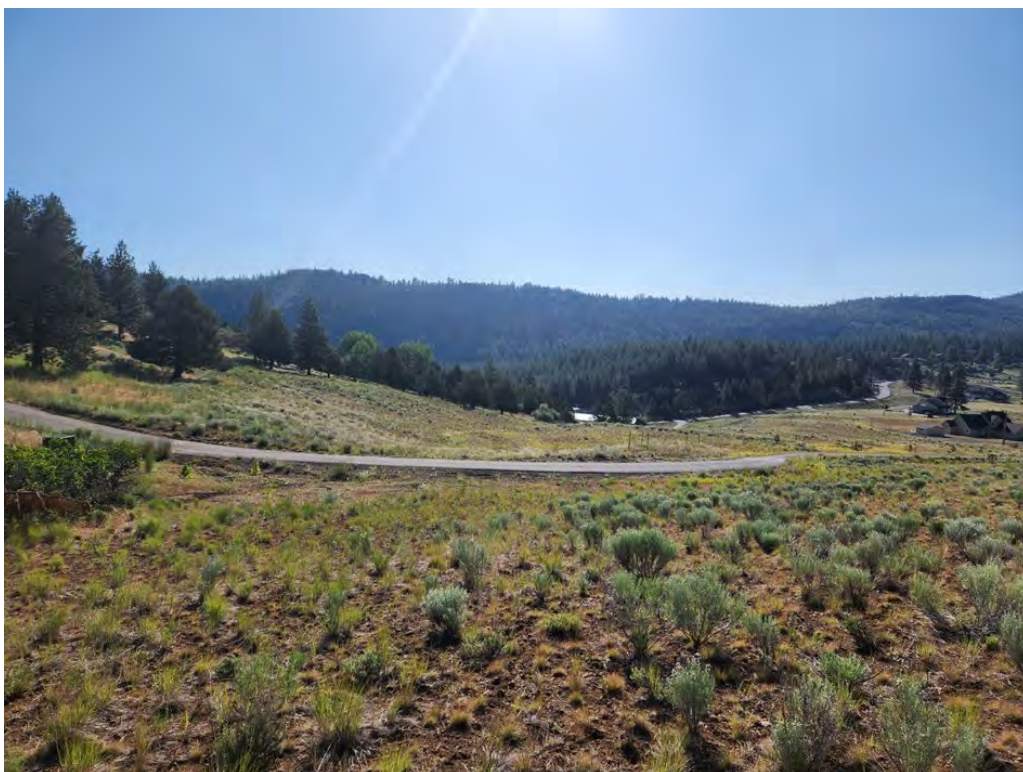
Parcel H – View facing Southeast from Northwest corner; vegetation growth since trenching (2021).
