RE: Annual Inspection for Parcel M
North Ridge Estates Superfund Site
ECSI No. 5999

Operations and Maintenance Inspection Form

2021 Annual Inspection Summary Report
North Ridge Estates - Operable Unit 1
Klamath Falls, Oregon

Figure
M.3

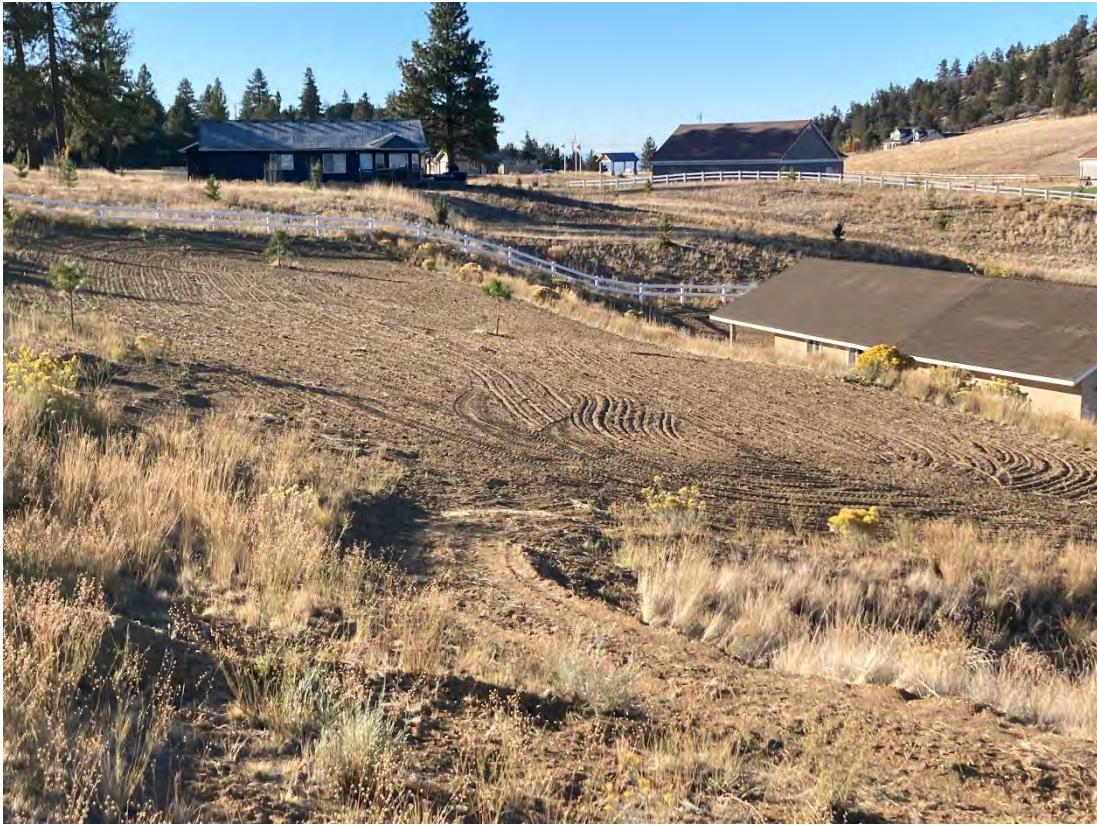
Tire tracks present on the eastern portion of the property. Note large area without vegetation.

Significant areas of the property are devoid of vegetation (see map in inspection report). The two foot soil cover must be maintained to remain protective and the vegetation cover is a key component. The Easement and Equitable Servitude recorded with Klamath County requires you to maintain and keep the protective caps in good repair. Please re-seed the areas within the next 30 days and continue to re-seed until the vegetation cover has been re-established.

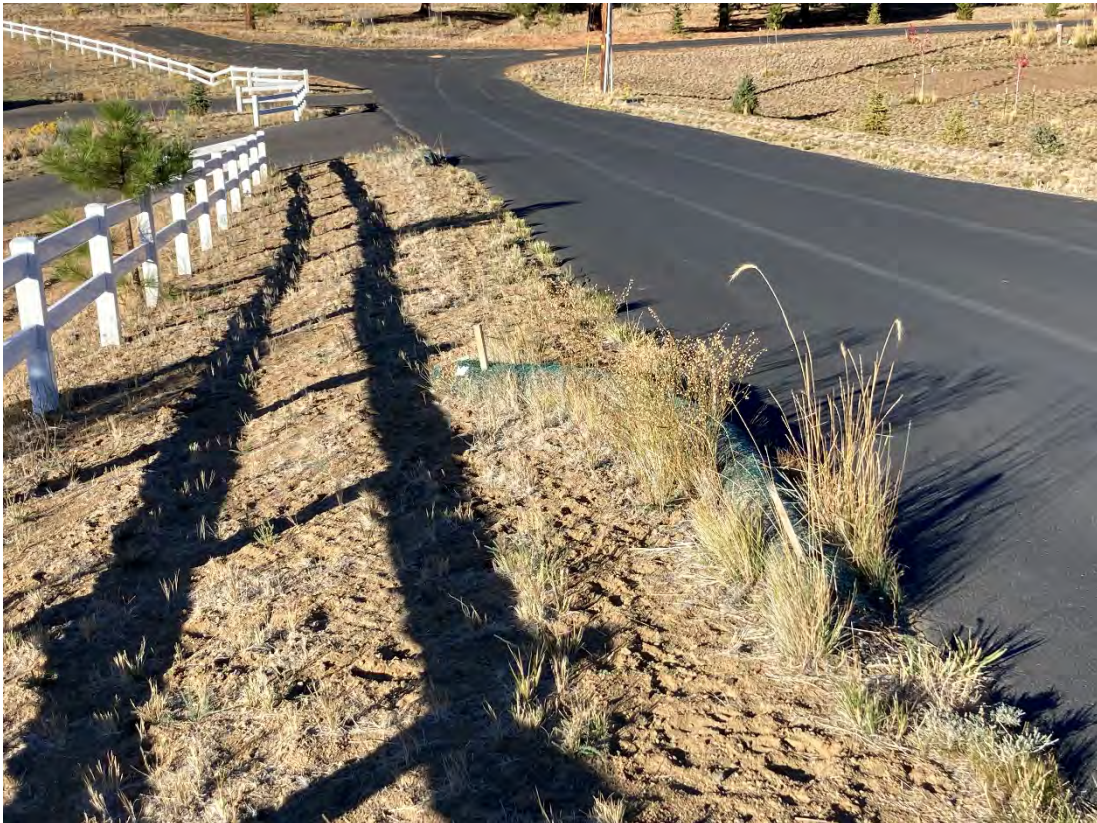
Straw wattles were present along the driveway to try and prevent erosion. Some cracking of the driveway was noted adjacent to these areas.

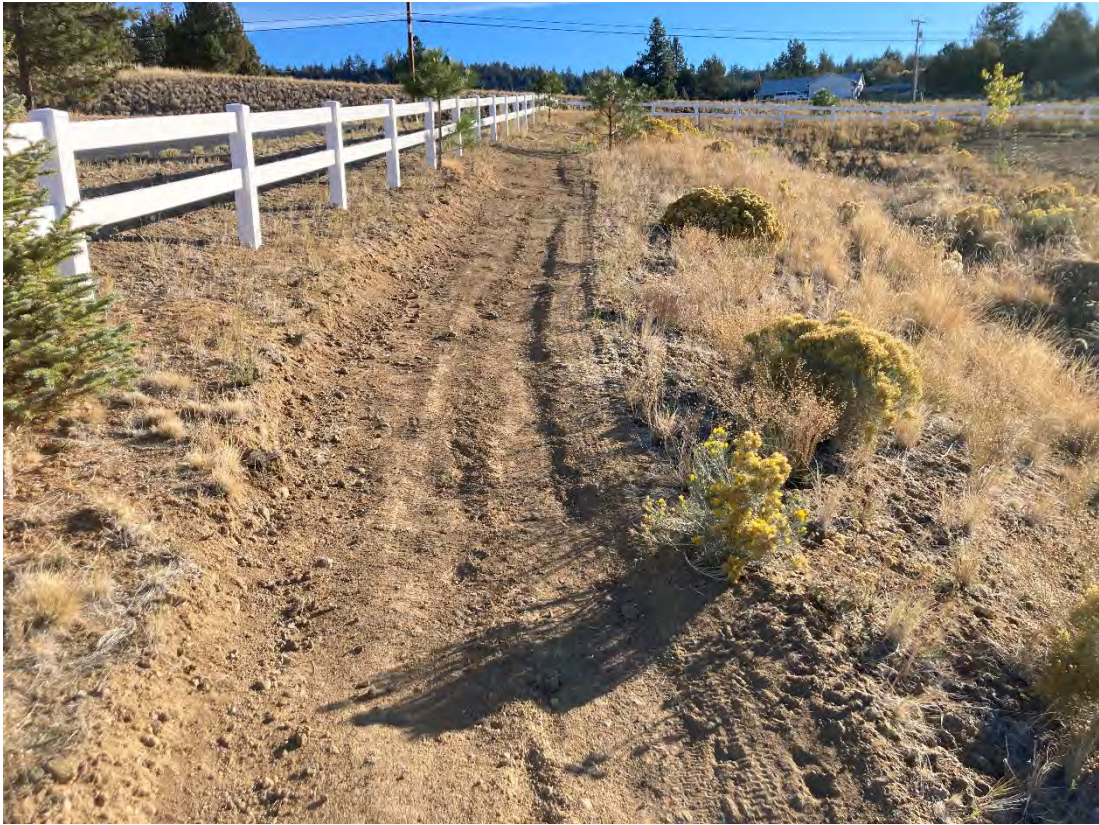
Tire tracks present (less than 4" deep) noted. Note tracks without vegetation along north fence line.

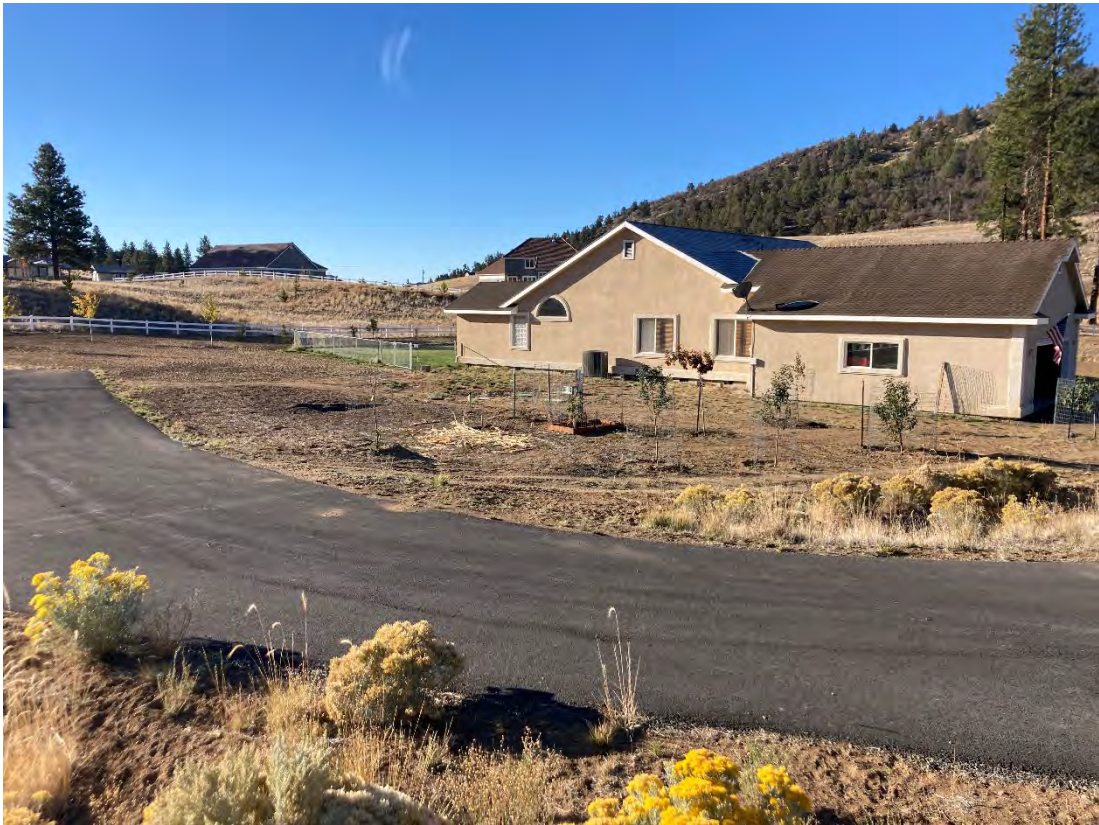
View of the house and landscaping on the eastern portion of the property. Note sparse vegetation observed in this area.

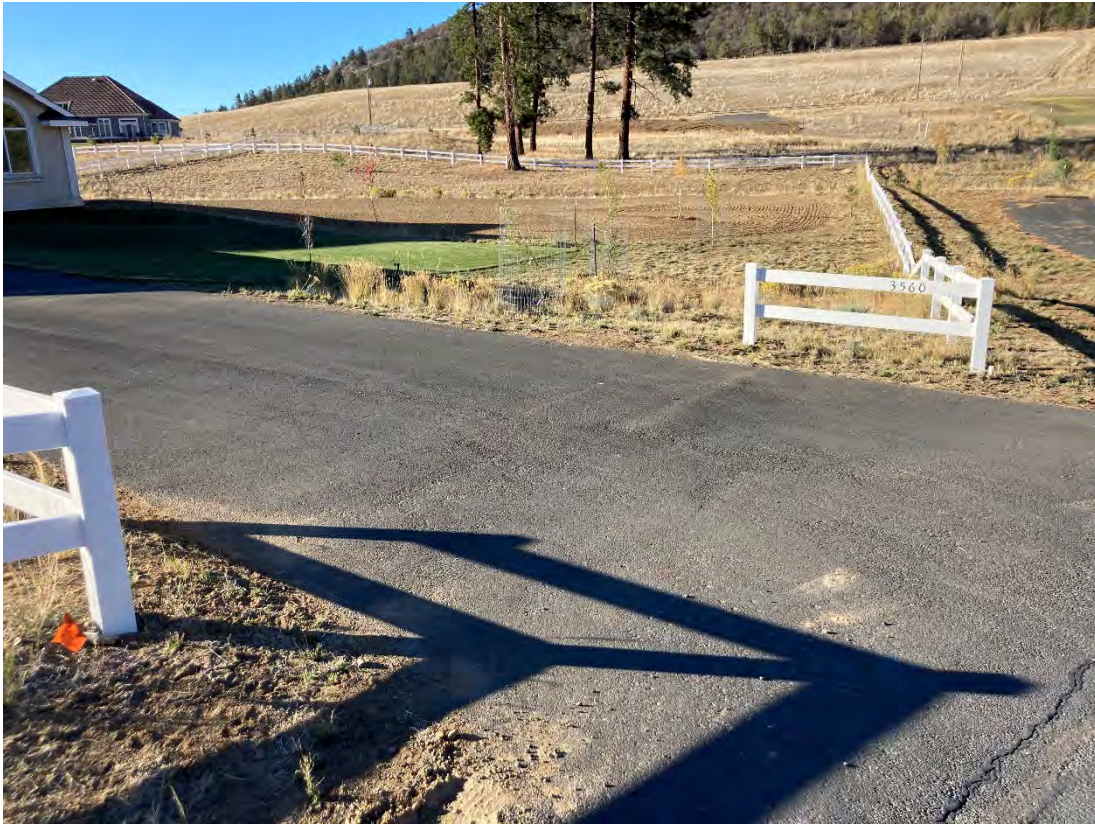
Typical condition of the driveway pavement on the northern property line.

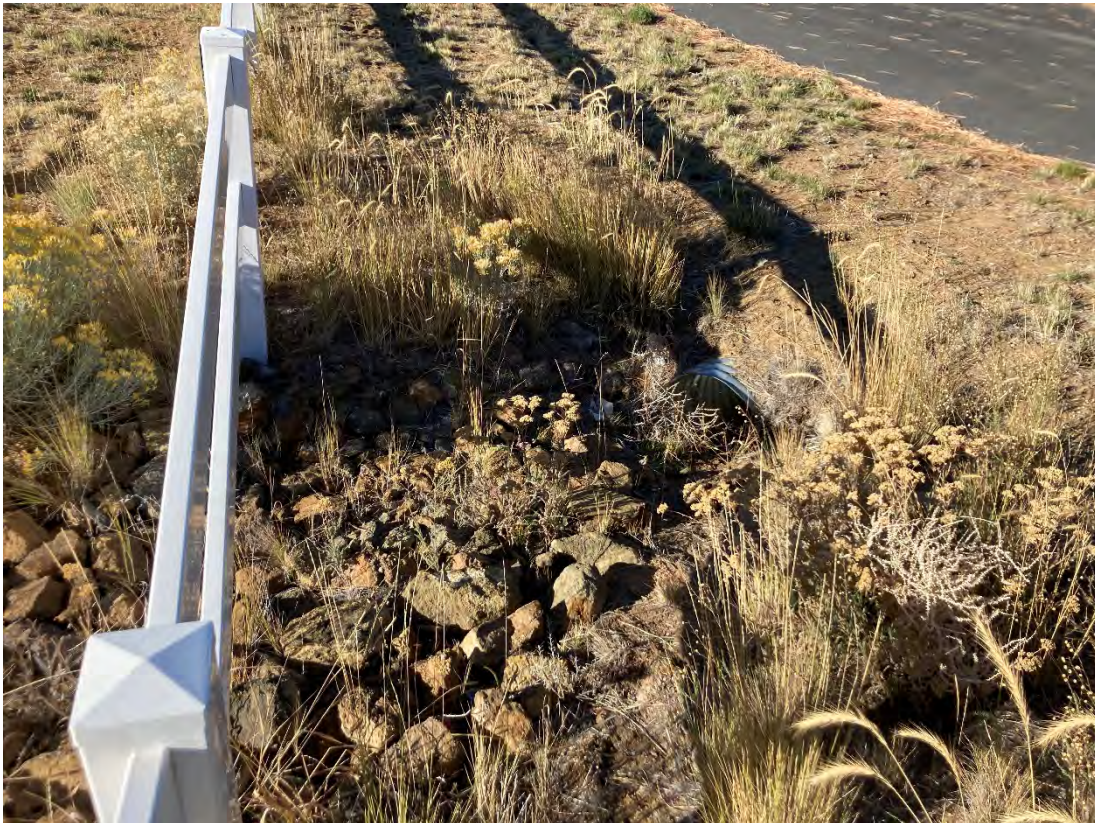
Ditches and Culverts	Obstructions observed in ditches or culverts that may impede conveyance of stormwater?	<input type="checkbox"/>	<input type="checkbox"/>	<input checked="" type="checkbox"/>	<input type="checkbox"/>	Two culverts are minimally impacted by vegetation.	Watch during subsequent inspections.
	Damaged observed to riprap surface? Note if riprap is not intact or not effectively providing armor protection.	<input type="checkbox"/>	<input type="checkbox"/>	<input checked="" type="checkbox"/>	<input type="checkbox"/>		
	Are there any areas that show signs of excessive scour? (i.e., gullies forming along centerline of ditch)	<input type="checkbox"/>	<input type="checkbox"/>	<input checked="" type="checkbox"/>	<input type="checkbox"/>		
	Are culvert inlets and outlets damaged?	<input type="checkbox"/>	<input type="checkbox"/>	<input checked="" type="checkbox"/>	<input type="checkbox"/>

Most culvert were obstructed by some vegetation.

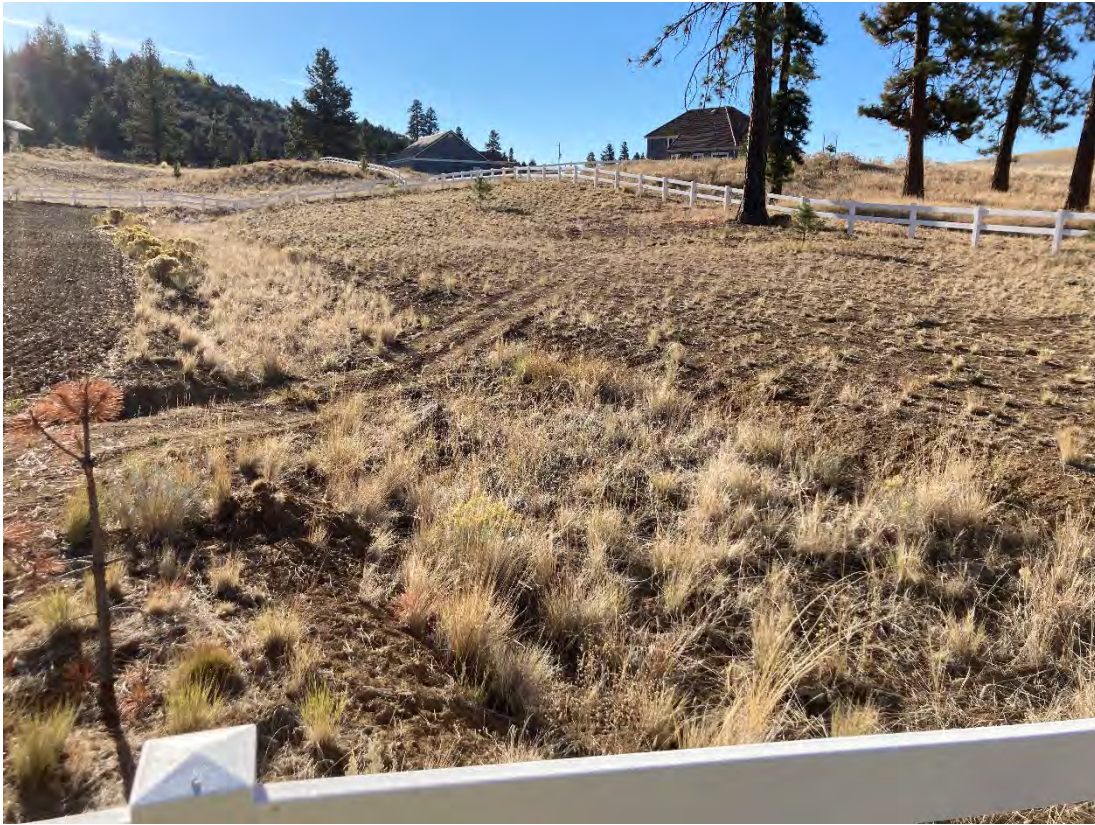
Tire tracks noted on the western portion of the property.

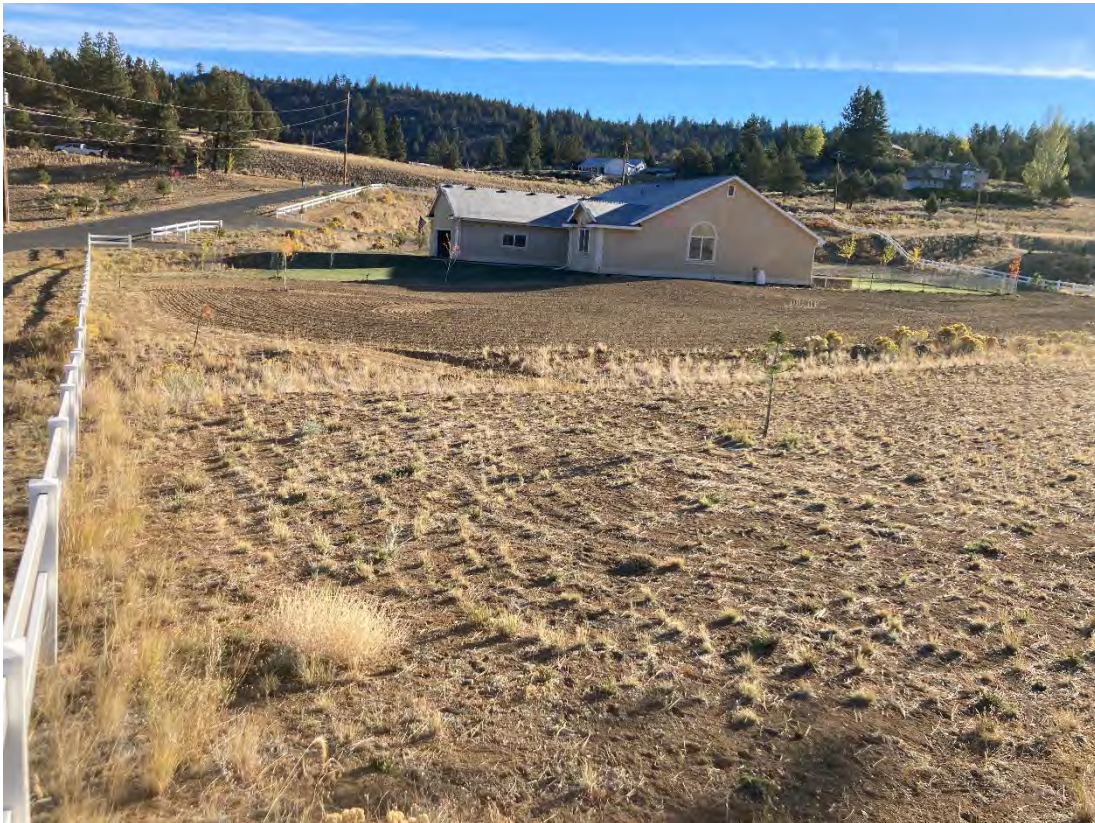
View of the NW edge of the removal area/cap, from the east corner, looking NE. Note large area without vegetation on west side of residence.

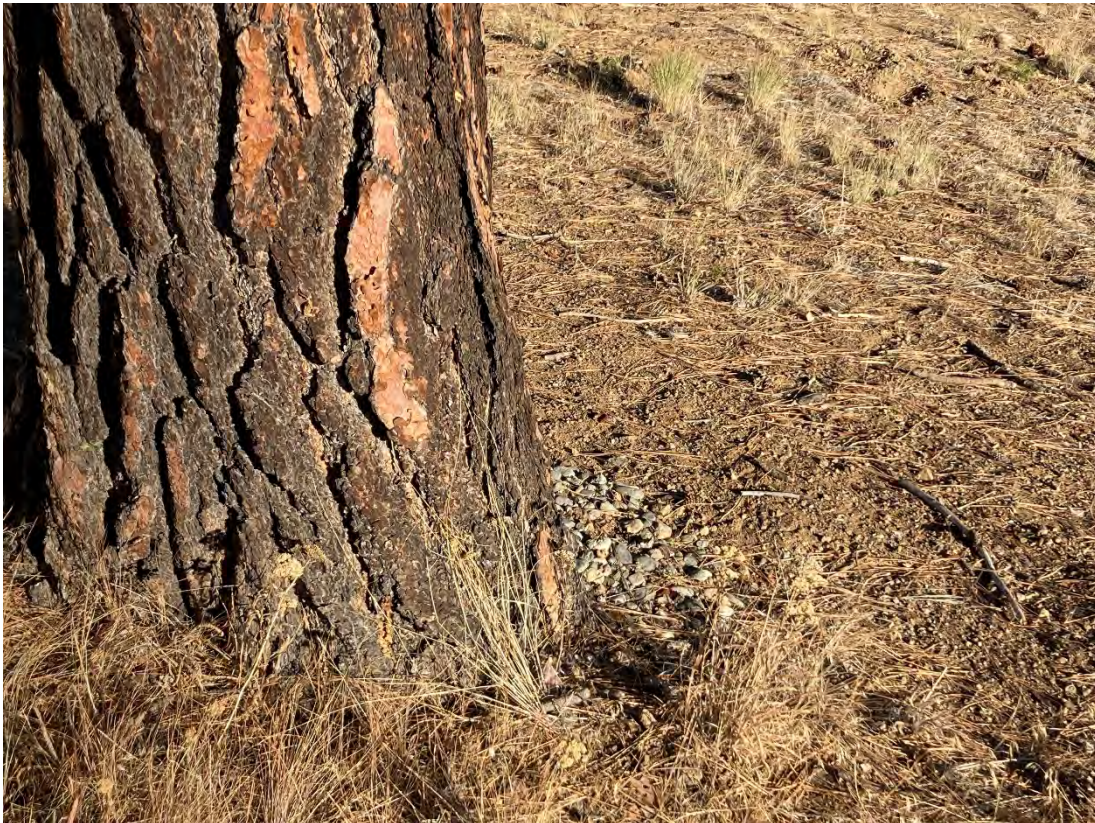
No ACM was located within the dripline of legacy trees.

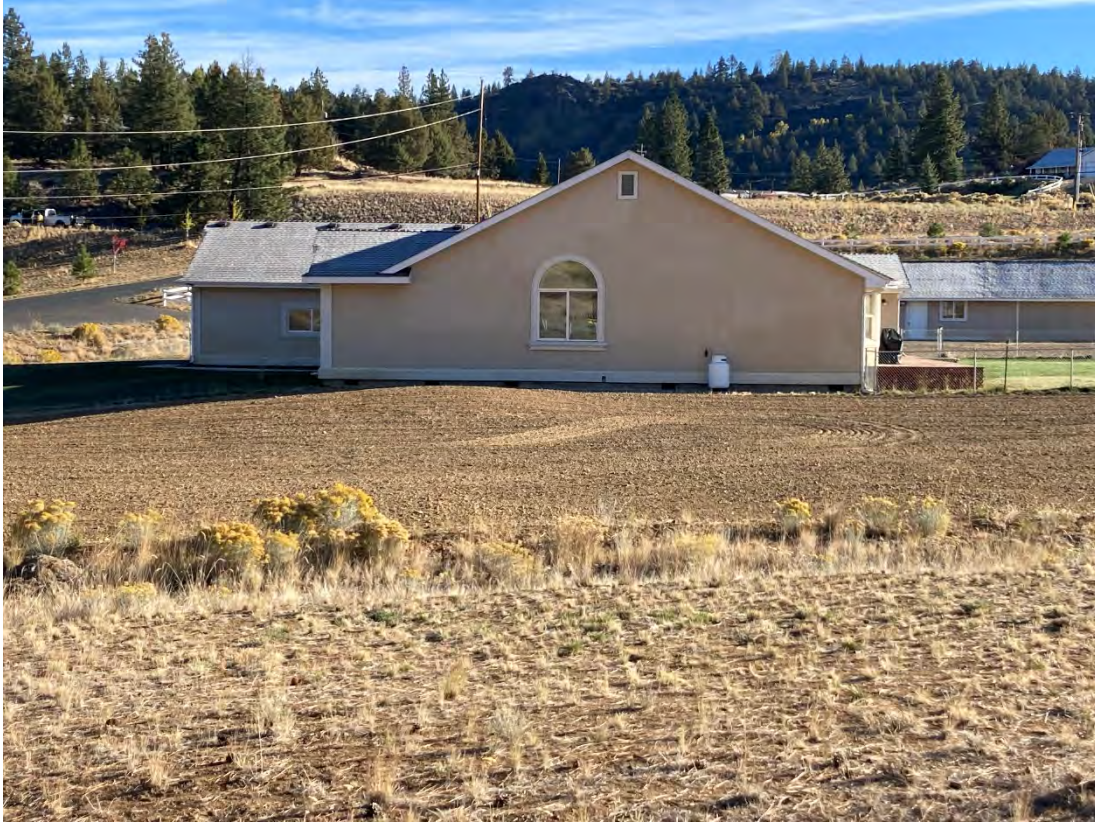
View of the western portion of the property and house. Note large area without vegetation on west side of residence.

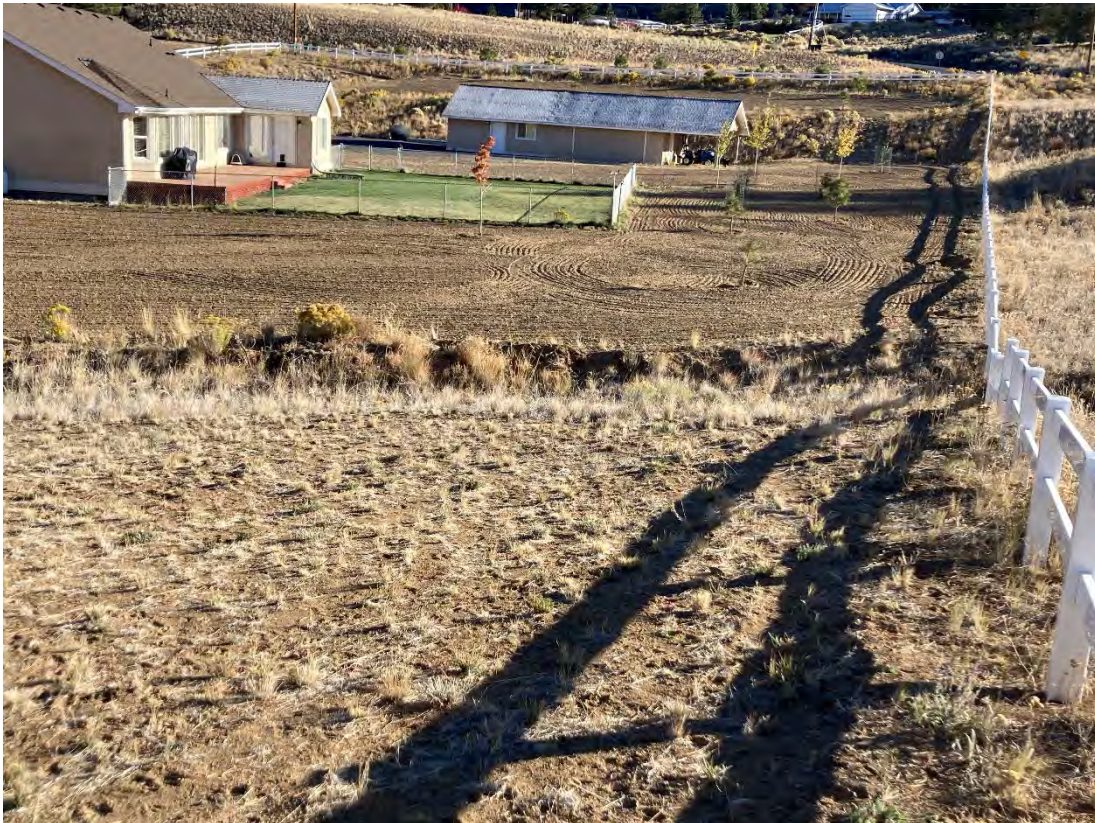
View of the southern portion of the parcel from the southern corner. Note large area without vegetation on west side of residence.
