RE: Annual Inspection for Parcel N  
North Ridge Estates Superfund Site  
ECSI No. 6000

***Parcel N***

Operations and Maintenance Inspection Form

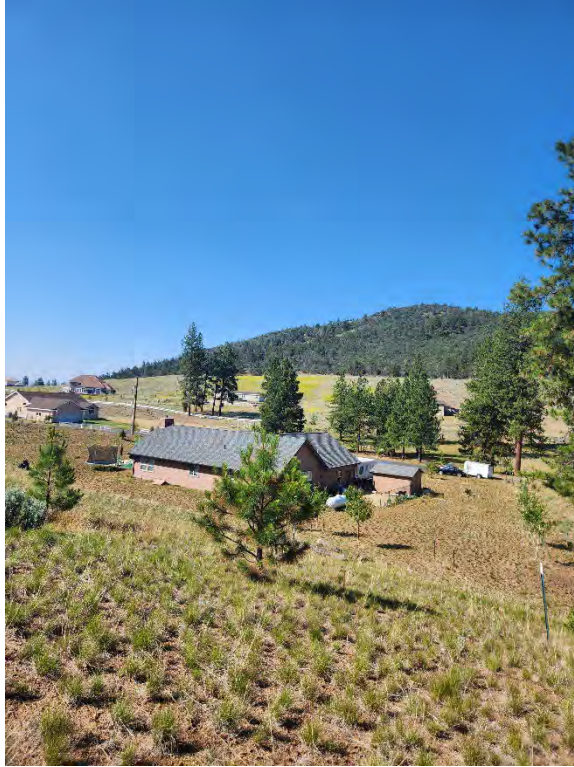
Parcel N – View from North corner of Parcel.

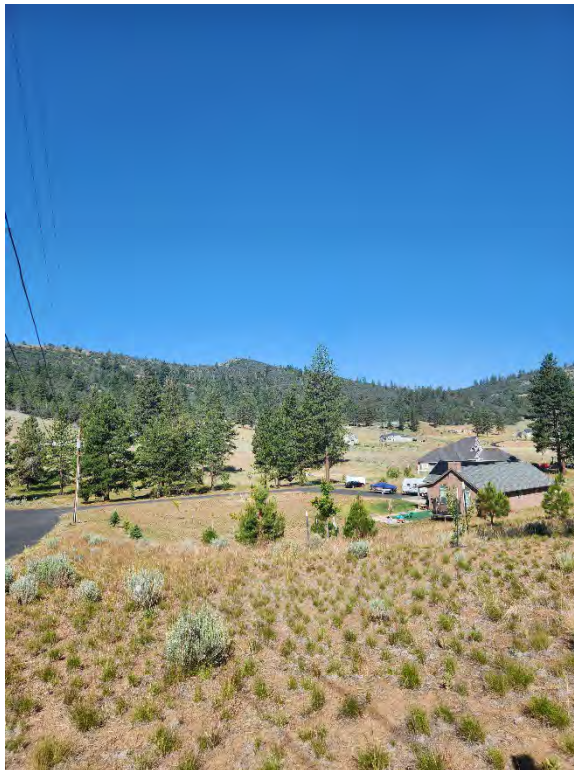
Parcel N – View from East Corner of Parcel.

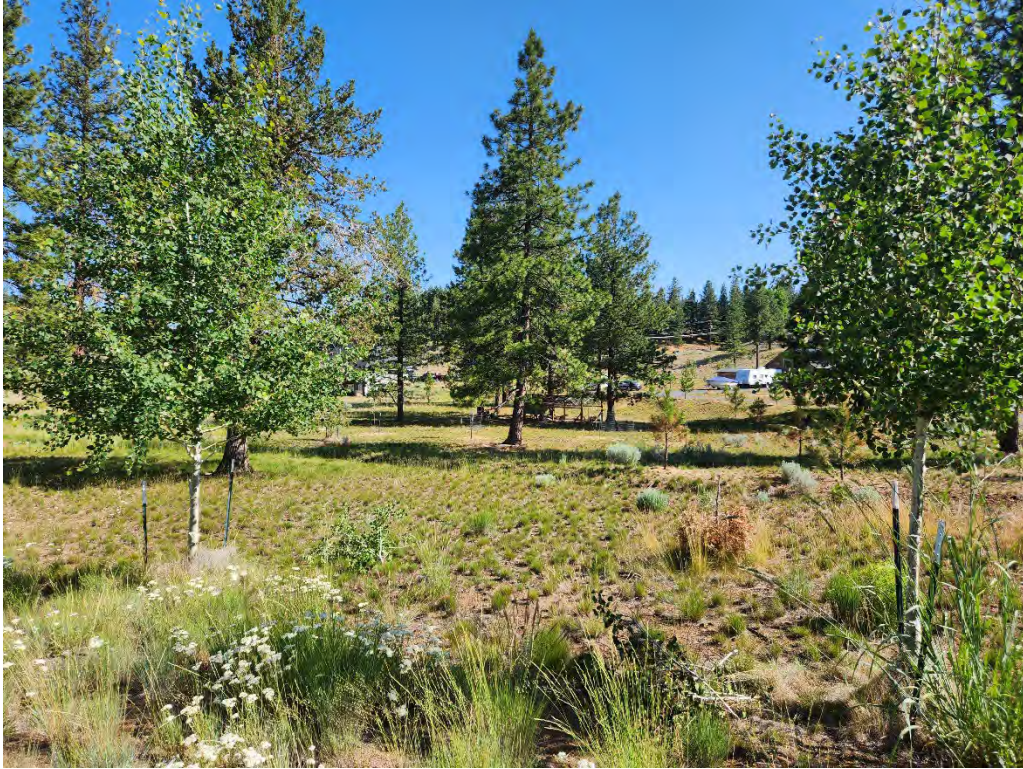
Parcel N – View from South corner of Parcel.

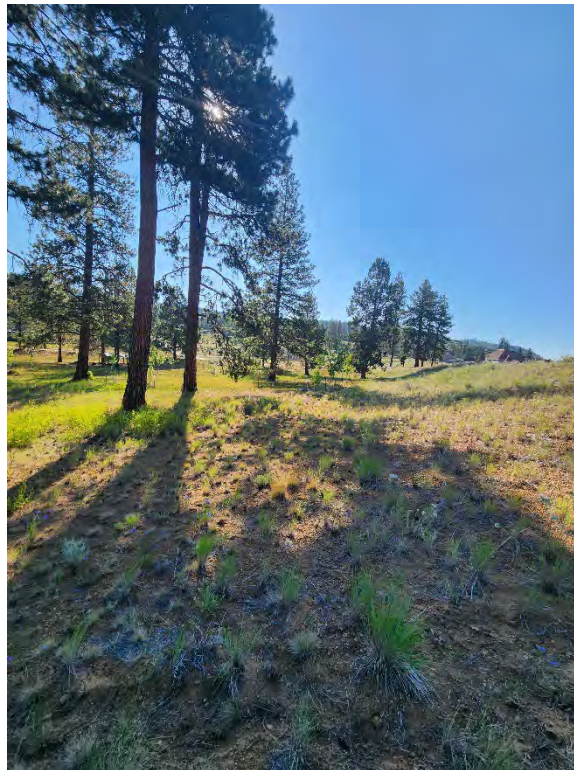
Parcel N – View from West corner of Parcel.

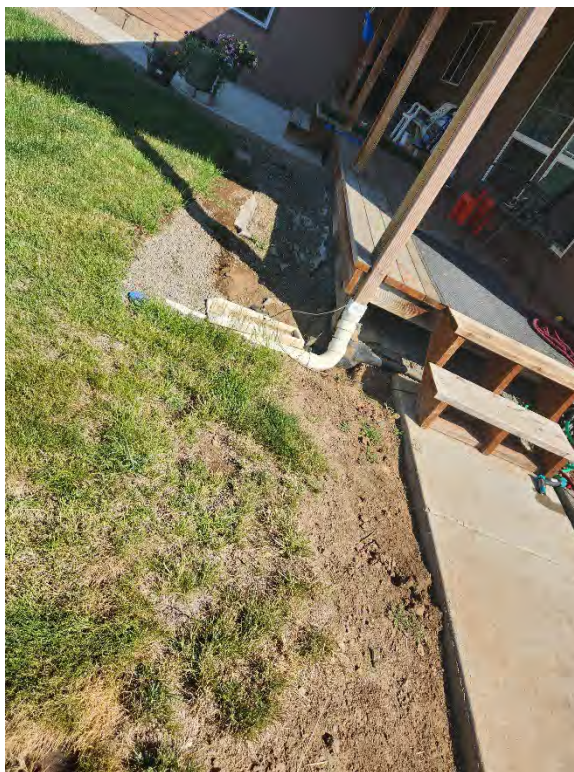
Parcel N – Black Geomembrane visible underneath Porch.
