RE: Annual Inspection for Parcel O  
North Ridge Estates Superfund Site  
ECSI No. 6001

***Parcel O***

## Operations and Maintenance Inspection Form

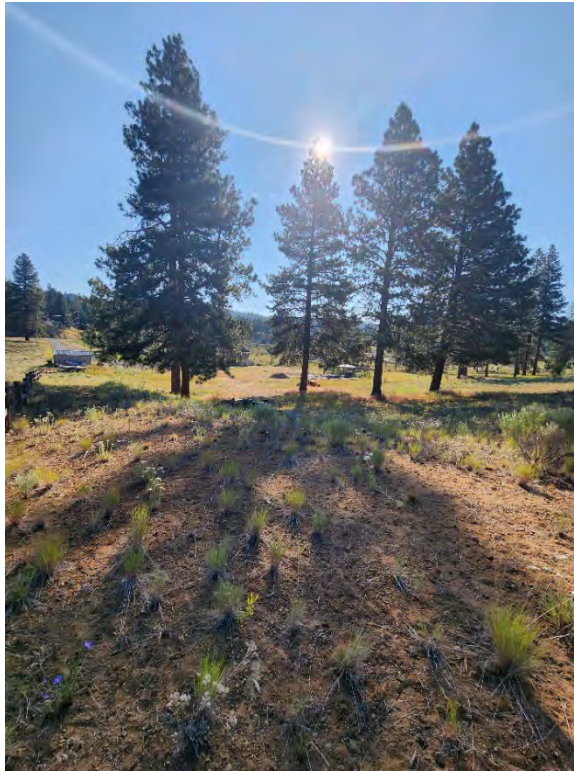
Parcel O – View facing East from West corner.

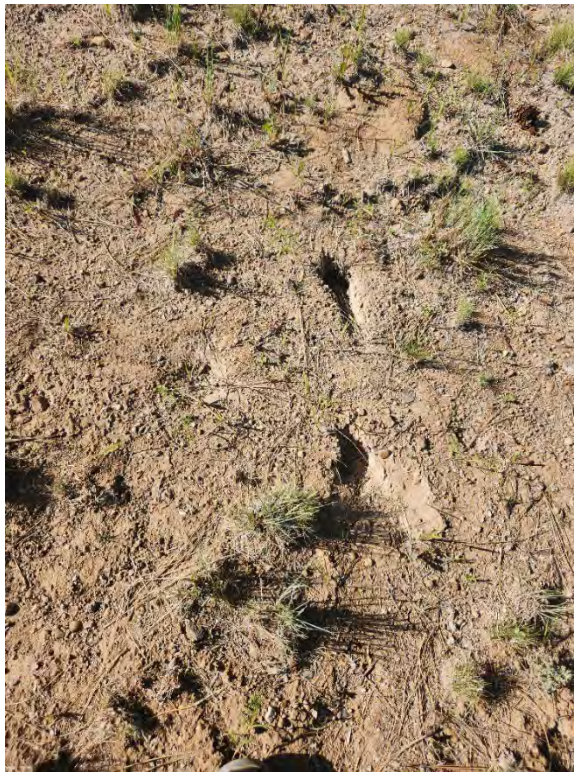
Parcel O – Animal Hoof Prints (2-inches deep) observed on Southern portion of Parcel.

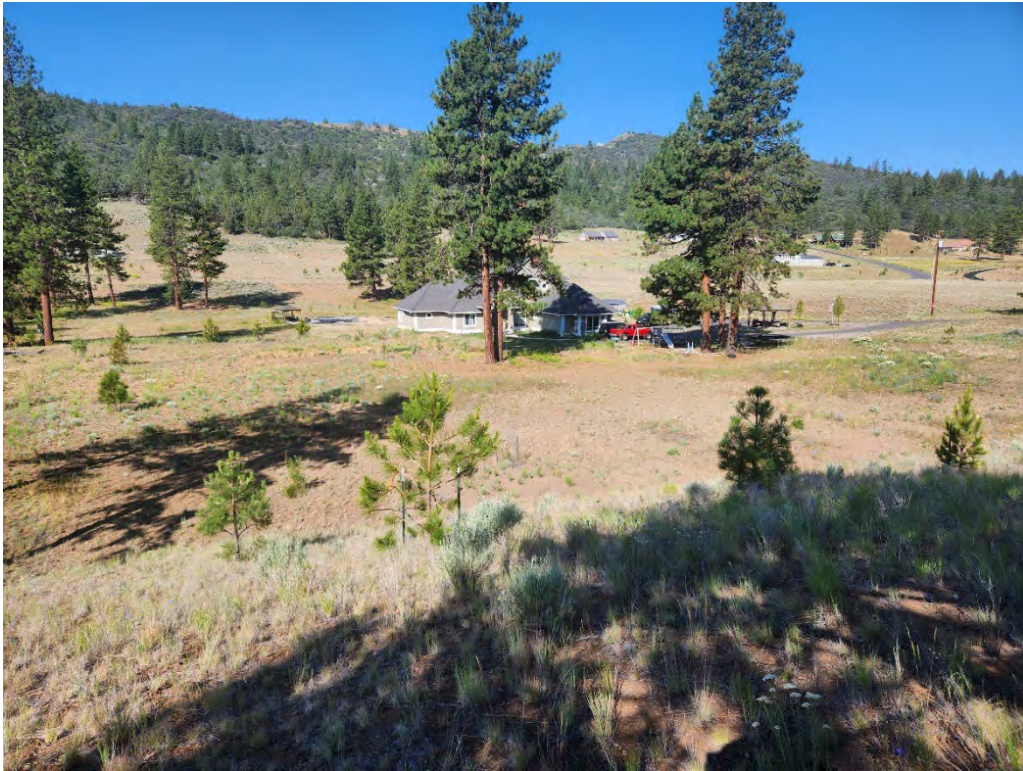
Parcel O – View facing West from East corner.

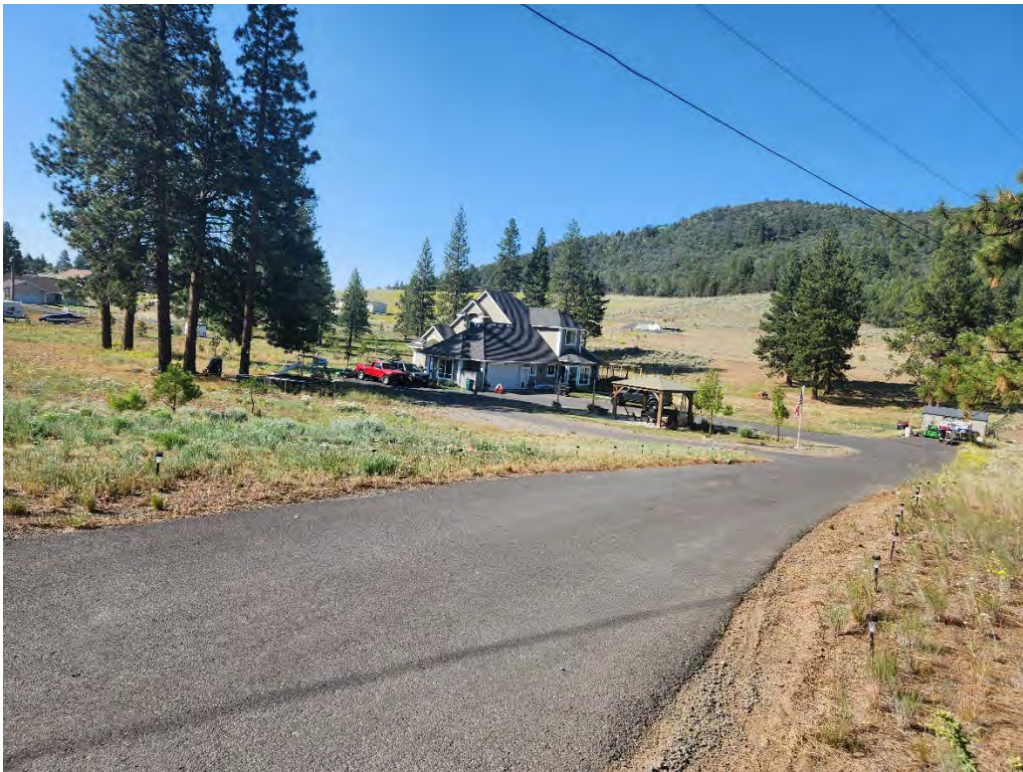
Parcel O – View facing South from Northern corner.

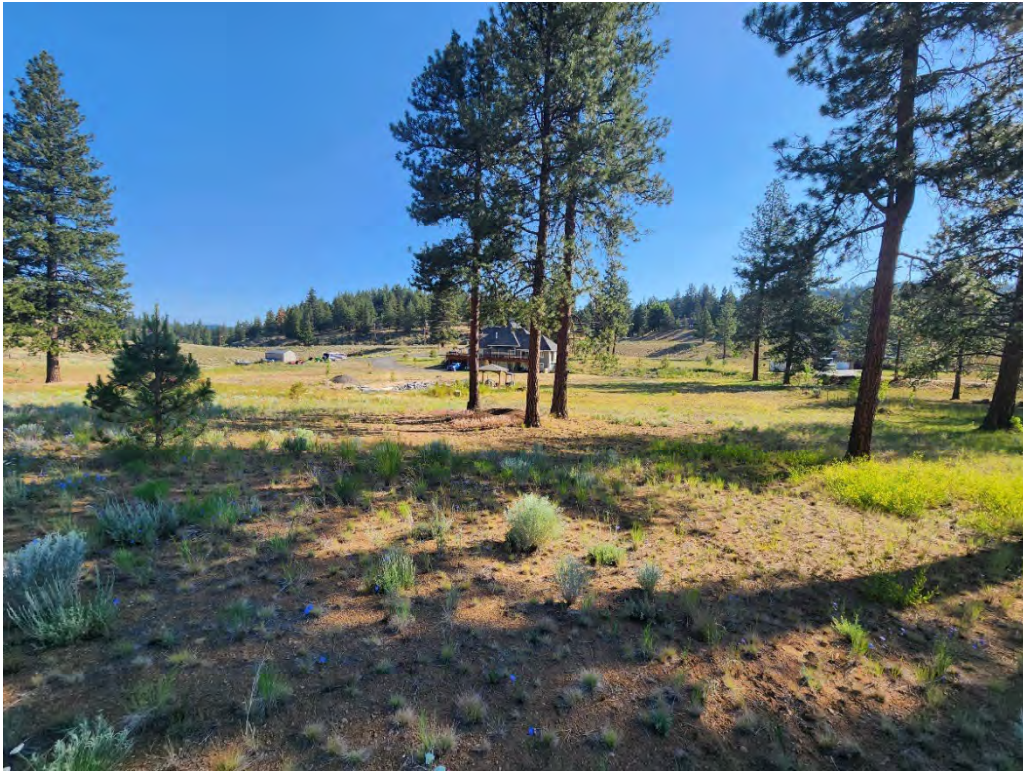
Parcel O – View facing North from Southern corner.

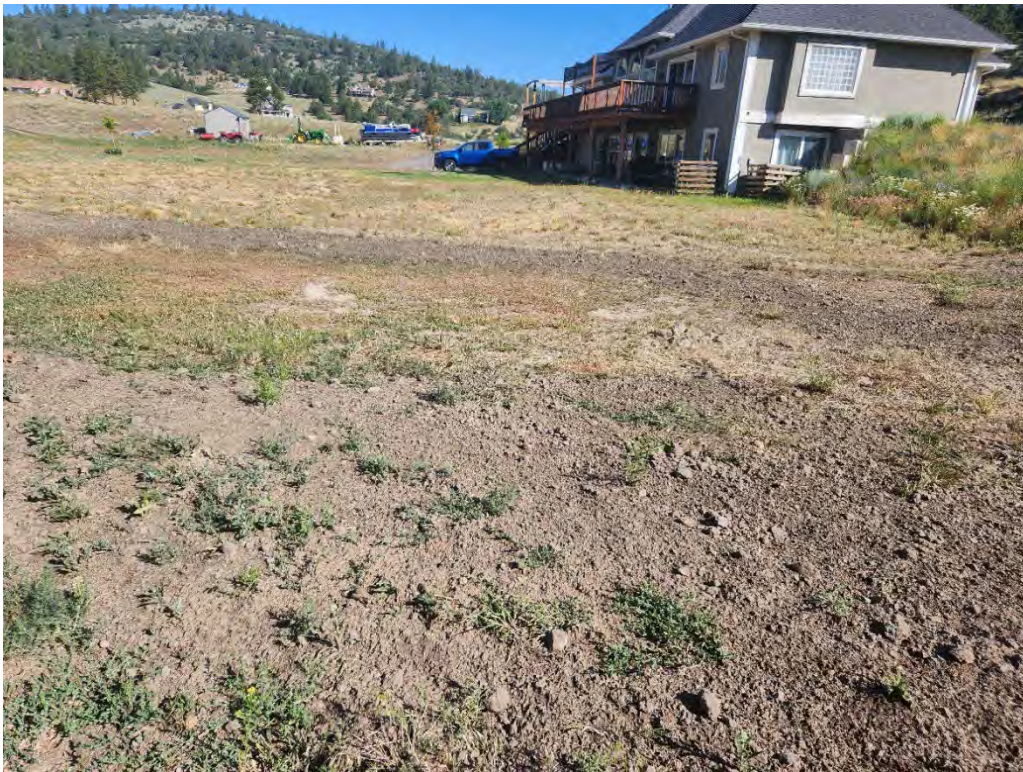
Extensive repairs were performed due to the city waterline repairs and will be monitored to evaluate restoration of vegetation.

Parcel O – South Central washout repaired in response to water leak that occurred near Old Fort Road in April 2023.
