RE: Annual Inspection for Parcel P
North Ridge Estates Superfund Site
ECSI No. 6002

Operations and Maintenance Inspection Form

Lot P Inspection

2023 Annual Inspection Summary Report
North Ridge Estates - Operable Unit 1
Klamath Falls, Oregon

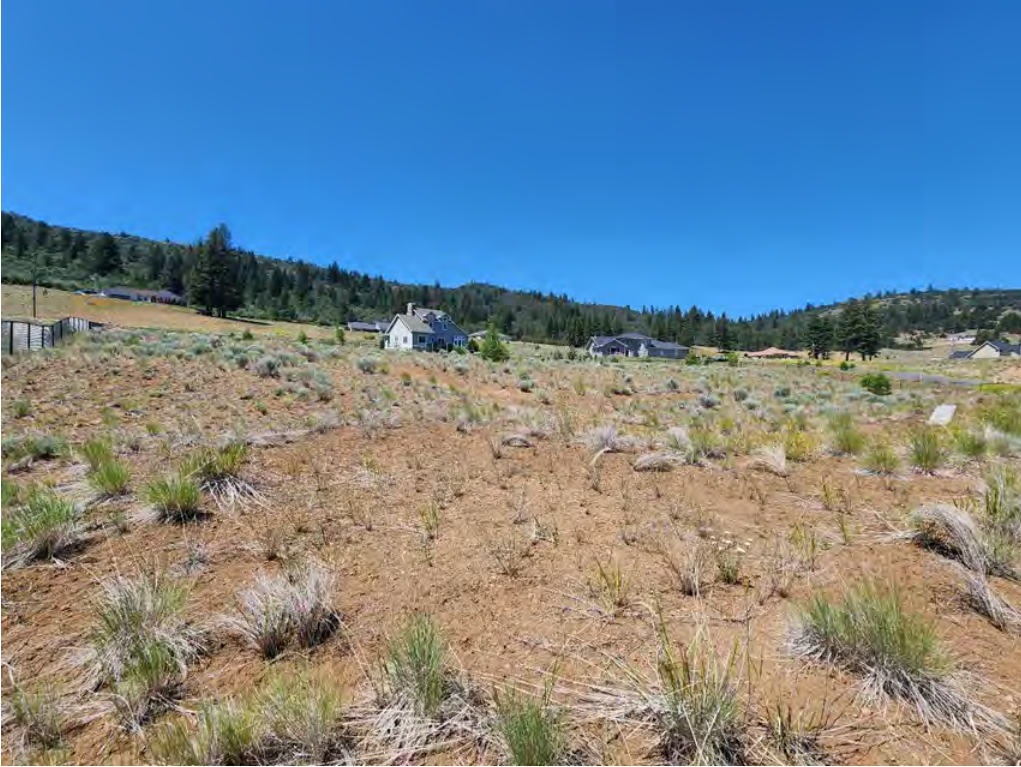
Parcel P – View facing West from East corner.

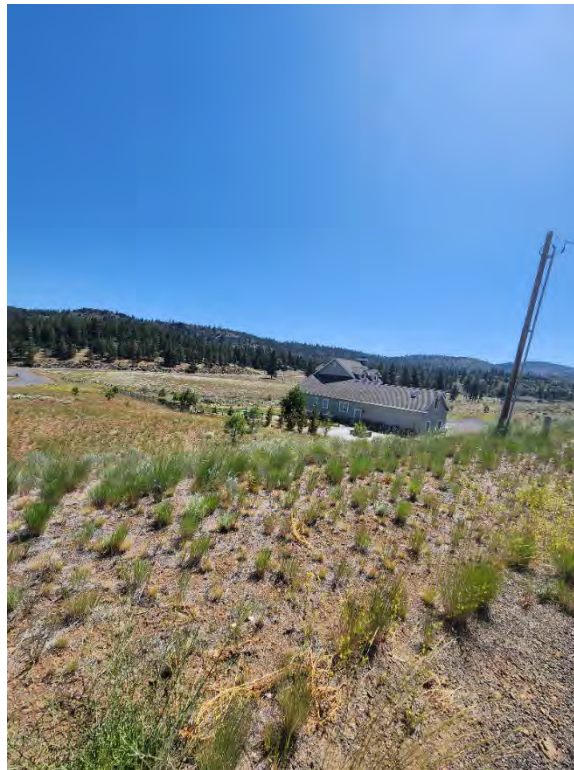
Parcel P – View facing East from West corner.

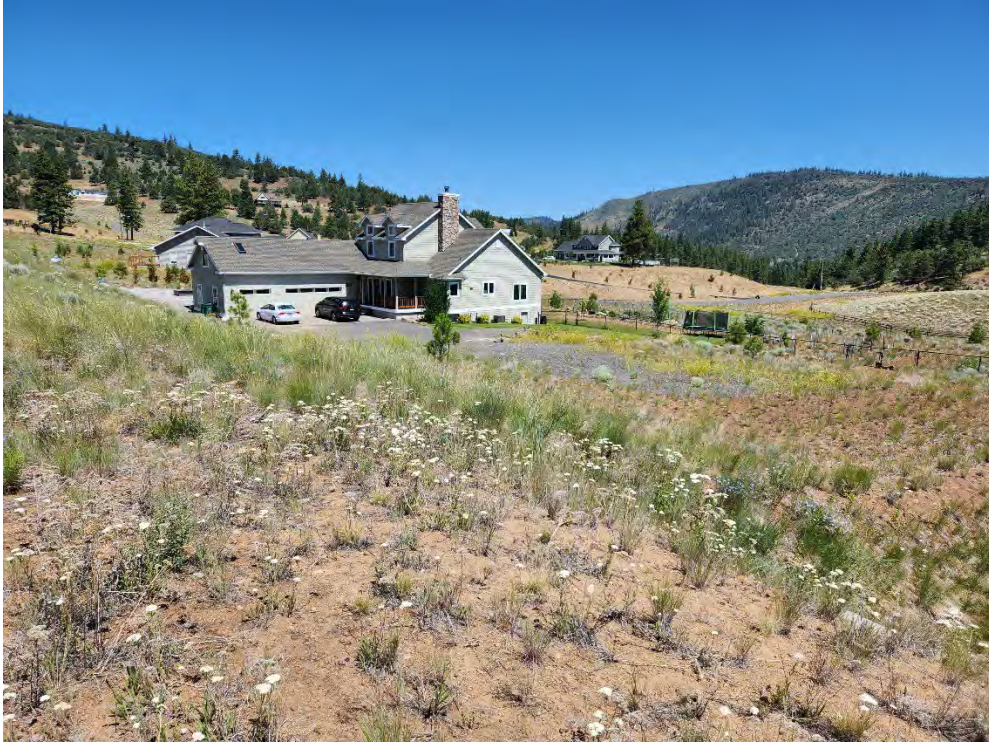
Parcel P – View facing North from Southern corner.

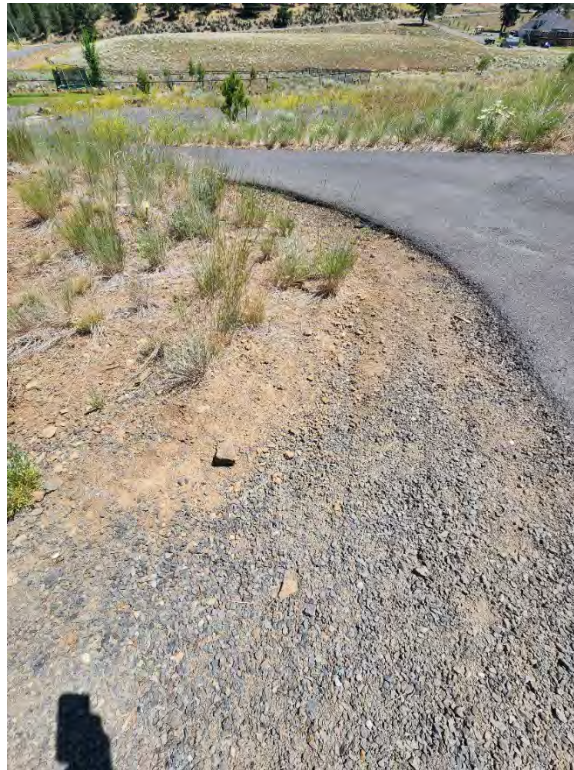
Parcel P – Rills along driveway (same as 2022).

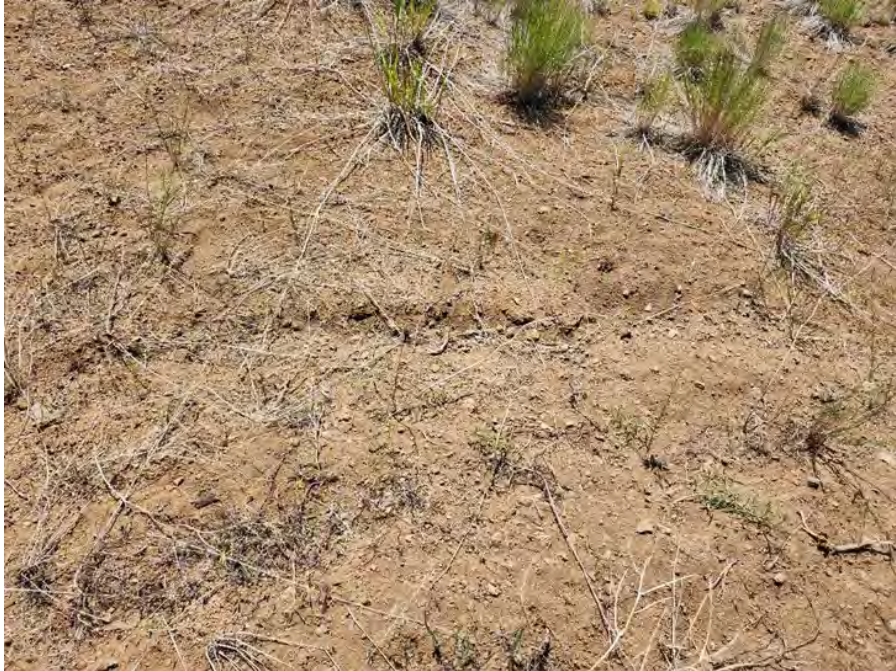
Parcel P – Rill observed near Northern portion of Parcel.

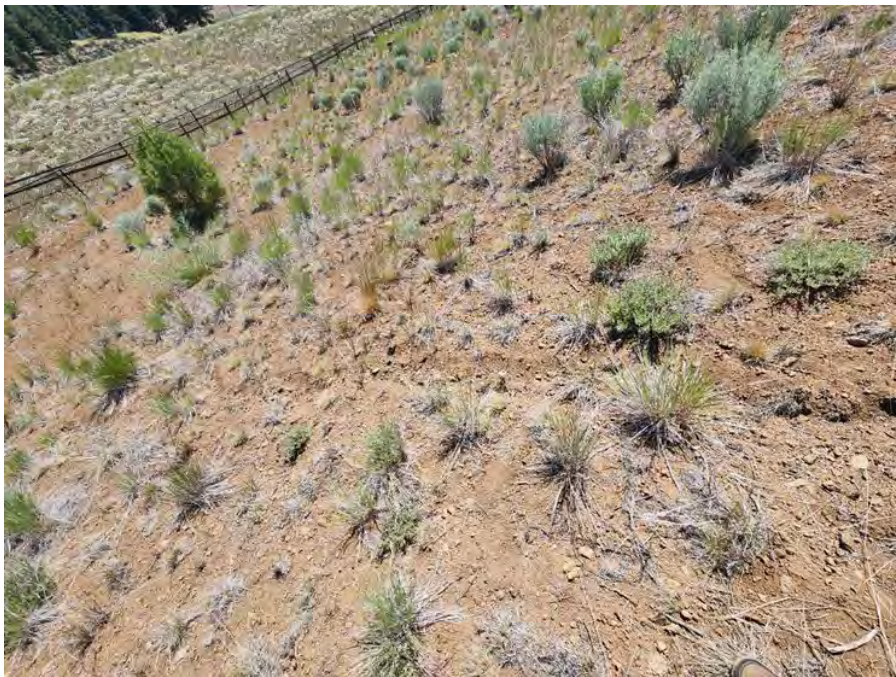
Parcel P – Rill observed near Northern portion of Parcel.

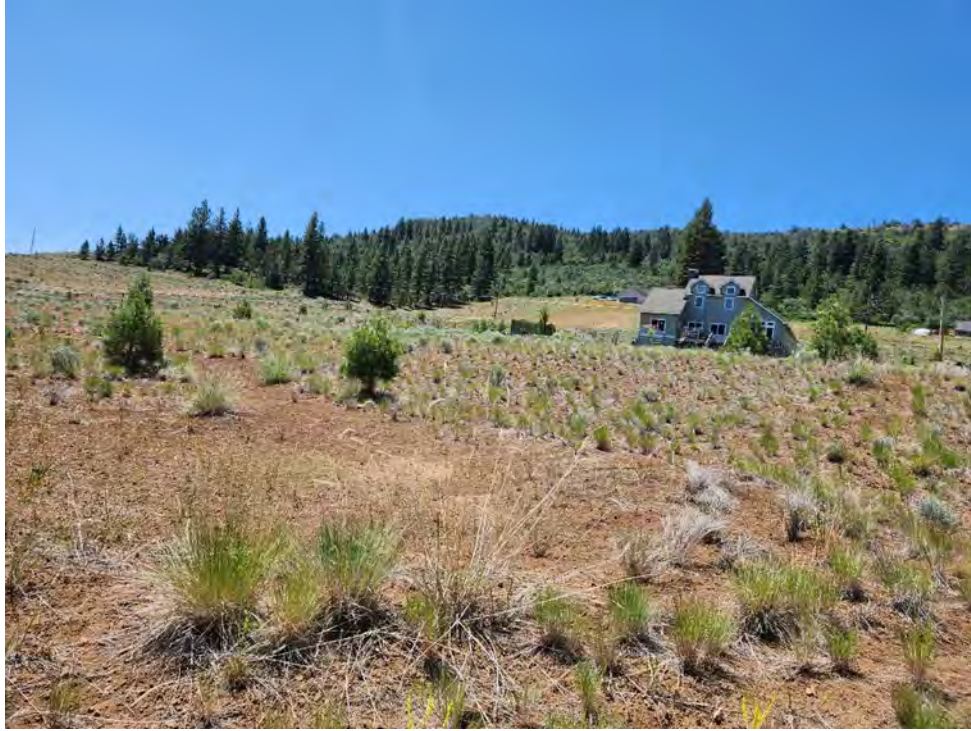
Parcel P – View facing South from Northern corner.
