Department of Environmental Quality

RE: Annual Inspection for Parcels Q, MBK-A, MBK-B, & MBK-C  
North Ridge Estates Superfund Site  
ECSI Nos. 6003, 6026, 6027, & 6028

Operations and Maintenance Inspection Form

2023 Annual Inspection Summary Report  
North Ridge Estates - Operable Unit 1  
Klamath Falls, Oregon

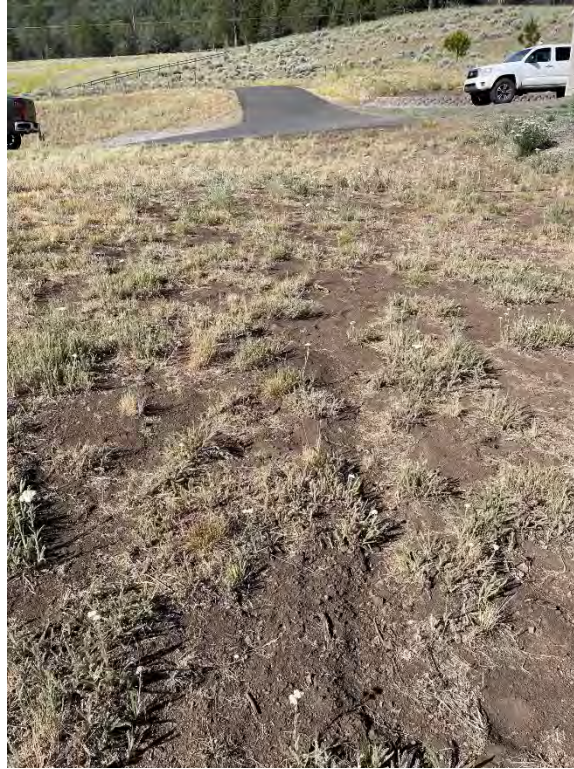
Parcel Q – New Rill in the West Central portion of the Parcel.

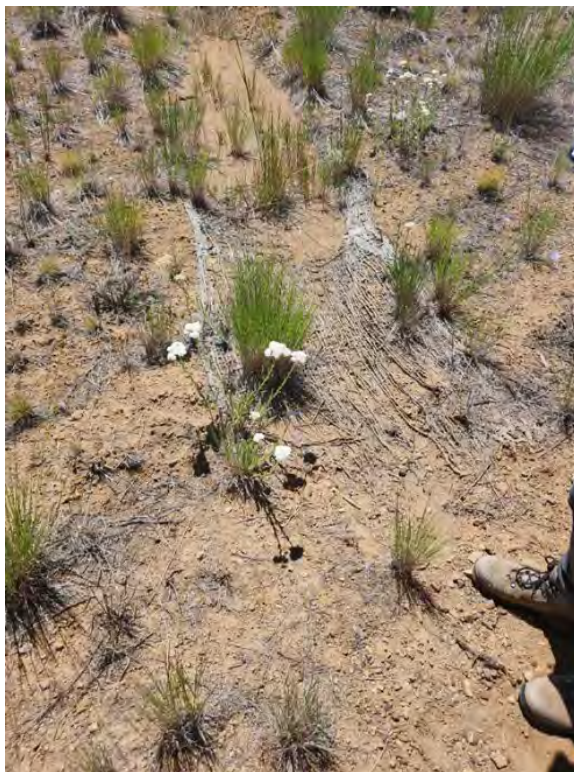
Parcel MBK-A – View of coconut fiber mat.

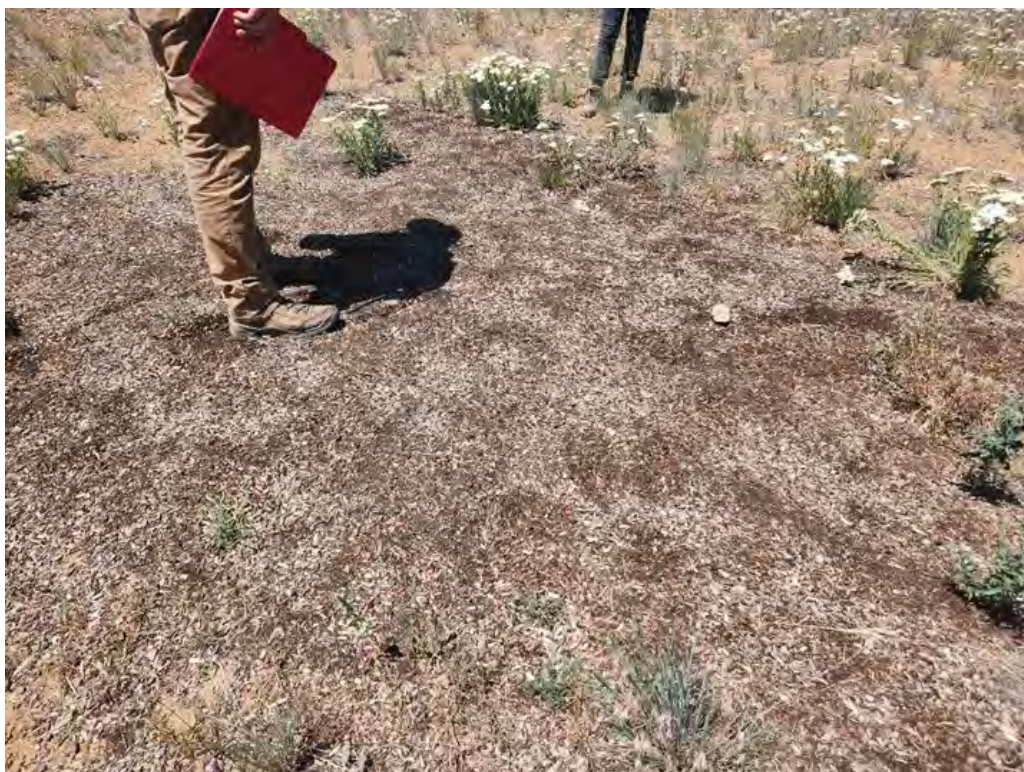
Parcel MBK-A – Bark mulch pile located on North Central area of Parcel.

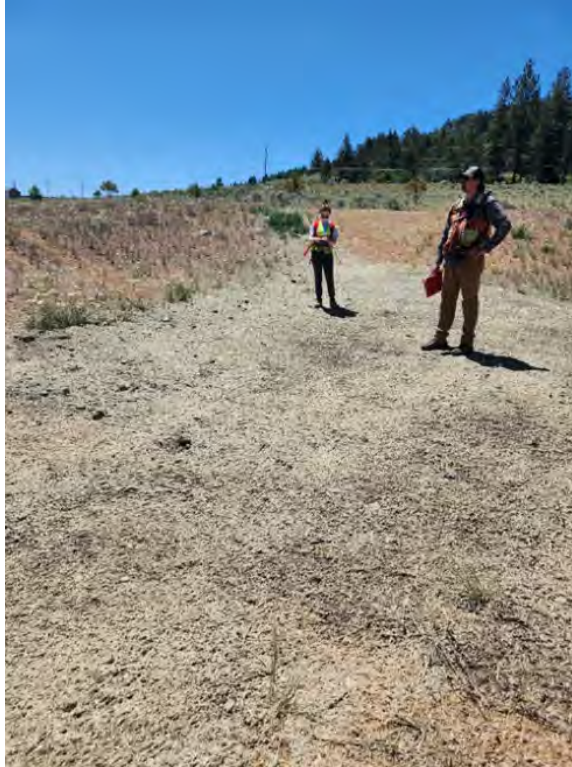
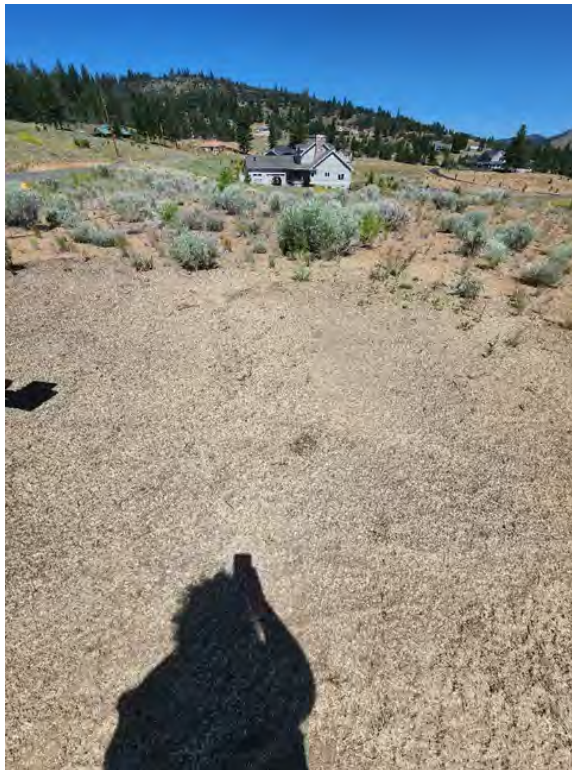
<input type="checkbox"/>	<input type="checkbox"/>	<input type="checkbox"/>	<input type="checkbox"/>	Recent repairs made to the northeast corner of the parcel were observed during the 2023 inspection. Washout erosion caused by a leaking water overflow meter was backfilled with topsoil material in April 2023. According to the City of Klamath Falls, no damage to the soil cap was greater than 2 feet.	
		<input type="checkbox"/>	<input type="checkbox"/>	<input type="checkbox"/>	<input type="checkbox"/>		
		<input type="checkbox"/>	<input type="checkbox"/>	<input type="checkbox"/>	<input type="checkbox"/>		
		<input type="checkbox"/>	<input type="checkbox"/>	<input type="checkbox"/>	<input type="checkbox"/>

Parcel MBK-B – Washout erosion was backfilled in response to leaking water overflow meter in April 2023.

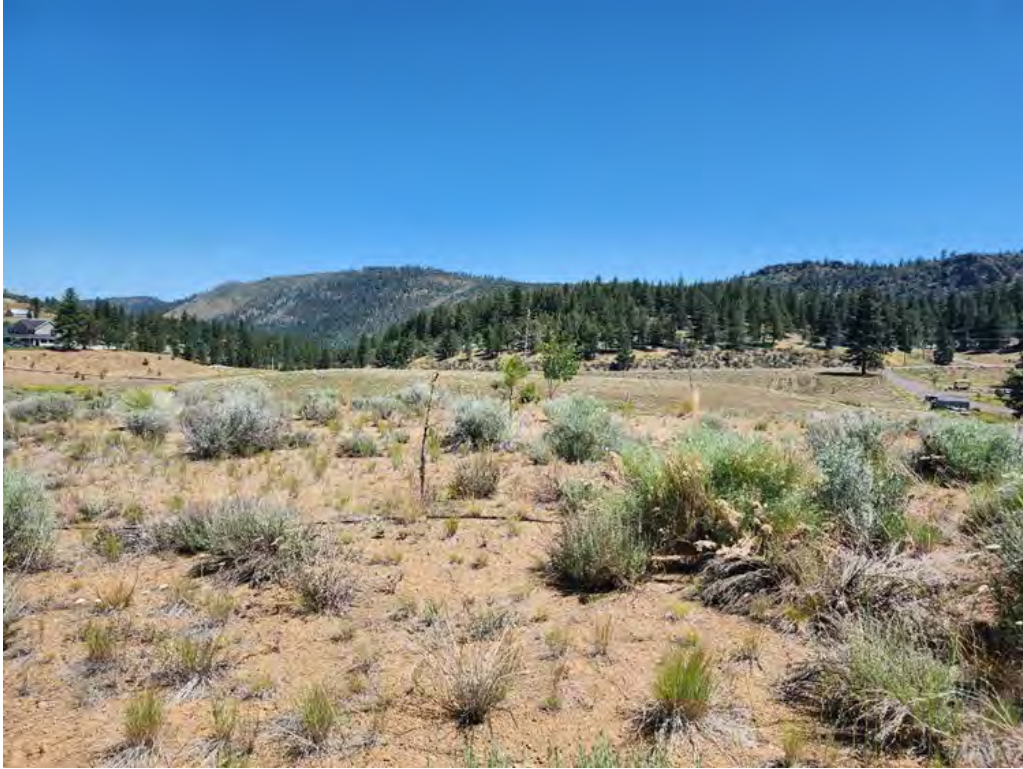
Parcel MBK-B – View of distressed Trees on Parcel; Trees likely not receiving adequate irrigation.

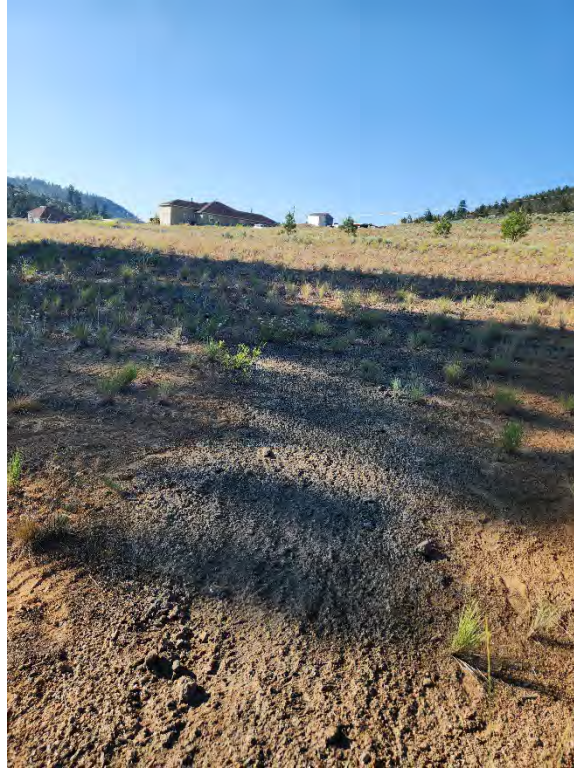
<input type="checkbox"/>	<input type="checkbox"/>	<input type="checkbox"/>	<input type="checkbox"/>	Recent repairs made to the northern central portion of parcel were observed during the 2023 inspection. Washout erosion that occurred in February 2023 by a leaking frozen air valve was backfilled with topsoil material. According to the City of Klamath Falls, no damage to the soil cap was greater than 2 feet.	
		<input type="checkbox"/>	<input type="checkbox"/>	<input type="checkbox"/>	<input type="checkbox"/>		
		<input type="checkbox"/>	<input type="checkbox"/>	<input type="checkbox"/>	<input type="checkbox"/>		
		<input type="checkbox"/>	<input type="checkbox"/>	<input type="checkbox"/>	<input type="checkbox"/>

Parcel MBK-C – View of North Central portion of Parcel; repairs made in response to washout caused by frozen air valve.

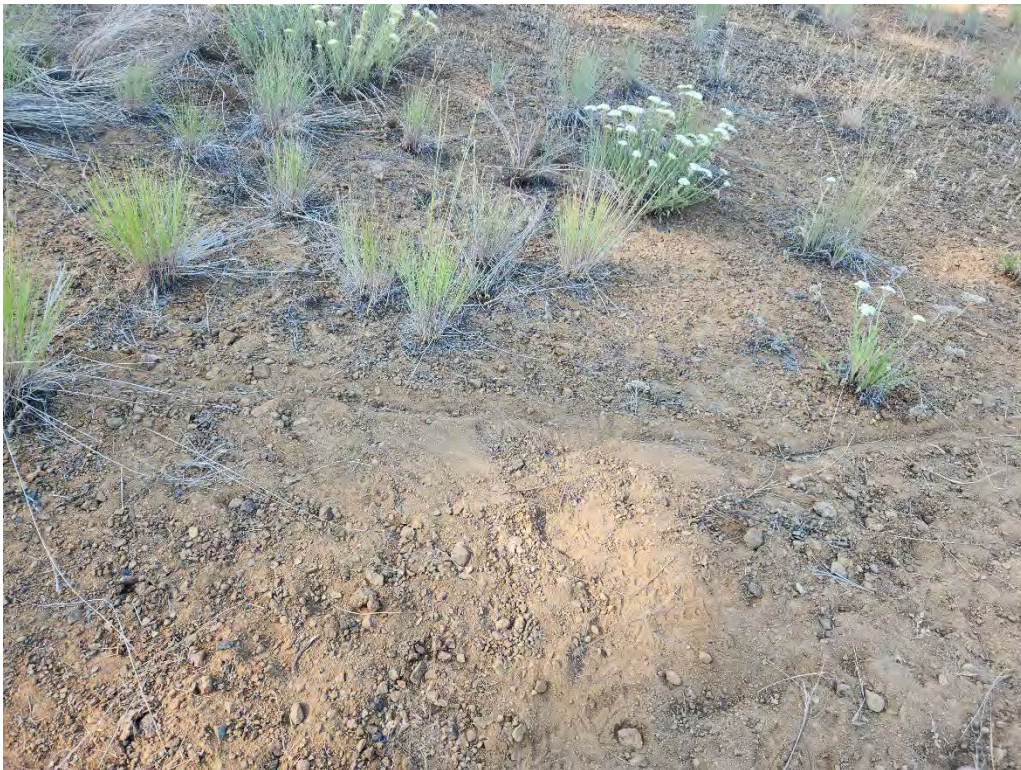
Part I. General Site Information							
Site Name:		North Ridge Estates		State/Country:		Oregon (Klamath County)	
EPA Point of Contact		Linda Meyer (206) 553-6636		ODEQ Point of Contact		Katie Daugherty (503) 860-3943	
Inspection Date:		7/5/2023		Person(s) Performing Inspection:		Ben Echt (Apex Companies, LLC)	
Person(s) Performing Inspection:							
Part II. Remedy Performance Assessment							
Remedy Component	Potential Problem	Yes (Repair Needed)	Yes (Monitor/ No Repair)	No	N/A	If Yes, Describe Extent of Problem	Describe Potential Repair Solution
Protective Cap	Have rills developed deeper than 2 inches?	<input type="checkbox"/>	<input type="checkbox"/>	<input checked="" type="checkbox"/>	<input type="checkbox"/>		
	Are the rills within a 10-foot interval?	<input type="checkbox"/>	<input checked="" type="checkbox"/>	<input type="checkbox"/>	<input type="checkbox"/>	A total of three rills were identified within 10 feet.

Parcel MBK-C – View of Rills near North Central portion of Parcel.

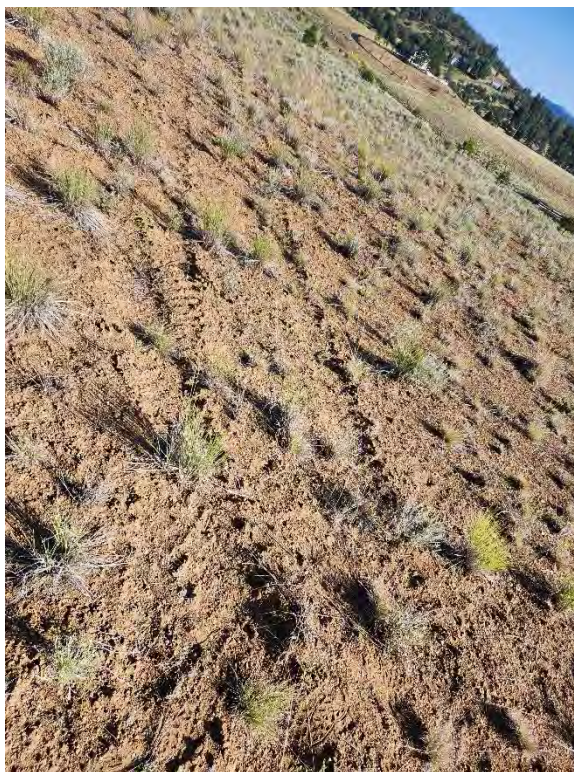
Parcel MBK-C – View of Tire Tracks near Southern portion of Parcel.
