RE: Annual Inspection for Parcel R  
North Ridge Estates Superfund Site  
ECSI No. 6002

***Parcel R***

Operations and Maintenance Inspection Form

2023 Annual Inspection Summary Report  
North Ridge Estates - Operable Unit 1  
Klamath Falls, Oregon

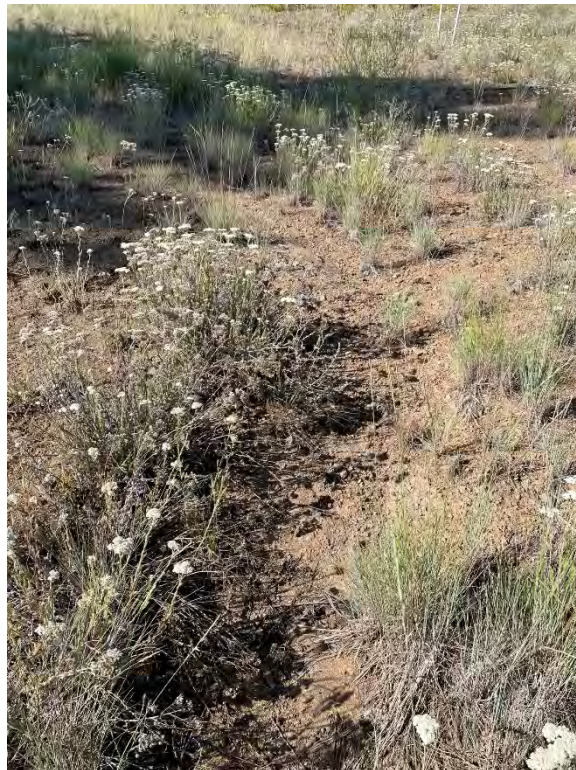
Parcel R – New Rill located at the Northwest corner of Parcel.

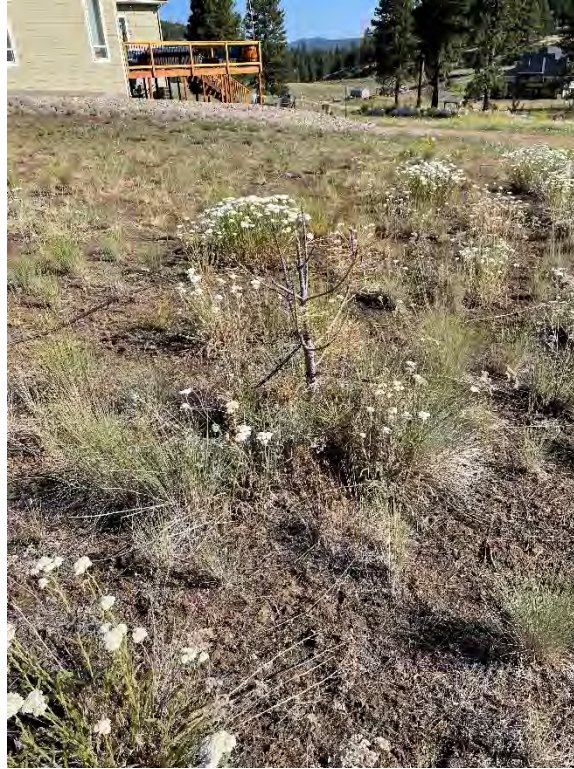
Parcel R – Newly planted tree (distressed) found on the Southwest side of the Parcel.
