RE: Annual Inspection for Parcel S
North Ridge Estates Superfund Site
ECSI No. 6005

Operations and Maintenance Inspection Form

Lot S Inspection

2023 Annual Inspection Summary Report
North Ridge Estates - Operable Unit 1
Klamath Falls, Oregon

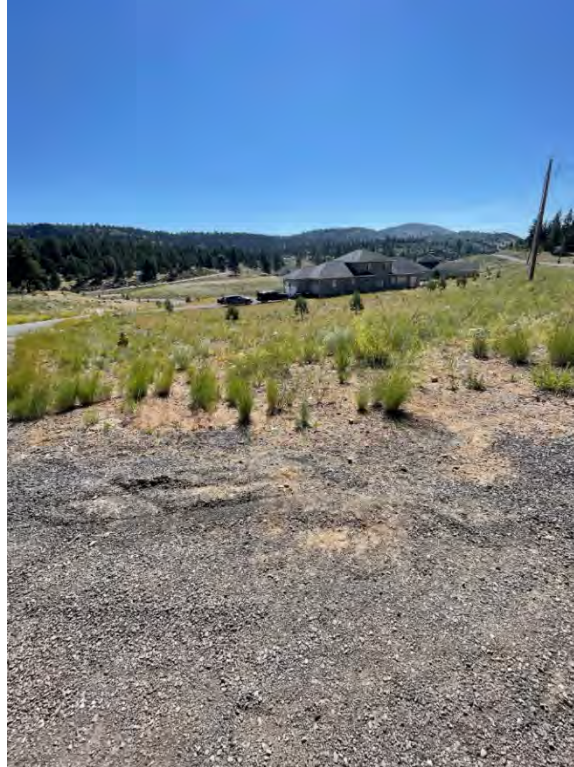
Parcel S – Northwest corner of Parcel, facing Southeast.

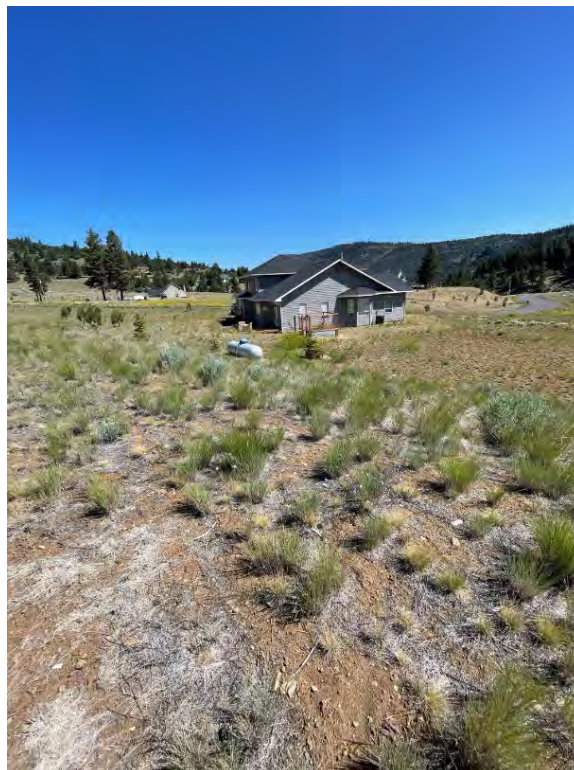
Parcel S – Southwest corner of the Parcel, facing Northeast.

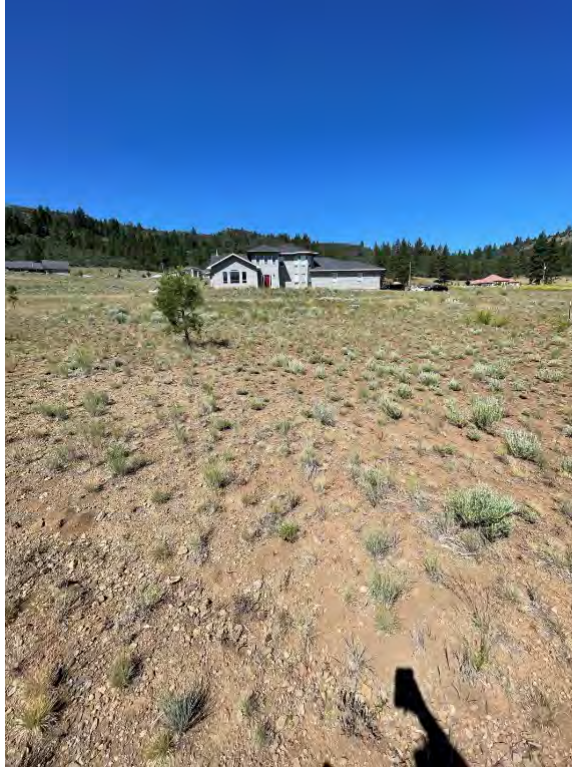
Parcel S – Northeast corner of the Parcel, facing West.

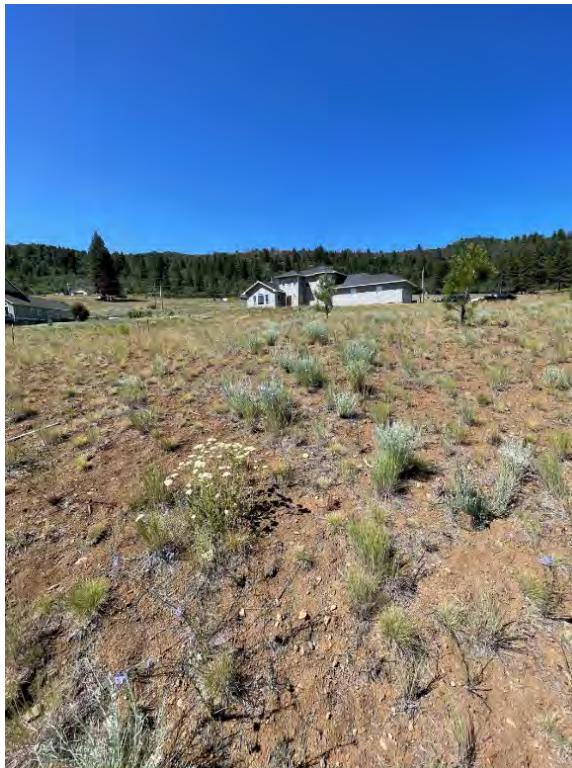
Parcel S – Northeast corner of the Parcel, facing Southwest.

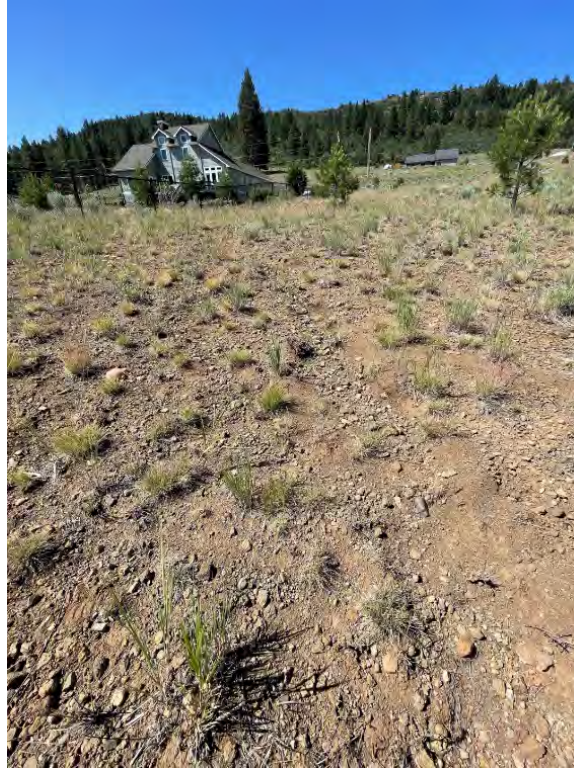
Parcel S – New Rill on Southwest side of the Parcel.

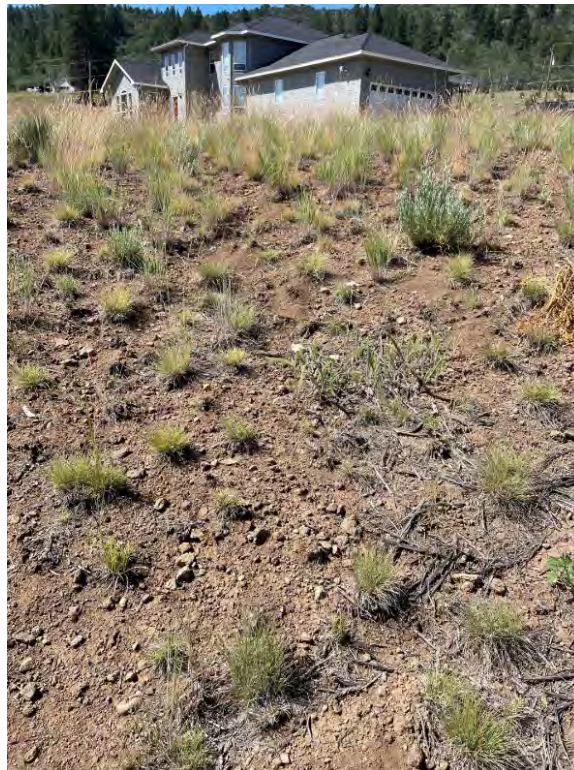
Parcel S – New Rill on the North Side of the Parcel near the driveway.
