RE: Annual Inspection for Parcel W  
North Ridge Estates Superfund Site  
ECSI No. 6006

Operations and Maintenance Inspection Form

2023 Annual Inspection Summary Report  
North Ridge Estates - Operable Unit 1  
Klamath Falls, Oregon

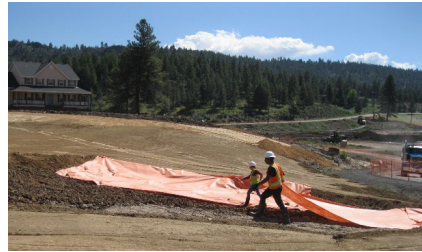
*Example of Orange Liner. 2018. Installing marker barrier consisting of rock base and orange liner on Parcel B prior to covering with clean soil.*

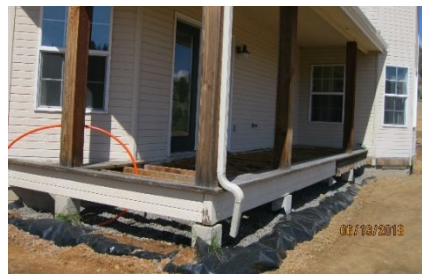
*Example of Black Liner. 2018. Black liner with rock to hold in place on Parcel A.*

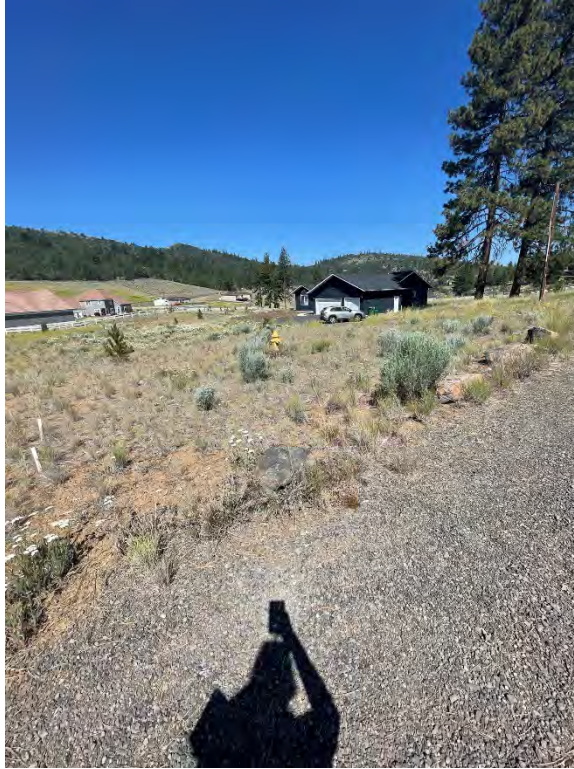
Parcel W – Southeast corner of Parcel, facing Northwest.

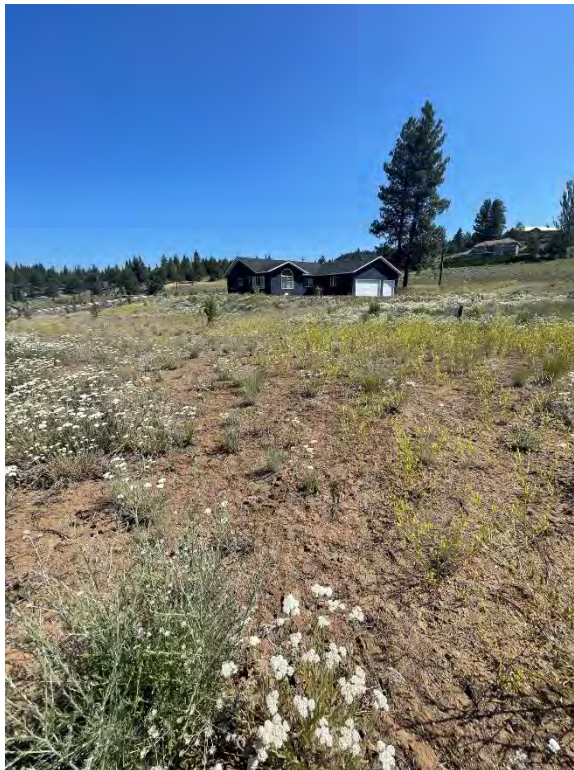
Parcel W – Southwest corner of Parcel, facing Northeast.

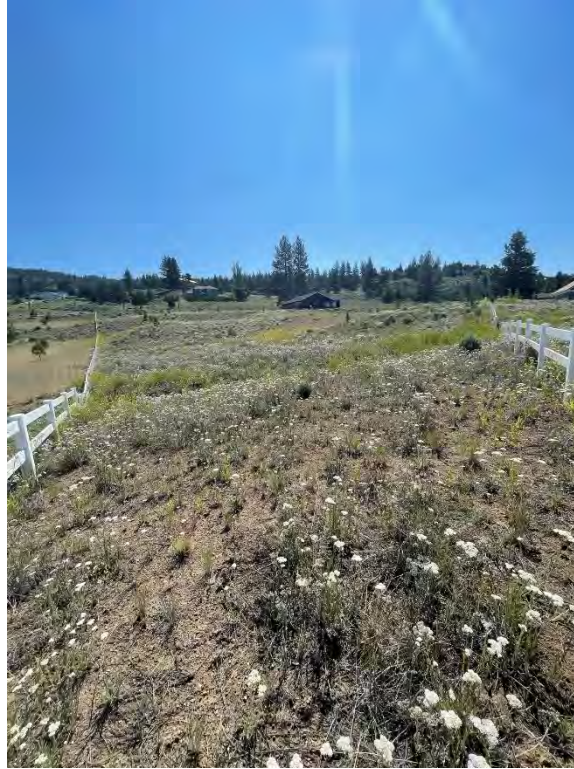
Parcel W – Northwest corner of Parcel, facing Southwest.

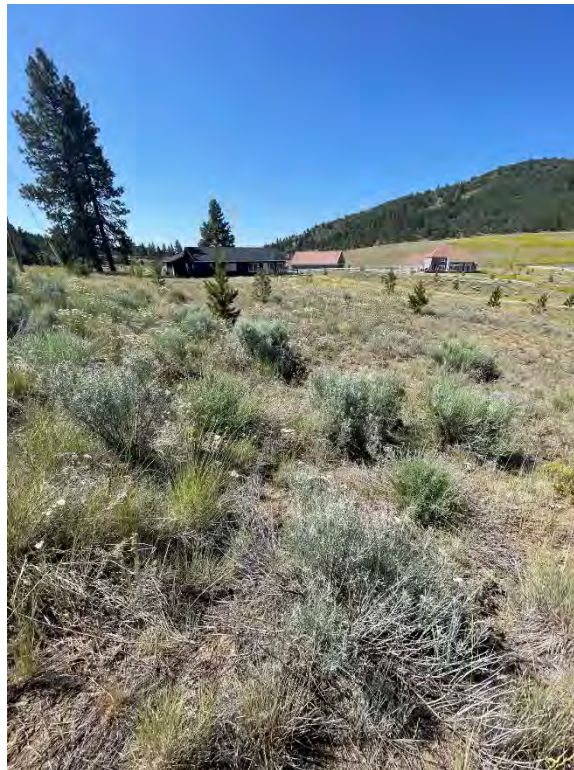
Parcel W – Northeast Corner of Parcel, facing Southwest.

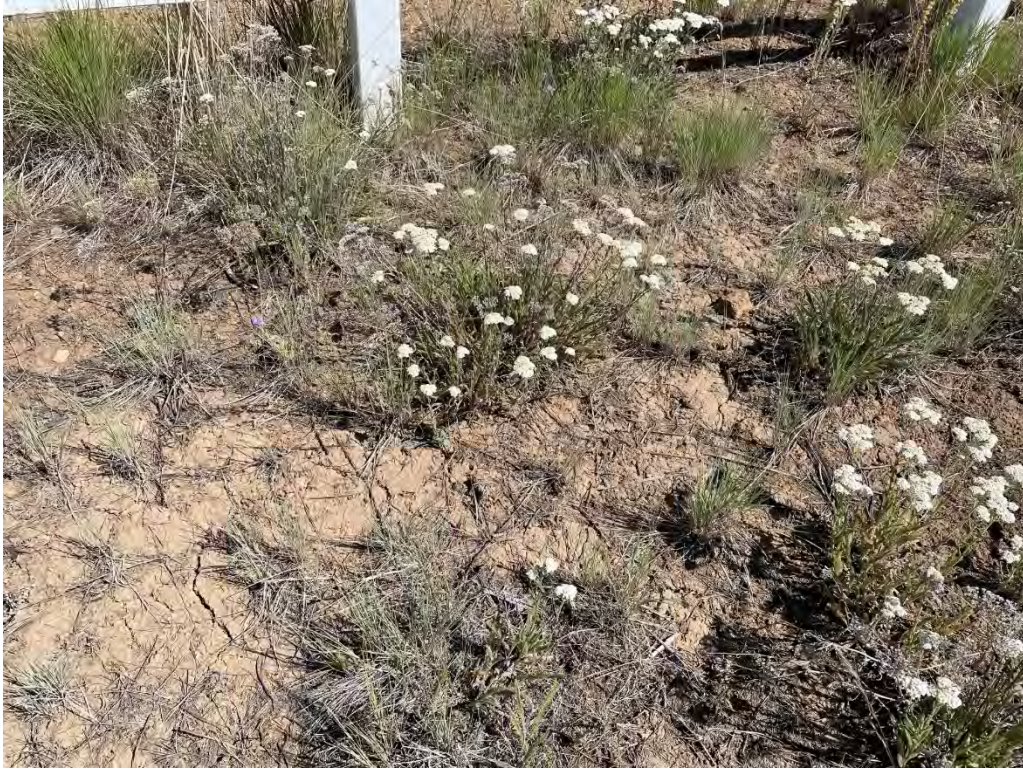
Parcel W – Mud cracks located on the West side of the Parcel.

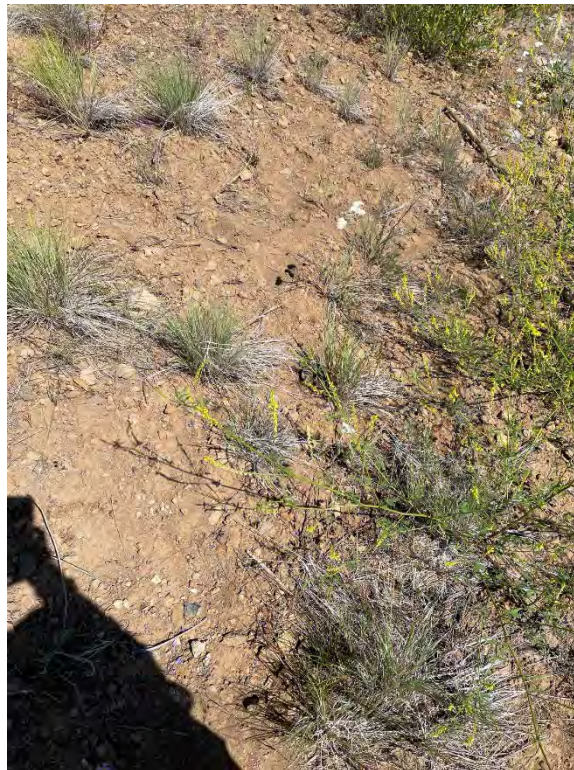
| Part I. General Site Information | | | | | | | |
|---|---|---|---|---|---|---|---|
| Protective Cap | Have rills developed deeper than 2 inches? | <input type="checkbox"/> | <input type="checkbox"/> | <input checked="" type="checkbox"/> | <input type="checkbox"/> | A total of five new rills were observed on the southeast corner of parcel. | |

Parcel W – New rills were identified on the Southwest side of the Parcel.
