RE: Annual Inspection for Parcel X
North Ridge Estates Superfund Site
ECSI No. 6007

Operations and Maintenance Inspection Form

2023 Annual Inspection Summary Report
North Ridge Estates - Operable Unit 1
Klamath Falls, Oregon

Figure
X.3

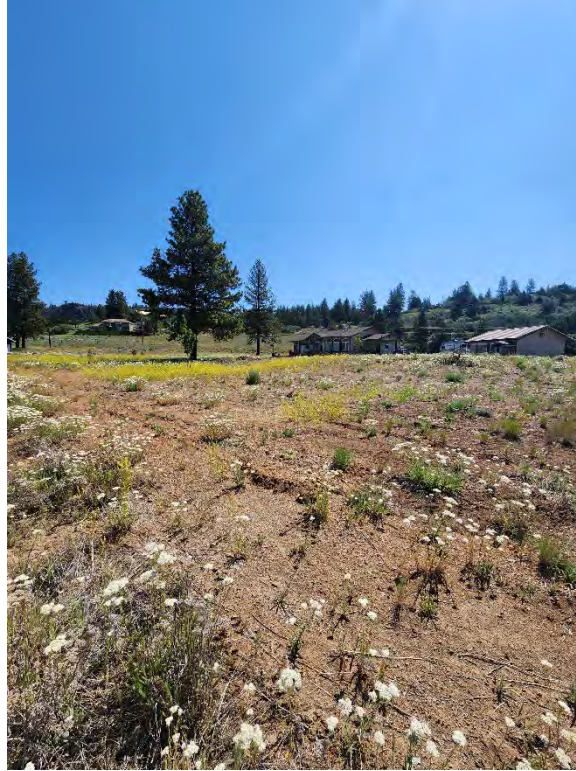
Parcel X – View from Western Corner of Parcel.

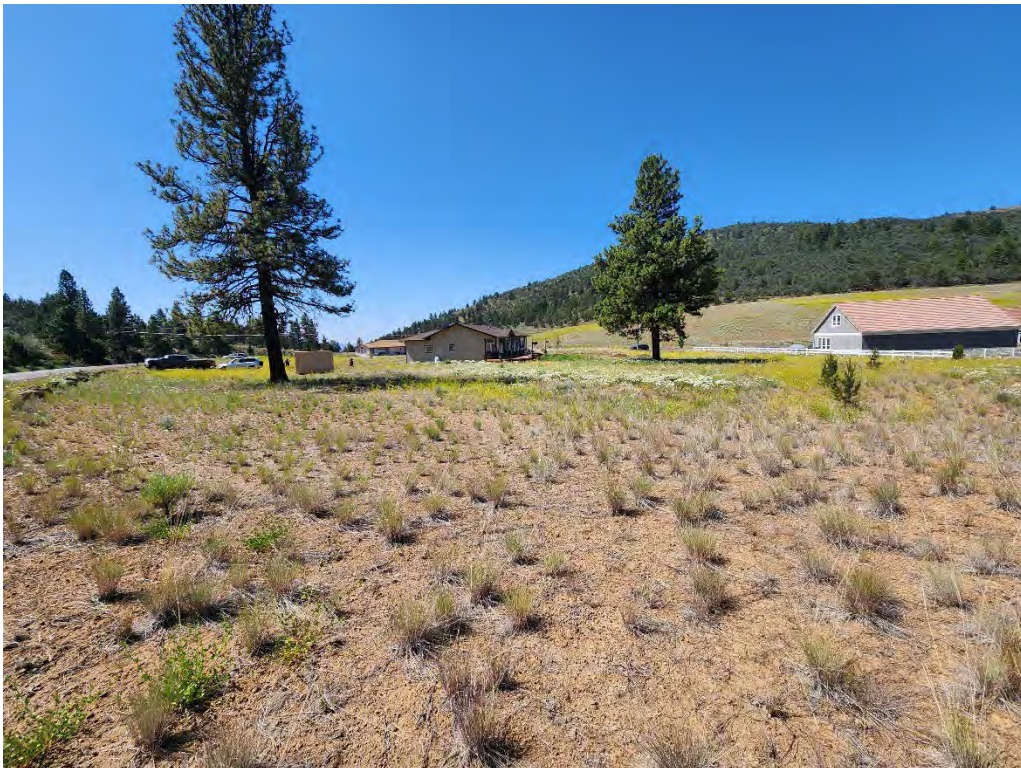
Parcel X – View from Northern corner of Parcel.

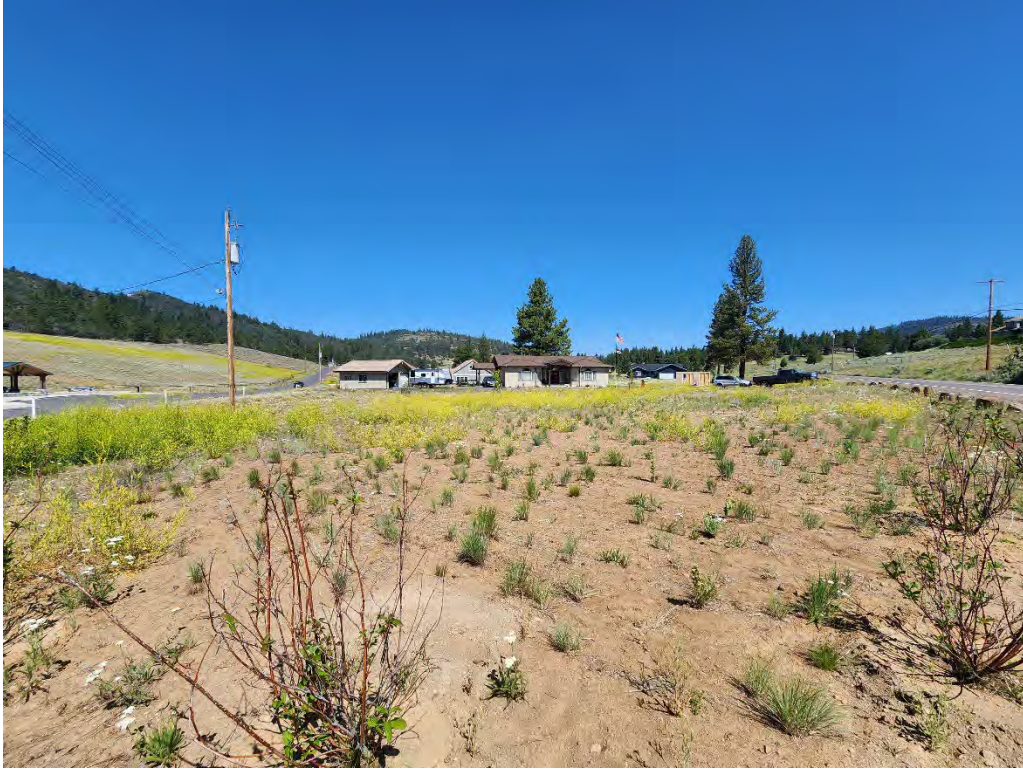
Parcel X – View from Southern corner of Parcel.

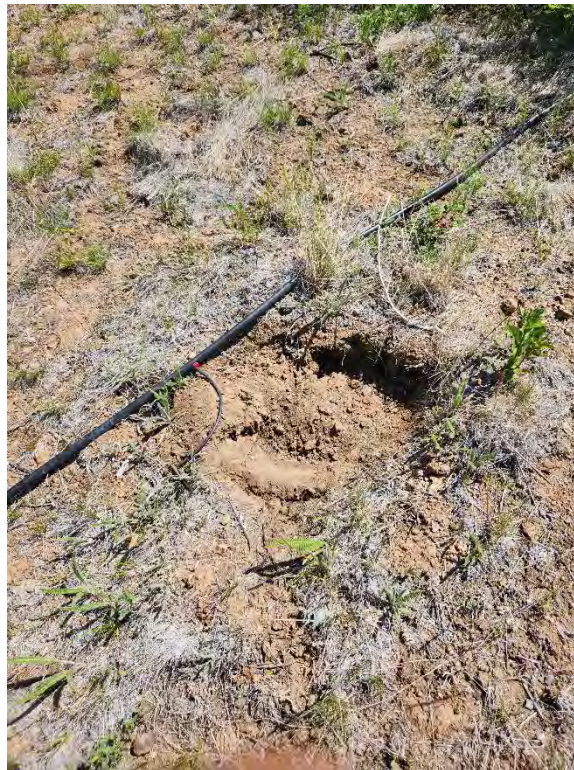
Parcel X – View of Hole (4-inches deep) located on Southern portion of Parcel; related to Tree removal.

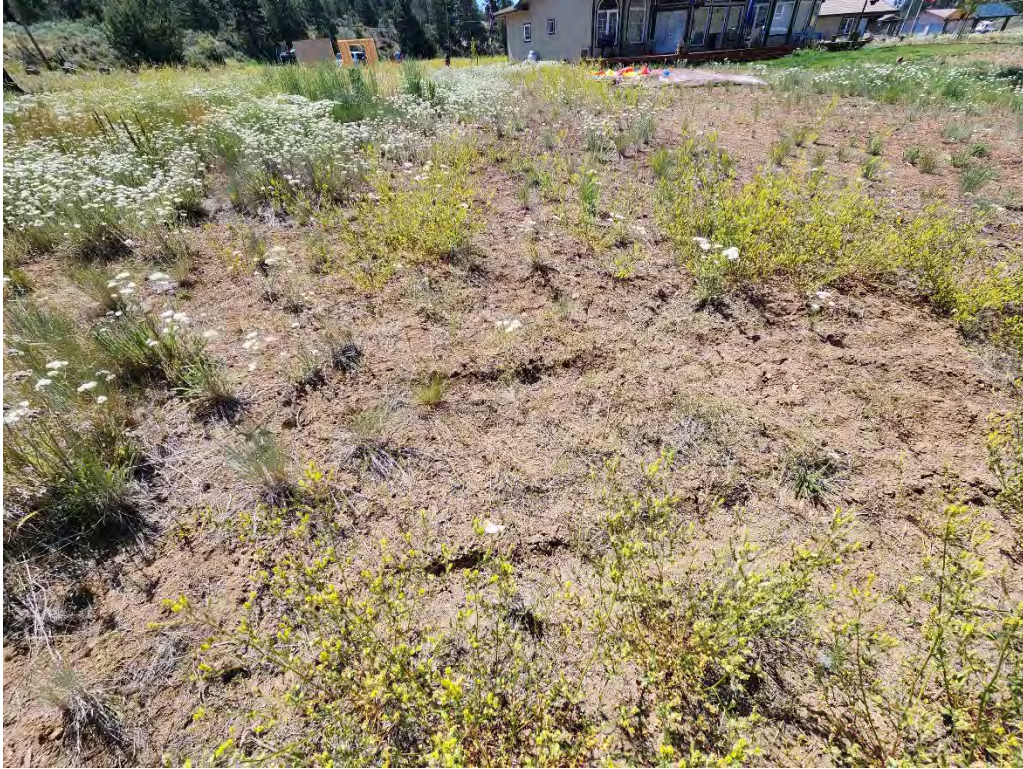
Parcel X – View of Rills located near Northern portion of Parcel.

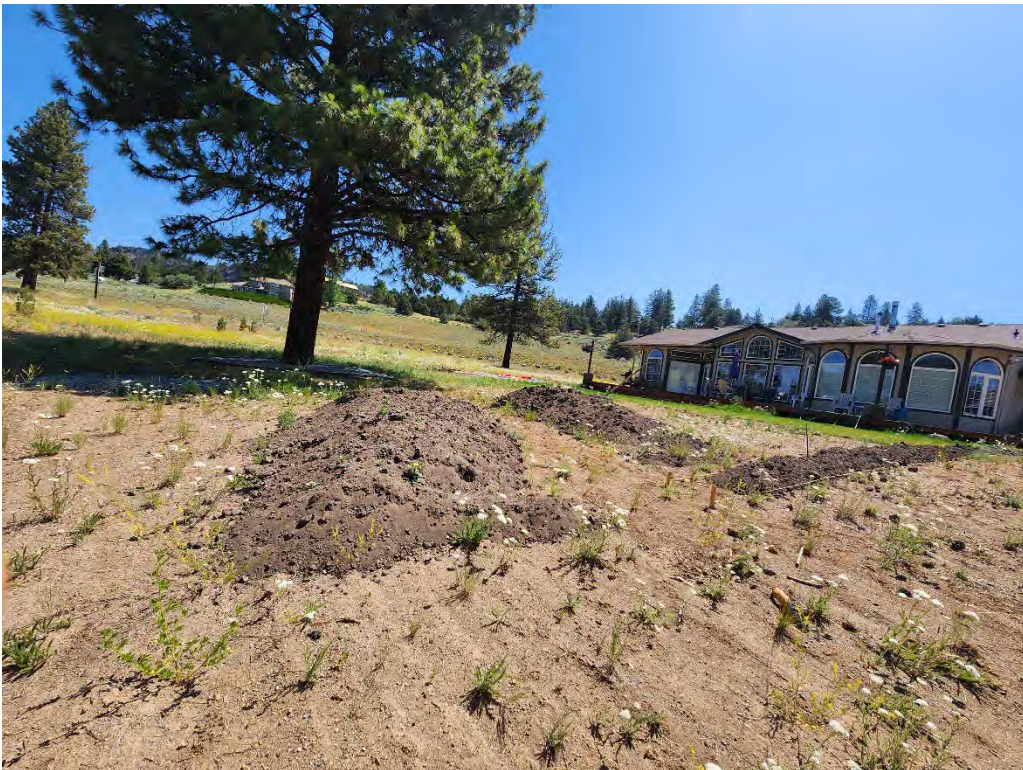
Parcel X – Newly constructed garden beds observed West of residence; no damage to cap observed.
