Department of Environmental Quality

RE: Annual Inspection for Parcel Y  
North Ridge Estates Superfund Site  
ECSI No. 6008

Operations and Maintenance Inspection Form

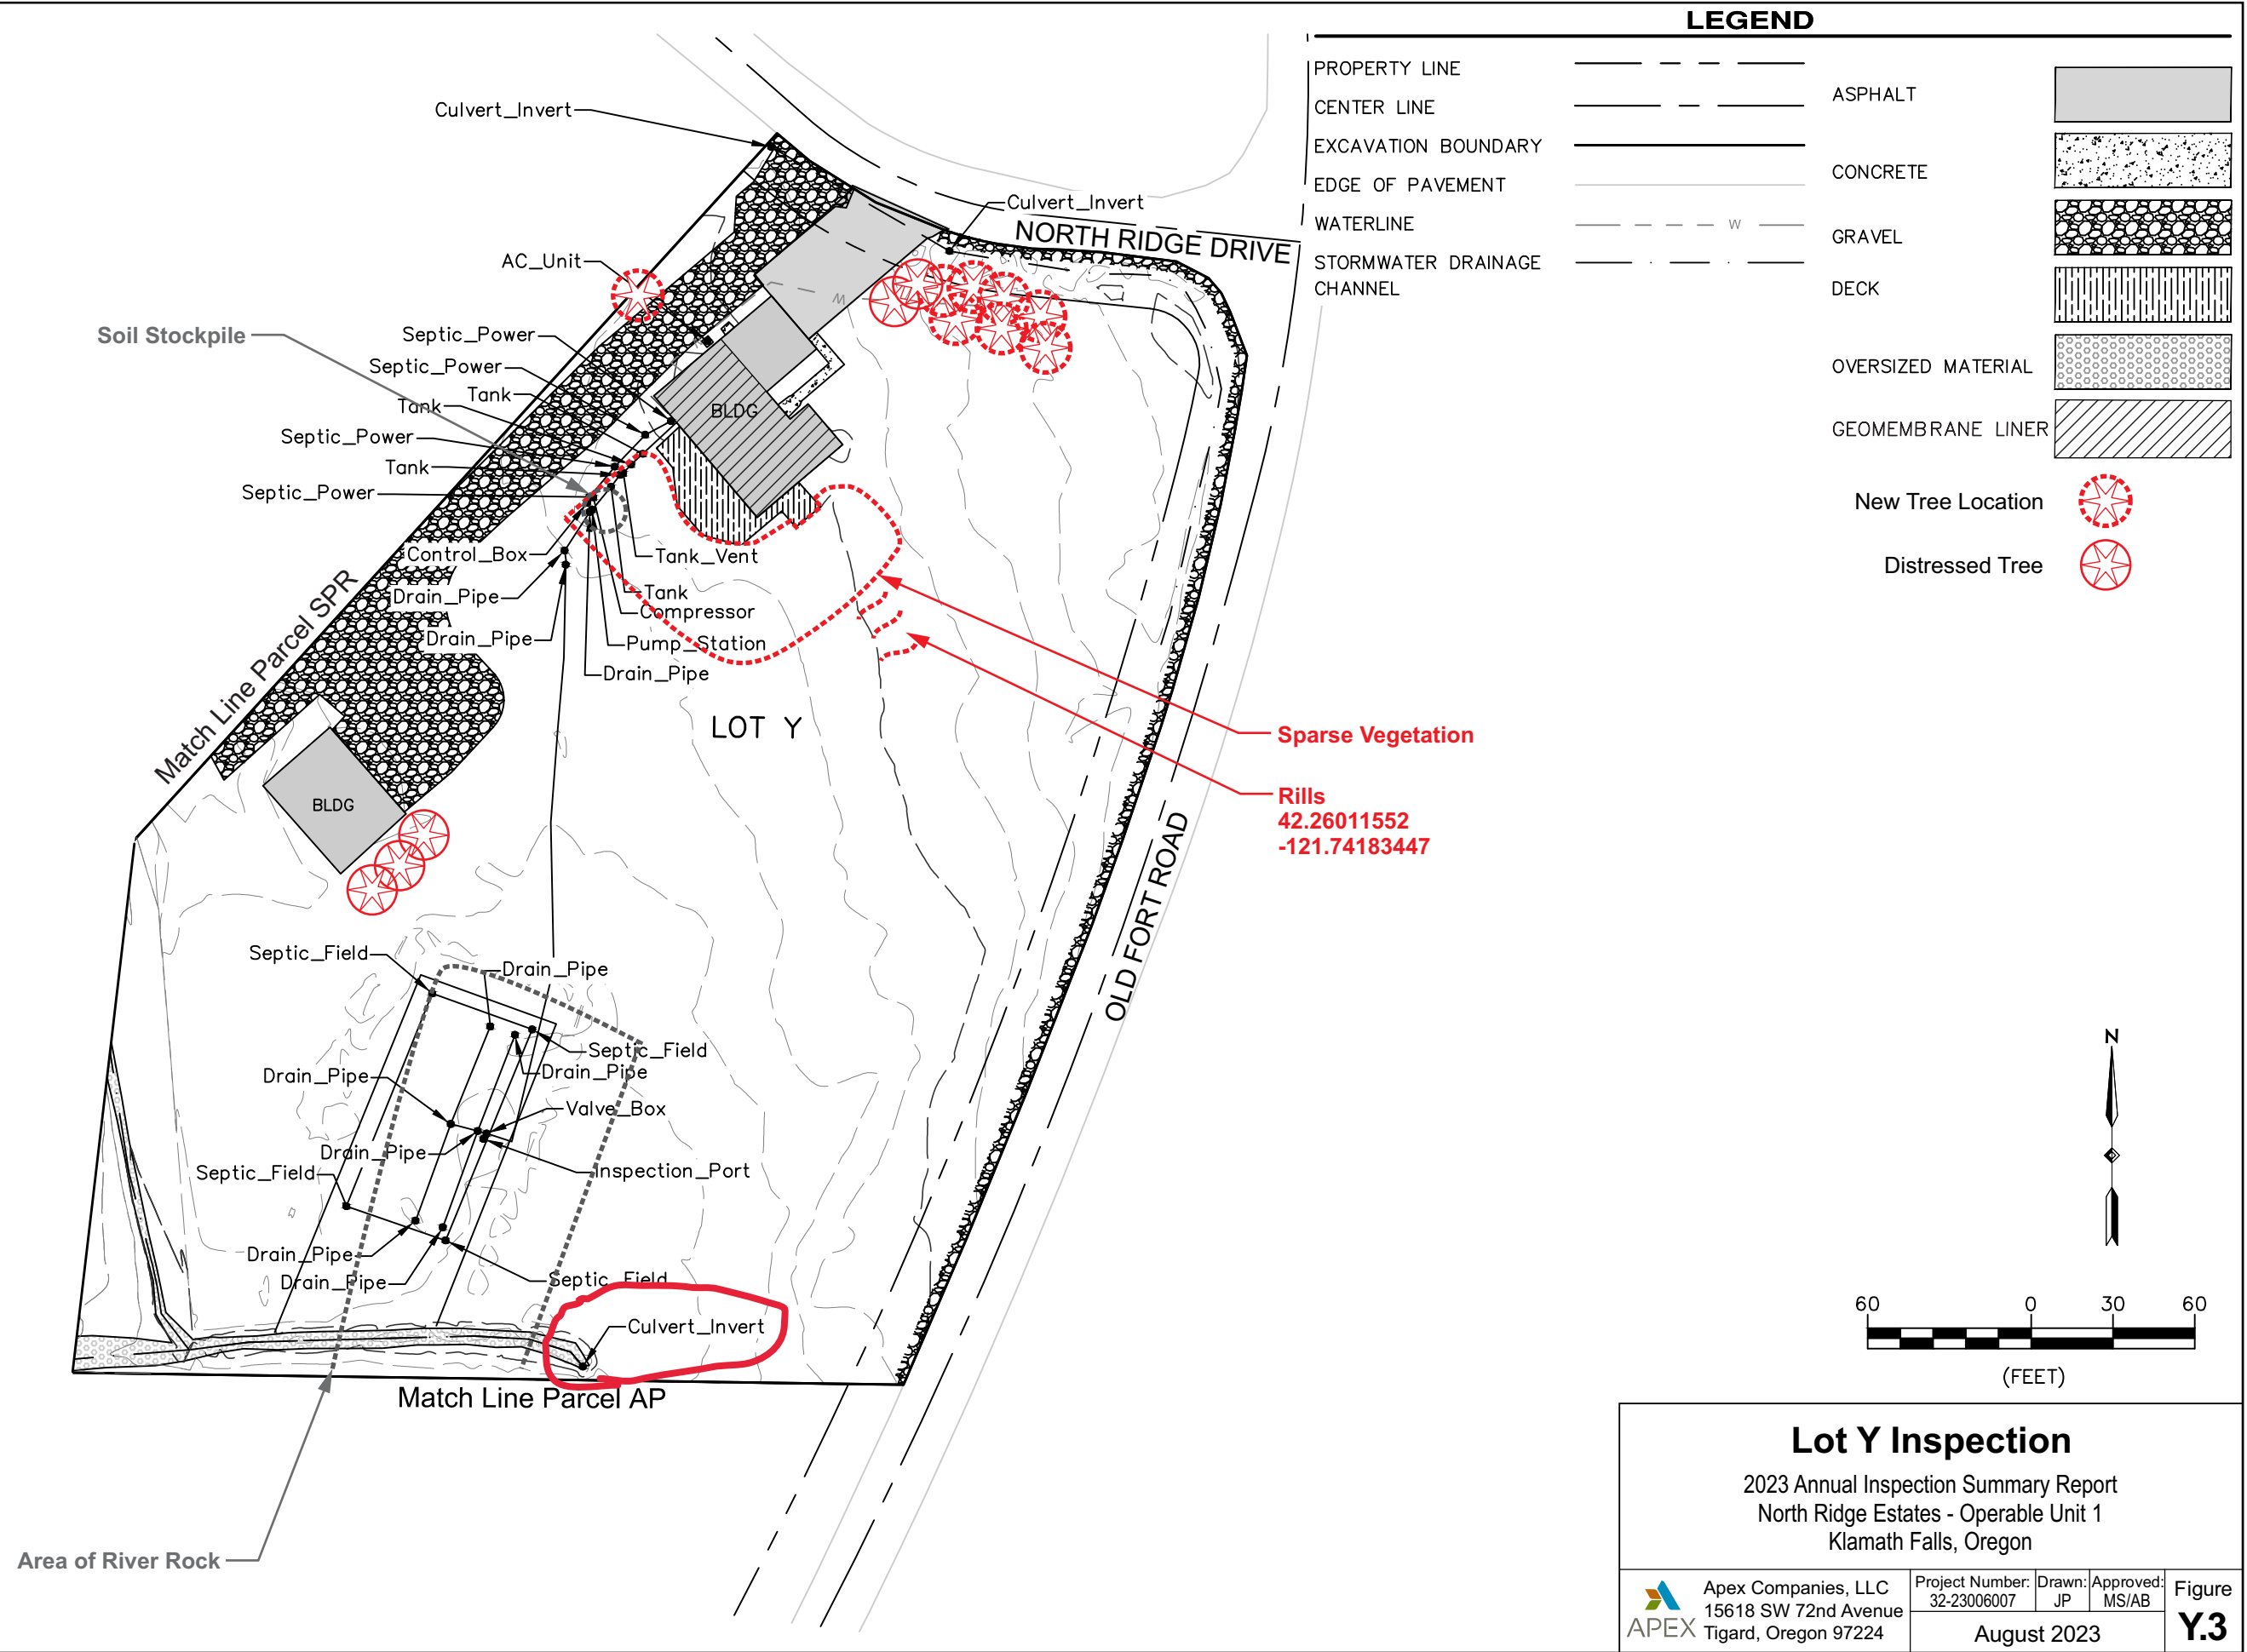
1. **Blocked culvert.** The end of the culvert located on your property that travels beneath your neighbors driveway is partially obstructed (see enclosed figure).

**Corrective Action.** Remove the material obstructing the culvert to allow the unrestricted flow of stormwater by November 12, 2023.

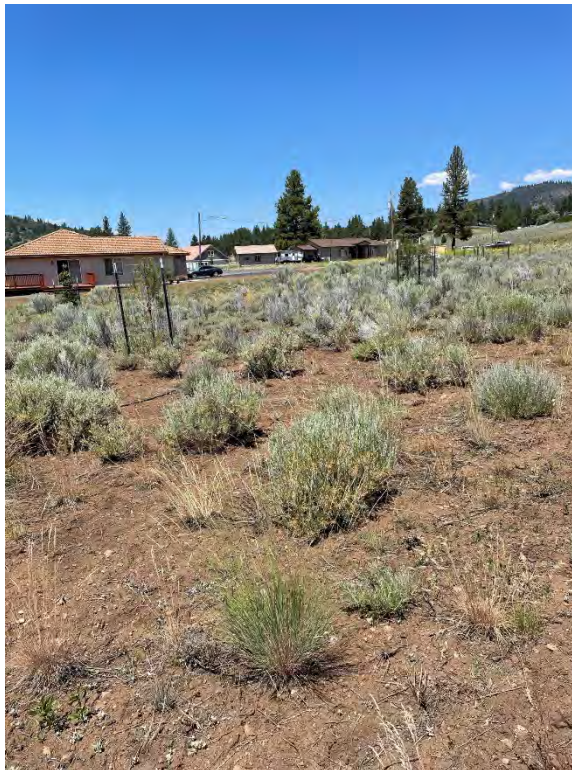
Parcel Y – Distressed trees located along the North side of the Parcel.

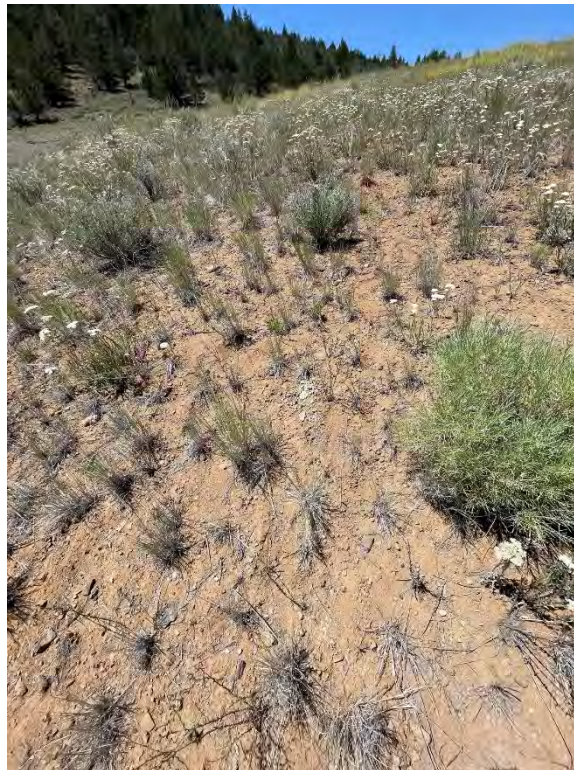
Parcel Y – New Rills observed on the Southwest corner of the Parcel.
