RE: Annual Inspection for Parcel Z
North Ridge Estates Superfund Site
ECSI No. 6009

The Oregon Department of Environmental Quality completed an annual inspection of the protective cap on your property located at 3547 North Ridge Drive during the week of July 3, 2023. The protective cap appears to be in good condition with a few minor areas to watch. Enclosed for your information is a summary of the inspection.

Parcel Z

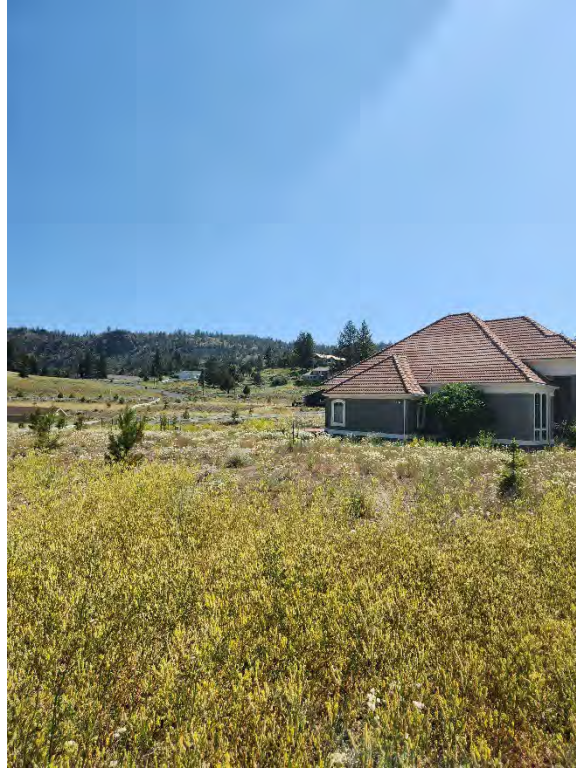
Parcel Z – View from Western corner of Parcel.

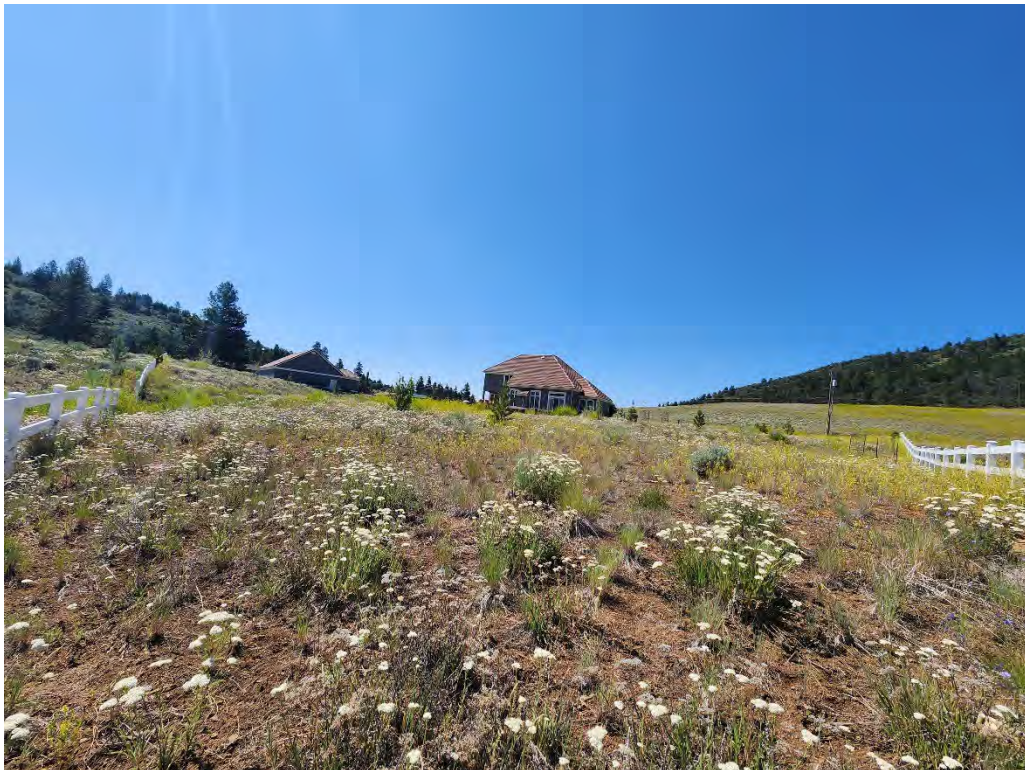
Parcel Z – View from Northern corner of Parcel.

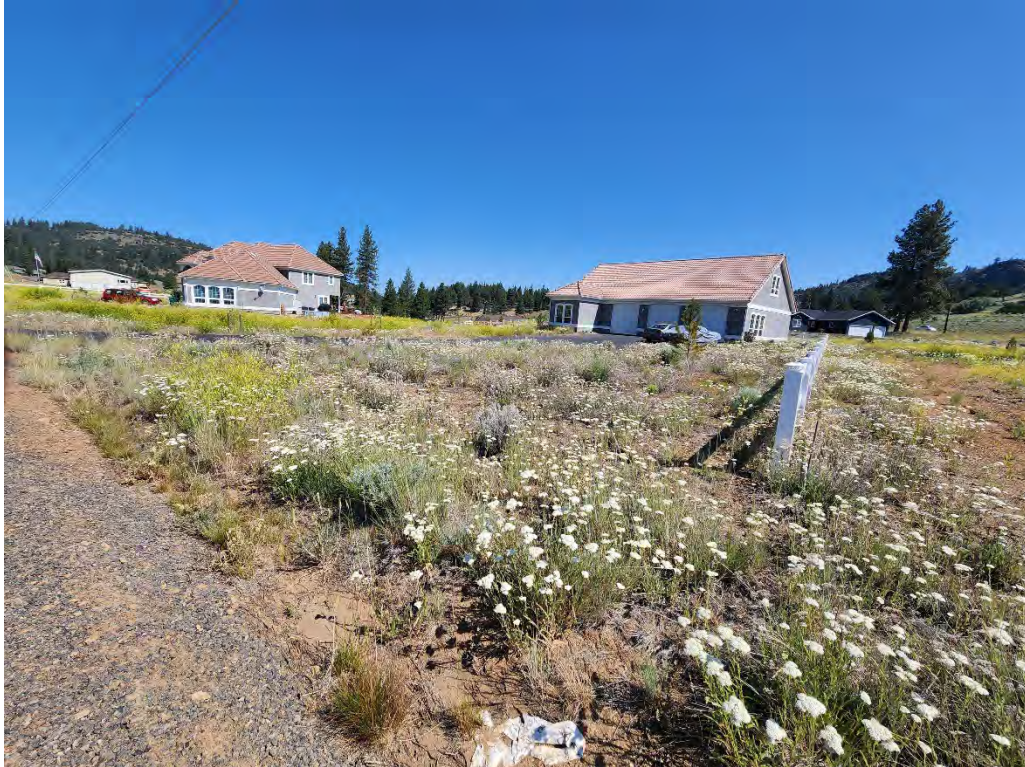
Parcel Z – View from Southern corner of Parcel.

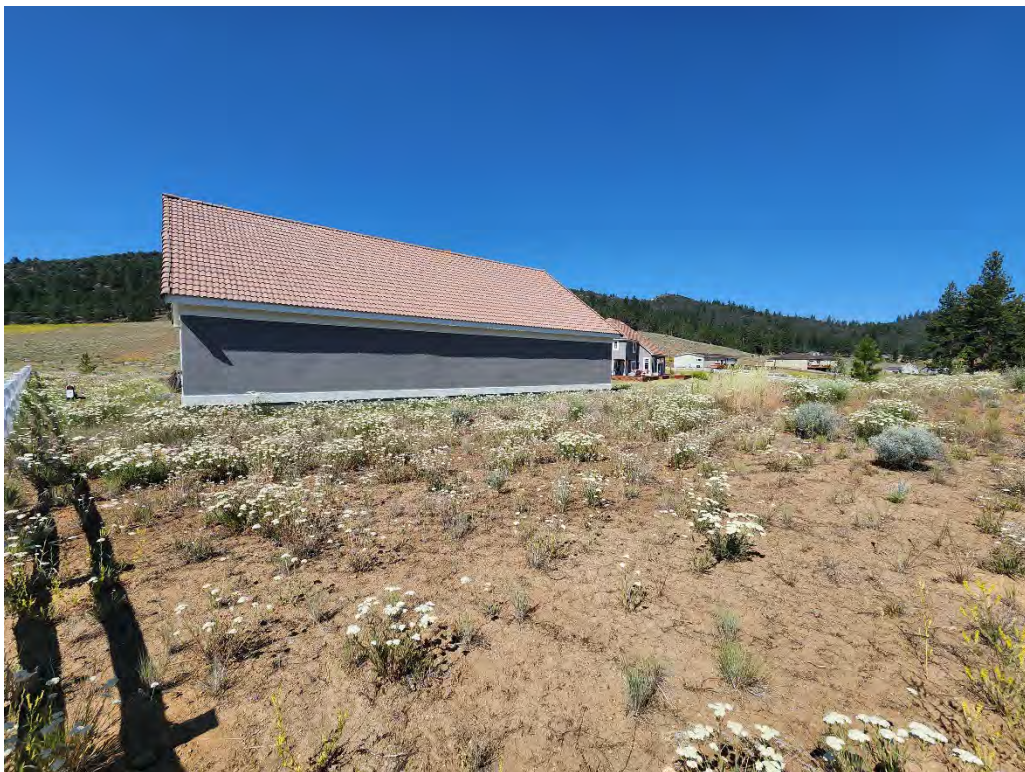
Parcel Z – View from East corner of Parcel.

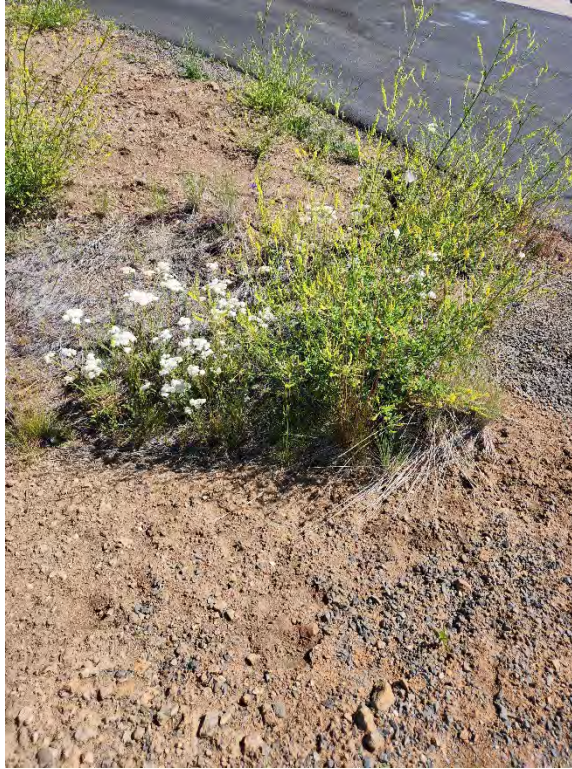
Ditches and Culverts	Obstructions observed in ditches or culverts that may impede conveyance of stormwater?	<input checked="" type="checkbox"/>	<input type="checkbox"/>	<input type="checkbox"/>	<input type="checkbox"/>	Both culverts on the southwestern portion of the parcel along North Ridge Drive were obstructed by vegetation. Probel has been persistent since 2021.	Remove obstructions from culverts to enable stormwater flow.
	Damaged observed to riprap surface? Note if riprap is not intact or not effectively providing armor protection.	<input type="checkbox"/>	<input checked="" type="checkbox"/>	<input type="checkbox"/>	<input type="checkbox"/>	Some rip rap was observed to be missing in the ditch on the southern portion of parcel. (Same as 2021)	
	Are there any areas that show signs of excessive scour? (i.e., gullies forming along centerline of ditch)	<input type="checkbox"/>	<input type="checkbox"/>	<input checked="" type="checkbox"/>	<input type="checkbox"/>

Parcel Z – View of Culvert blocked by vegetation.

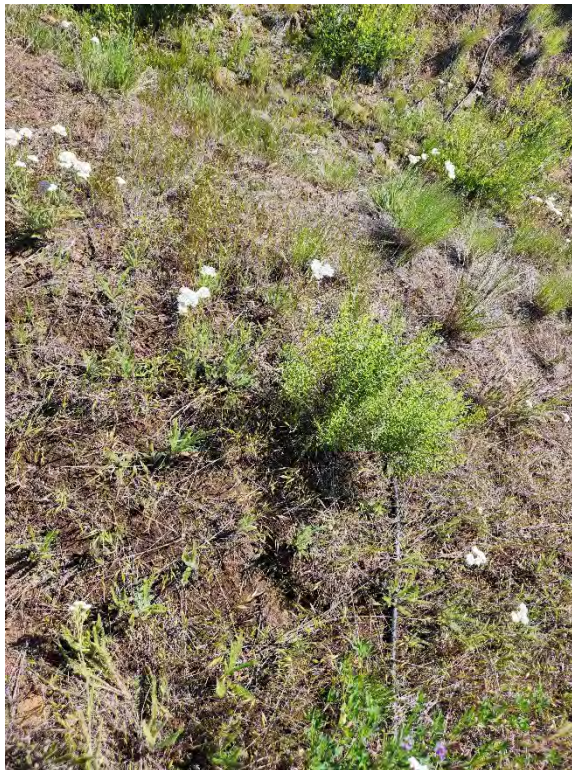
Parcel Z – View of Rill observed on Northern portion of Parcel.
