RE: Annual Inspection for Parcel AM
North Ridge Estates Superfund Site
ECSI No. 5987

Operations and Maintenance Inspection Form

2023 Annual Inspection Summary Report
North Ridge Estates - Operable Unit 1
Klamath Falls, Oregon

Figure
AM.3

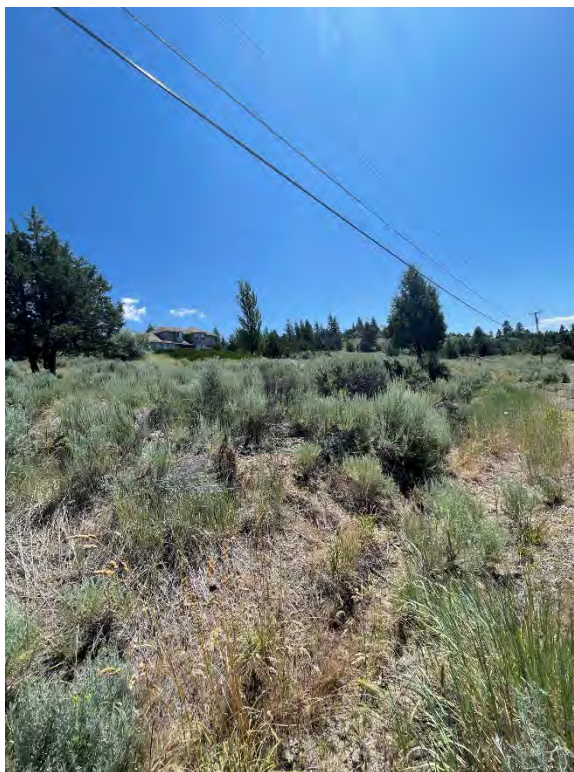
Parcel AM – Northwest corner of Parcel, facing Southeast.

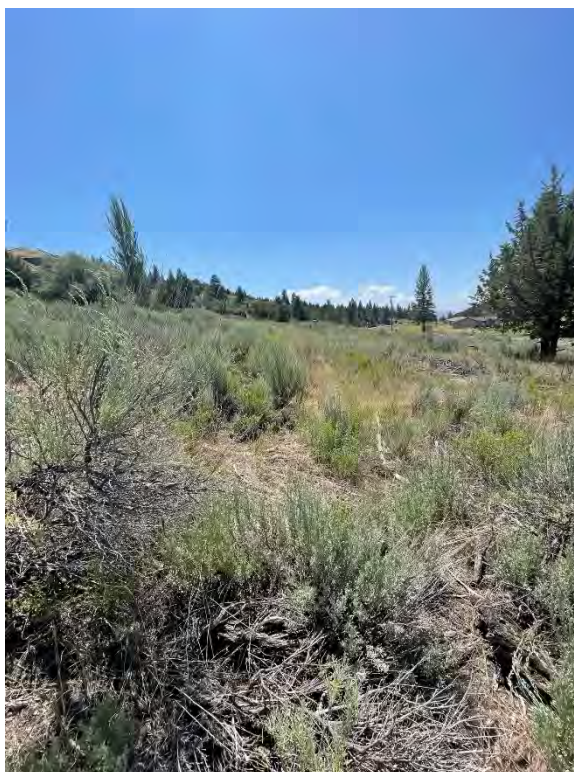
Parcel AM – Northeast corner of Parcel, facing Southwest.

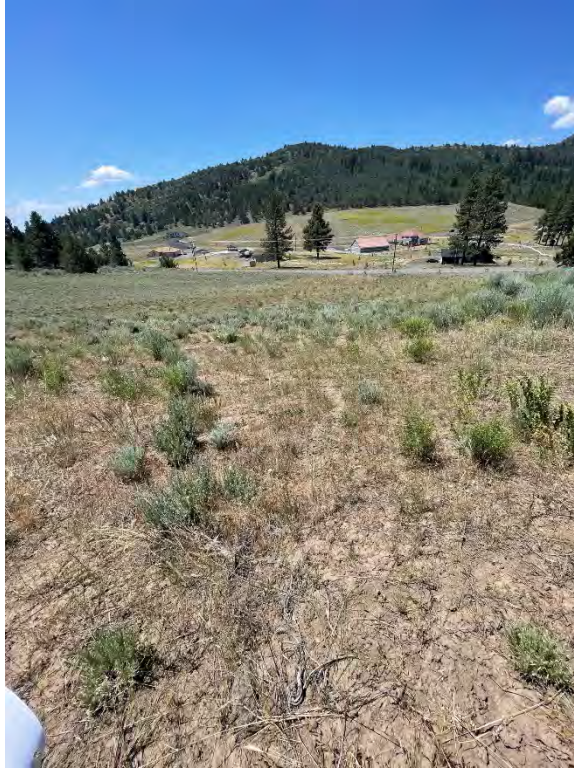
Parcel AM – East central corner of the Parcel, facing South.

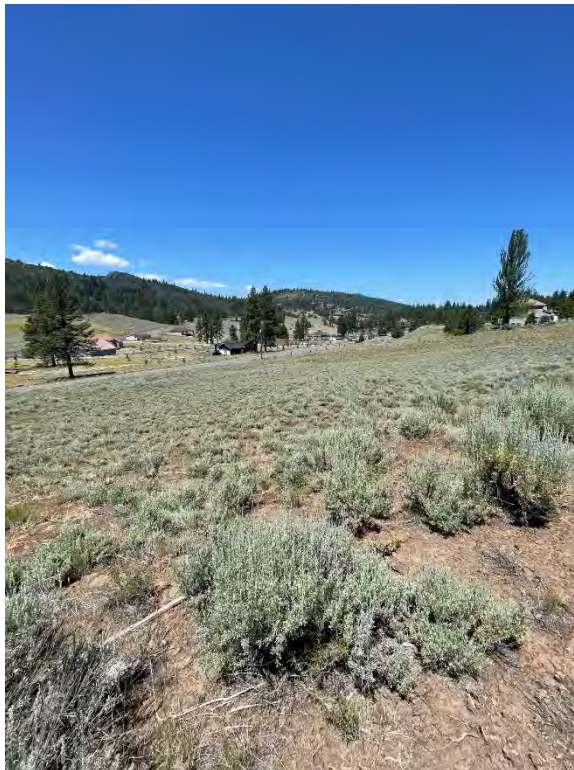
Parcel AM – Northeast corner of Parcel, facing Southwest.

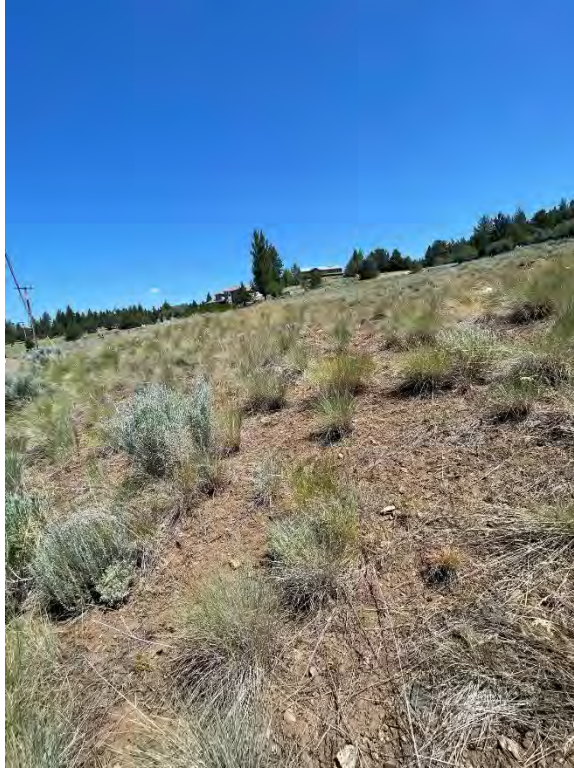
Parcel AM – Southwest corner of Parcel, facing East.

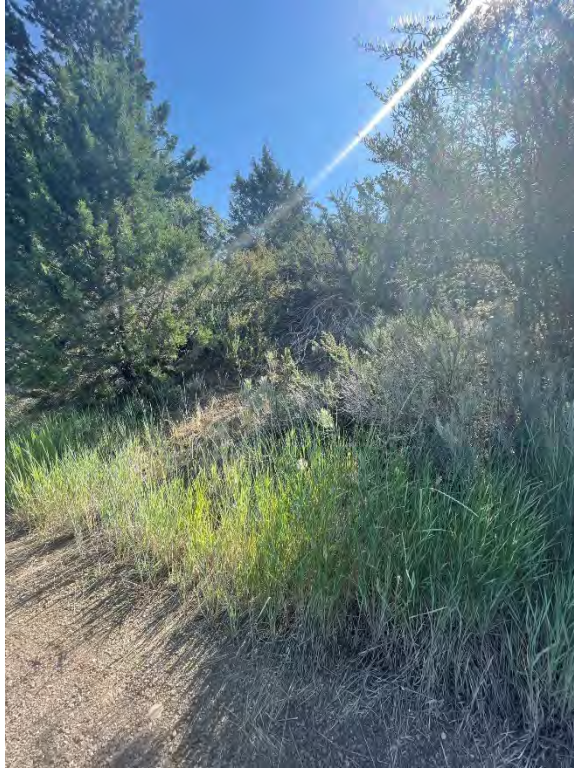
Parcel AS – Southwest corner of Parcel, facing Northeast.

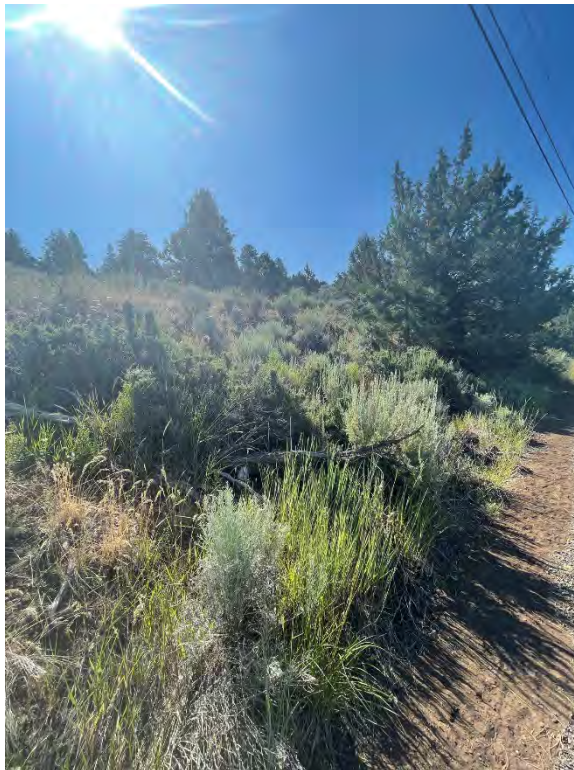
Parcel AS – Northeast corner of Parcel, facing Southeast.

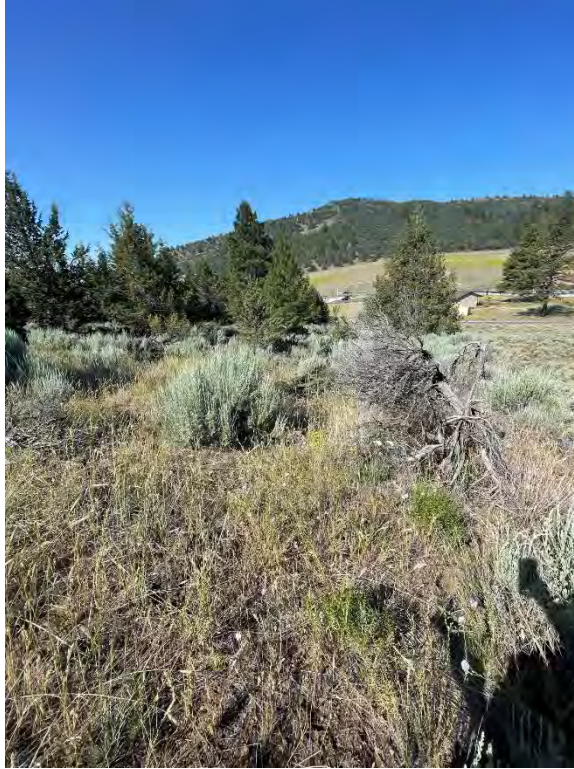
Parcel AS – Northeast corner of Parcel, facing Southwest.

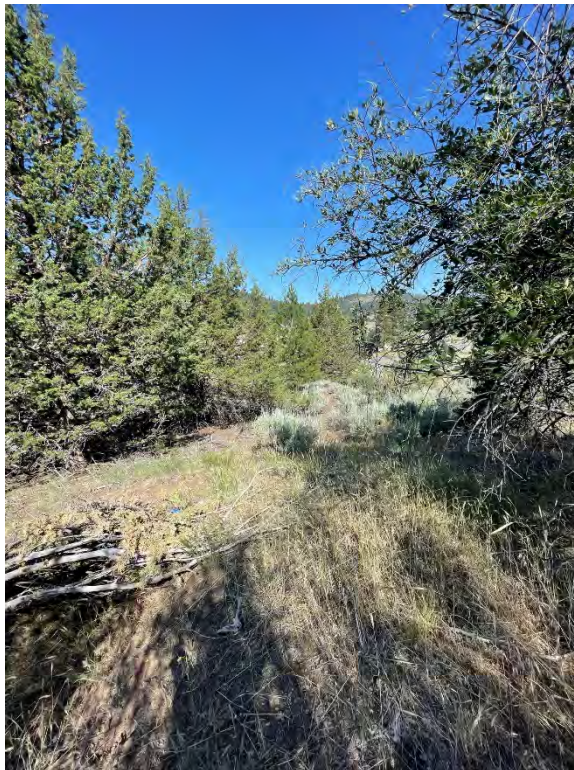
Parcel AS – Southeast corner of Parcel, facing Northwest.

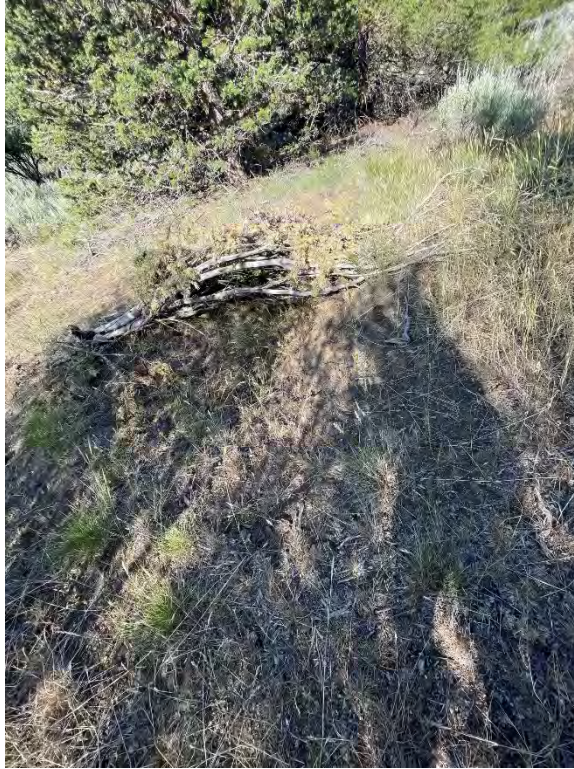
Parcel AS – Large Hole (2-feet deep) found on Southeast corner.
