RE: Annual Inspection for Parcels AK, BJ, and BI
North Ridge Estates Superfund Site
ECSI No. 6012

Operations and Maintenance Inspection Form

Lot AK Inspection
2023 Annual Inspection Summary Report
North Ridge Estates - Operable Unit 1
Klamath Falls, Oregon

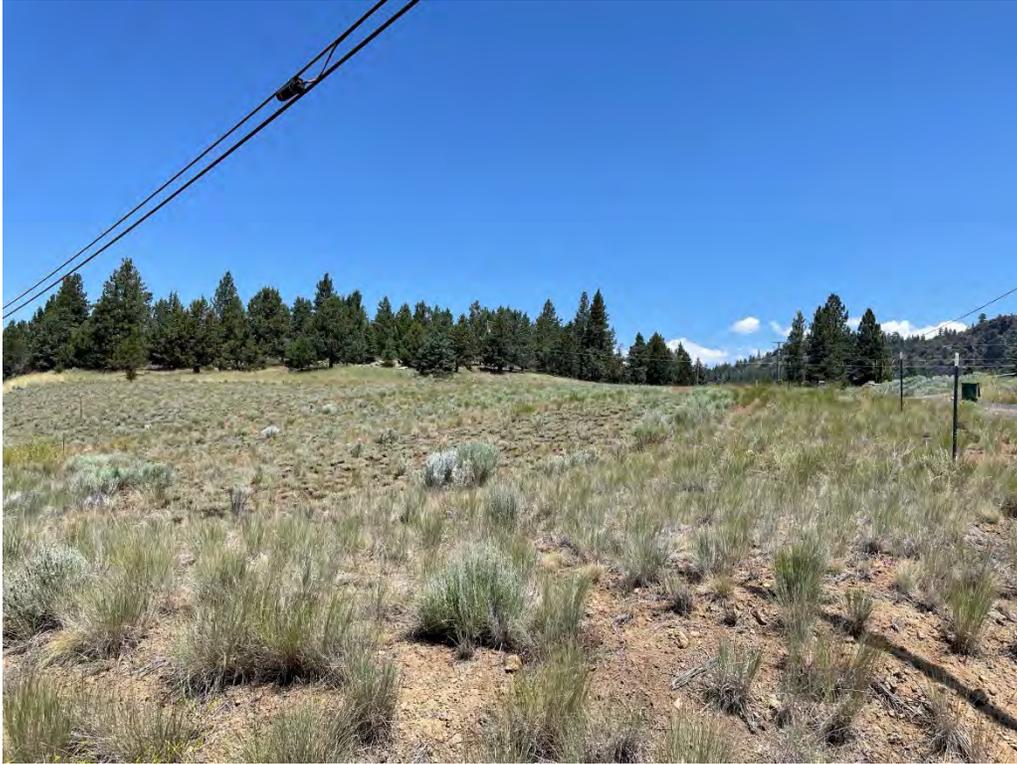
Parcel AK – Southeast corner of Parcel, facing Northwest.

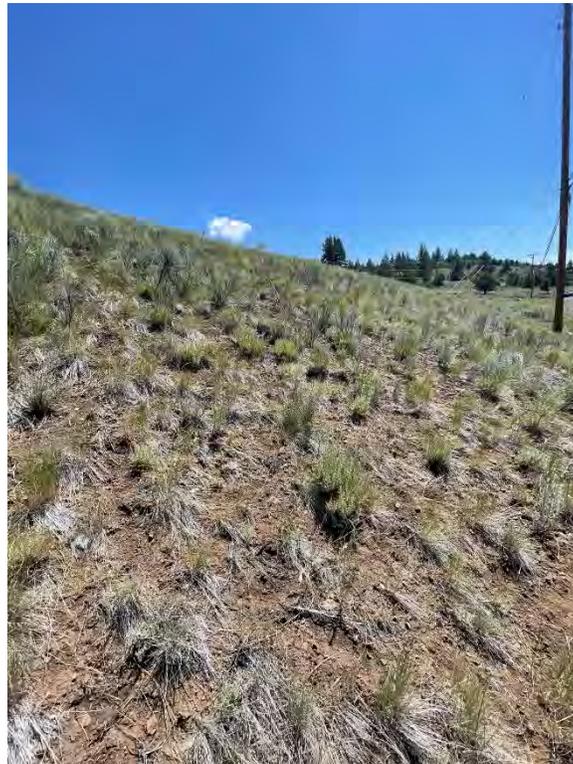
Parcel AK – Northwest corner of Parcel, facing Southeast.

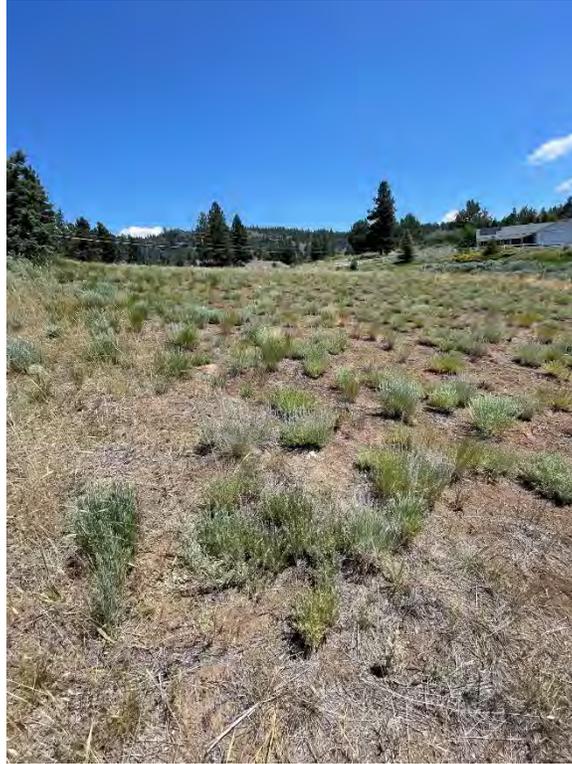
Parcel AK – Central corner, facing Northeast.

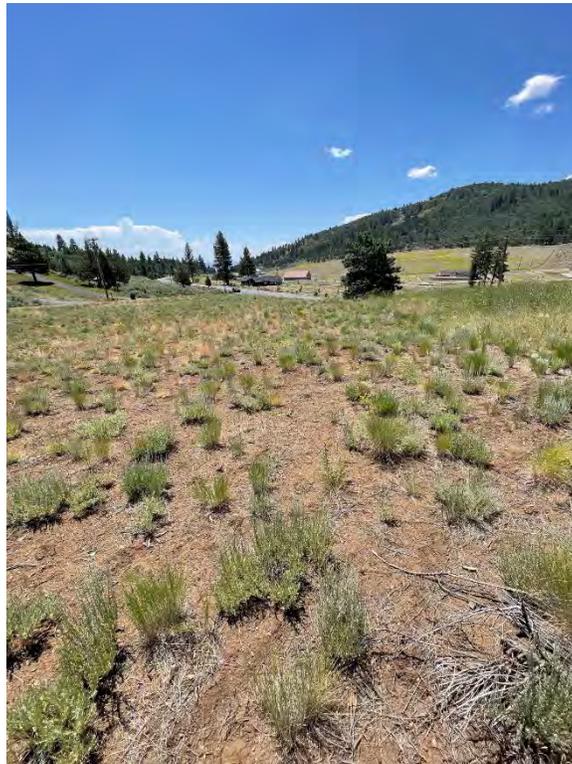
Parcel AK – North Central corner of Parcel, facing South.

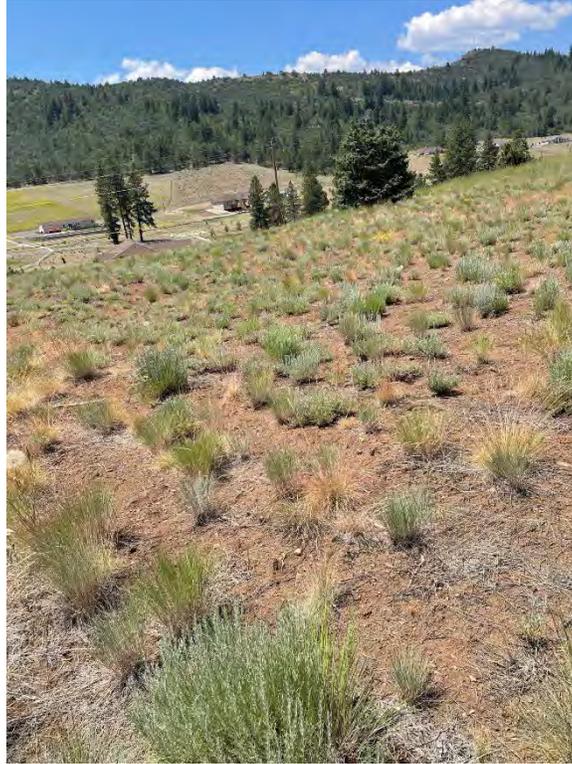
Parcel AK – Northeast corner of Parcel, facing Southwest.

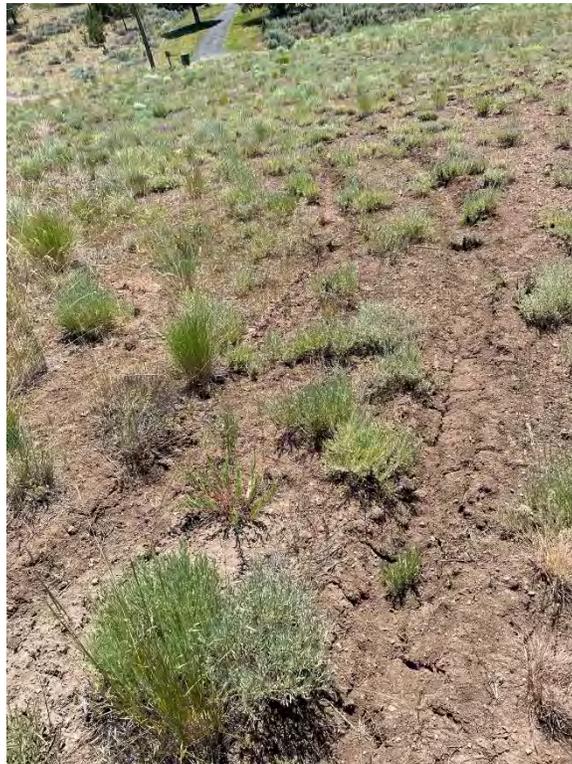
Parcel AK – Tire Tracks (2-inches deep) located in the Central corner of the Parcel.

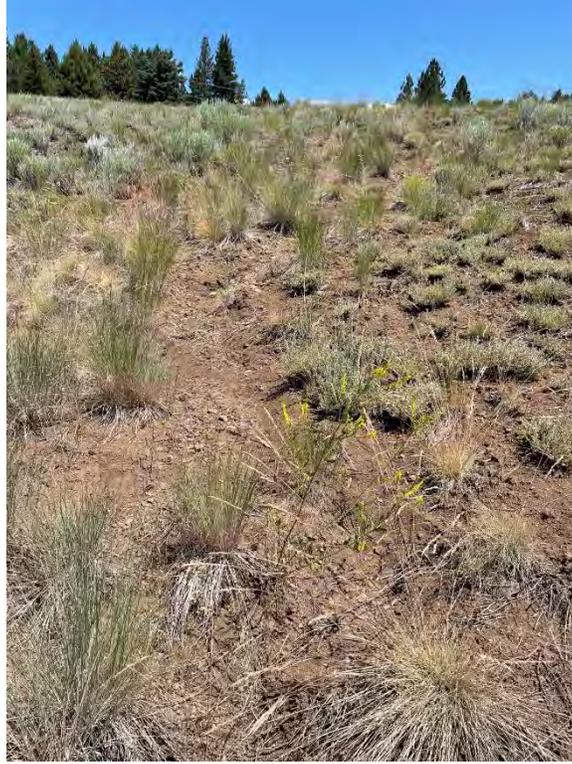
AK Parcel – New rill located on the West side of the Parcel.

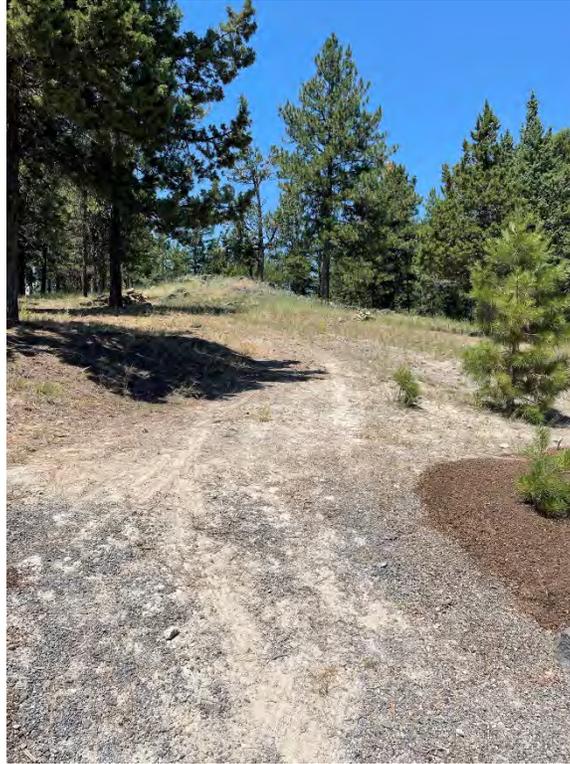
Parcel BI – East side of Parcel, facing West.

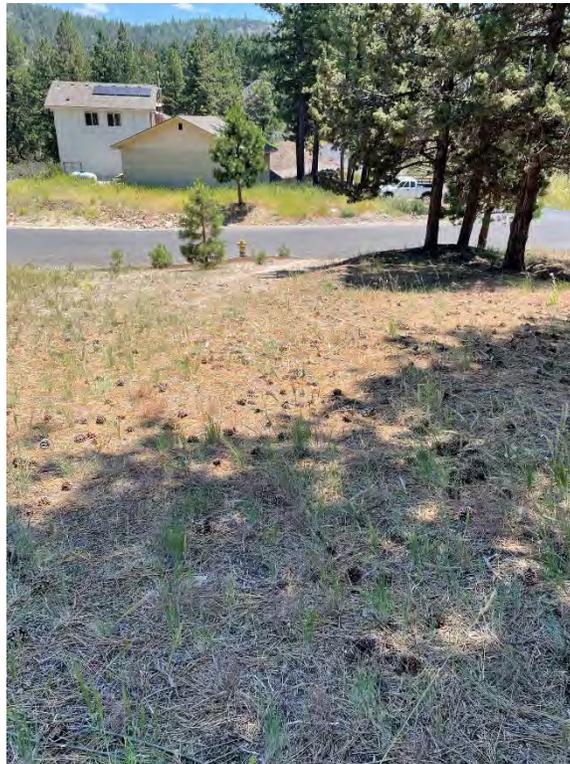
Parcel BI – West side of Parcel, facing East.

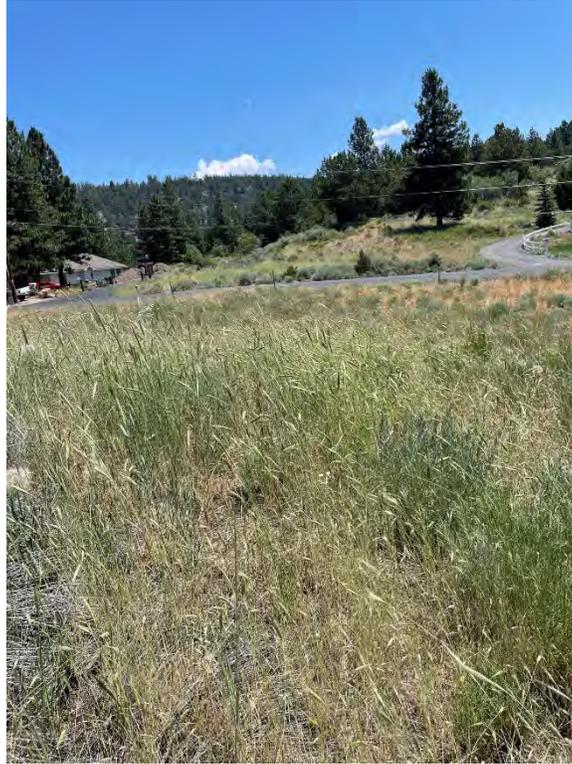
Parcel BJ – West side of South portion of Parcel, facing East.

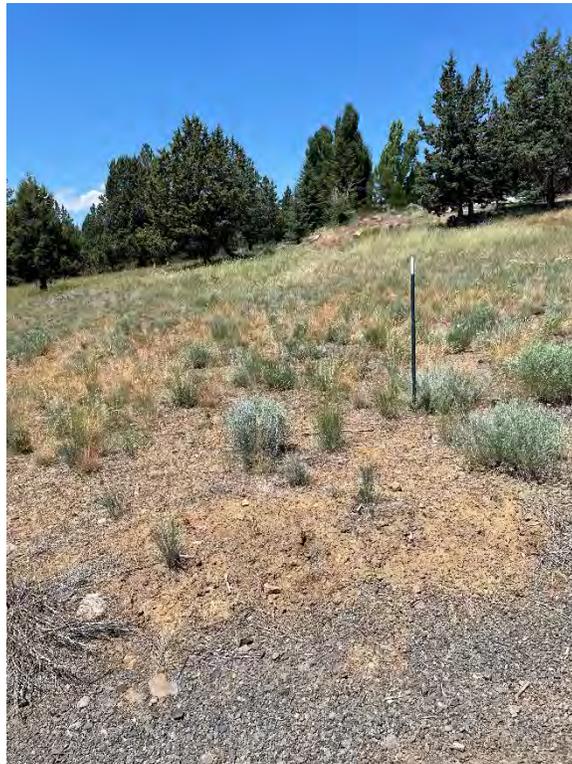
Parcel BJ – East side of South portion of Parcel, facing West.

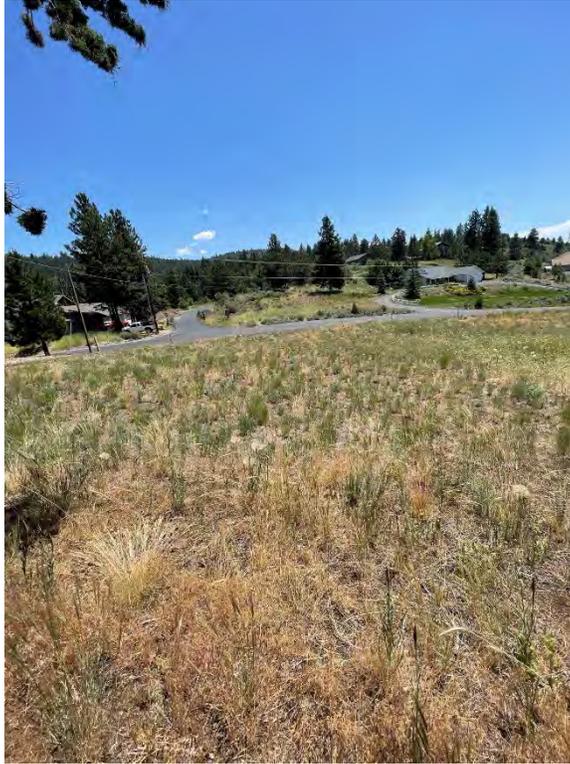
Parcel BJ – West side of Northern portion of Parcel, facing East.

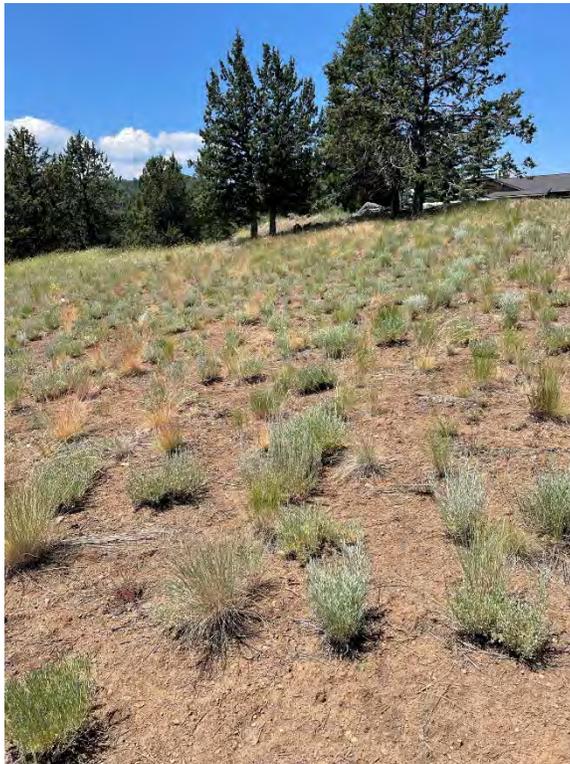
Parcel BJ – East side of the Northern portion of the Parcel, facing West.

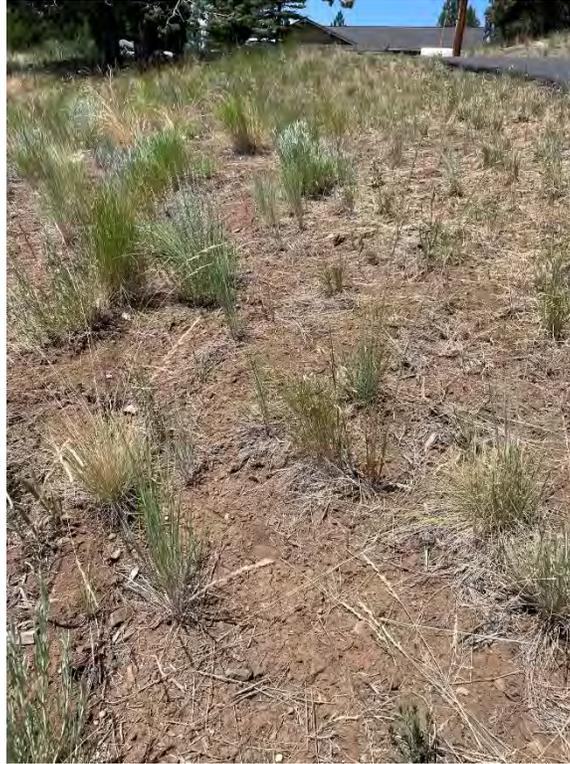
Parcel BJ – A new Rill developed within the Northern portion of the Parcel.
