RE: Annual Inspection for Parcel AR
North Ridge Estates Superfund Site
ECSI No.6013

Parcel AR and BK

Operations and Maintenance Inspection Form

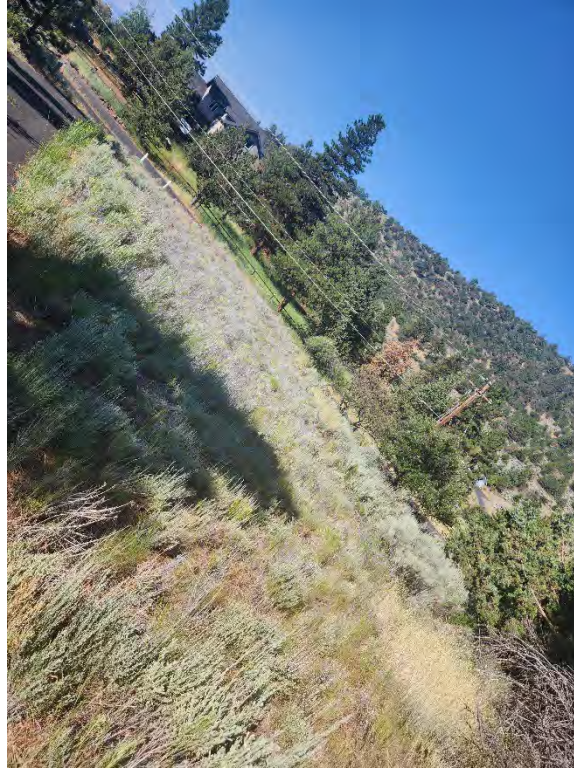
Parcel AR – View facing West from Eastern corner of Parcel.

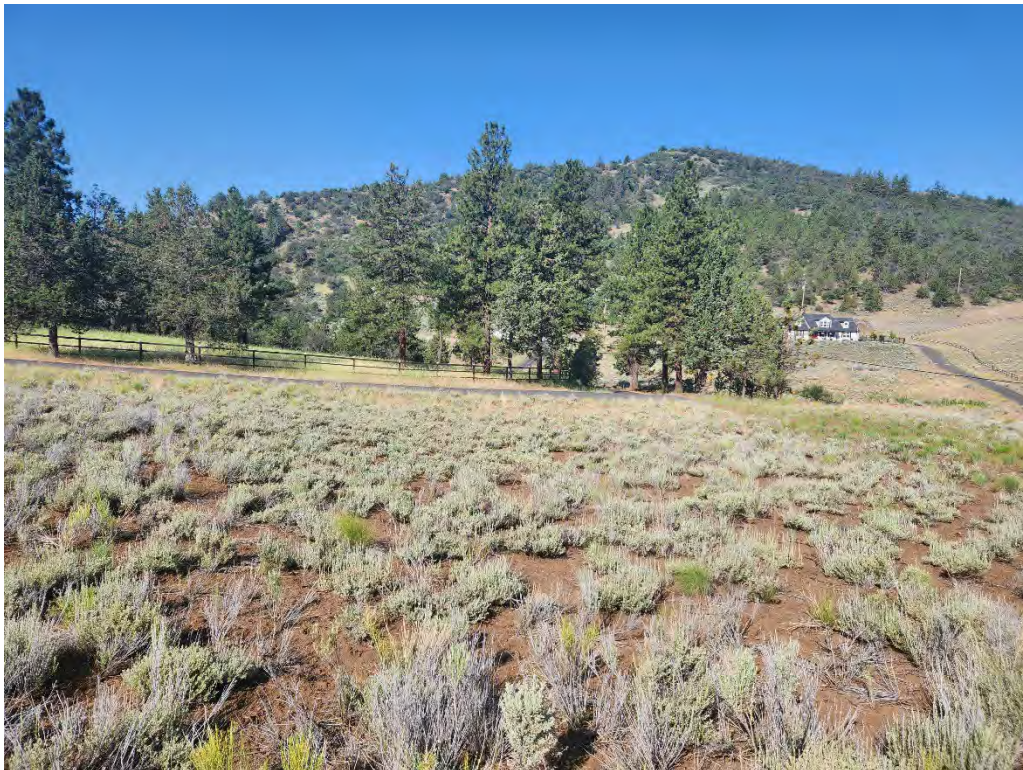
Parcel AR – View facing Southwest from North corner of Parcel.

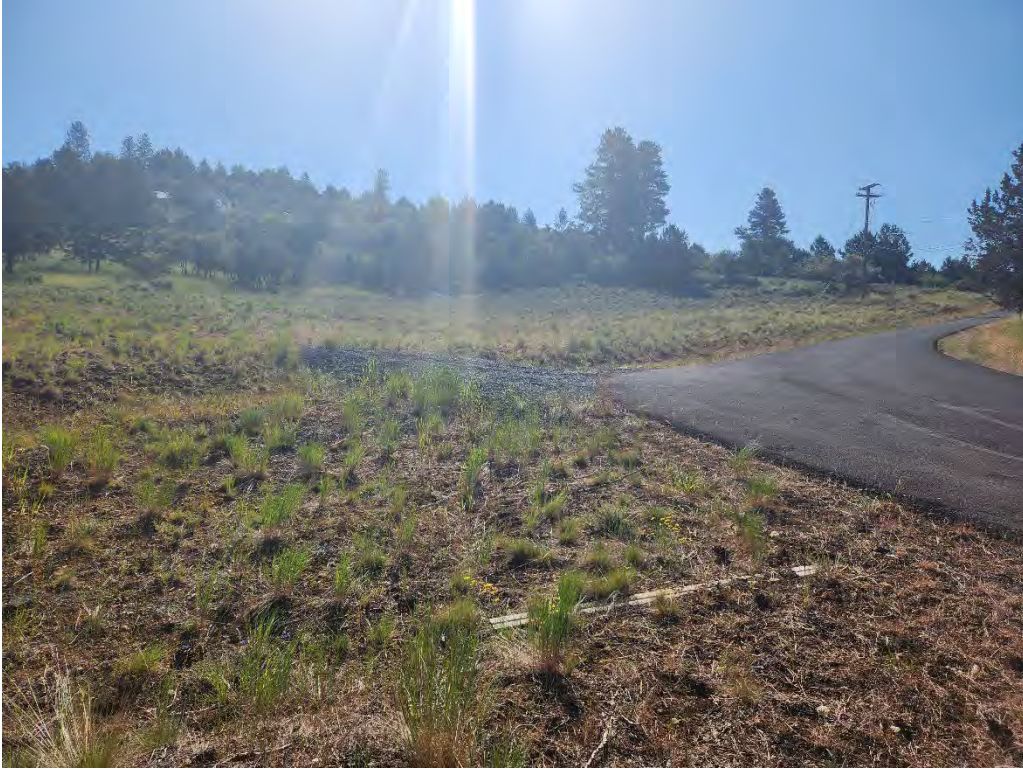
Parcel AR – View from Northwest corner of Parcel.

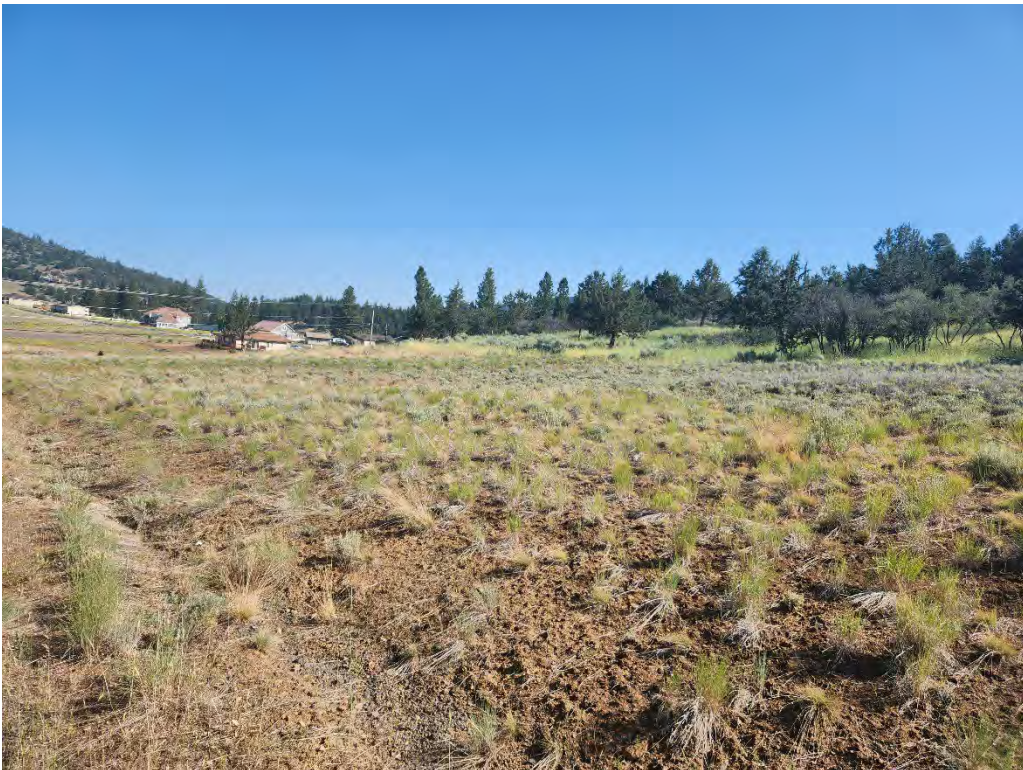
Parcel AR – View from South Central corner of Parcel.

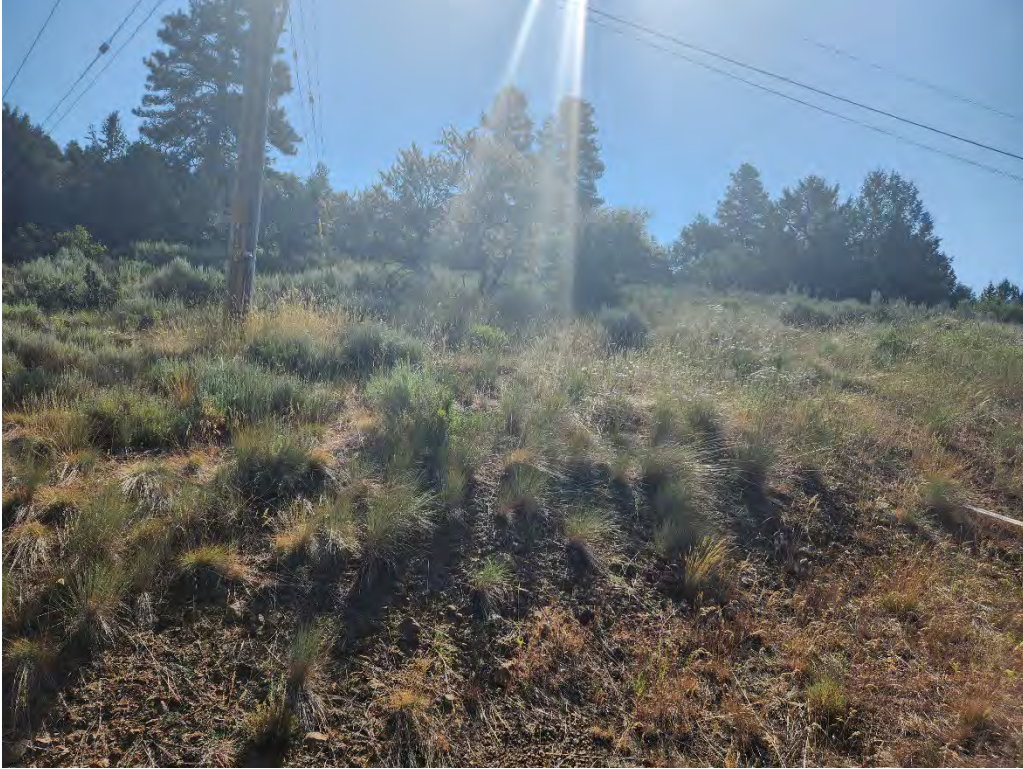
Parcel AR – View from South Central Area of Parcel.

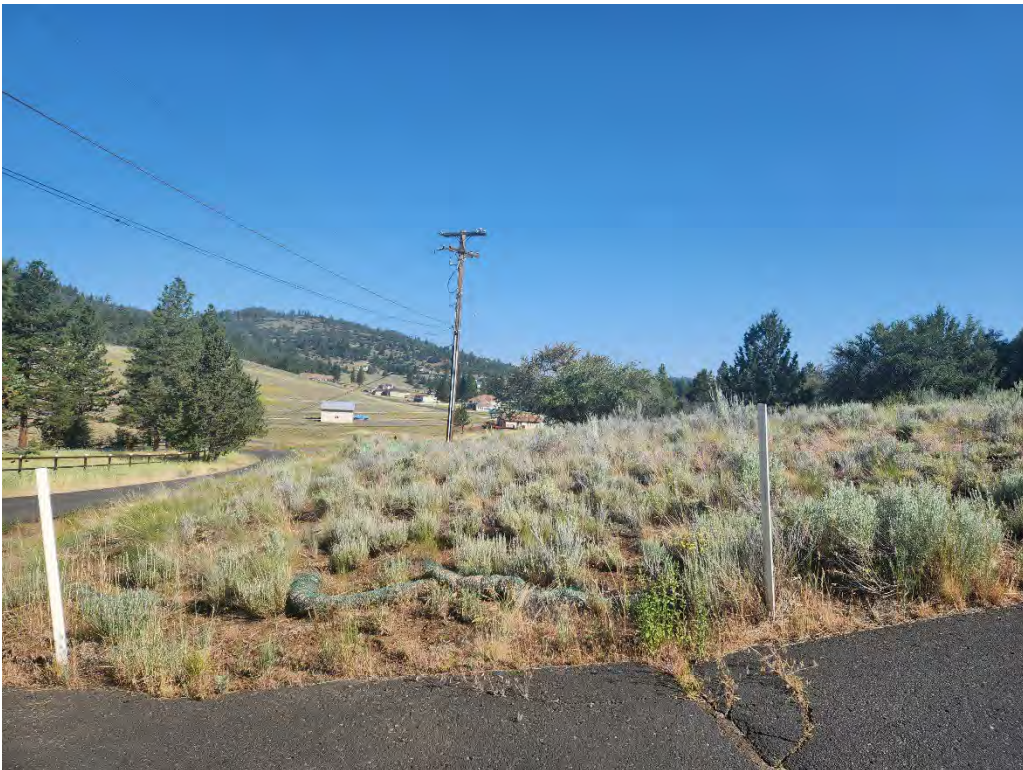
Parcel AR – View facing North from Southern corner of Parcel.

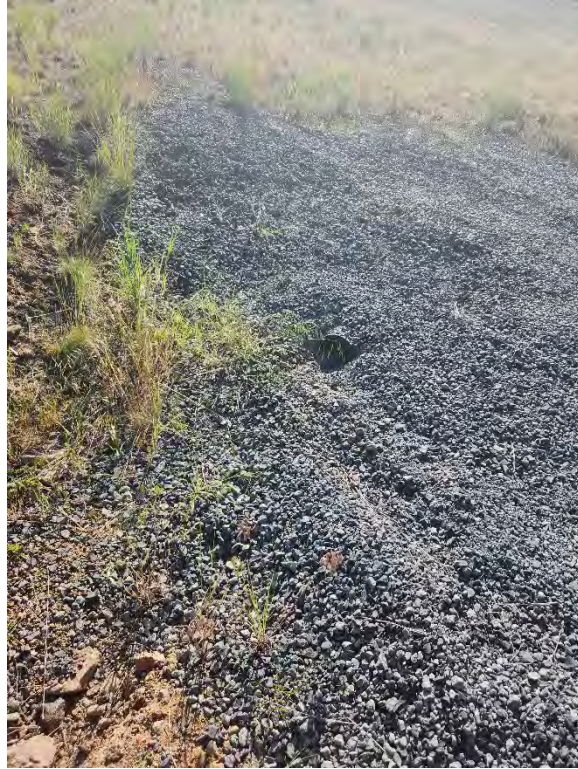
1. **Blocked culvert.** The culvert located along the private drive on your property was obstructed (see enclosed figure).

Ditches and Culverts	Obstructions observed in ditches or culverts that may impede conveyance of stormwater?	<input checked="" type="checkbox"/>	<input type="checkbox"/>	<input type="checkbox"/>	<input type="checkbox"/>	Partially blocked and fully buried culverts were identified on the west side of Parcel AR.	Remove obstructions from culverts to enable stormwater flow.
	Damaged observed to riprap surface? Note if riprap is not intact or not effectively providing armor protection.	<input type="checkbox"/>	<input type="checkbox"/>	<input type="checkbox"/>	<input checked="" type="checkbox"/>		
	Are there any areas that show signs of excessive scour? (i.e., gullies forming along centerline of ditch)	<input type="checkbox"/>	<input type="checkbox"/>	<input type="checkbox"/>	<input checked="" type="checkbox"/>		
	Are culvert inlets and outlets damaged?	<input type="checkbox"/>	<input type="checkbox"/>	<input type="checkbox"/>	<input checked="" type="checkbox"/>

Parcel AR - View of blocked culvert on Western partition of parcel.

Corrective Action. Remove the material obstructing the culvert to allow the unrestricted flow of stormwater by November 12, 2023.

DEQ will perform an inspection the week of November 13, 2023 to confirm the culvert has been cleared.

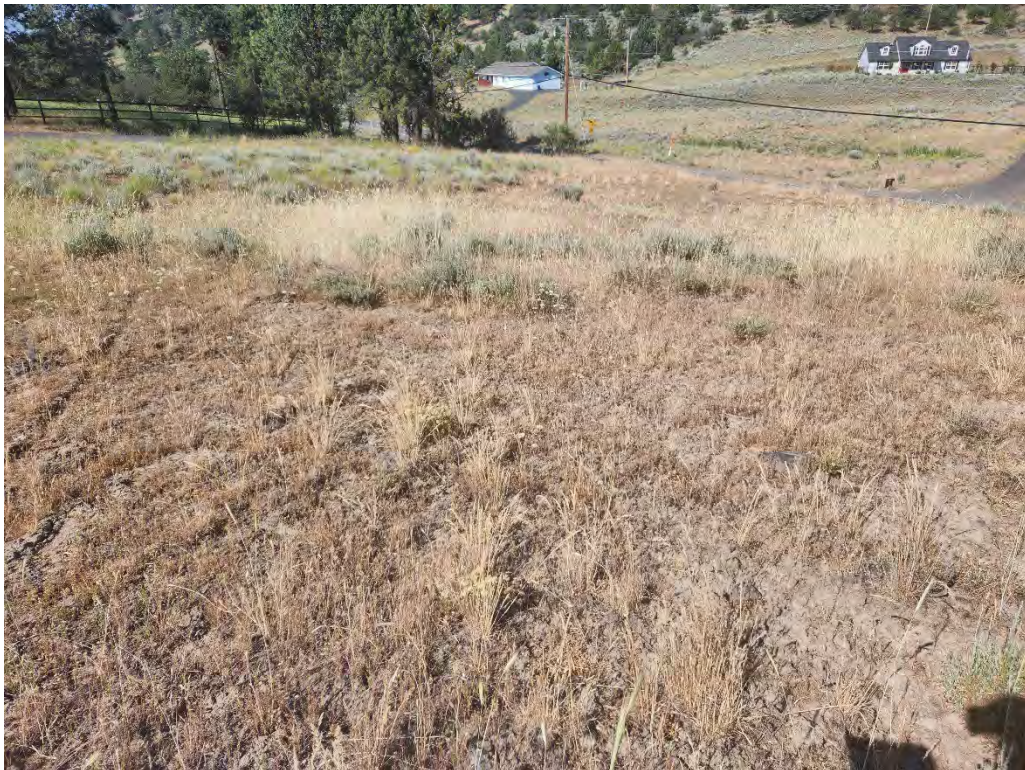
Parcel BK – View from Northeast corner of Parcel.

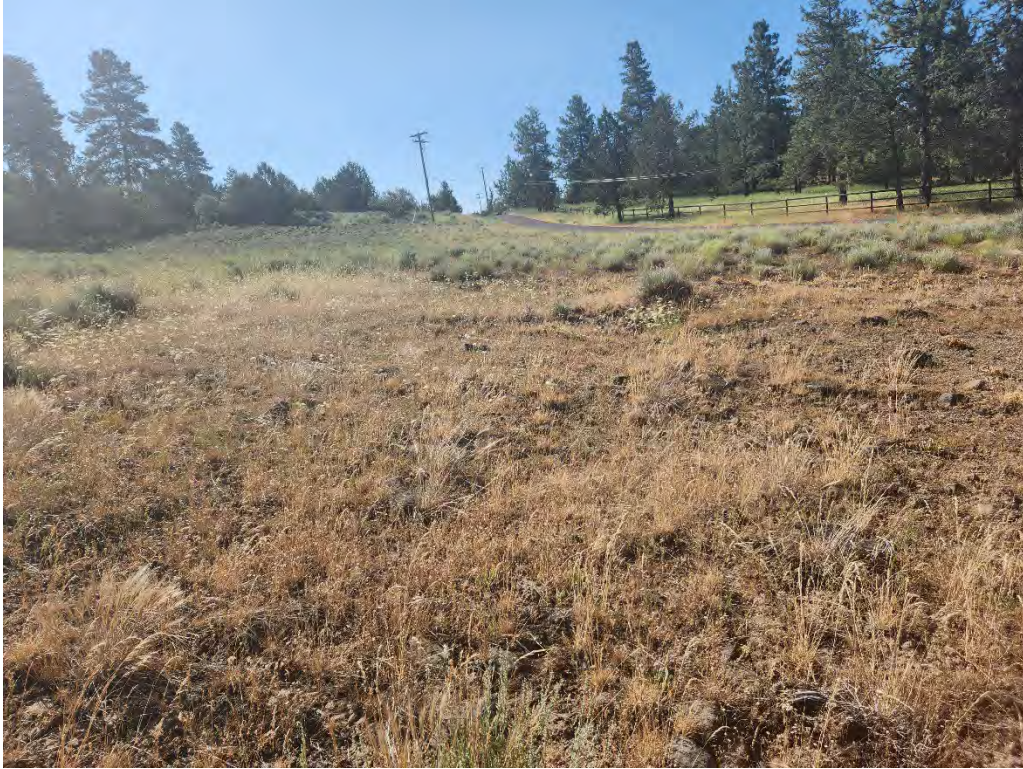
Parcel BK – View from Northwest corner of Parcel.

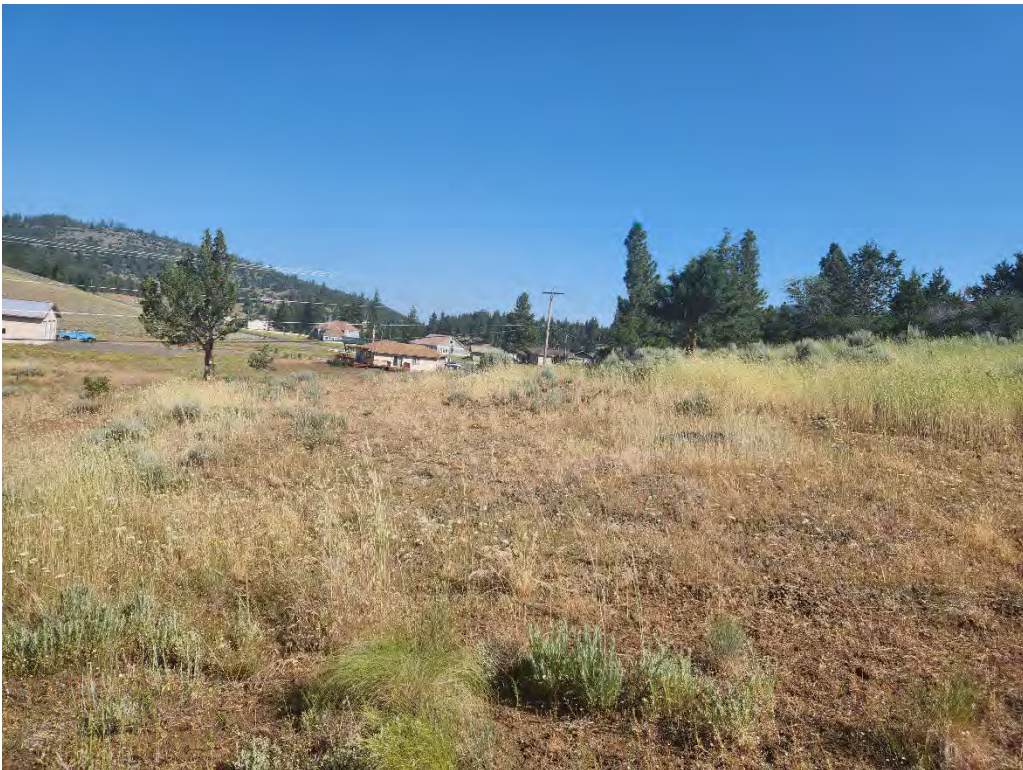
Parcel BK – View from Southeast corner of Parcel.

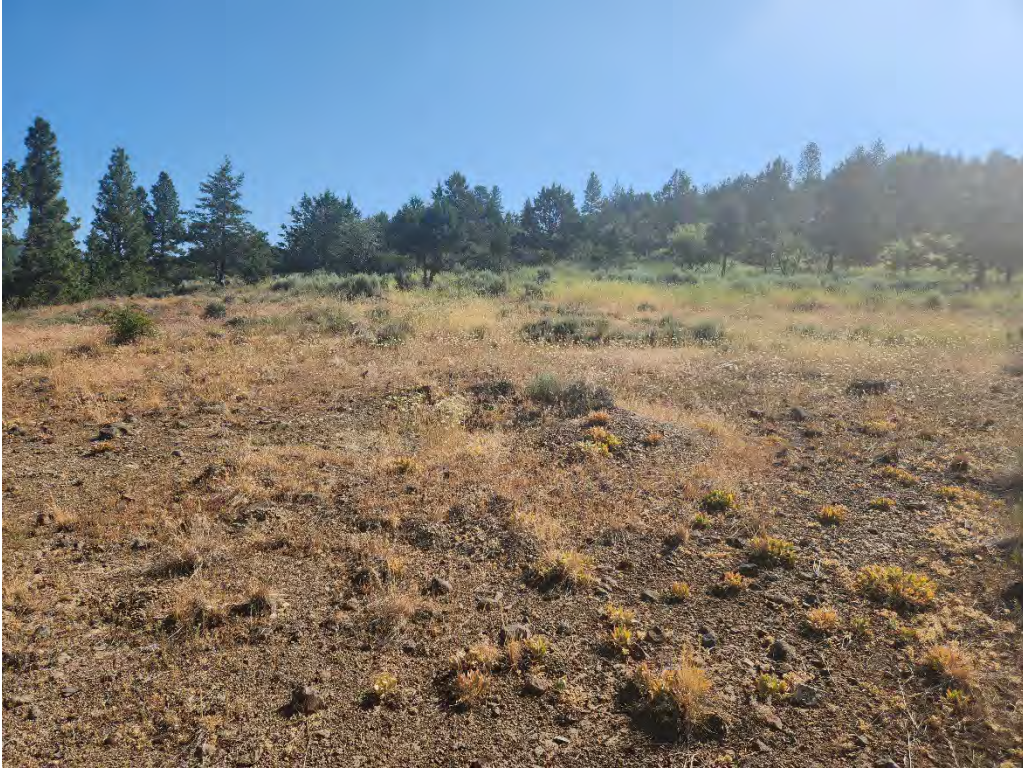
Parcel BK – View from Southwest corner of Parcel.
