RE: Annual Inspection for Parcels BL, MBK-F, & part of AI  
North Ridge Estates Superfund Site  
ECSI No. 6015

## Digging at the North Ridge Estates Superfund Site

## Operations and Maintenance Inspection Form

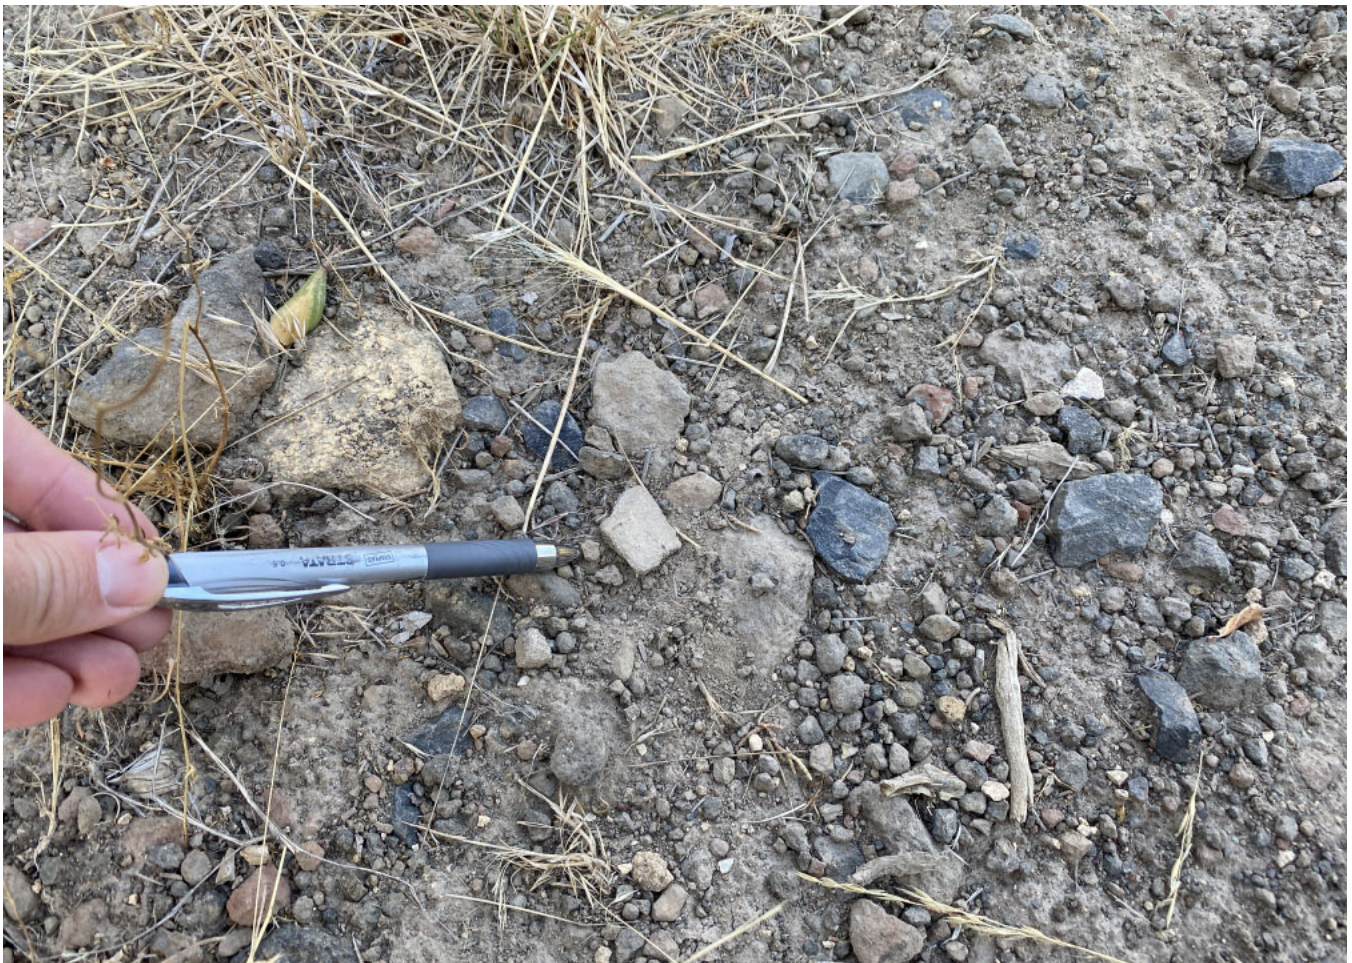
One piece of concrete asbestos board (CAB) was located during inspection. It was approximately 1" square.

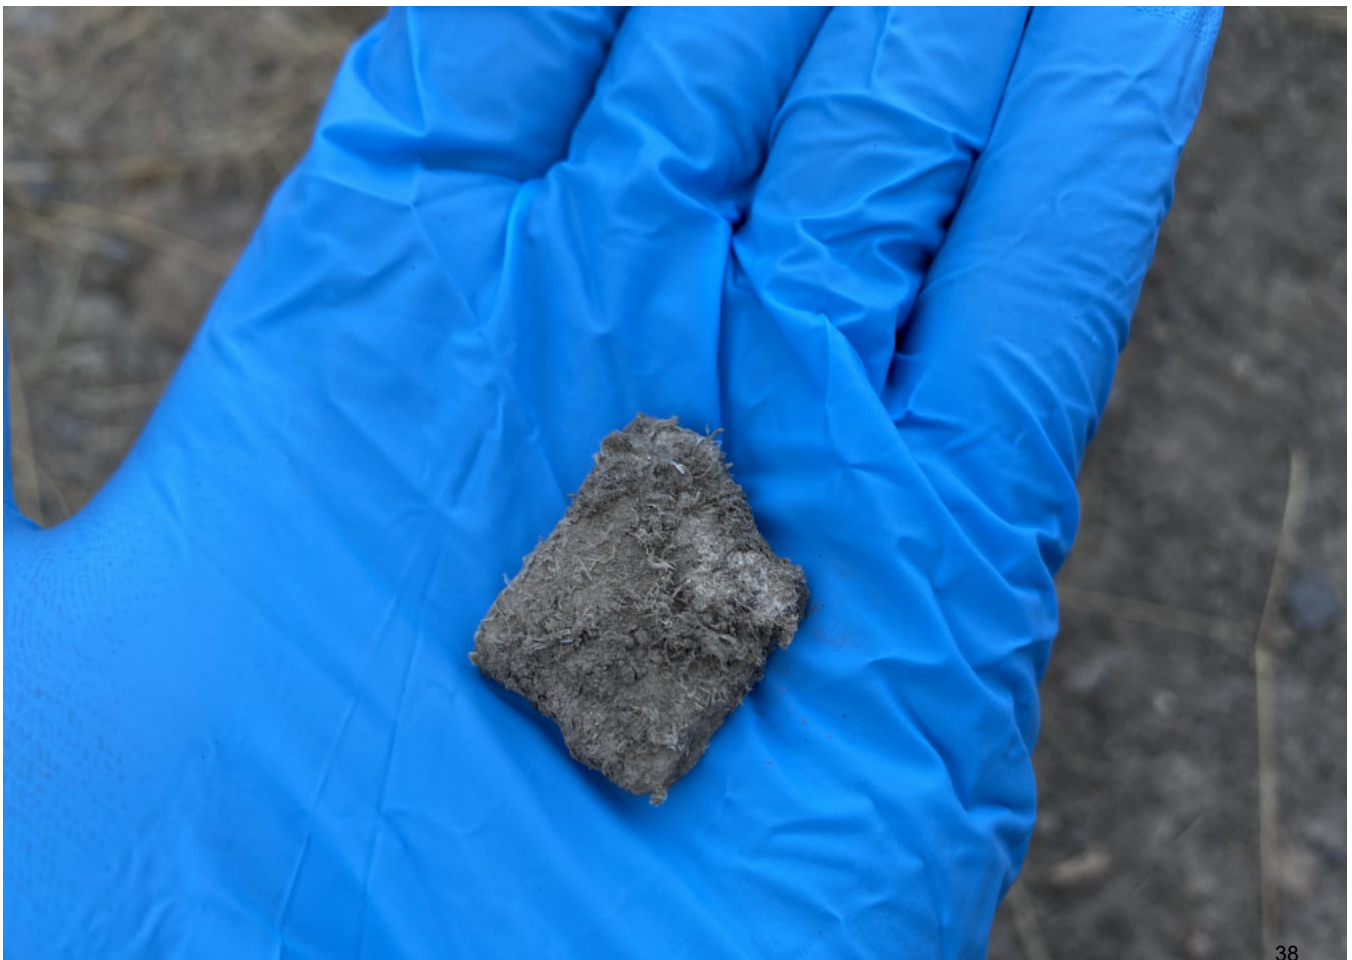
The piece of CAB was placed in a sample bag and removed from the site.

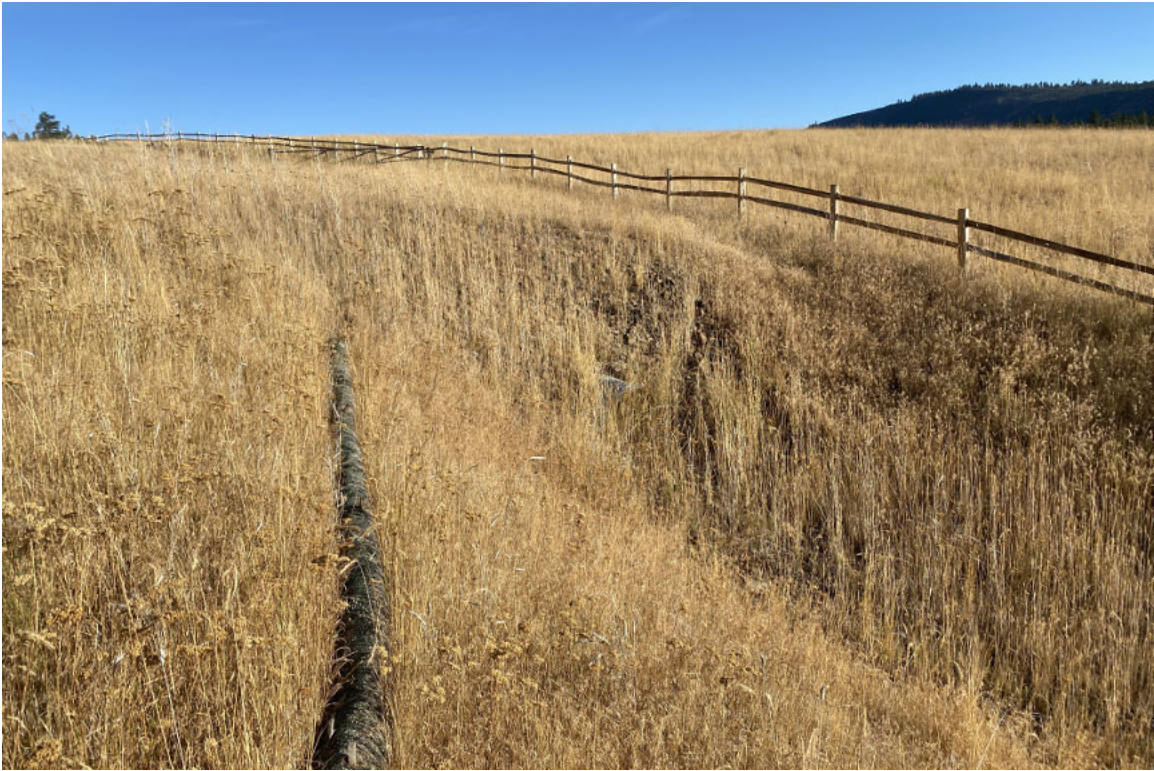
A straw wattle was located adjacent to the crest of the slope next to the southern culvert.

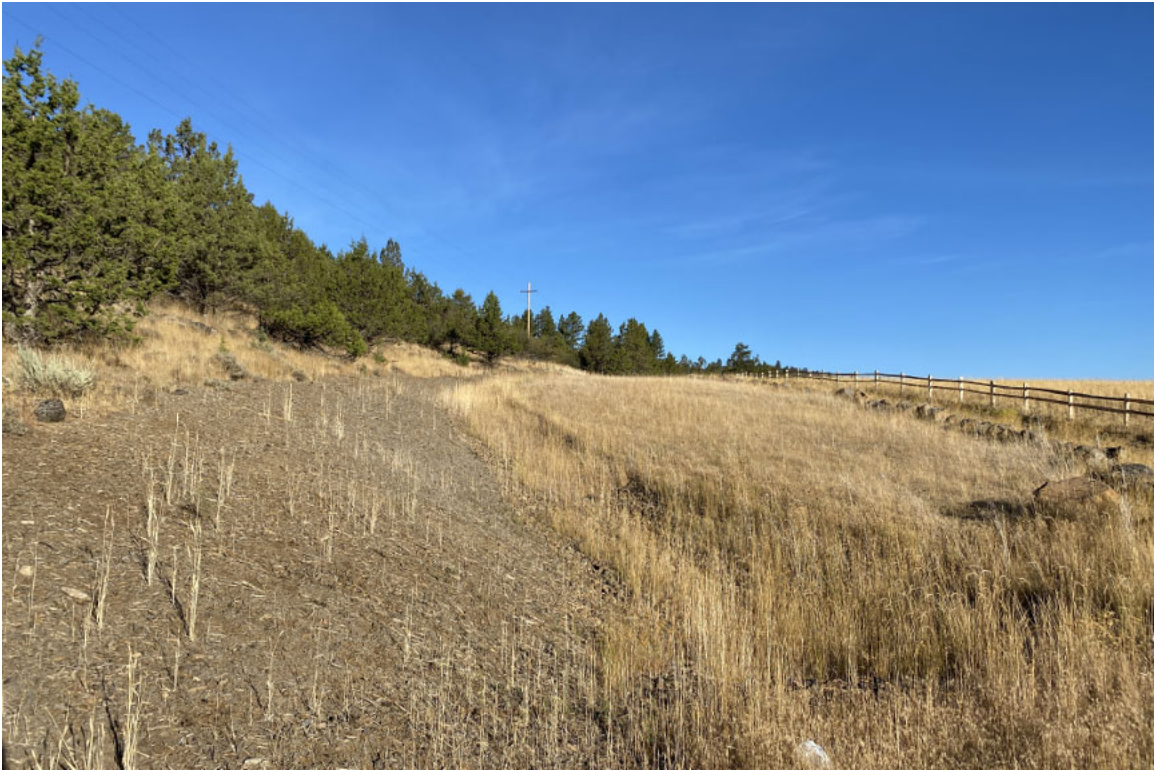
Heavy mulching was added to the western edge of the drainage ditch.  
Vegetation in this area was sparse.

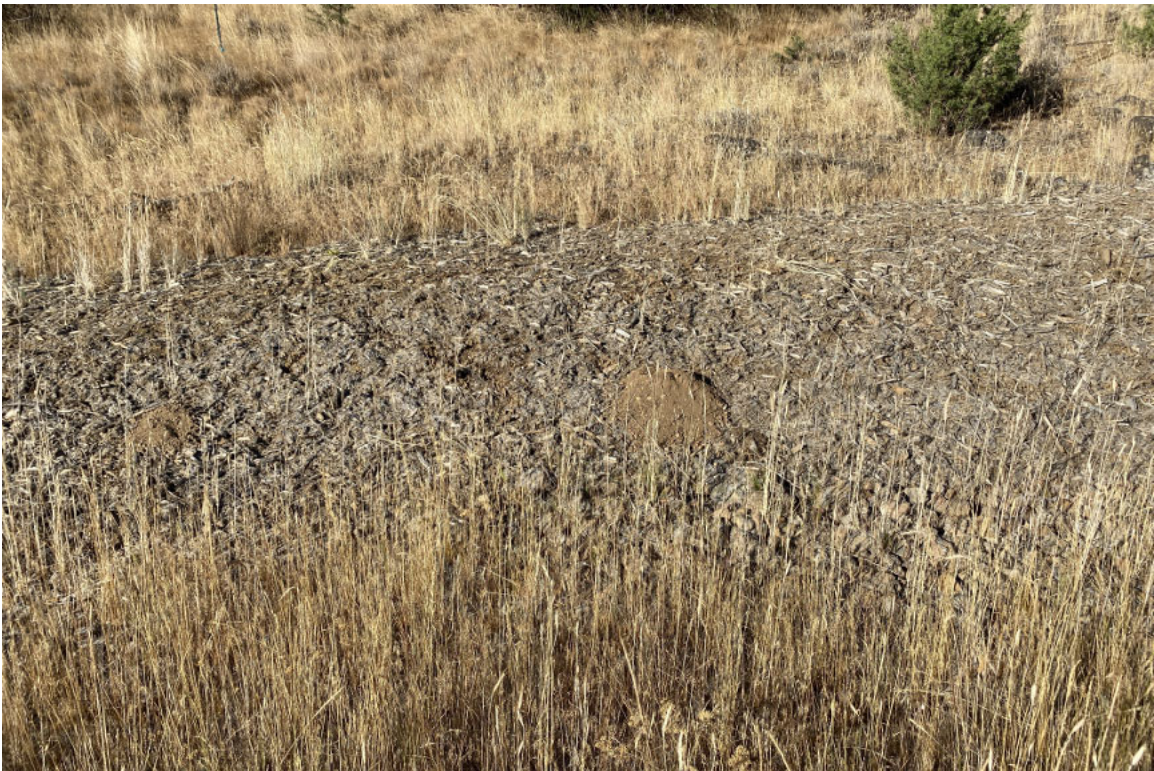
Some soil mounds caused by animal activity were located adjacent to the drainage ditch.

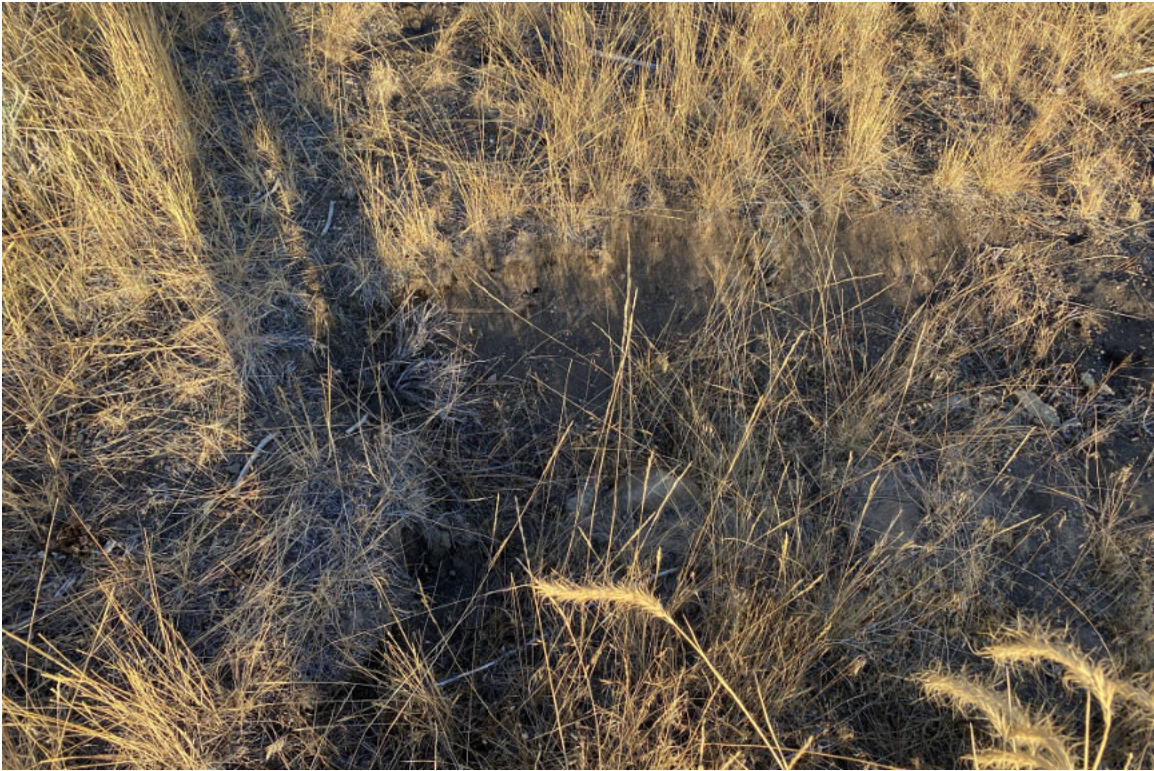
Cap soils at one location have settled vs. the native grade.

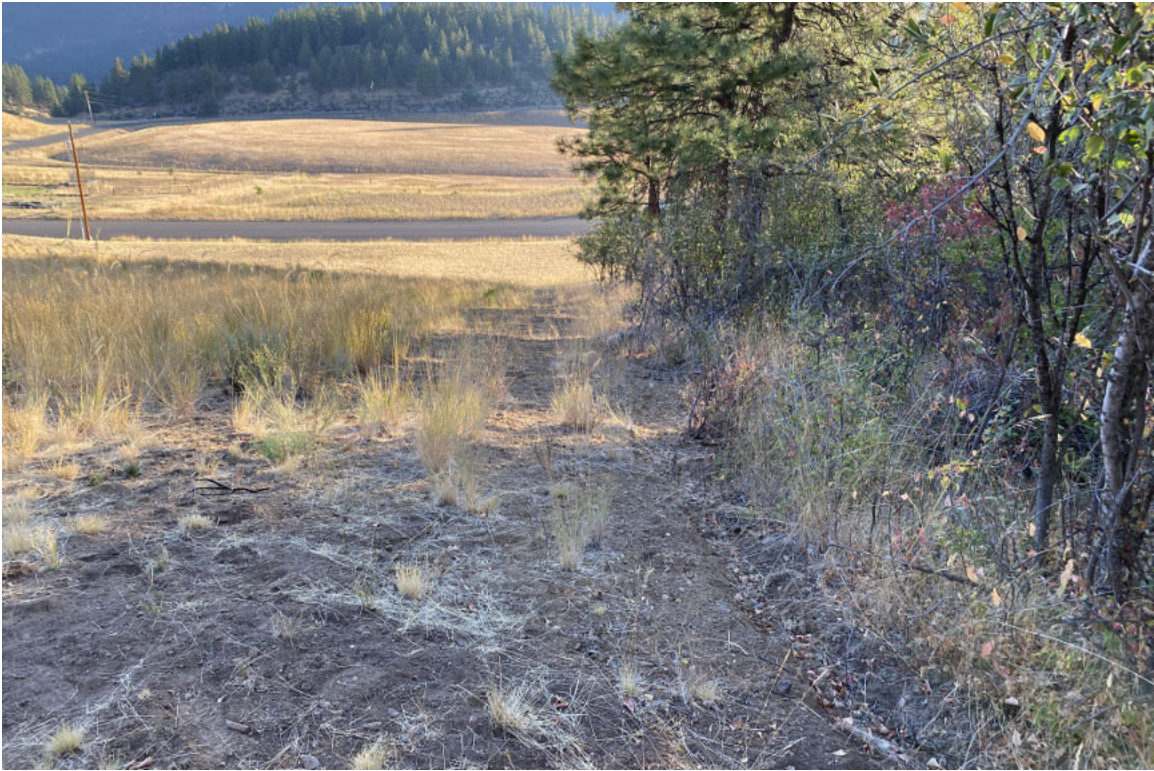
A gully formed along the eastern edge of the property, view from the southern corner.

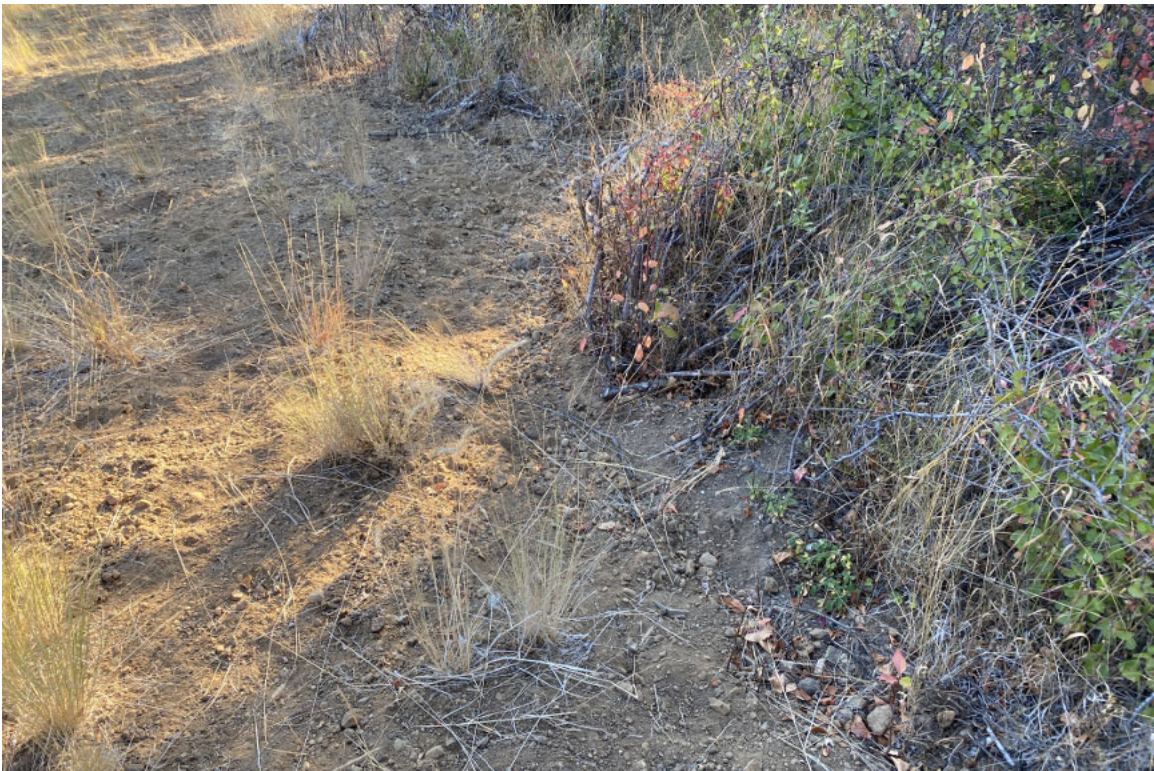
View of the soil cap compared to the native grade.

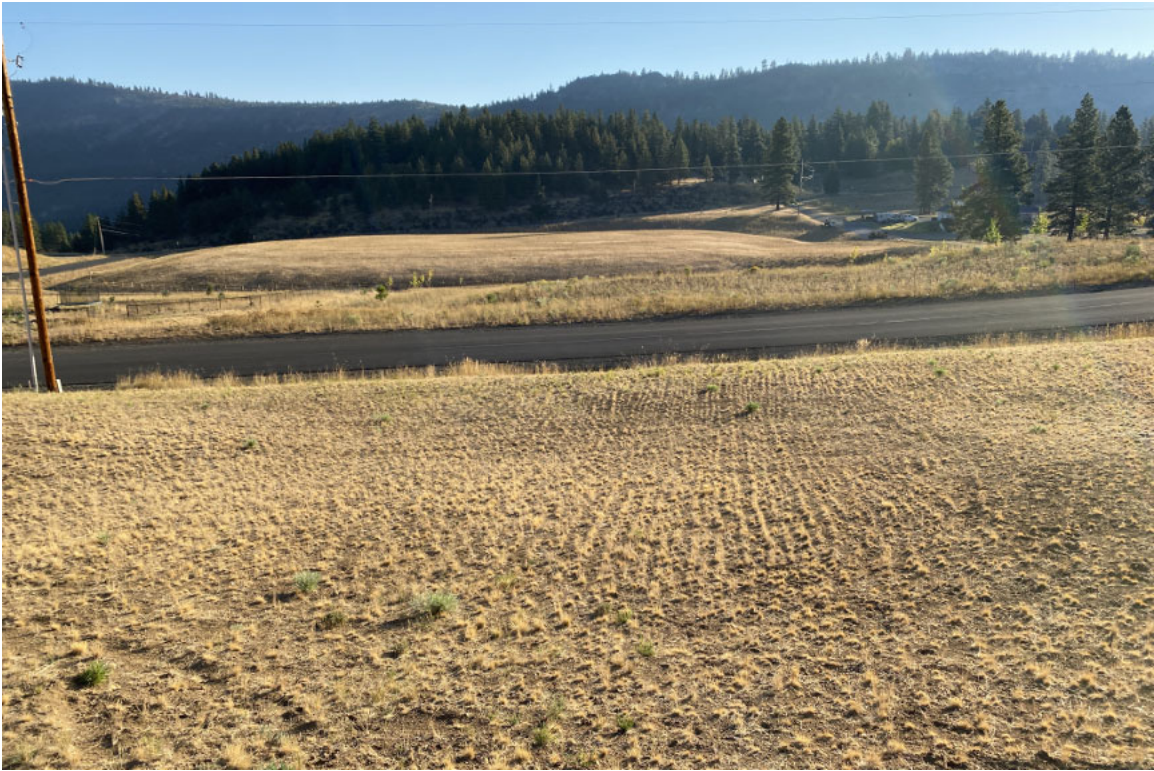
Tire tracks were located in the western portion of the property.

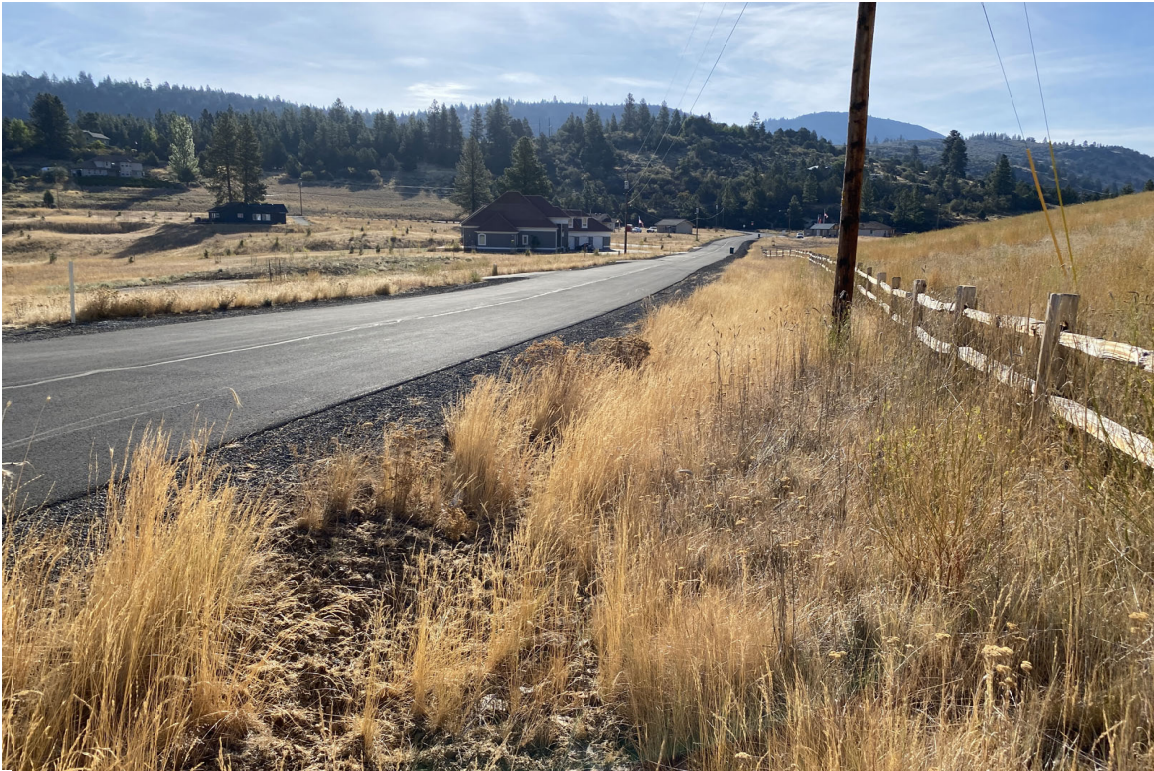
At the northern edge where Parcel AI and AL meet North Ridge Drive appears to have been washed out and been repaired.

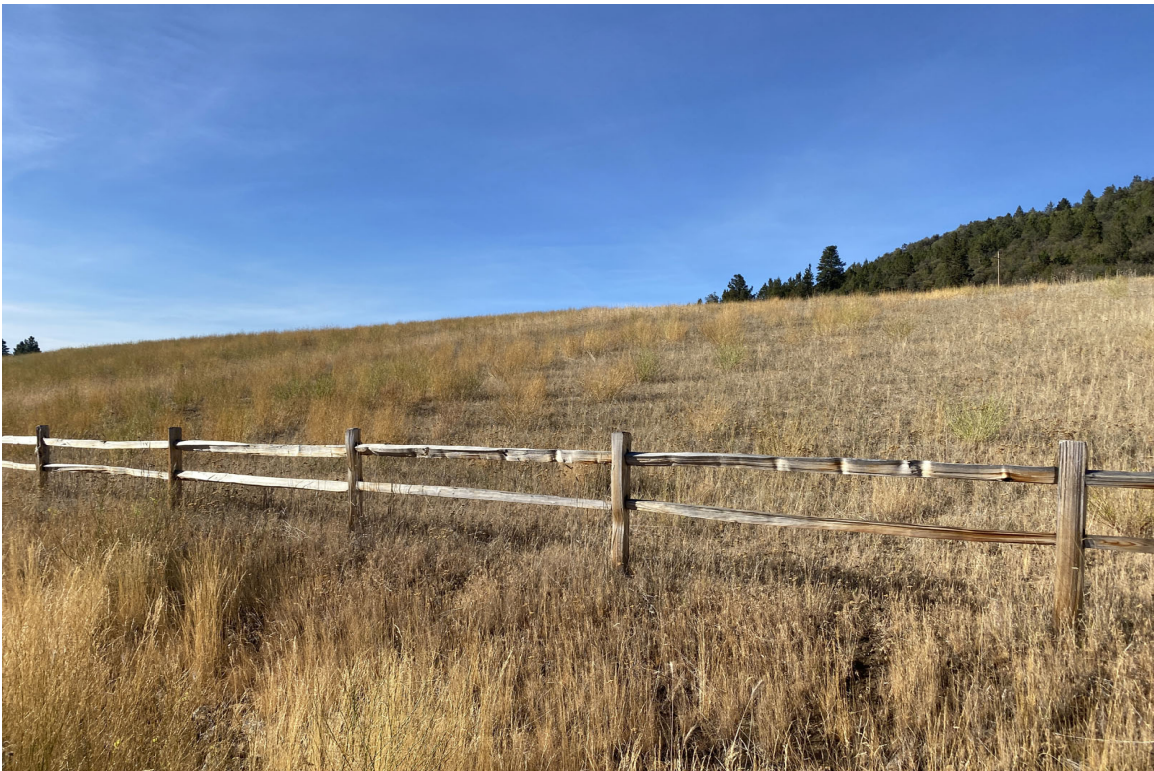
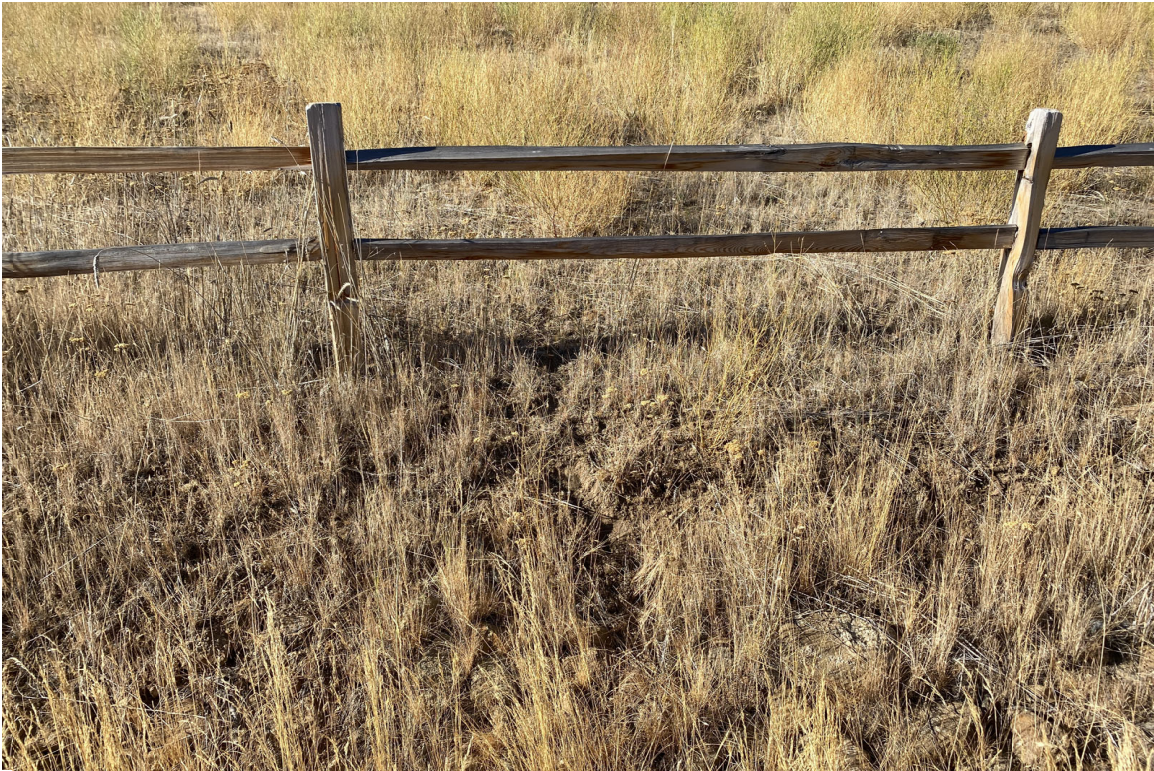
Several rills (approximately 2" deep) located along the drainage ditch between the SPR and North Ridge Drive.

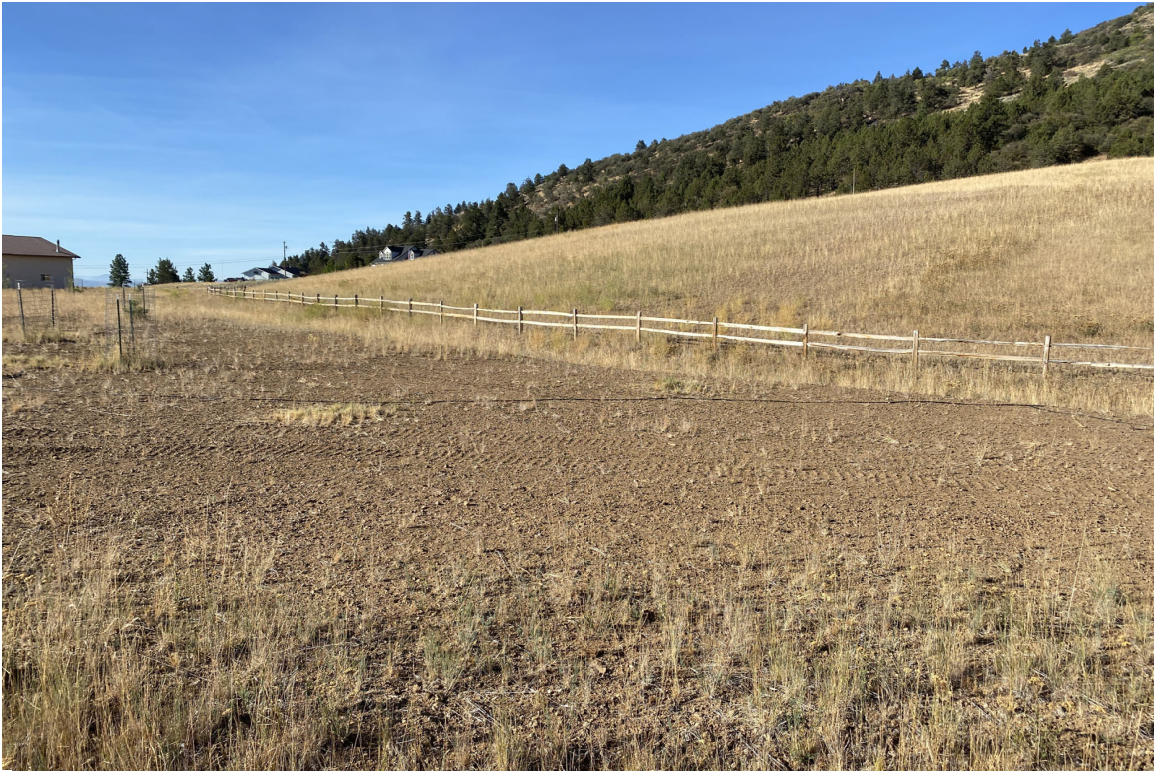
The NW portion of the public park has limited vegetated cover.

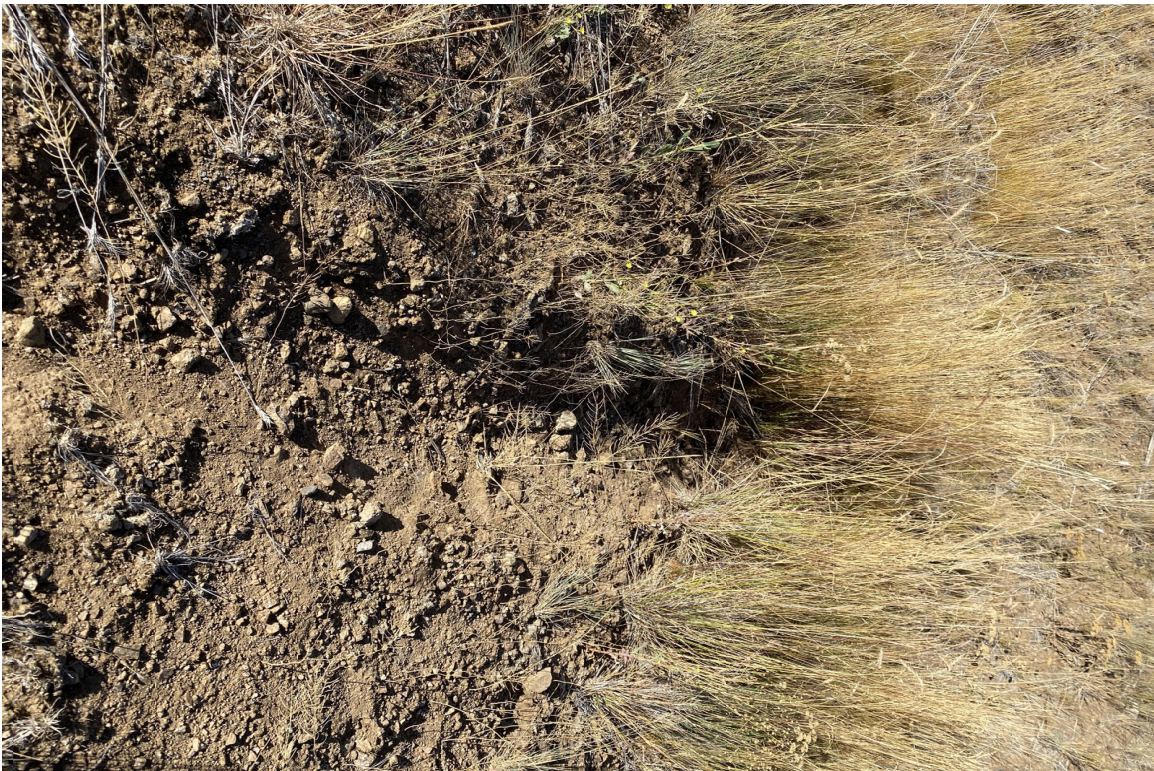
A gully was located from the western edge of the park into the drainage ditch that separates the park from the SPR.

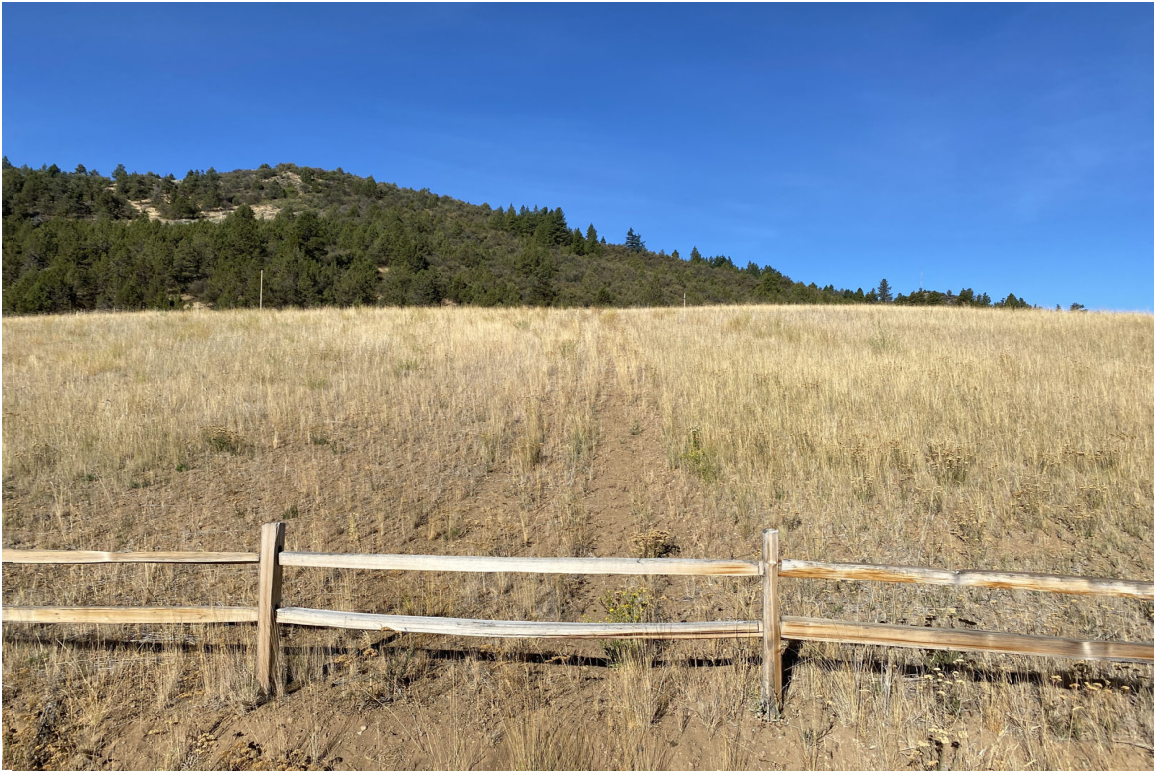
A previously repaired gully on the SPR.

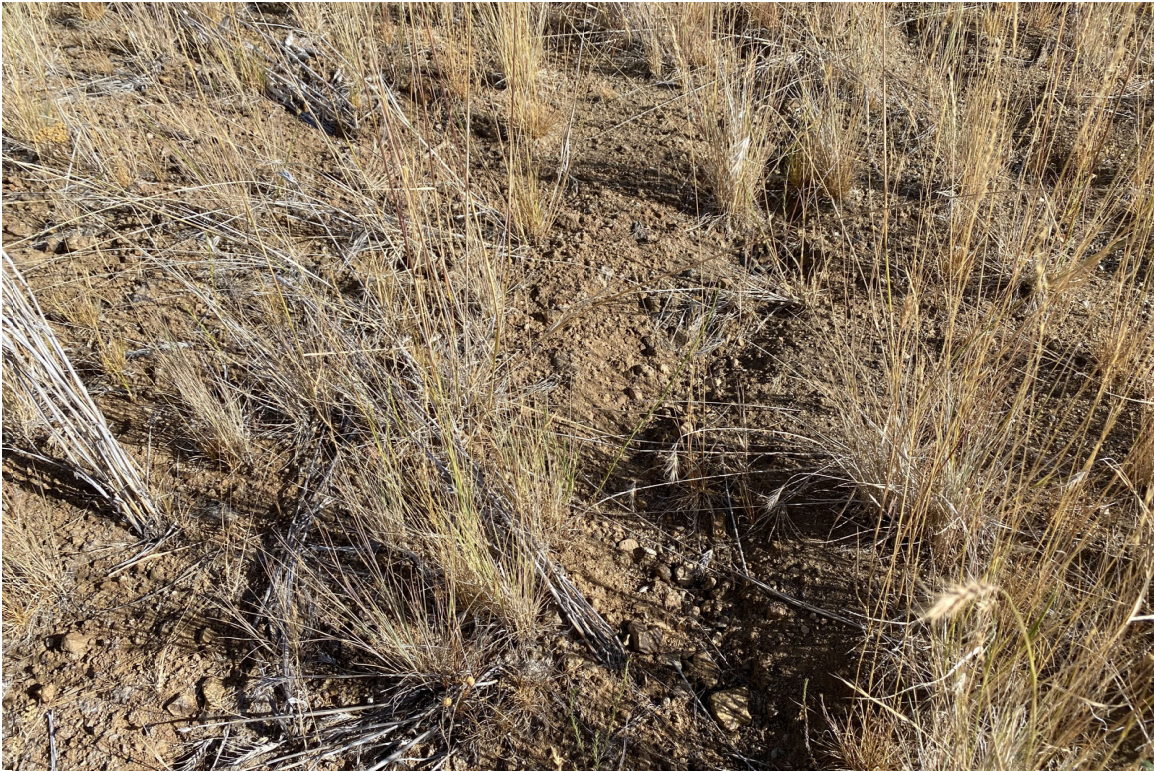
A gully was located at the western corner of Parcel AG.

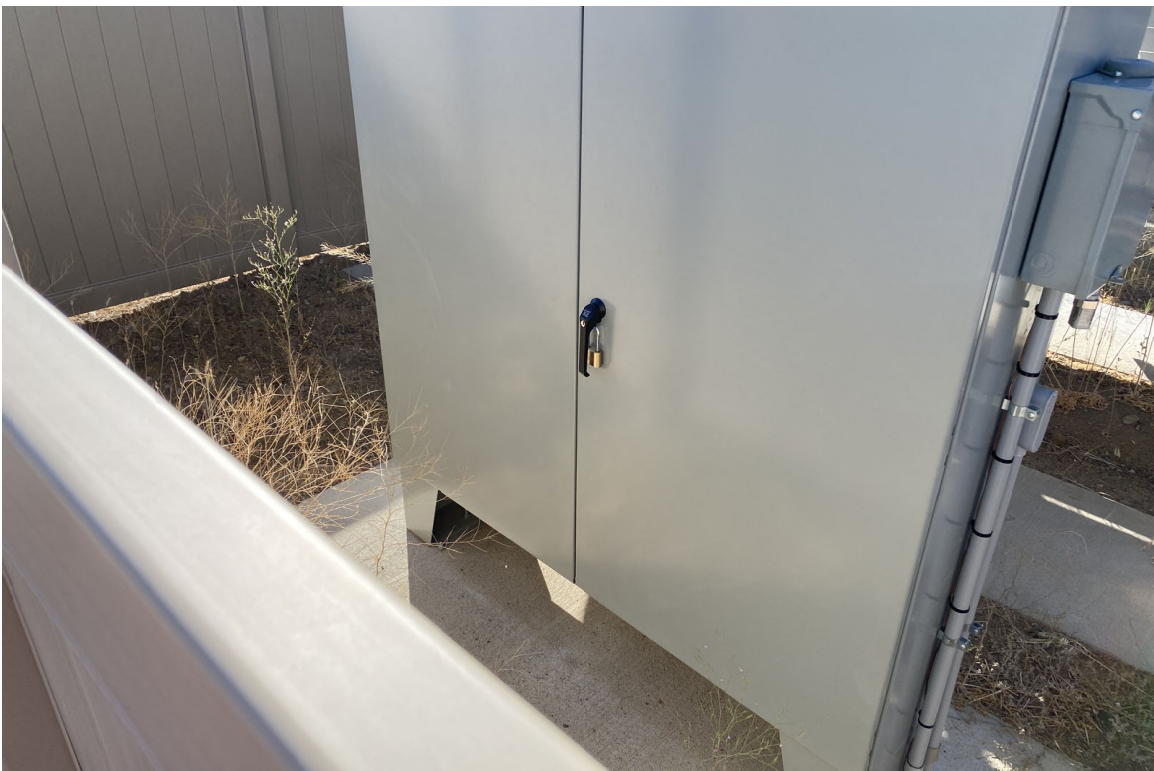
Within the fenced enclosure, limited vegetation is growing.

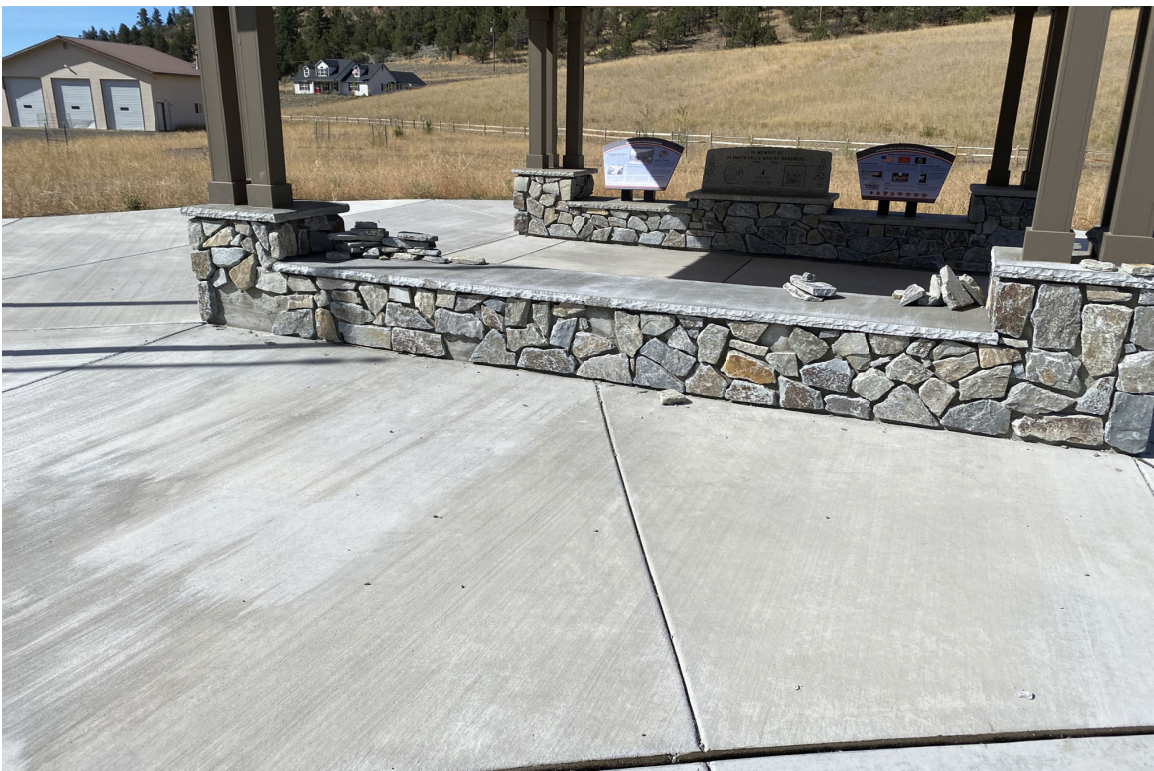
Some of the rock-work placed on the gazebo is failing and coming off the structure.
