RE: Annual Inspection for Parcels BL, MBK-F, & part of AI
North Ridge Estates Superfund Site
ECSI No. 6015

The Oregon Department of Environmental Quality completed an annual inspection of the protective cap on your property located on North Ridge Drive during the week of July 3, 2023. The protective cap appears to be in good condition with a few minor areas to watch. Enclosed for your information is a summary of the inspection.

2023 Annual Inspection Summary Report

North Ridge Estates - Operable Unit 1

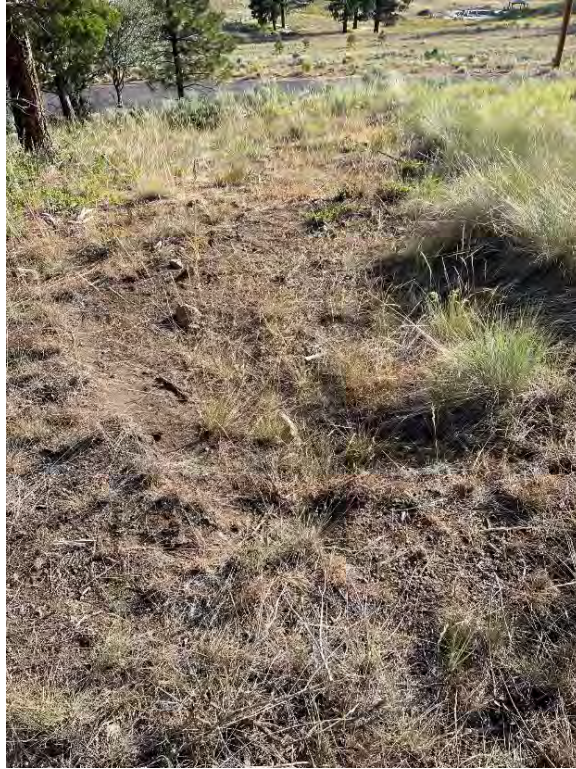
| Part I. General Site Information | | | | | | | |
|--|--|---|---|---|---|--|---|
| | Are there areas that show evidence of unstable slopes, subsidence, or slope failure? Are there signs of active bank erosion and/or lateral cutting? | <input type="checkbox"/> | <input checked="" type="checkbox"/> | <input type="checkbox"/> | <input type="checkbox"/> | Land subsidence and large depressions were present on the southeast portion of Parcel BL that adjoins Parcel AI. | |

Parcel BL – Partial land subsidence in the Southeast side of Northern Excavation Area.

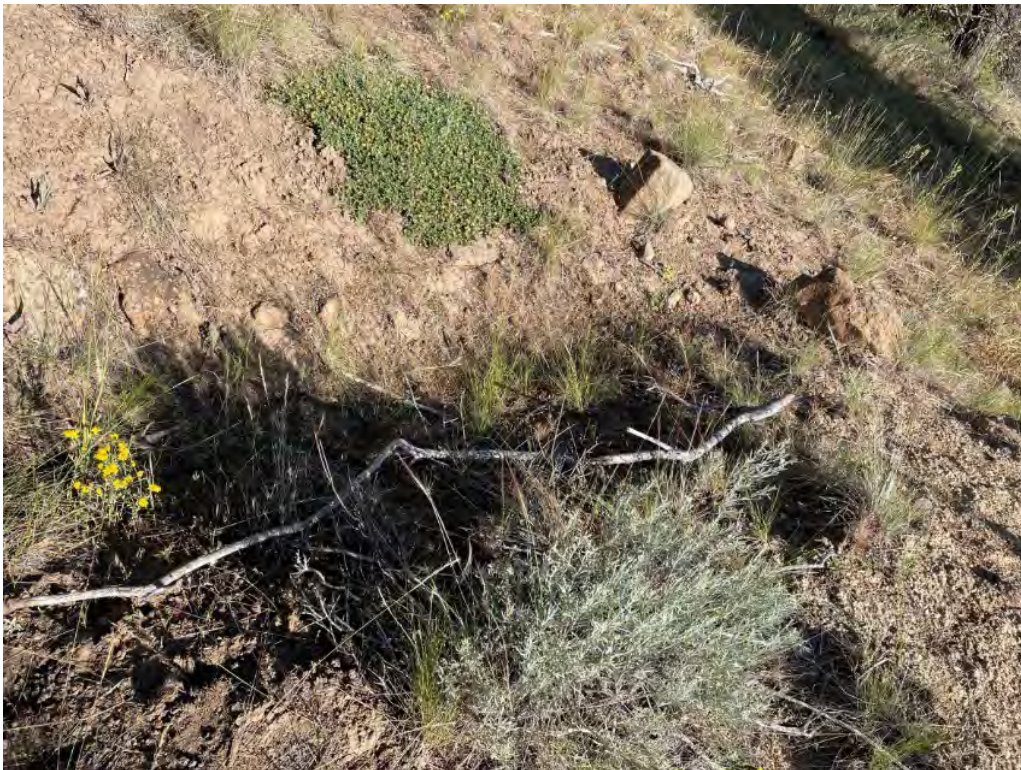
Parcel BL – Large depression located on the Southwest side of Northern Excavation Area.

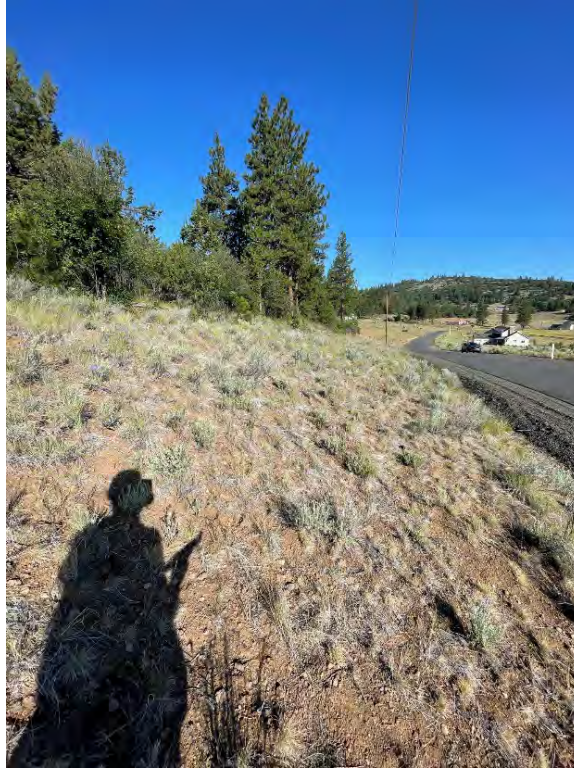
Parcel BL – Northeast corner of Northern Excavation Area, facing Northwest.

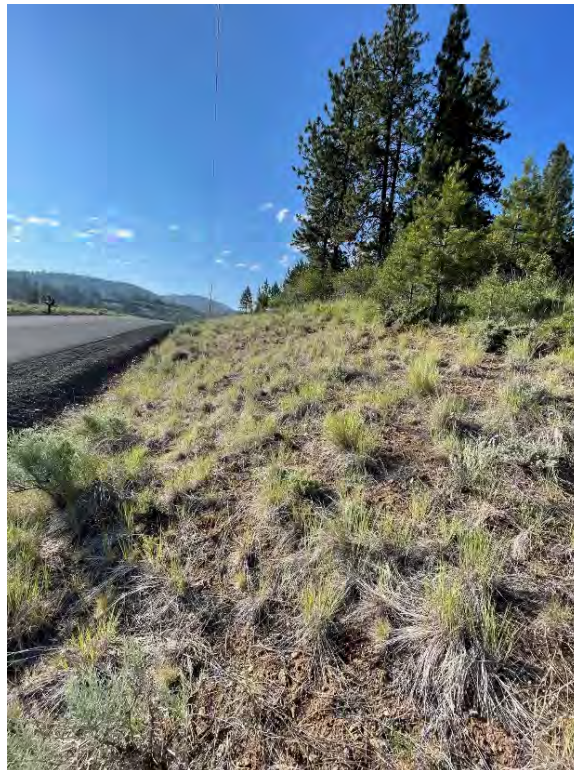
Parcel BL – Northwest corner of parcel of Northern Excavation Area, facing Southeast.

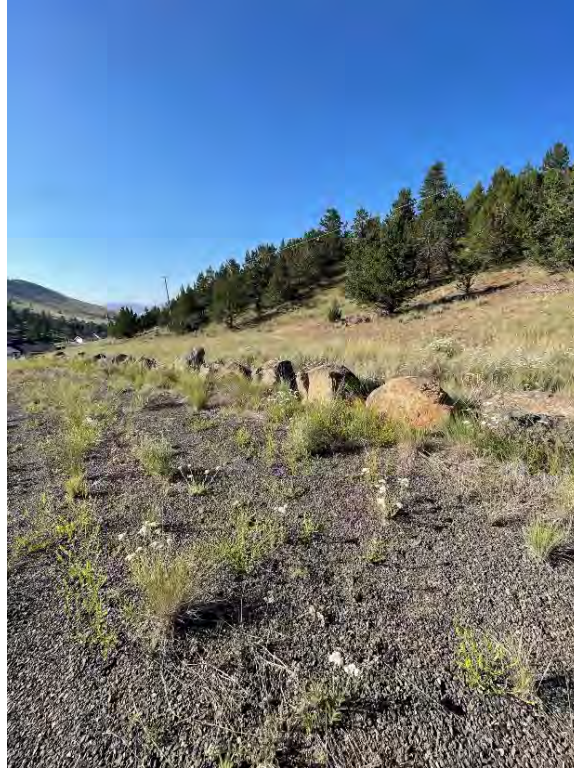
Parcel BL – Central Corner of Northern Excavation Area, facing Southeast.

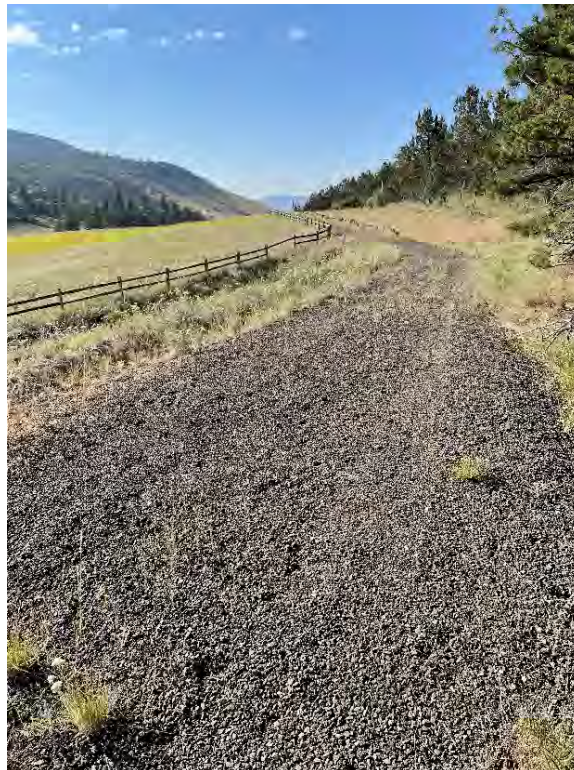
Parcel BL – Western corner of the Northern Excavation Area, facing Southeast.

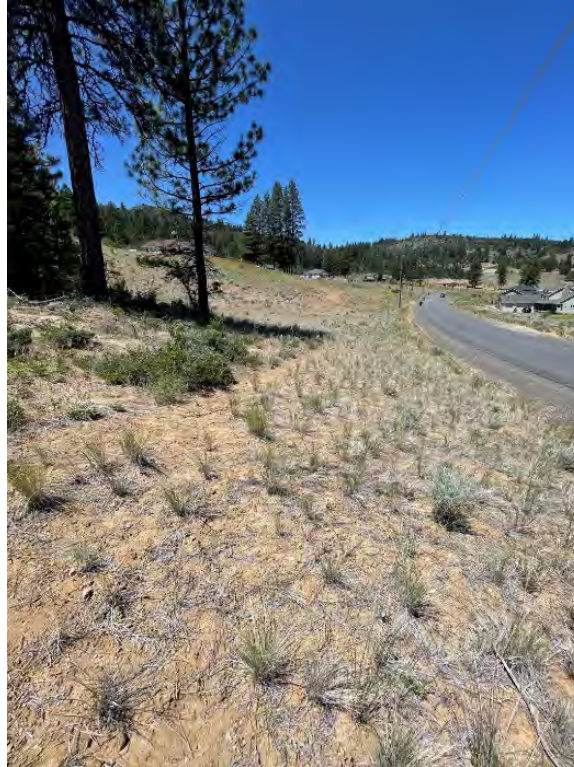
Parcel MBK-F – Northeast corner of Parcel, facing West.

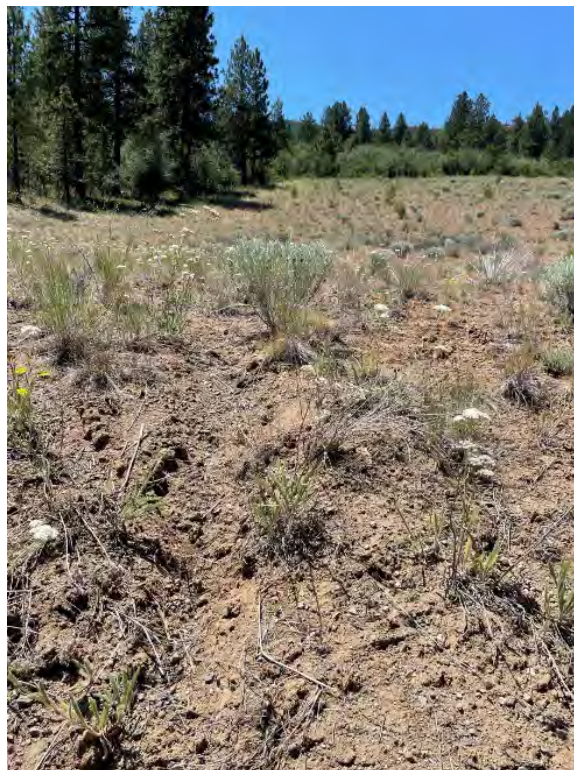
Parcel MBK-F – New Rill present on the Northwest side of the Parcel.

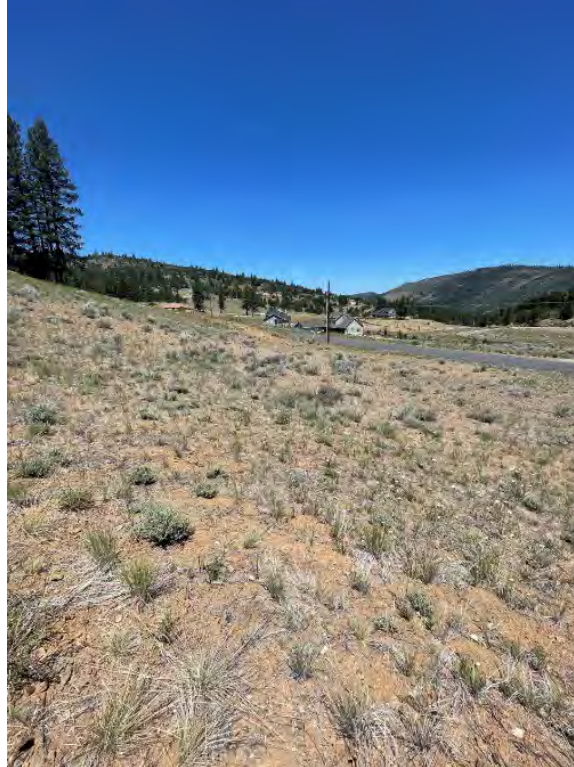
Parcel MBK-F – North Central corner, facing Northwest.

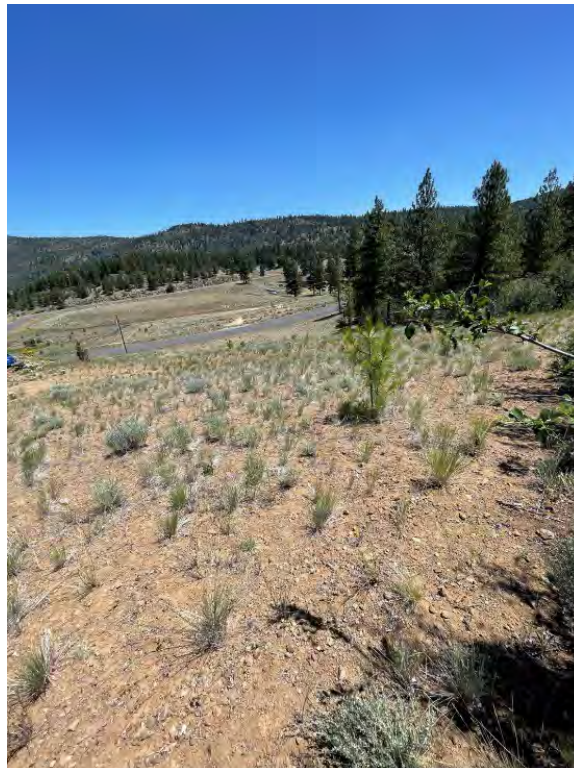
Parcel MBK-F – Southwest corner of Parcel, facing Northeast.

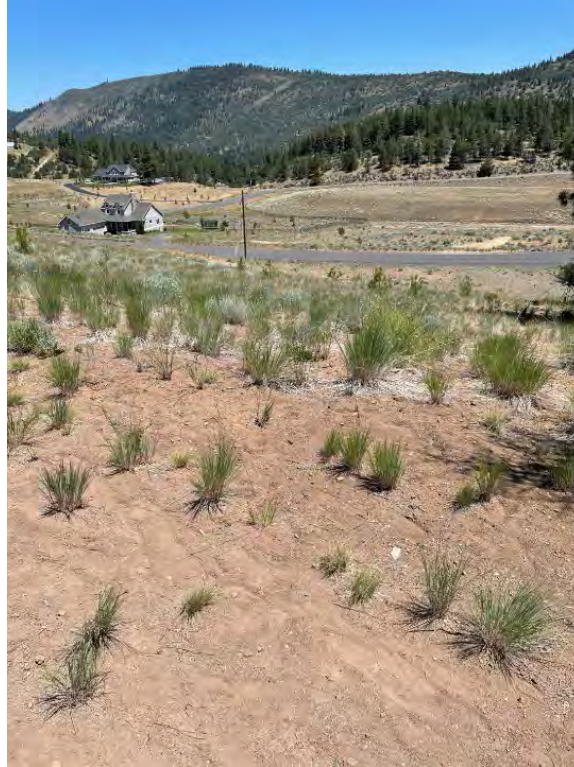
Parcel MBK-F – Southeast corner of Parcel, facing Northwest.

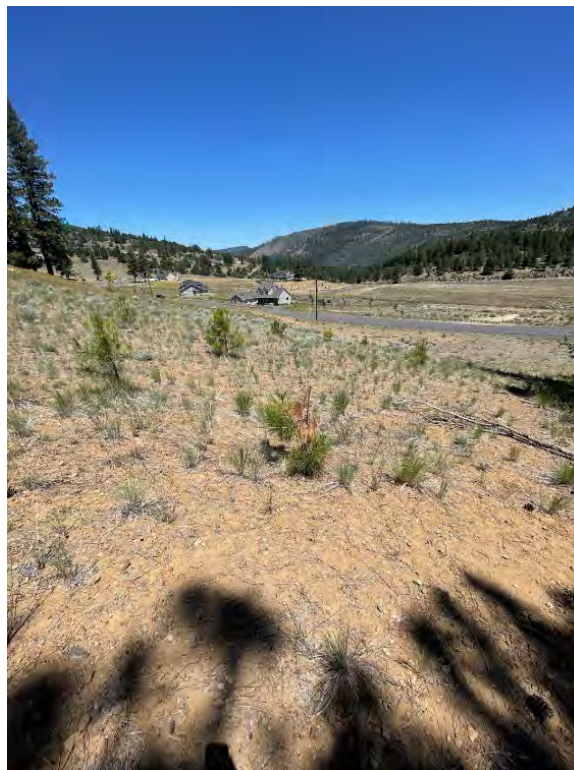
Parcel MBK-F – South Central corner of Parcel, facing Northwest.

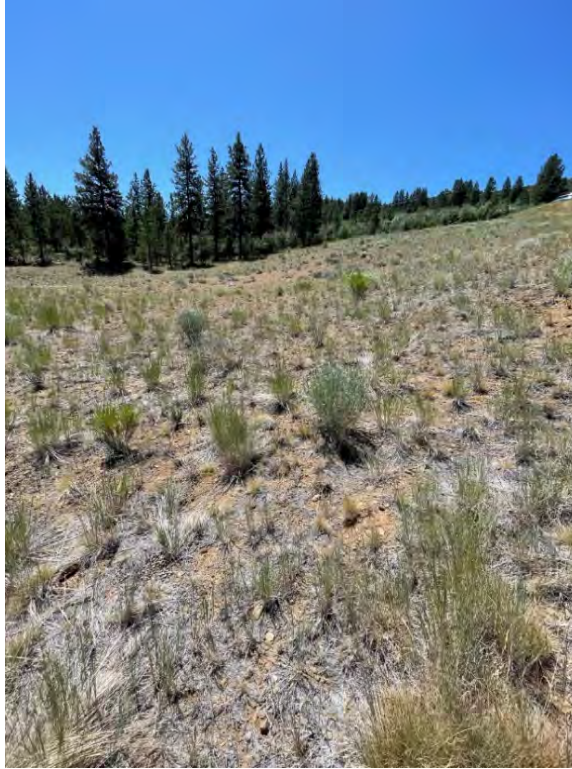
Parcel MBK-F – Northwest corner of Parcel, facing Southwest.

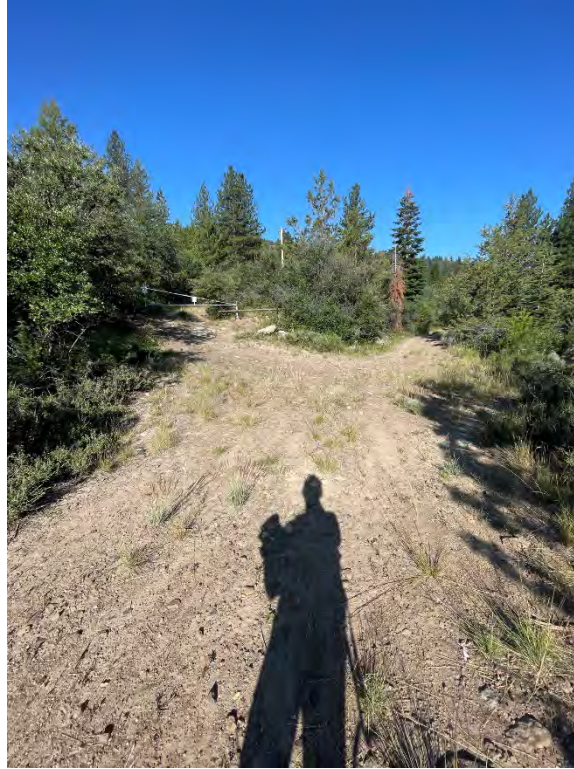
Antenna Road – Northeast corner of Parcel, facing West.

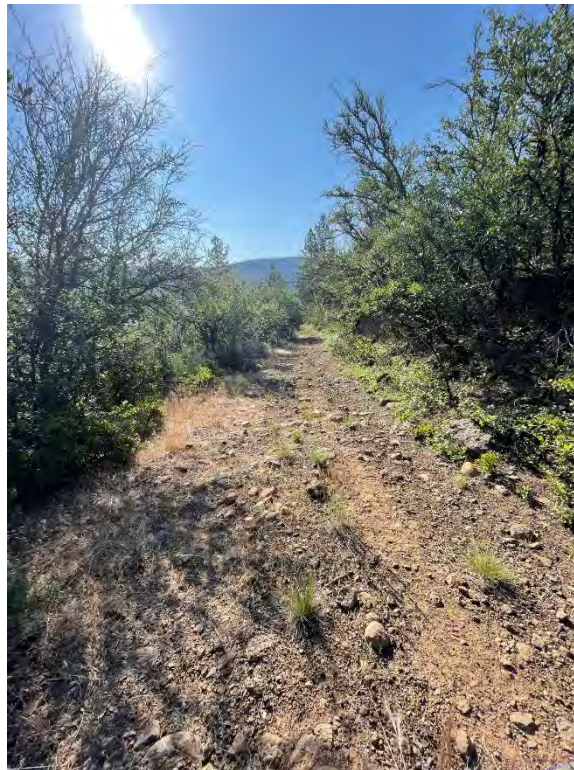
Antenna Road – West side of Parcel, facing Southeast.

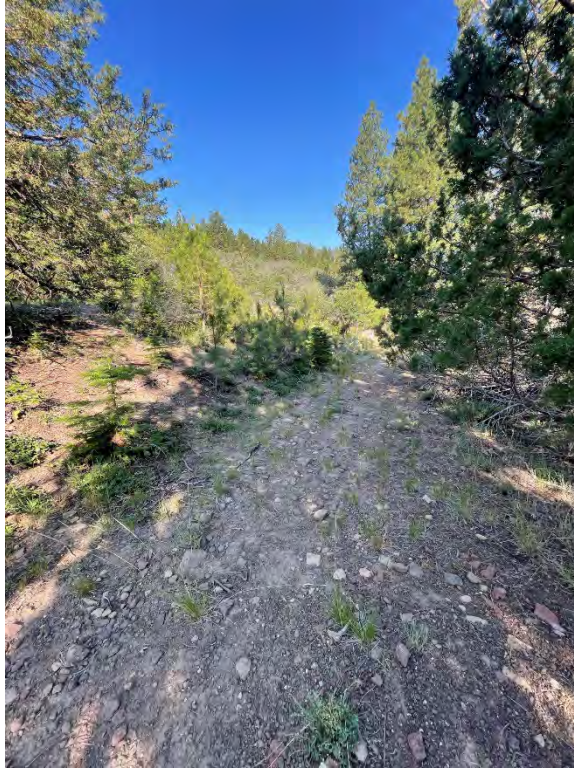
Antenna Road – East corner of Parcel, facing Northwest.

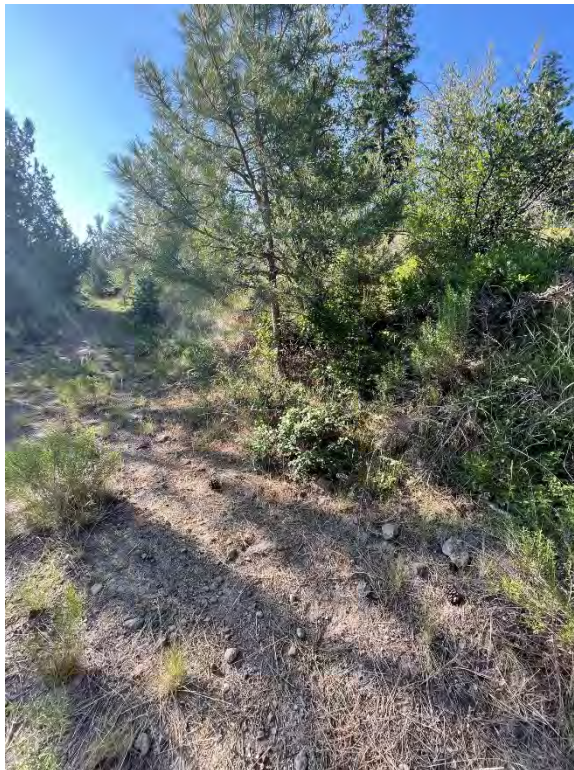
Antenna Road – North corner facing Southeast.
