RE: Annual Inspection for Parcel BR (part of)
North Ridge Estates Superfund Site
ECSI No. 6018

Parcel BR

Operations and Maintenance Inspection Form

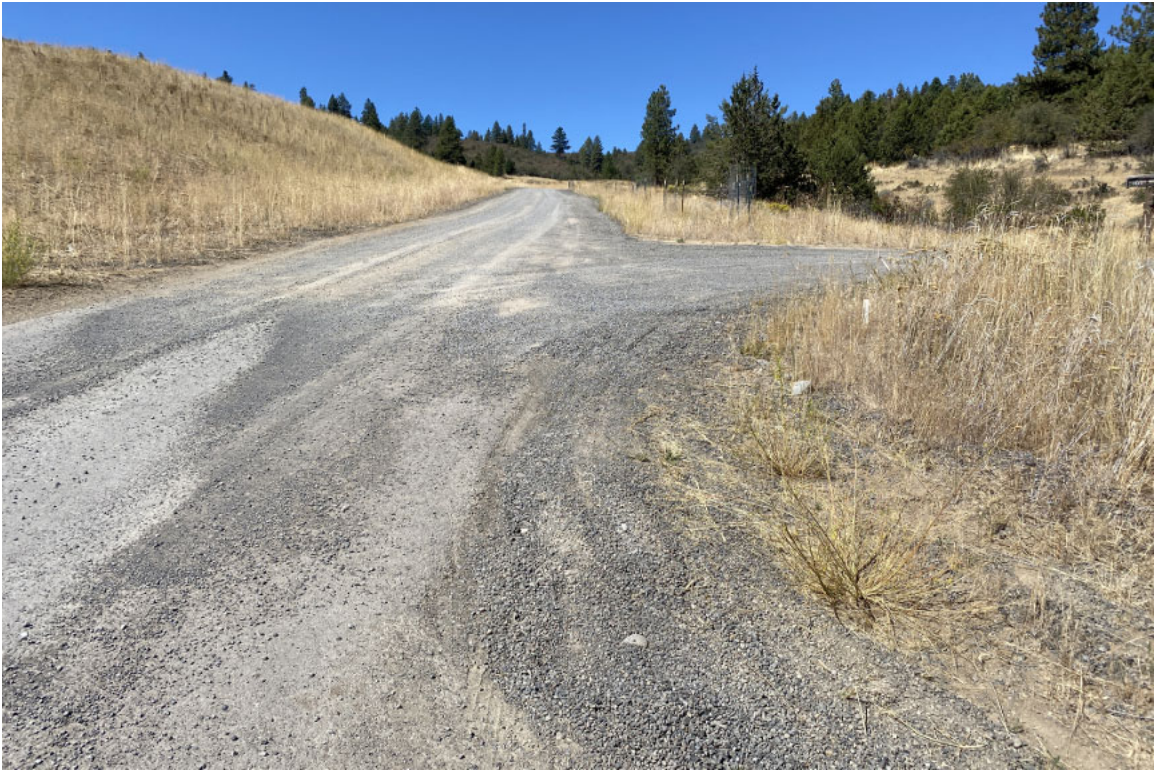
View of the southern edge of the BR removal area/cap, looking west from the SE corner.

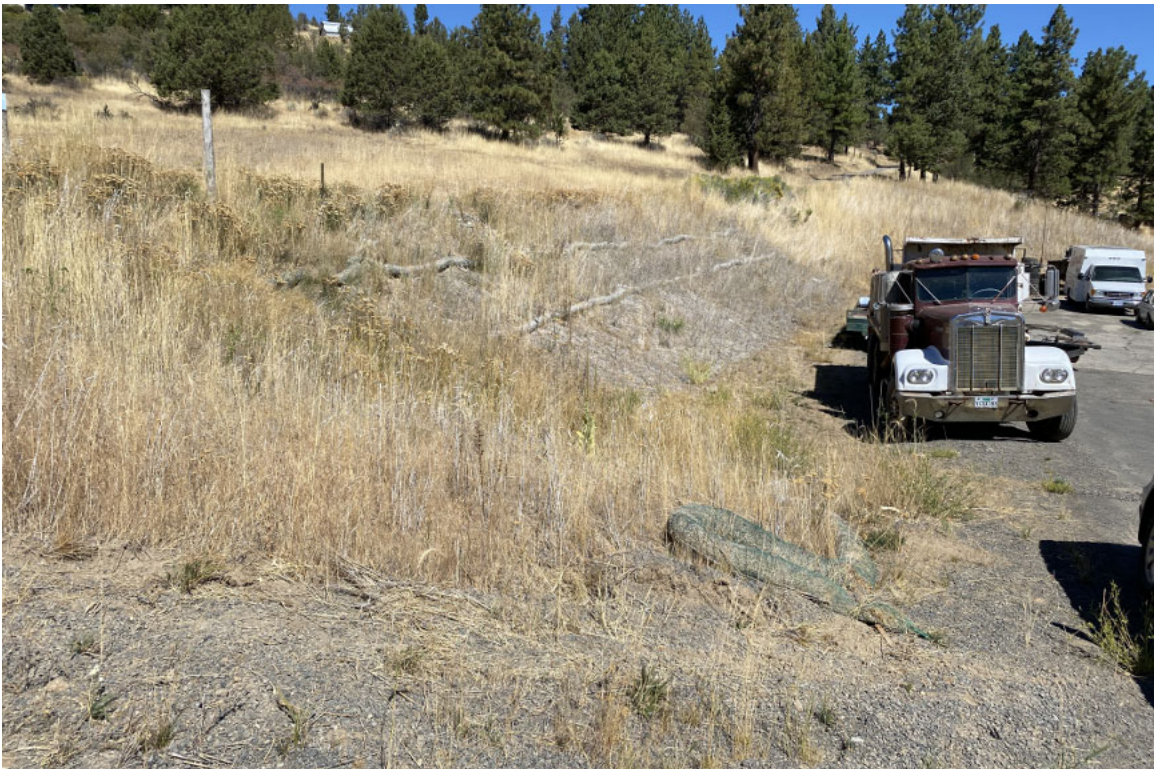
View of the eastern edge of the BR removal area looking north from the SE corner.

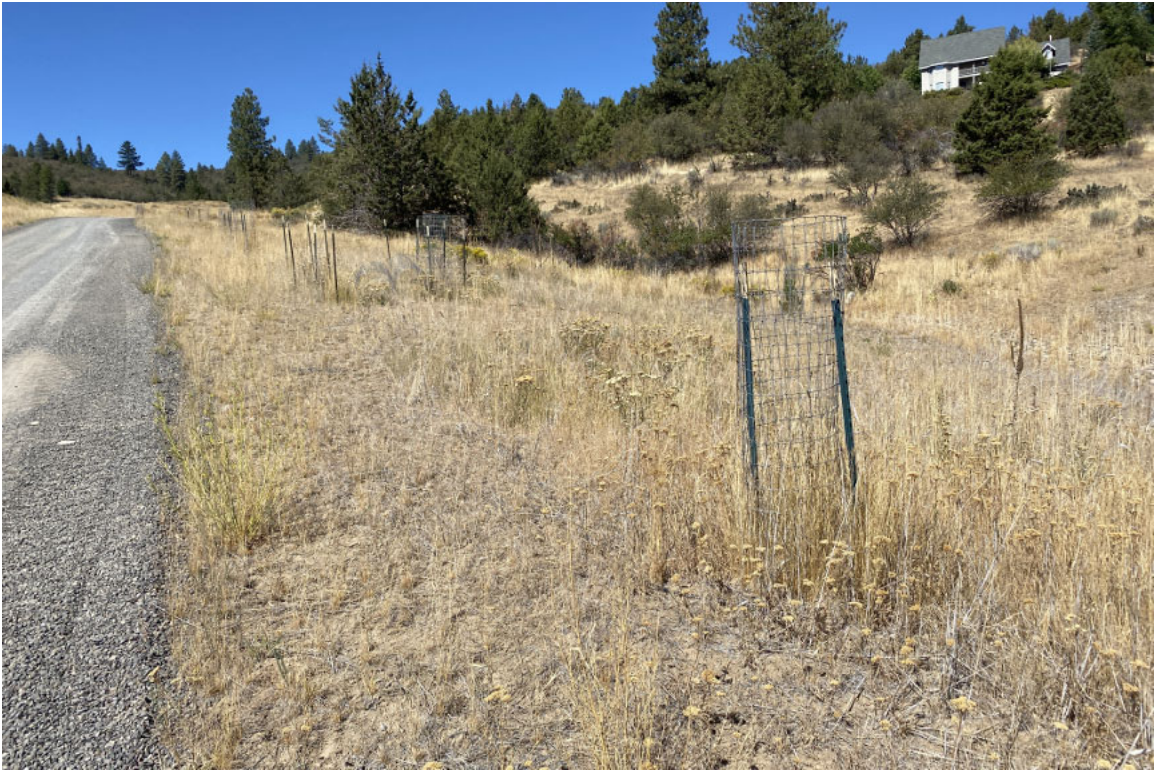
Vegetation	Evidence of distressed or sparse vegetation? (sparse vegetation no greater than 10 percent of area and bare areas no greater than 100 square feet)	<input type="checkbox"/>	<input type="checkbox"/>	<input checked="" type="checkbox"/>	<input type="checkbox"/>		
	Evidence of trees and shrubs in distress?	<input type="checkbox"/>	<input checked="" type="checkbox"/>	<input type="checkbox"/>	<input type="checkbox"/>	Yes. Many of the newly planted trees are showing signs of stress and two legacy trees just to the north of the removal area are showing signs of die off.	
	Are there any stressed or dying trees that may impact or damage the protective when felled?	<input type="checkbox"/>	<input type="checkbox"/>	<input checked="" type="checkbox"/>	<input type="checkbox"/>	Two legacy trees (mentioned above) are not believe to be able to damage the cap.

Several of the newly planted trees are dying or stressed.

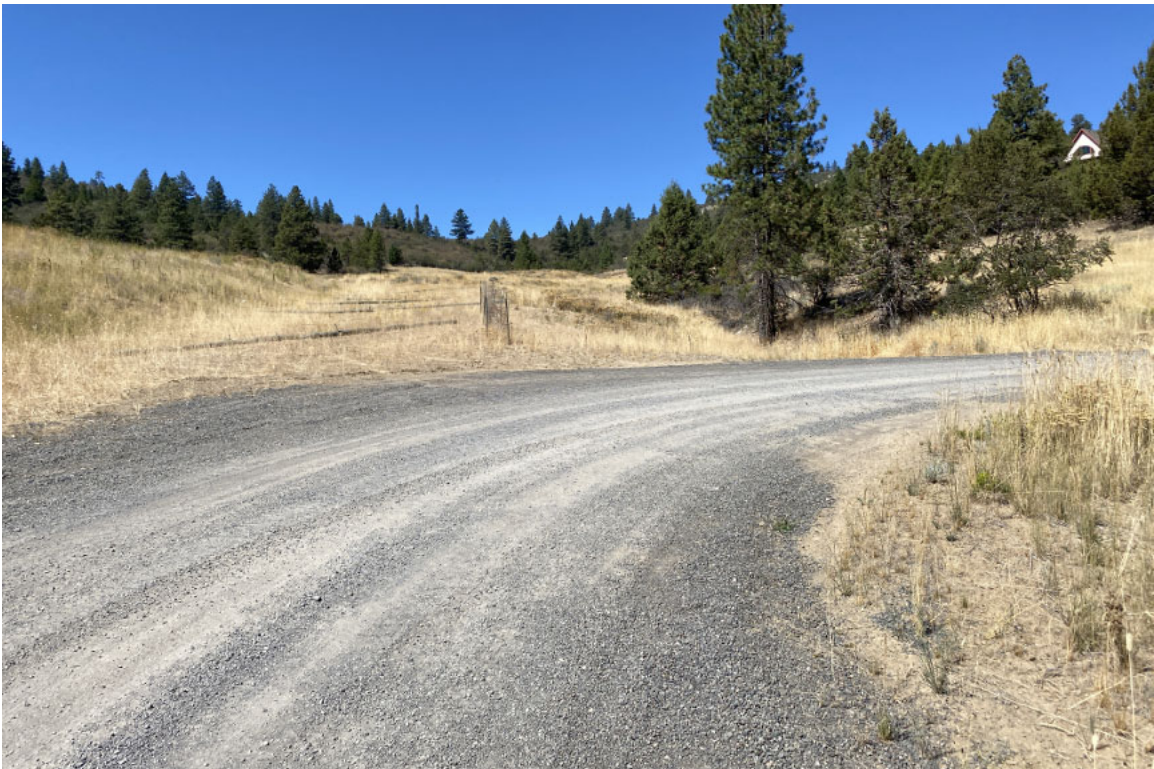
View of the southern edge of the BR removal area and cap, looking west.

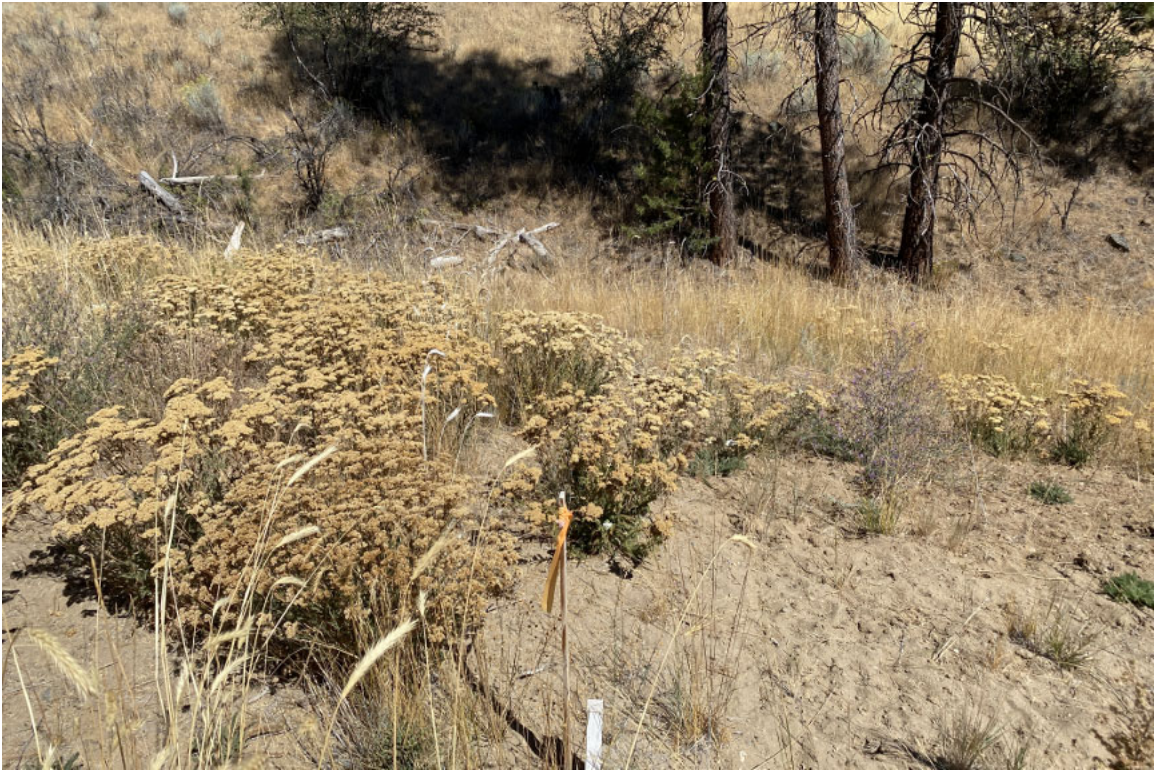
View of the west edge of the BR removal area/cap looking north from the SW corner.

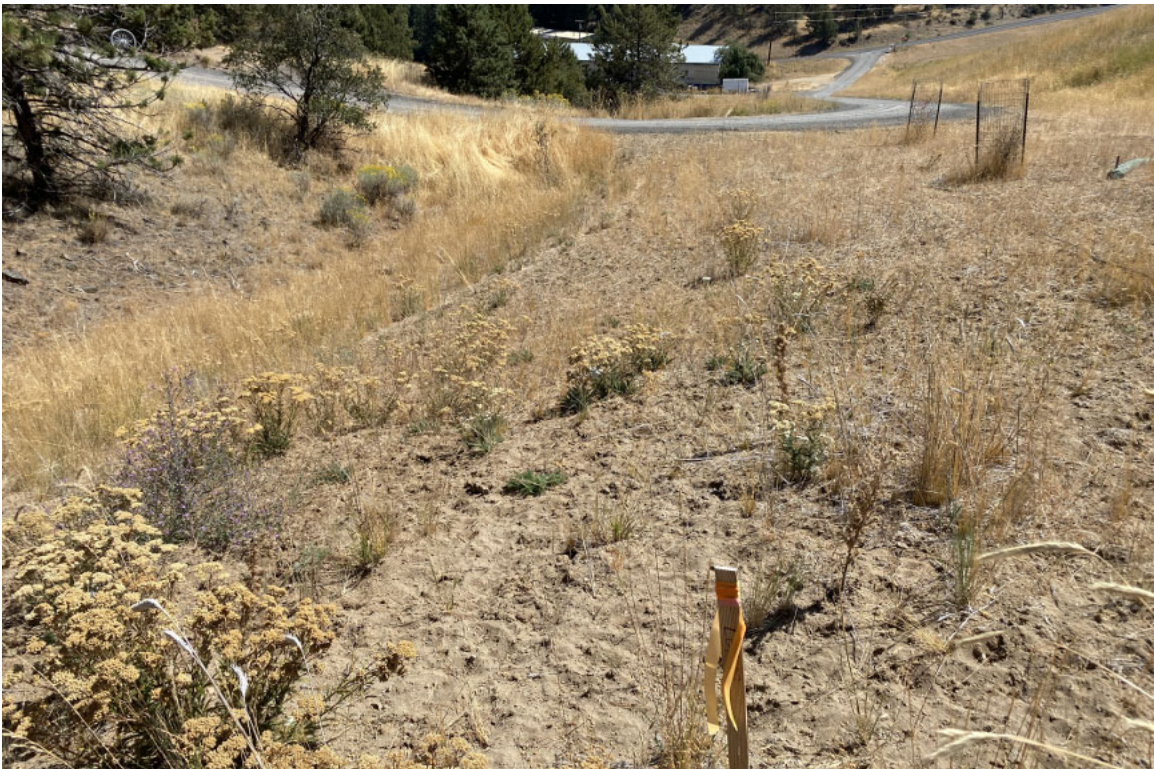
View of the southern end of the BR removal area/cap from the SW corner.

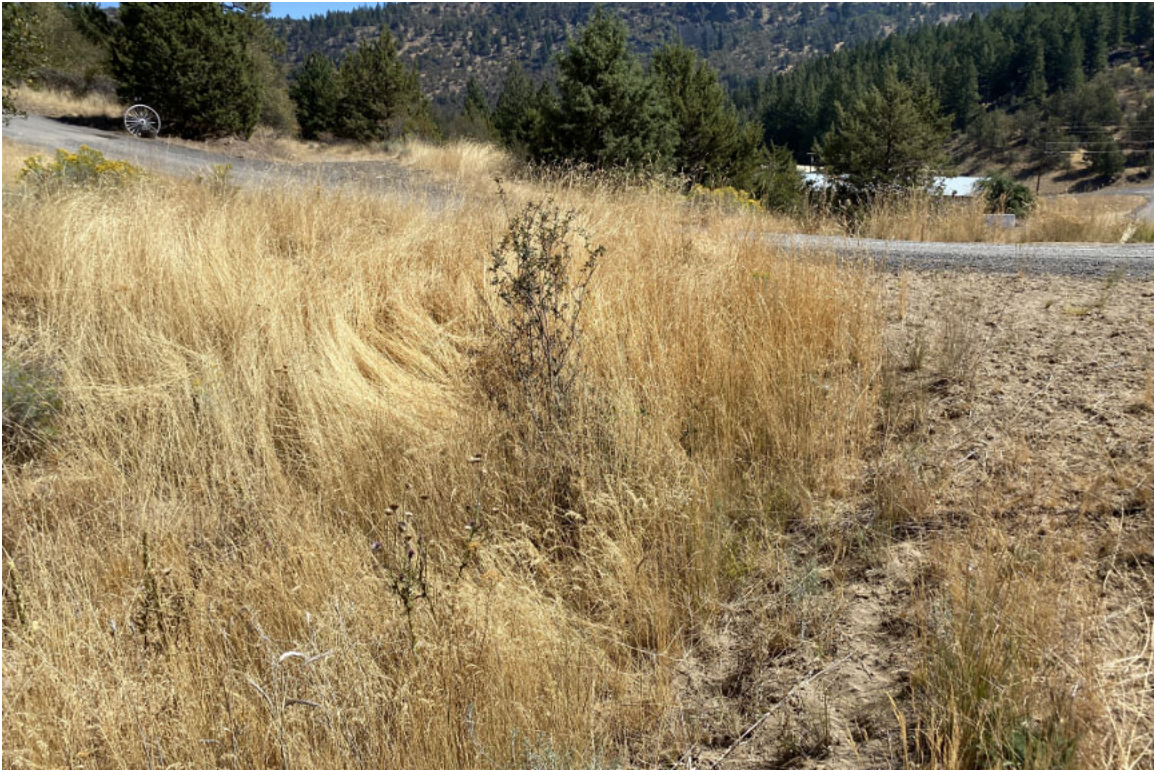
Ditches and Culverts	Obstructions observed in ditches or culverts that may impede conveyance of stormwater?	<input checked="" type="checkbox"/>	<input type="checkbox"/>	<input type="checkbox"/>	<input type="checkbox"/>	All onsite culverts has some level of blockage (~1/4 to 1/3), but may not significantly impact drainage.	Culverts could be cleared.
	Damaged observed to riprap surface? Note if riprap is not intact or not effectively providing armor protection.	<input type="checkbox"/>	<input type="checkbox"/>	<input checked="" type="checkbox"/>	<input type="checkbox"/>		
	Are there any areas that show signs of excessive scour? (i.e., gullies forming along centerline of ditch)	<input type="checkbox"/>	<input type="checkbox"/>	<input checked="" type="checkbox"/>	<input type="checkbox"/>	There are two or more locations where rock has been added to prevent stormwater scour as it enters the drainage ditch

Some of the culverts were heavily overgrown.

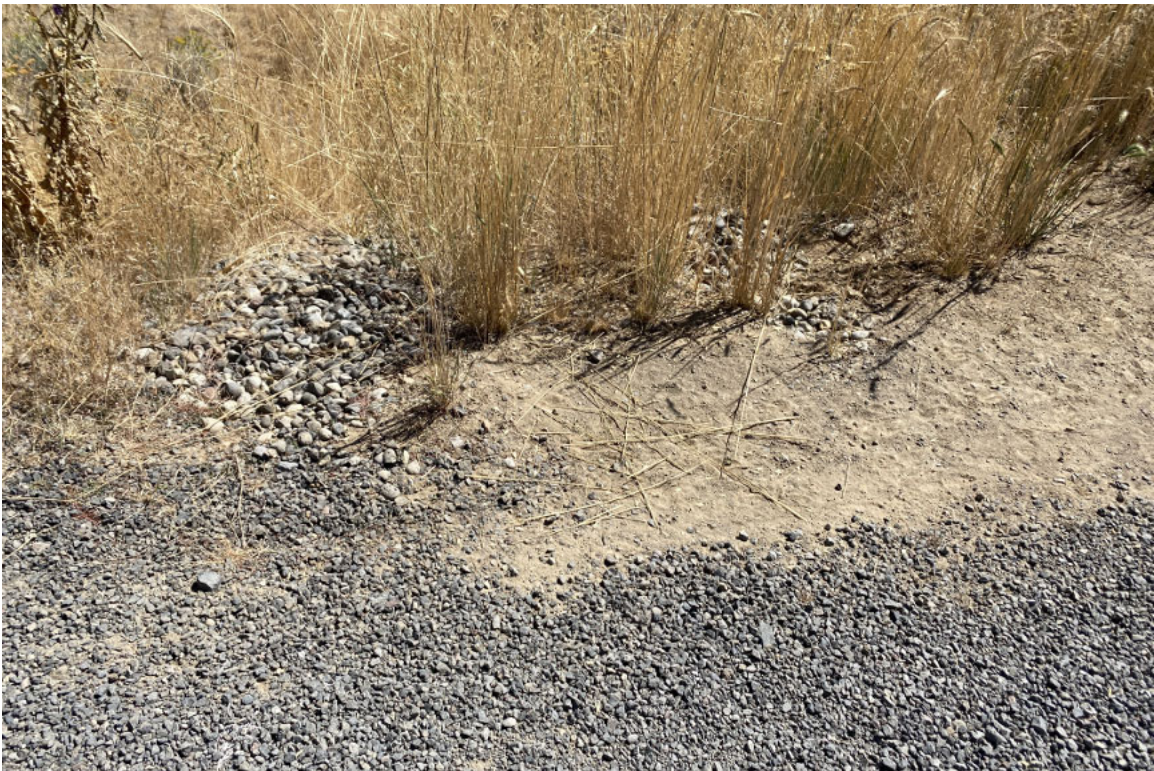
Round rock has been added in places to prevent/repair erosion locations.

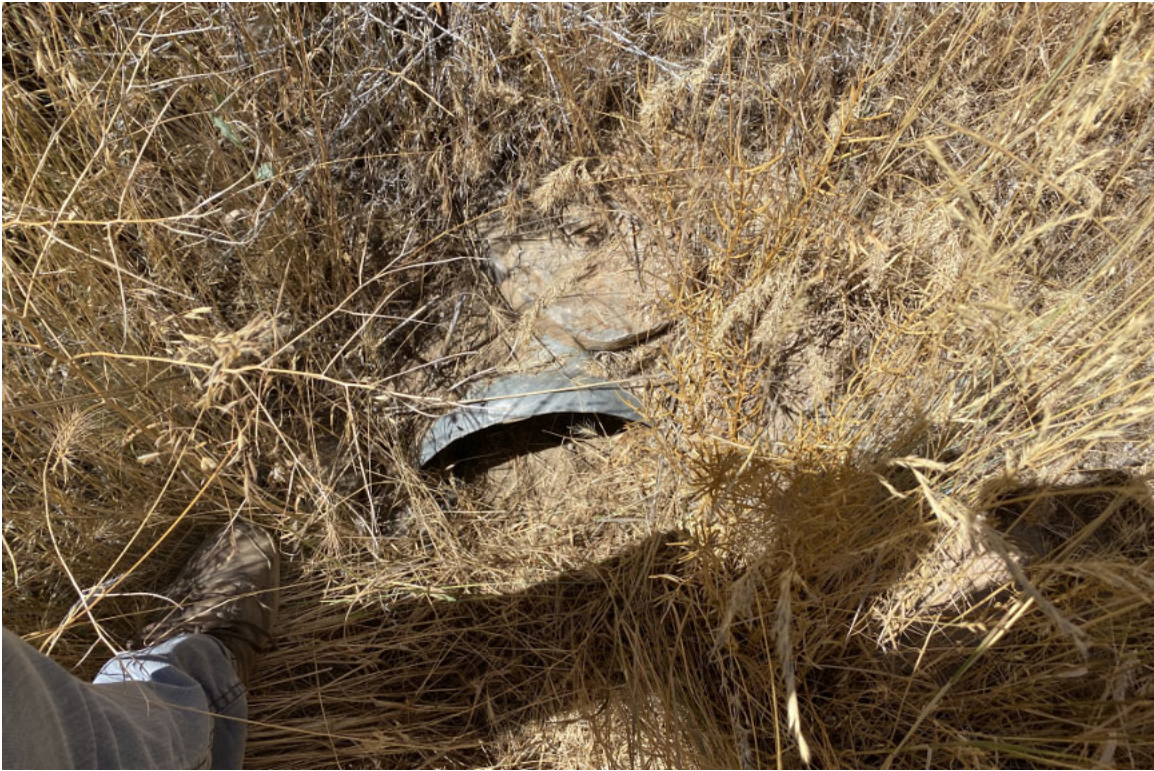
At least one of the culverts at the BR removal area was substantially blocked by sediment.

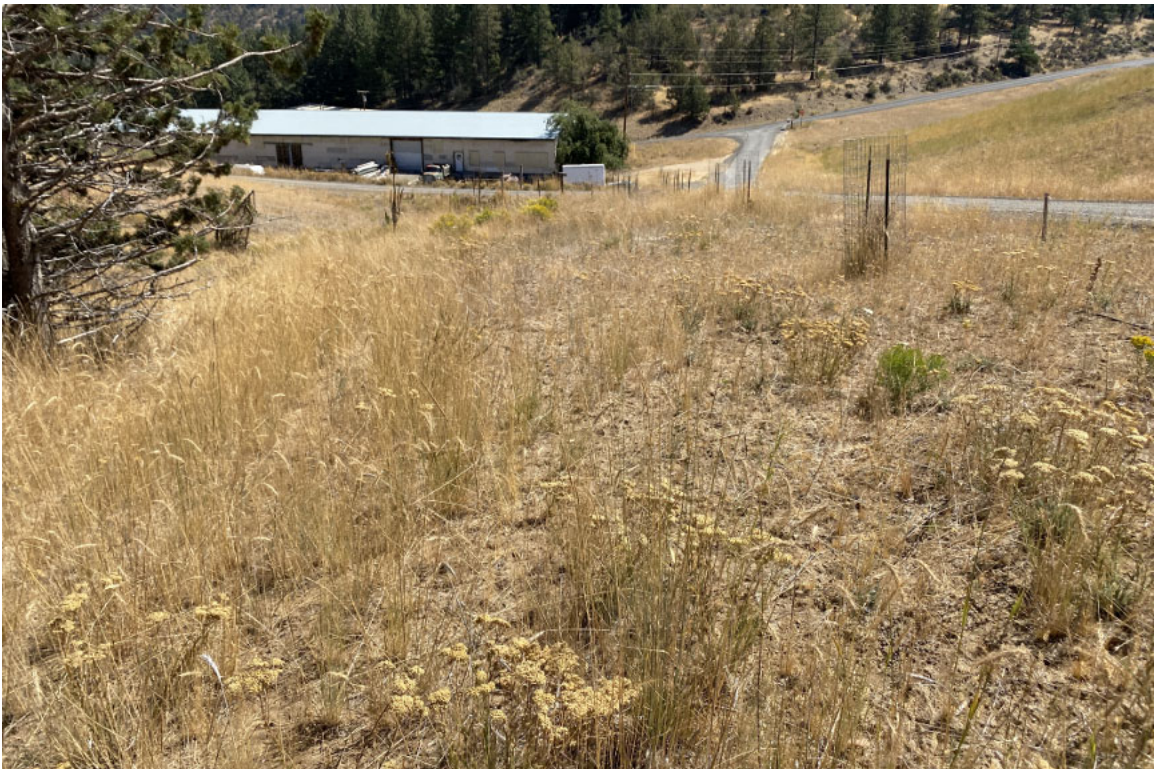
Two legacy trees just north of the cap were stressed/dying. If felled, it is unlikely to damage the cap.

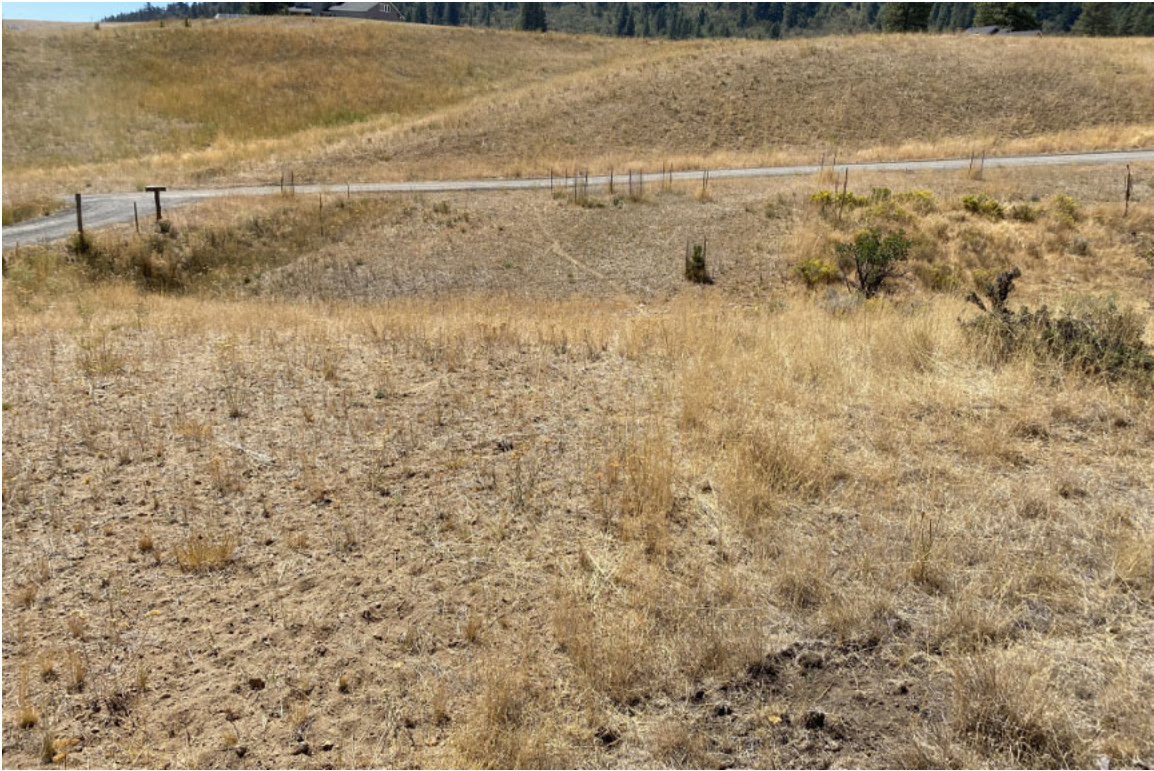
View of the NW edge of the removal area and cap, from the northern corner.

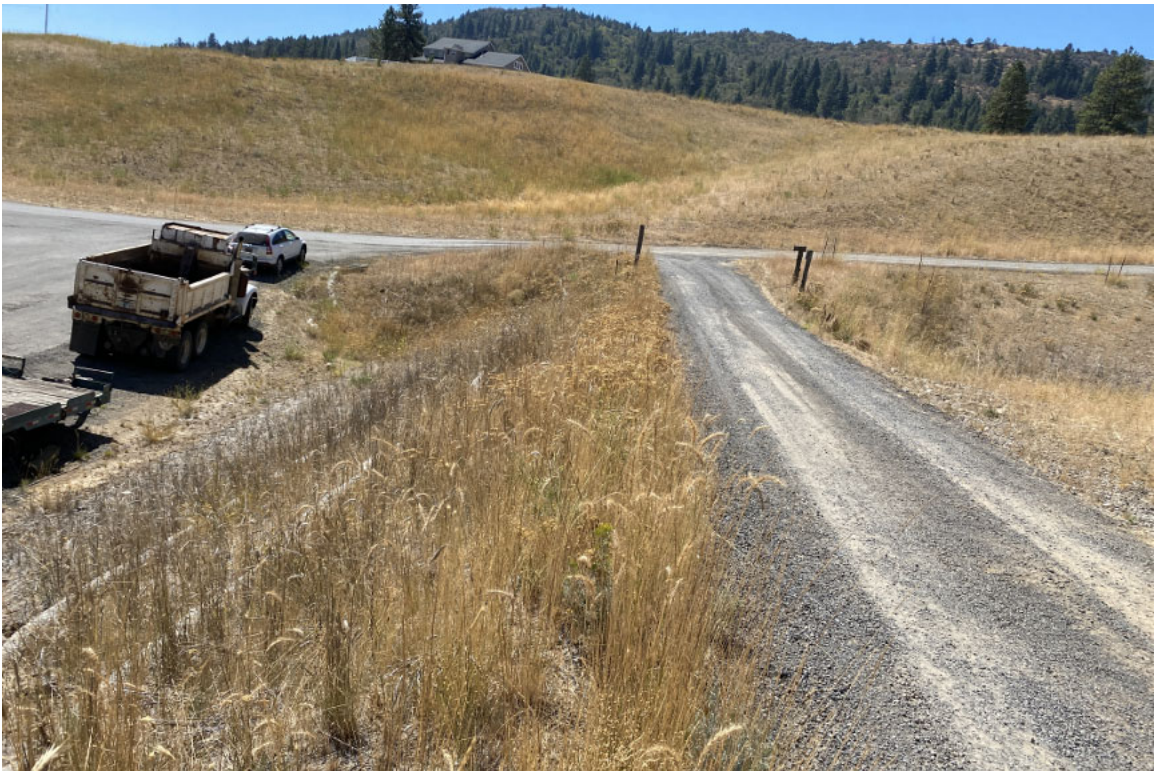
View of the eastern edge of the removal area from the NE corner.
