RE: Annual Inspection for Parcel BR (part of)
North Ridge Estates Superfund Site
ECSI No. 6018

Operations and Maintenance Inspection Form

Part I. General Site Information							
Site Name:	North Ridge Estates	State/County:	Oregon (Klamath County)	Parcel/Tax ID:	Parcel BR		
EPA Point of Contact	Linda Meyer (206) 553-6636	ODEQ Point of Contact	Katie Daugherty (503) 860-3943				
Inspection Date:	10/12/2021	Person(s) Performing Inspection:	Saul Montes (Apex Companies, LLC)	Person(s) Performing Inspection:			
Part II. Remedy Performance Assessment							
Remedy Component	Potential Problem	Yes (Repair Needed)	Yes (Monitor/No Repair)	No	N/A	If Yes, Describe Extent of Problem	Describe Potential Repair Solution
Protective Cap	Have rills developed deeper than 2 inches?	<input type="checkbox"/>	<input type="checkbox"/>	<input checked="" type="checkbox"/>	<input type="checkbox"/>		
	Are the rills within a 10-foot interval?	<input type="checkbox"/>	<input type="checkbox"/>	<input checked="" type="checkbox"/>	<input type="checkbox"/>		
	Have gullies developed deeper than 6 inches?	<input type="checkbox"/>	<input checked="" type="checkbox"/>	<input type="checkbox"/>	<input type="checkbox"/>	8-i

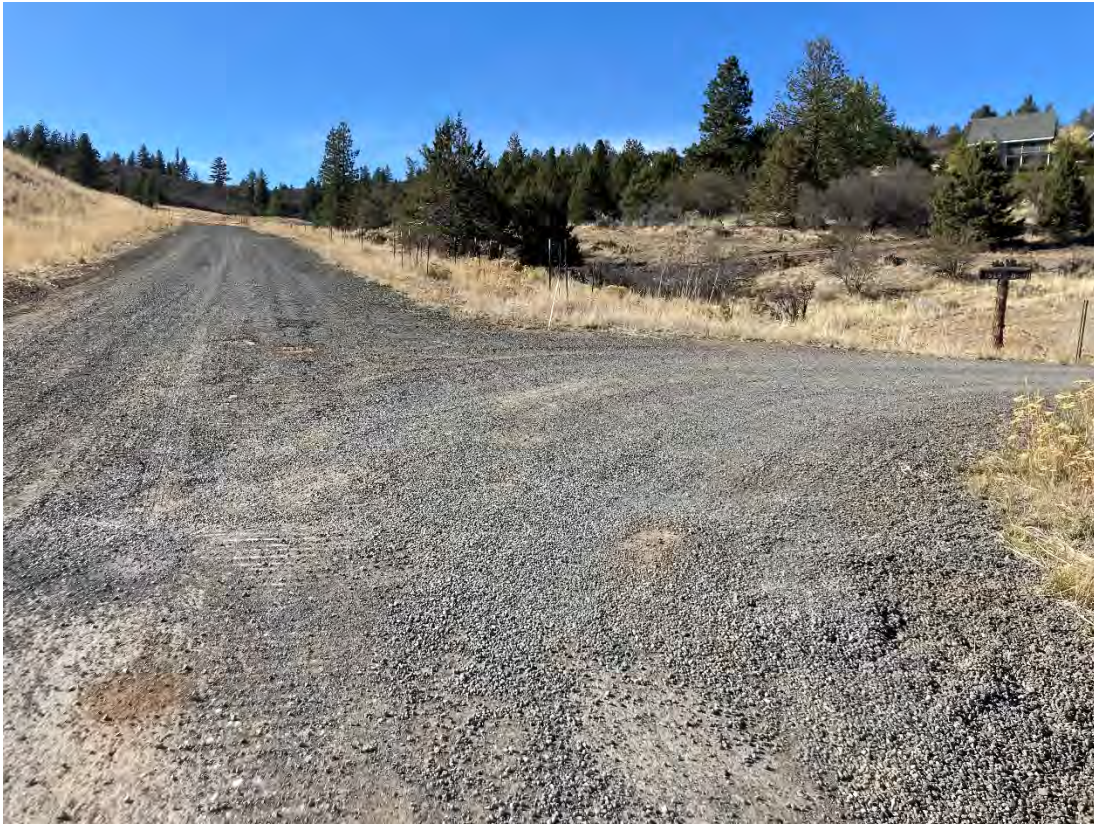
View of the southern edge of the BR removal area/cap, looking west from the SE corner.

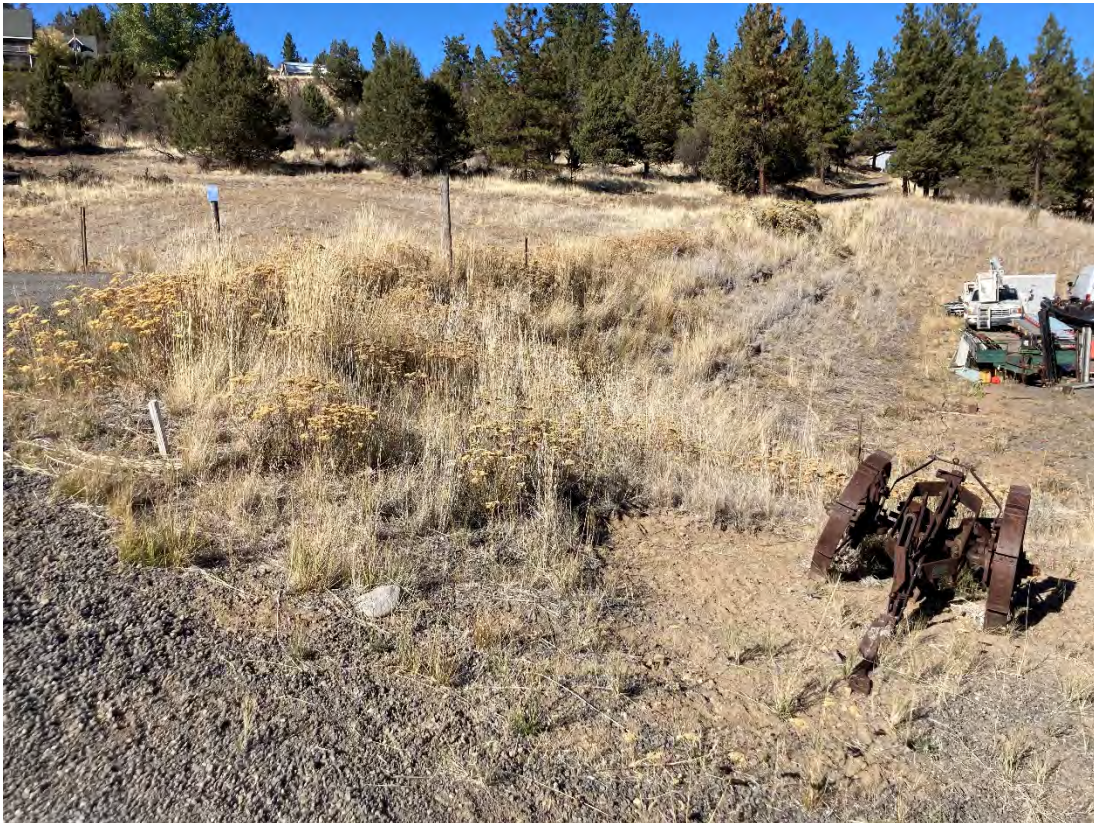
View of the NE portion of Parcel BR, looking from the SW corner.

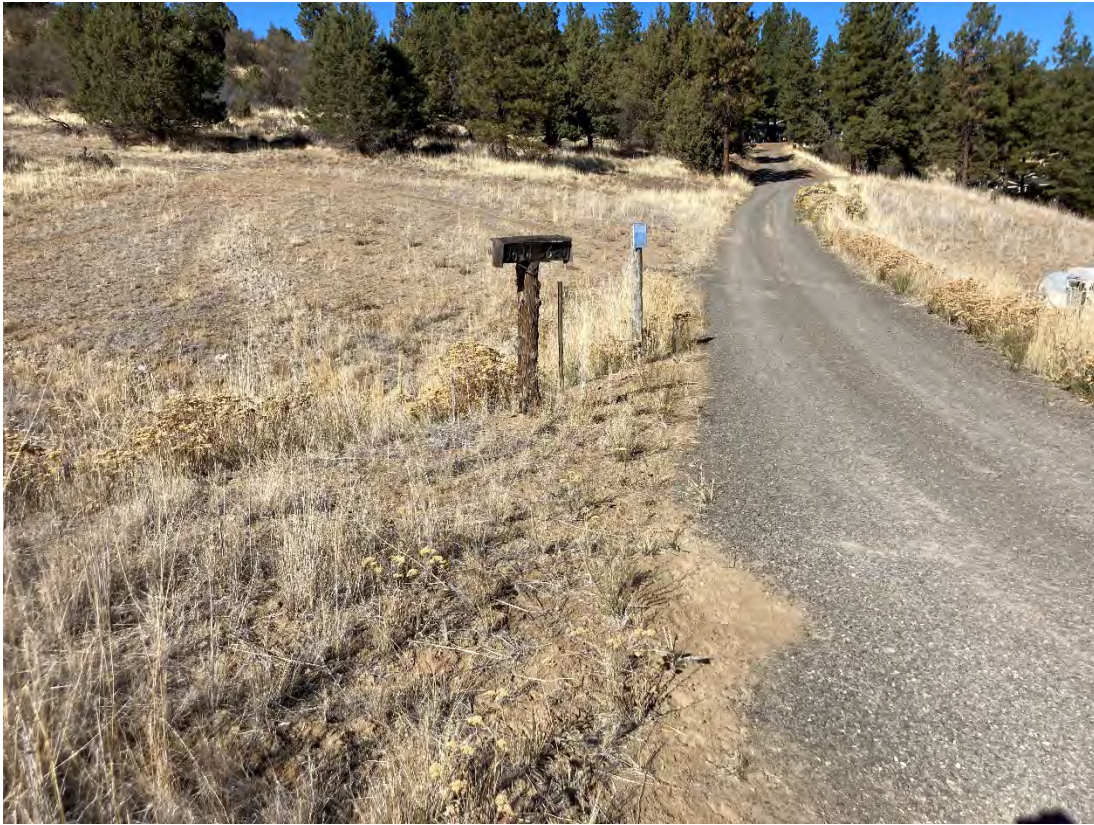
View of the SE portion of the property line, looking from the southwest corner.

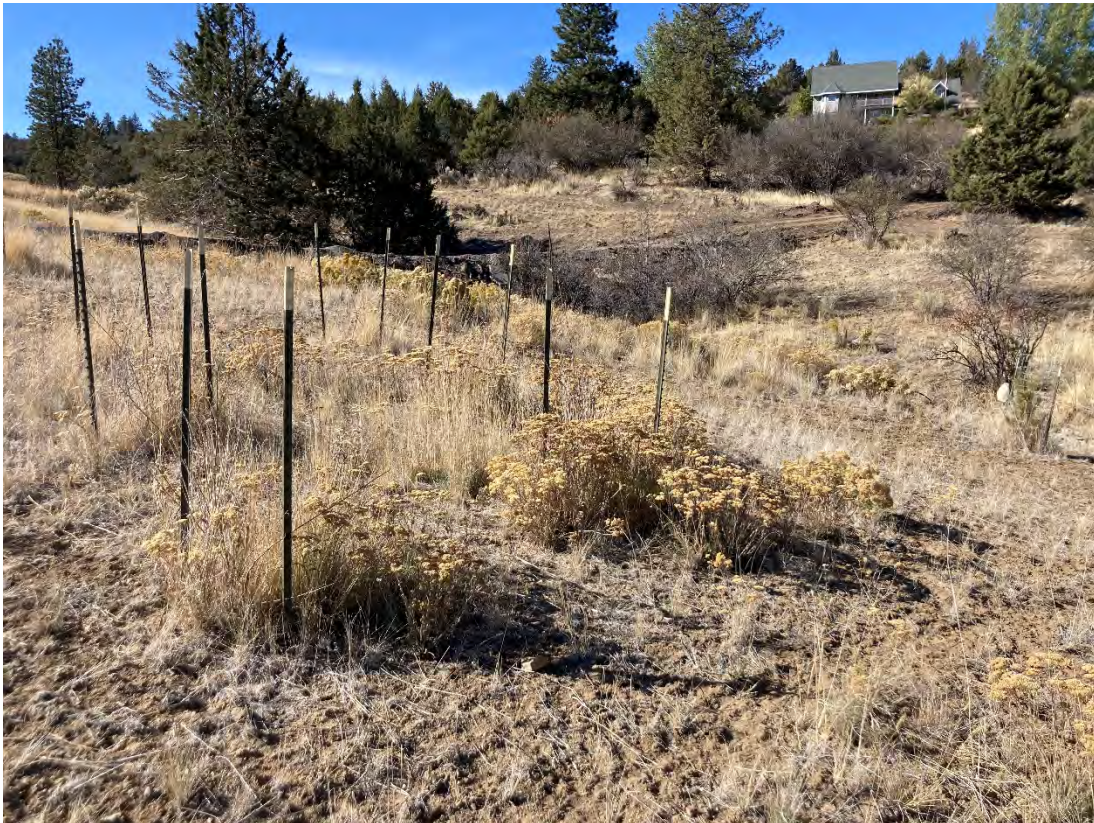
Vegetation	Evidence of distressed or sparse vegetation? (sparse vegetation no greater than 10 percent of area and bare areas no greater than 100 square feet)	<input type="checkbox"/>	<input type="checkbox"/>	<input checked="" type="checkbox"/>	<input type="checkbox"/>		
	Evidence of trees and shrubs in distress?	<input type="checkbox"/>	<input checked="" type="checkbox"/>	<input type="checkbox"/>	<input type="checkbox"/>	Yes. Many of the newly planted trees are showing signs of stress and two legacy trees just to the north of the removal area are showing signs of die off. (Same as 2020)	Vegetation will be watched during subsequent inspections to verify that dead vegetation does not impact soil cap.
	Are there any stressed or dying trees that may impact or damage the protective when felled?	<input type="checkbox"/>	<input type="checkbox"/>	<input checked="" type="checkbox"/>	<input type="checkbox"/>	Two legacy trees (mentioned above) are not believed to be able to damage the cap. (Same as 2020)	Trees will be watched during subsequent inspections to verify that dead vegetation does not impact soil cap.

Majority of newly planted trees are dead or stressed along the southwest hill of Parcel BR.

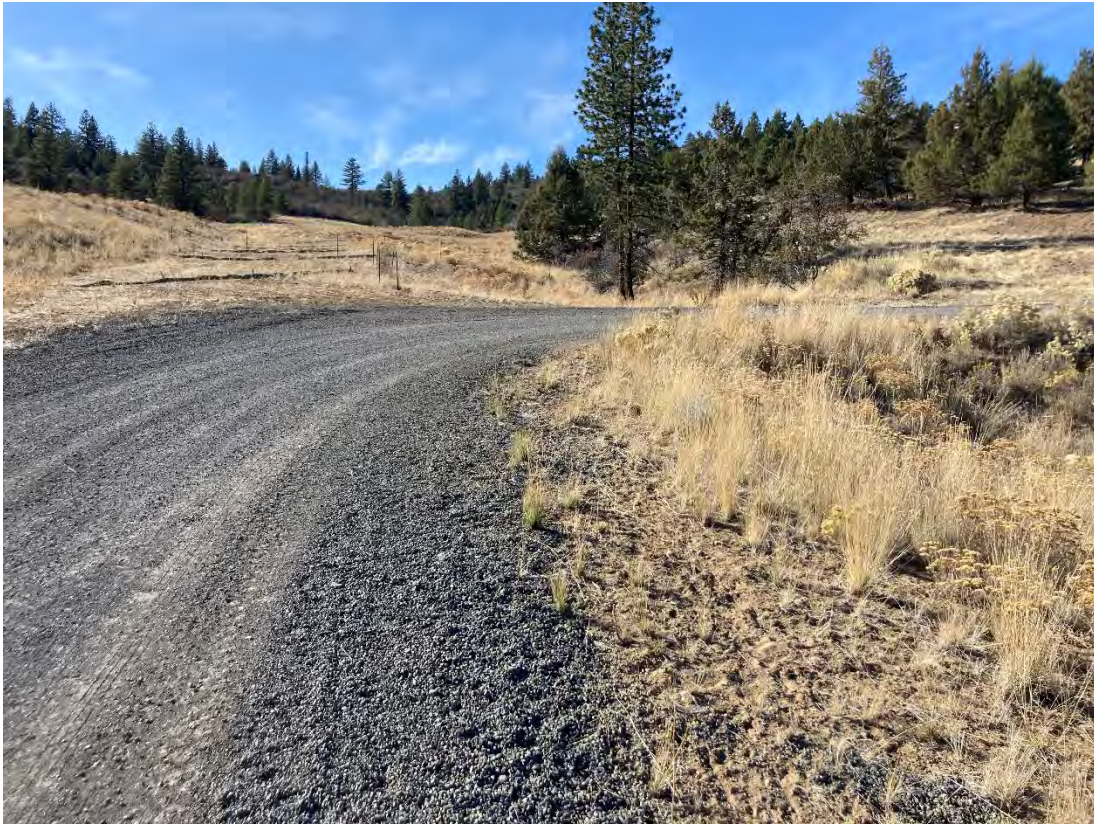
View of the southern edge of the BR removal area and cap, looking west.

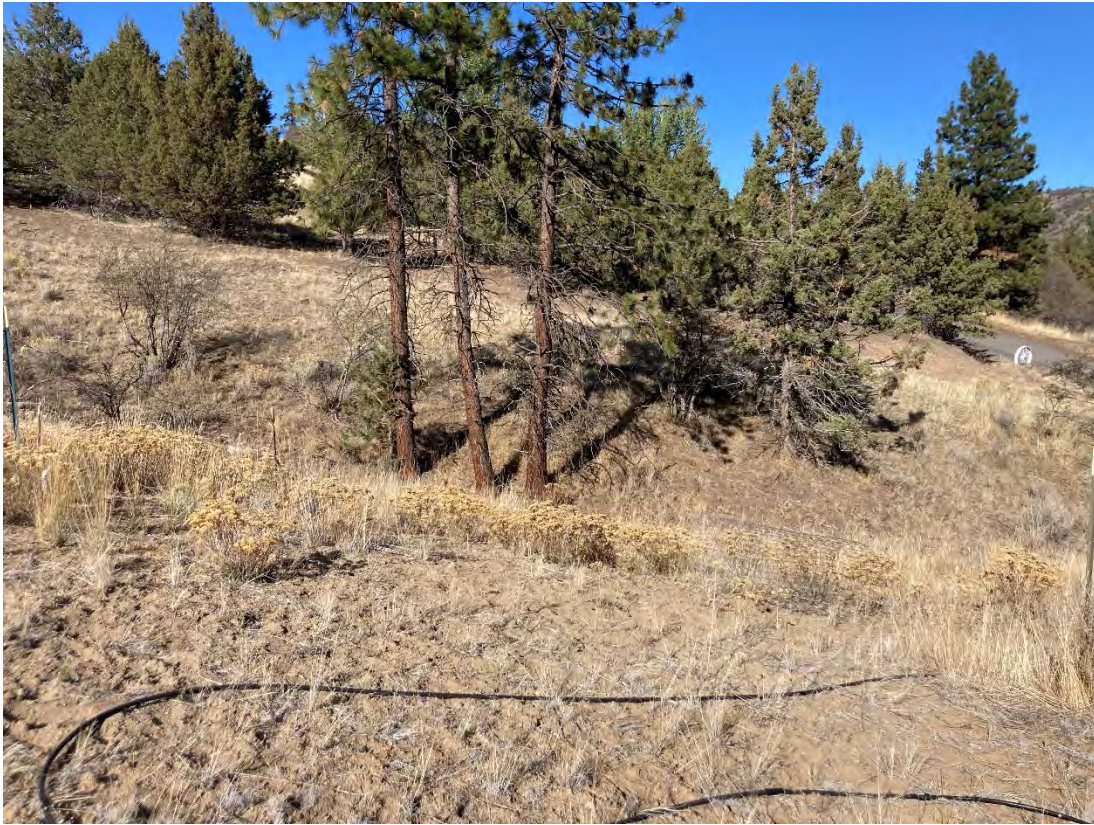
View of the west edge of the BR removal area/cap looking north from the southwest corner.

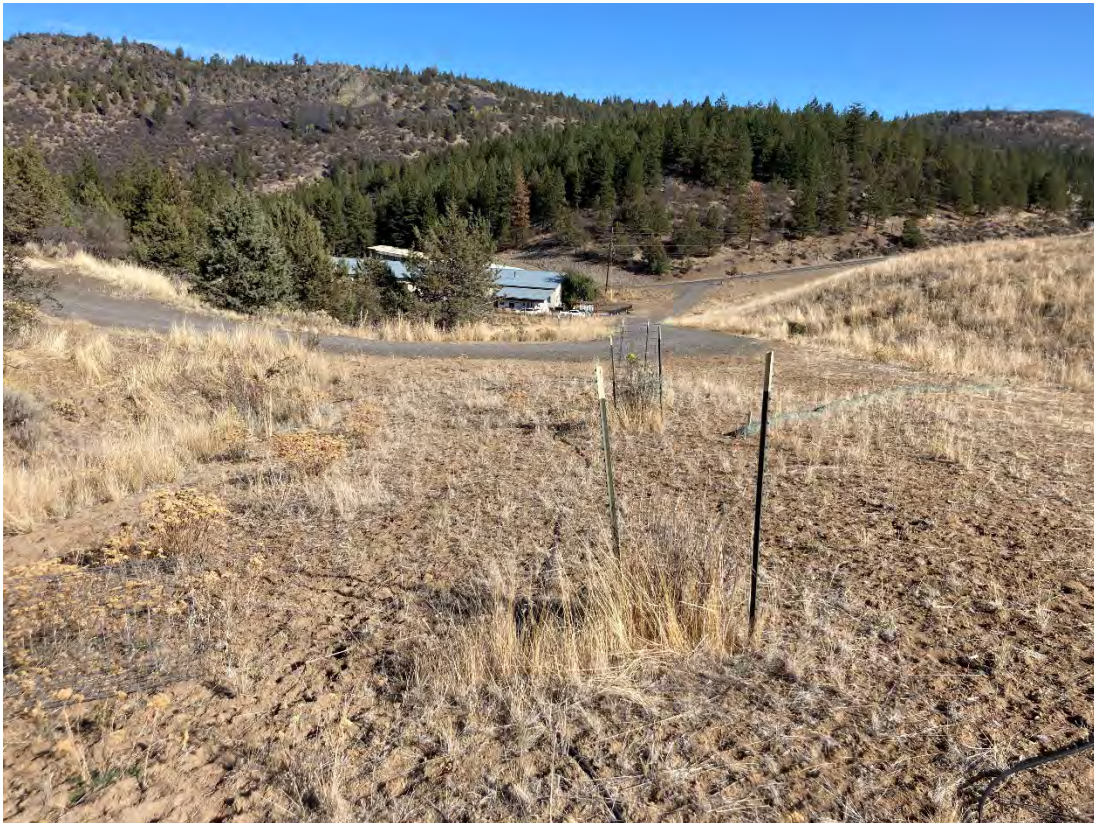
View of the southern end of Parcel BR removal area/cap from the southwest corner.
