RE: Annual Inspection for Parcel BR (part of)
North Ridge Estates Superfund Site
ECSI No. 6018

Parcel BR

Operations and Maintenance Inspection Form

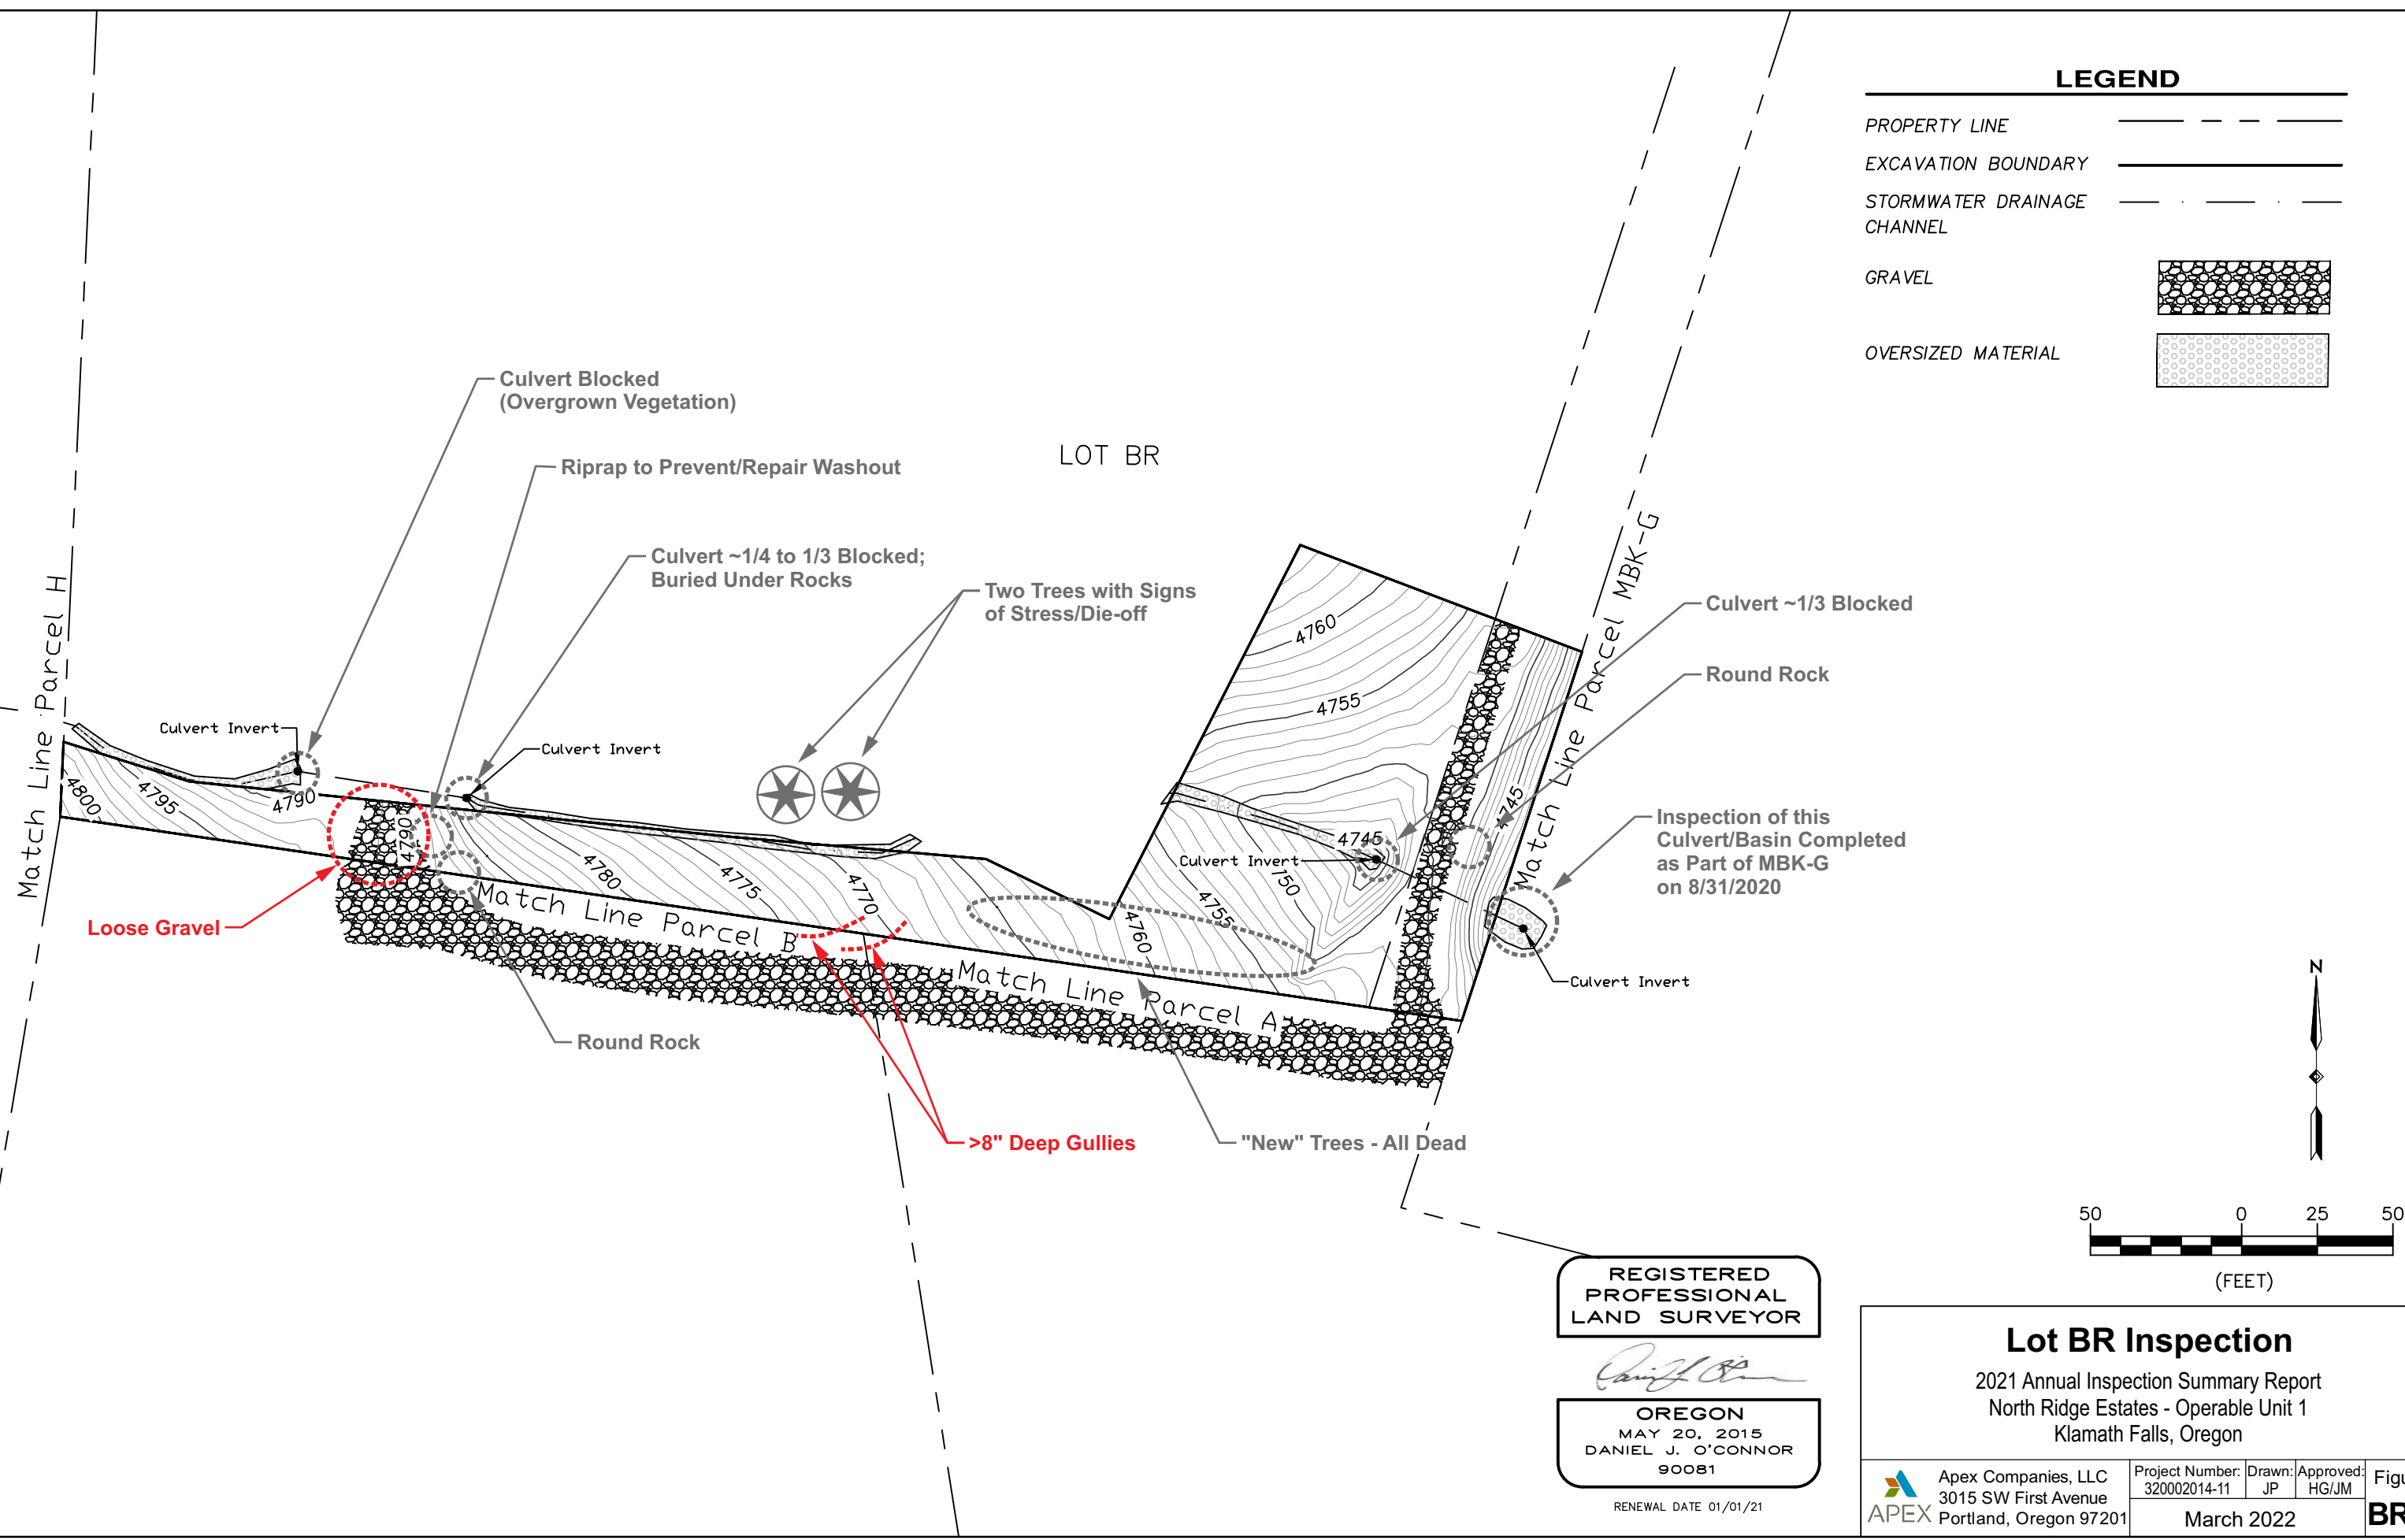
Several gullies were noted during the inspection (see map in inspection report). The two foot soil cover must be maintained to remain protective. The Easement and Equitable Servitude recorded with Klamath County requires you to maintain and keep the protective caps in good repair. Please smooth out and repair the areas identified in the enclosed inspection report within the next 30 days.

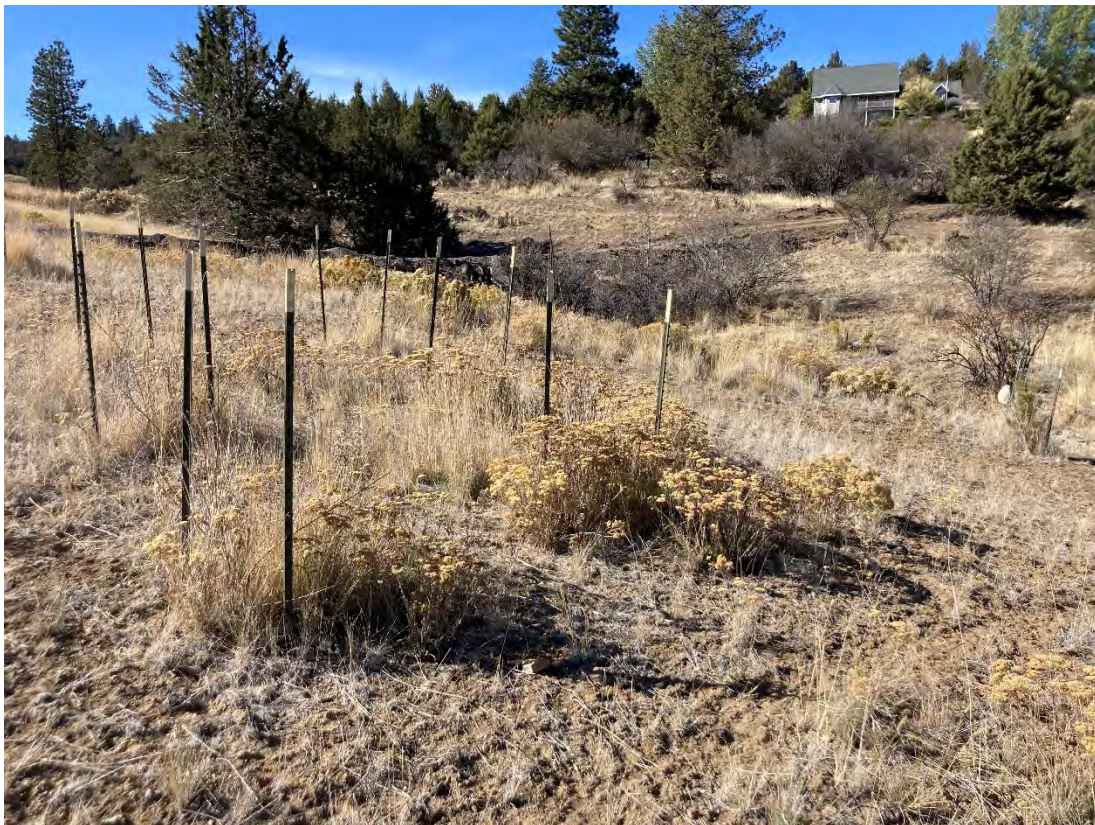
Vegetation	Evidence of distressed or sparse vegetation? (sparse vegetation no greater than 10 percent of area and bare areas no greater than 100 square feet)	<input type="checkbox"/>	<input type="checkbox"/>	<input checked="" type="checkbox"/>	<input type="checkbox"/>		
	Evidence of trees and shrubs in distress?	<input type="checkbox"/>	<input checked="" type="checkbox"/>	<input type="checkbox"/>	<input type="checkbox"/>	Yes. Many of the newly planted trees are showing signs of stress and two legacy trees just to the north of the removal area are showing signs of die off. (Same as 2020)	Vegetation will be watched during subsequent inspections to verify that dead vegetation does not impact soil cap.
	Are there any stressed or dying trees that may impact or damage the protective when felled?	<input type="checkbox"/>	<input type="checkbox"/>	<input checked="" type="checkbox"/>	<input type="checkbox"/>	Two legacy trees (mentioned above) are not believed to be able to damage the cap. (Same as 2020)	Trees will be watched during subsequent inspections to verify that dead vegetation does not impact soil cap.

Majority of newly planted trees are dead or stressed along the southwest hill of Parcel BR.

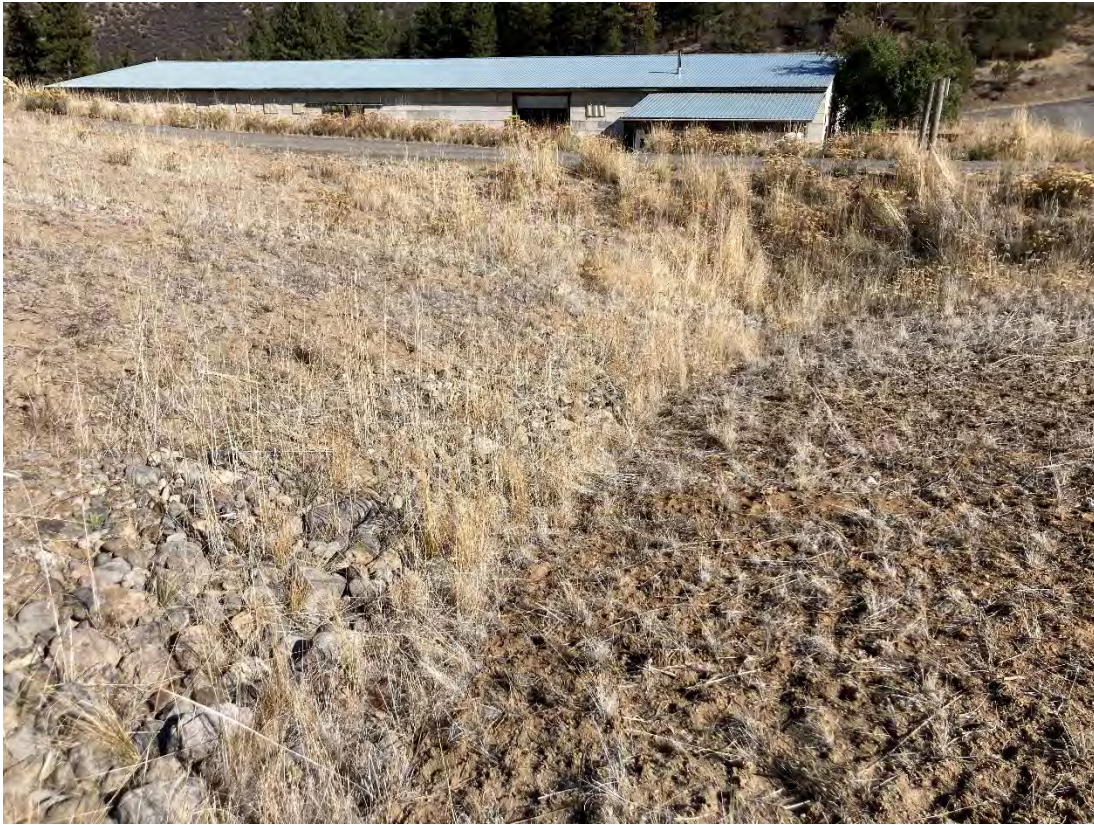
Round rocks were placed to create a drainage to prevent/repair erosion in the southwest portion of the property.

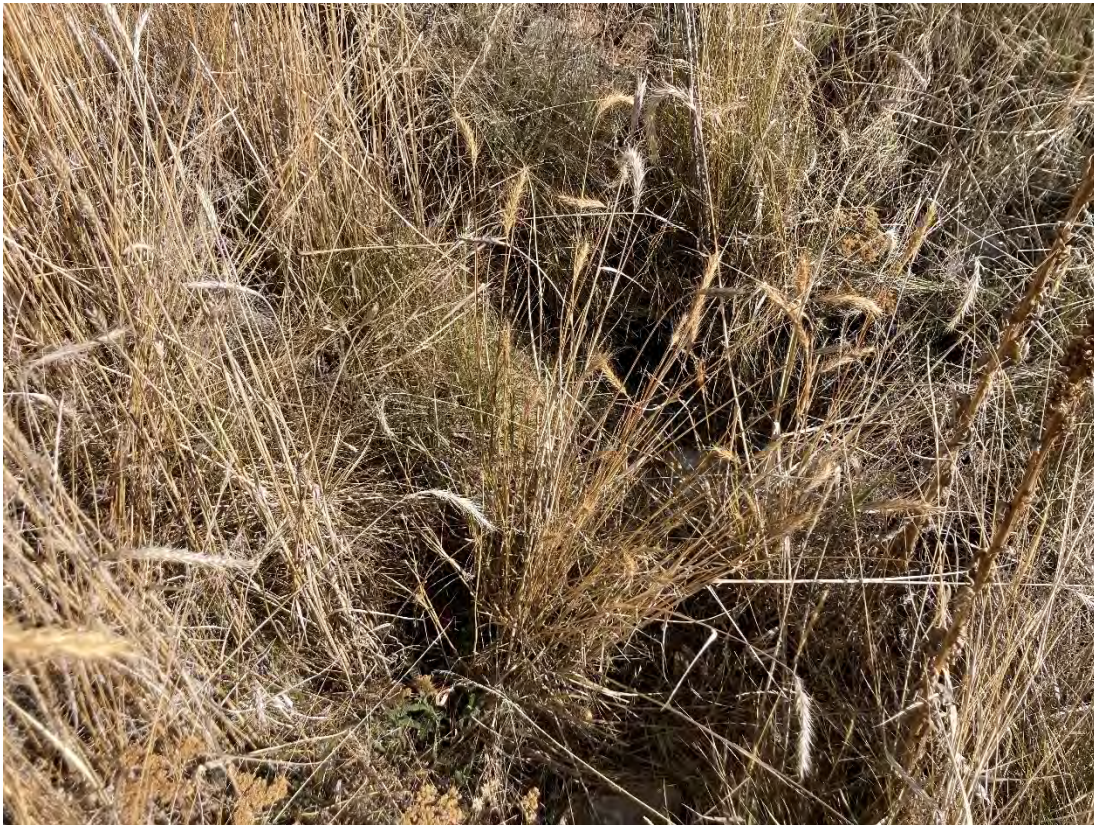
Ditches and Culverts	Obstructions observed in ditches or culverts that may impede conveyance of stormwater?	<input checked="" type="checkbox"/>	<input type="checkbox"/>	<input type="checkbox"/>	<input type="checkbox"/>	All onsite culverts have some level of blockage (~1/4 to 1/3), but may not significantly impact drainage. (Same as 2020)	Culverts could be cleared.
	Damaged observed to riprap surface? Note if riprap is not intact or not effectively providing armor protection.	<input type="checkbox"/>	<input type="checkbox"/>	<input checked="" type="checkbox"/>	<input type="checkbox"/>		
	Are there any areas that show signs of excessive scour? (i.e., gullies forming along centerline of ditch)	<input type="checkbox"/>	<input type="checkbox"/>	<input checked="" type="checkbox"/>	<input type="checkbox"/>		
	Are culvert inlets and outlets damaged?	<input type="checkbox"/>	<input type="checkbox"/>	<input checked="" type="checkbox"/>	<input type="checkbox"/>

Culverts under the driveway were severely obstructed by overgrown vegetation and soil.

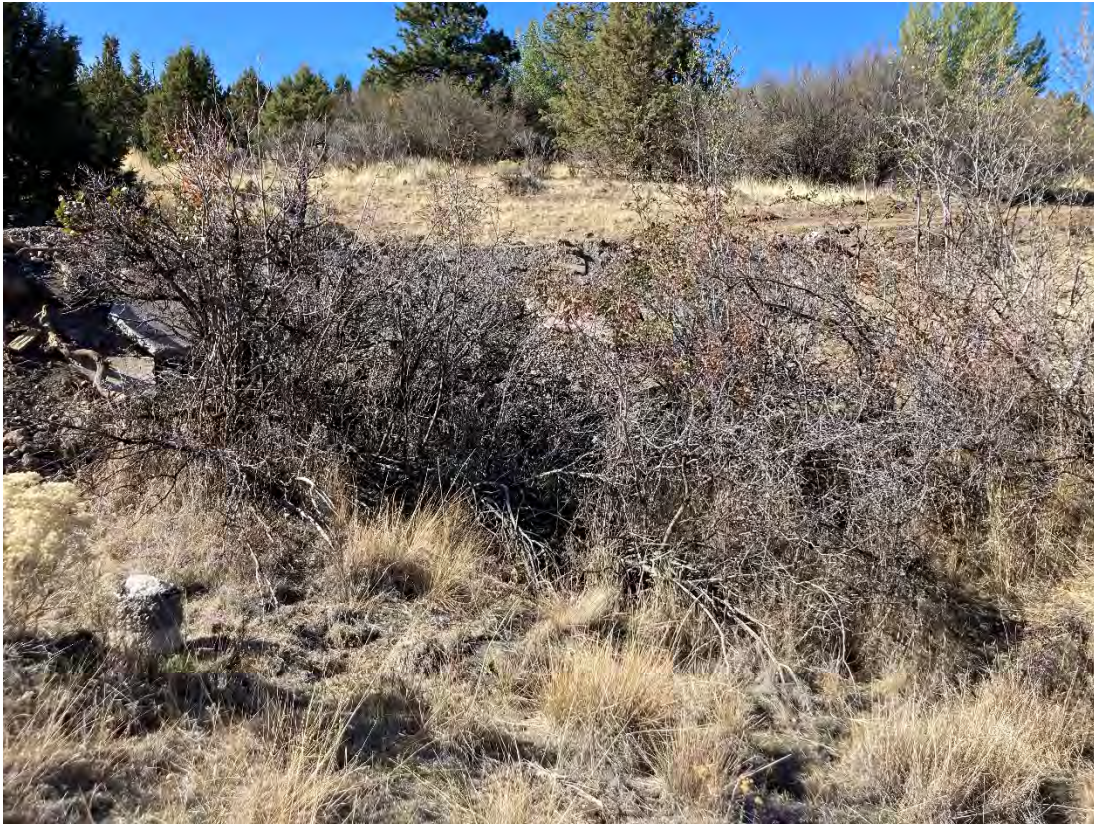
One of the culverts could not be identified under overgrown vegetation, rocks, and dead shrubs.

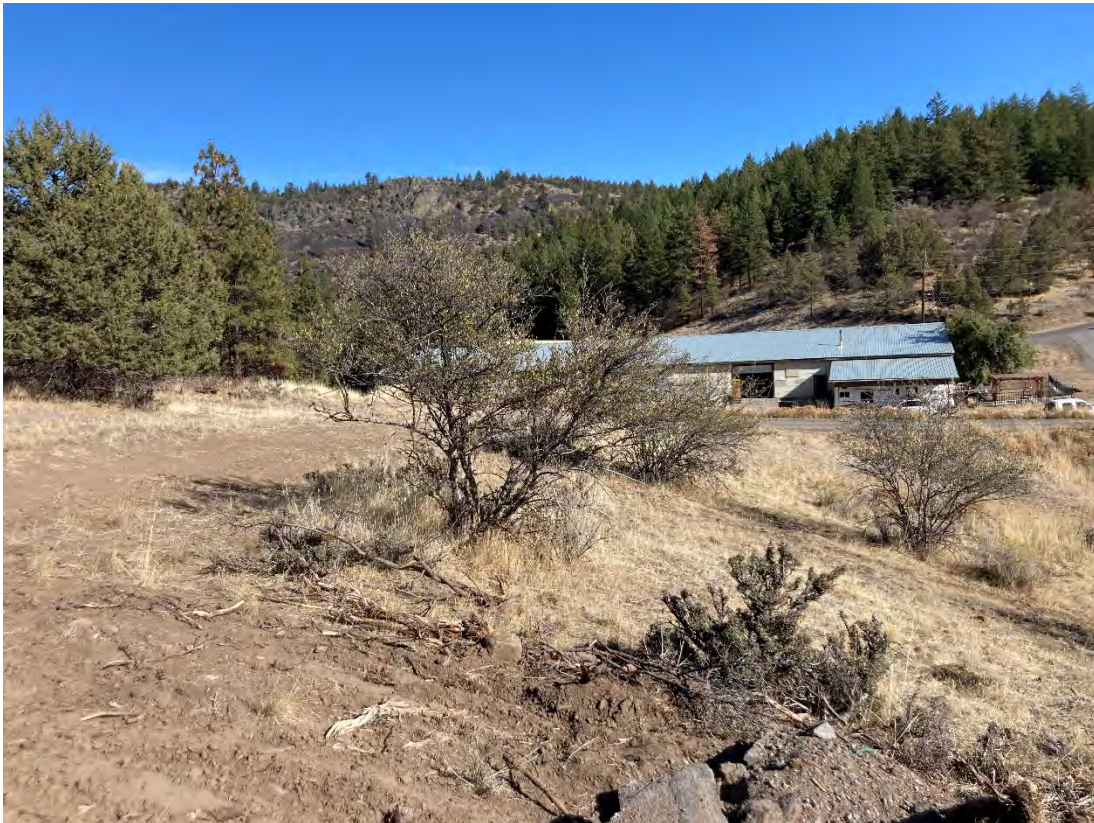
Two legacy trees just north of the cap were stressed/dying. If felled, it is unlikely to damage the cap.

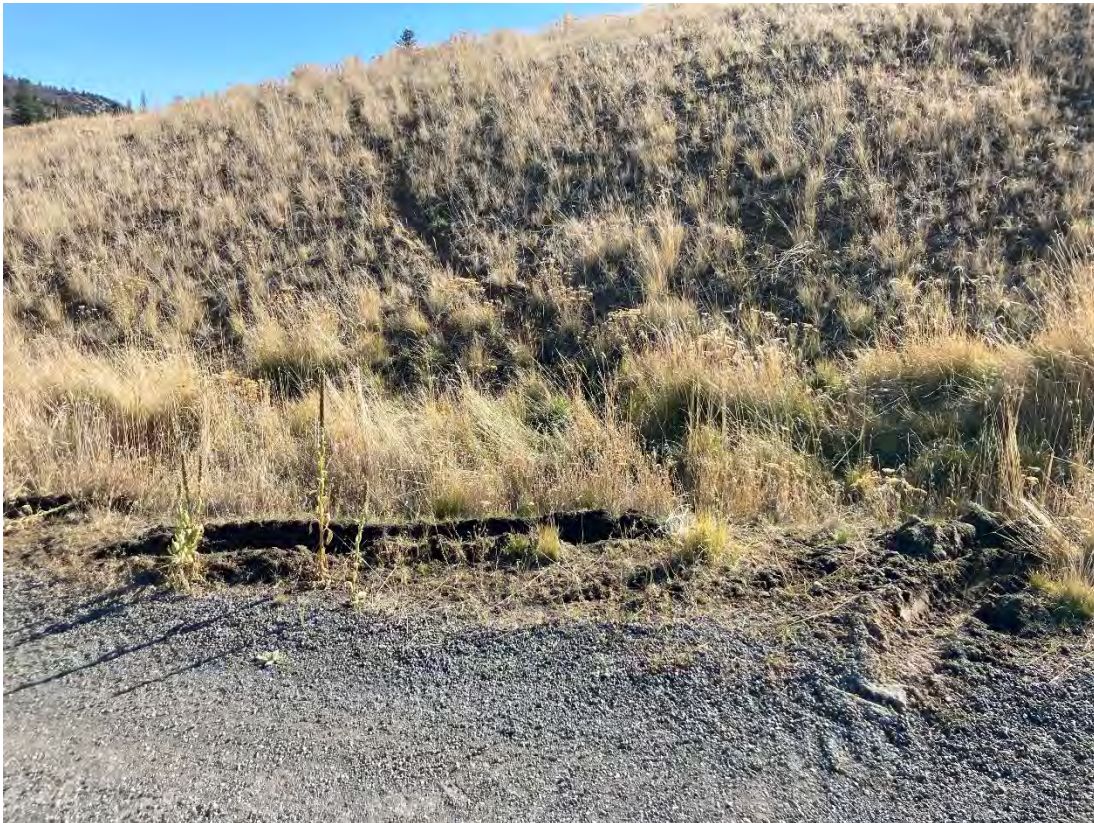
Deep tire tracks were noted along the ditch near the southwest edge of the property.

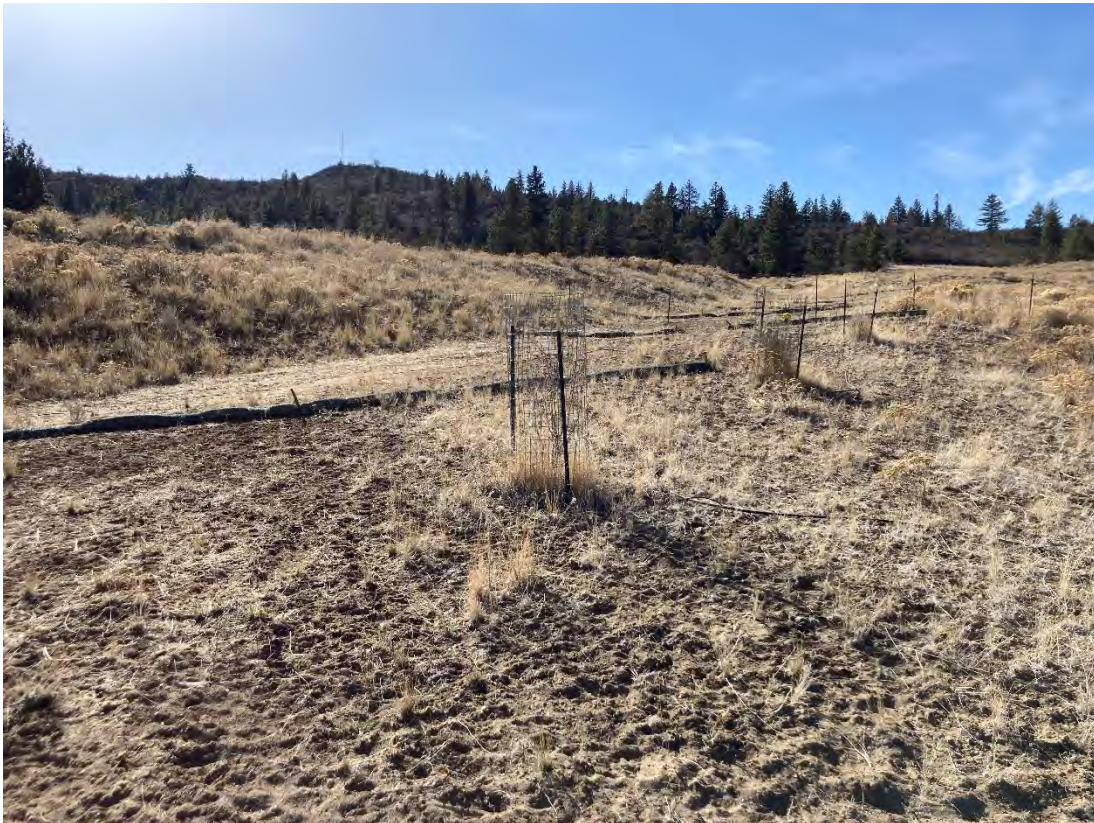
View of the northwest corner of Parcel BR, showing straw wattles still present and dead newly planted trees.
