RE: Annual Inspection for Parcel BR (part of)  
North Ridge Estates Superfund Site  
ECSI No. 6018

Operations and Maintenance Inspection Form

Parcel BR

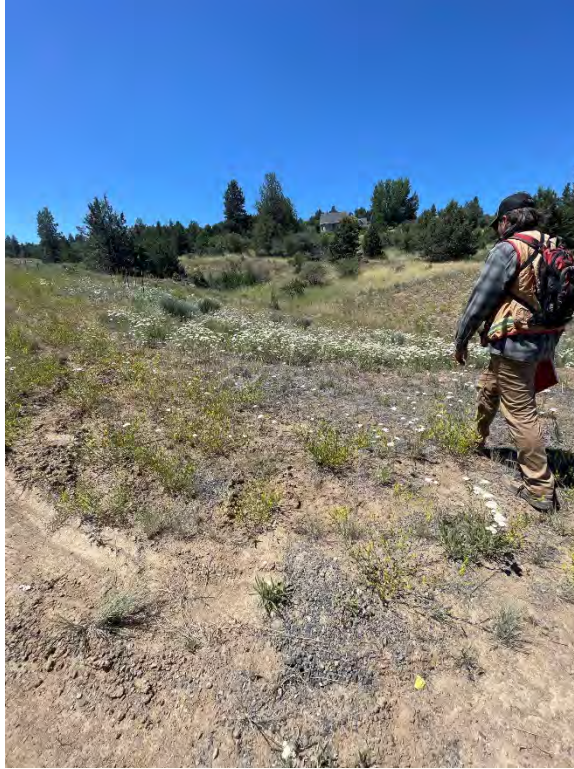
Parcel BR – Southeast corner of Parcel, facing Northwest.

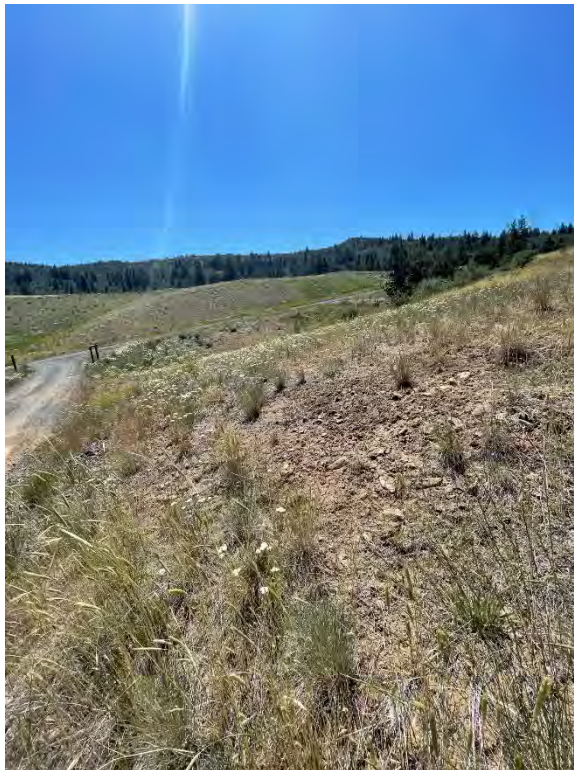
Parcel BR – Northeast corner of Parcel, facing Southeast.

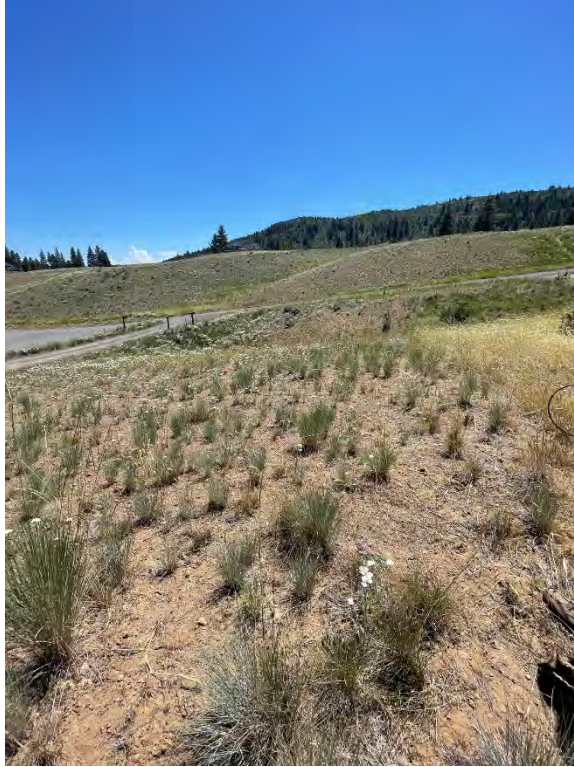
Parcel BR – North central corner of Parcel, facing Southeast.

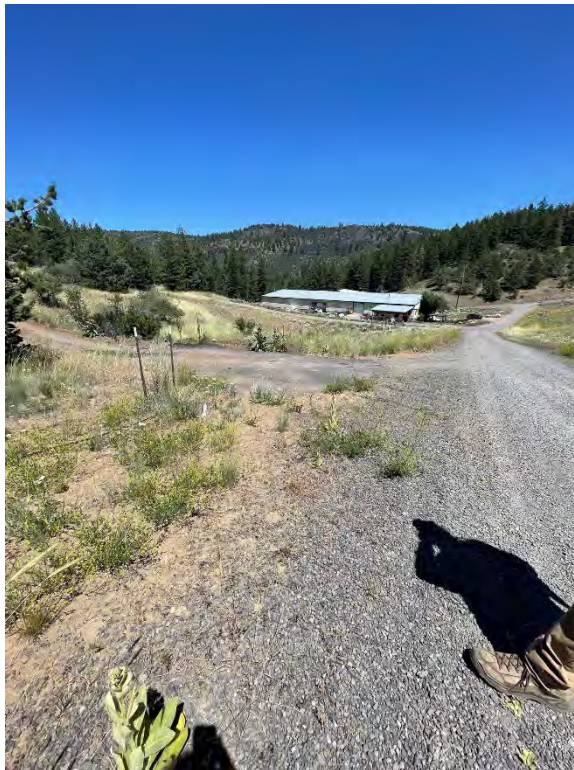
Parcel BR – Southwest corner of the Parcel, facing Northeast.

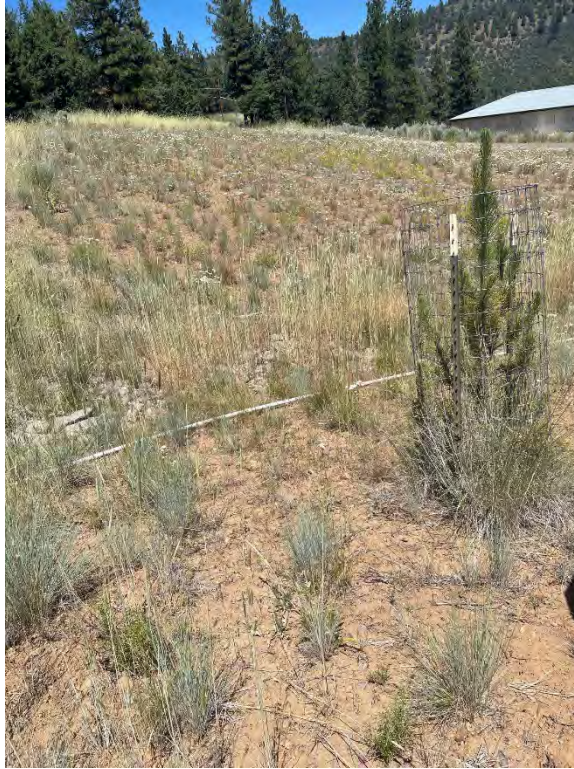
Parcel BR – Central corner of Parcel, facing Northeast.

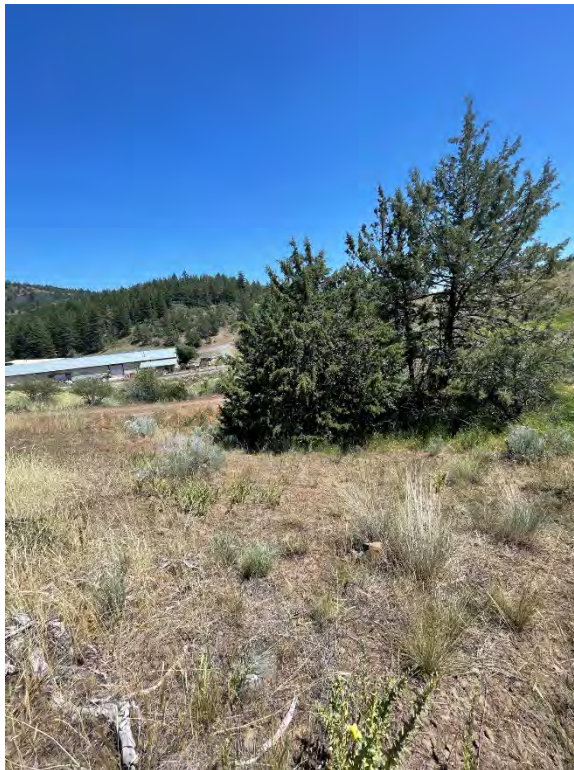
Parcel BR – Northwest Corner of Parcel, facing Southeast.
