RE: Annual Inspection for Parcel BR (part of)
North Ridge Estates Superfund Site
ECSI No. 6018

Parcel BR

Part I. General Site Information							
Site Name:		North Ridge Estates		State/Country:		Oregon (Klamath County)	
EPA Point of Contact		Linda Meyer (206) 553-6636		ODEQ Point of Contact		Katie Daugherty (503) 860-3943	
Inspection Date:		7/3/2023		Person(s) Performing Inspection:		Alex Evernden (Apex Companies, LLC)	
				Person(s) Performing Inspection:			
Part II. Remedy Performance Assessment							
Remedy Component	Potential Problem	Yes (Repair Needed)	Yes (Monitor/ No Repair)	No	N/A	If Yes, Describe Extent of Problem	Describe Potential Repair Solution
Protective Cap	Have rills developed deeper than 2 inches?	<input type="checkbox"/>	<input type="checkbox"/>	<input checked="" type="checkbox"/>	<input type="checkbox"/>		
	Are the rills within a 10-foot interval?	<input type="checkbox"/>	<input type="checkbox"/>	<input checked="" type="checkbox"/>	<input type="checkbox"/>		
	Have gullies developed deeper than 6 inches?	<input type="checkbox"/>	<input type="checkbox"/>	<input checked="" type="checkbox"/>	<input type="checkbox"/>

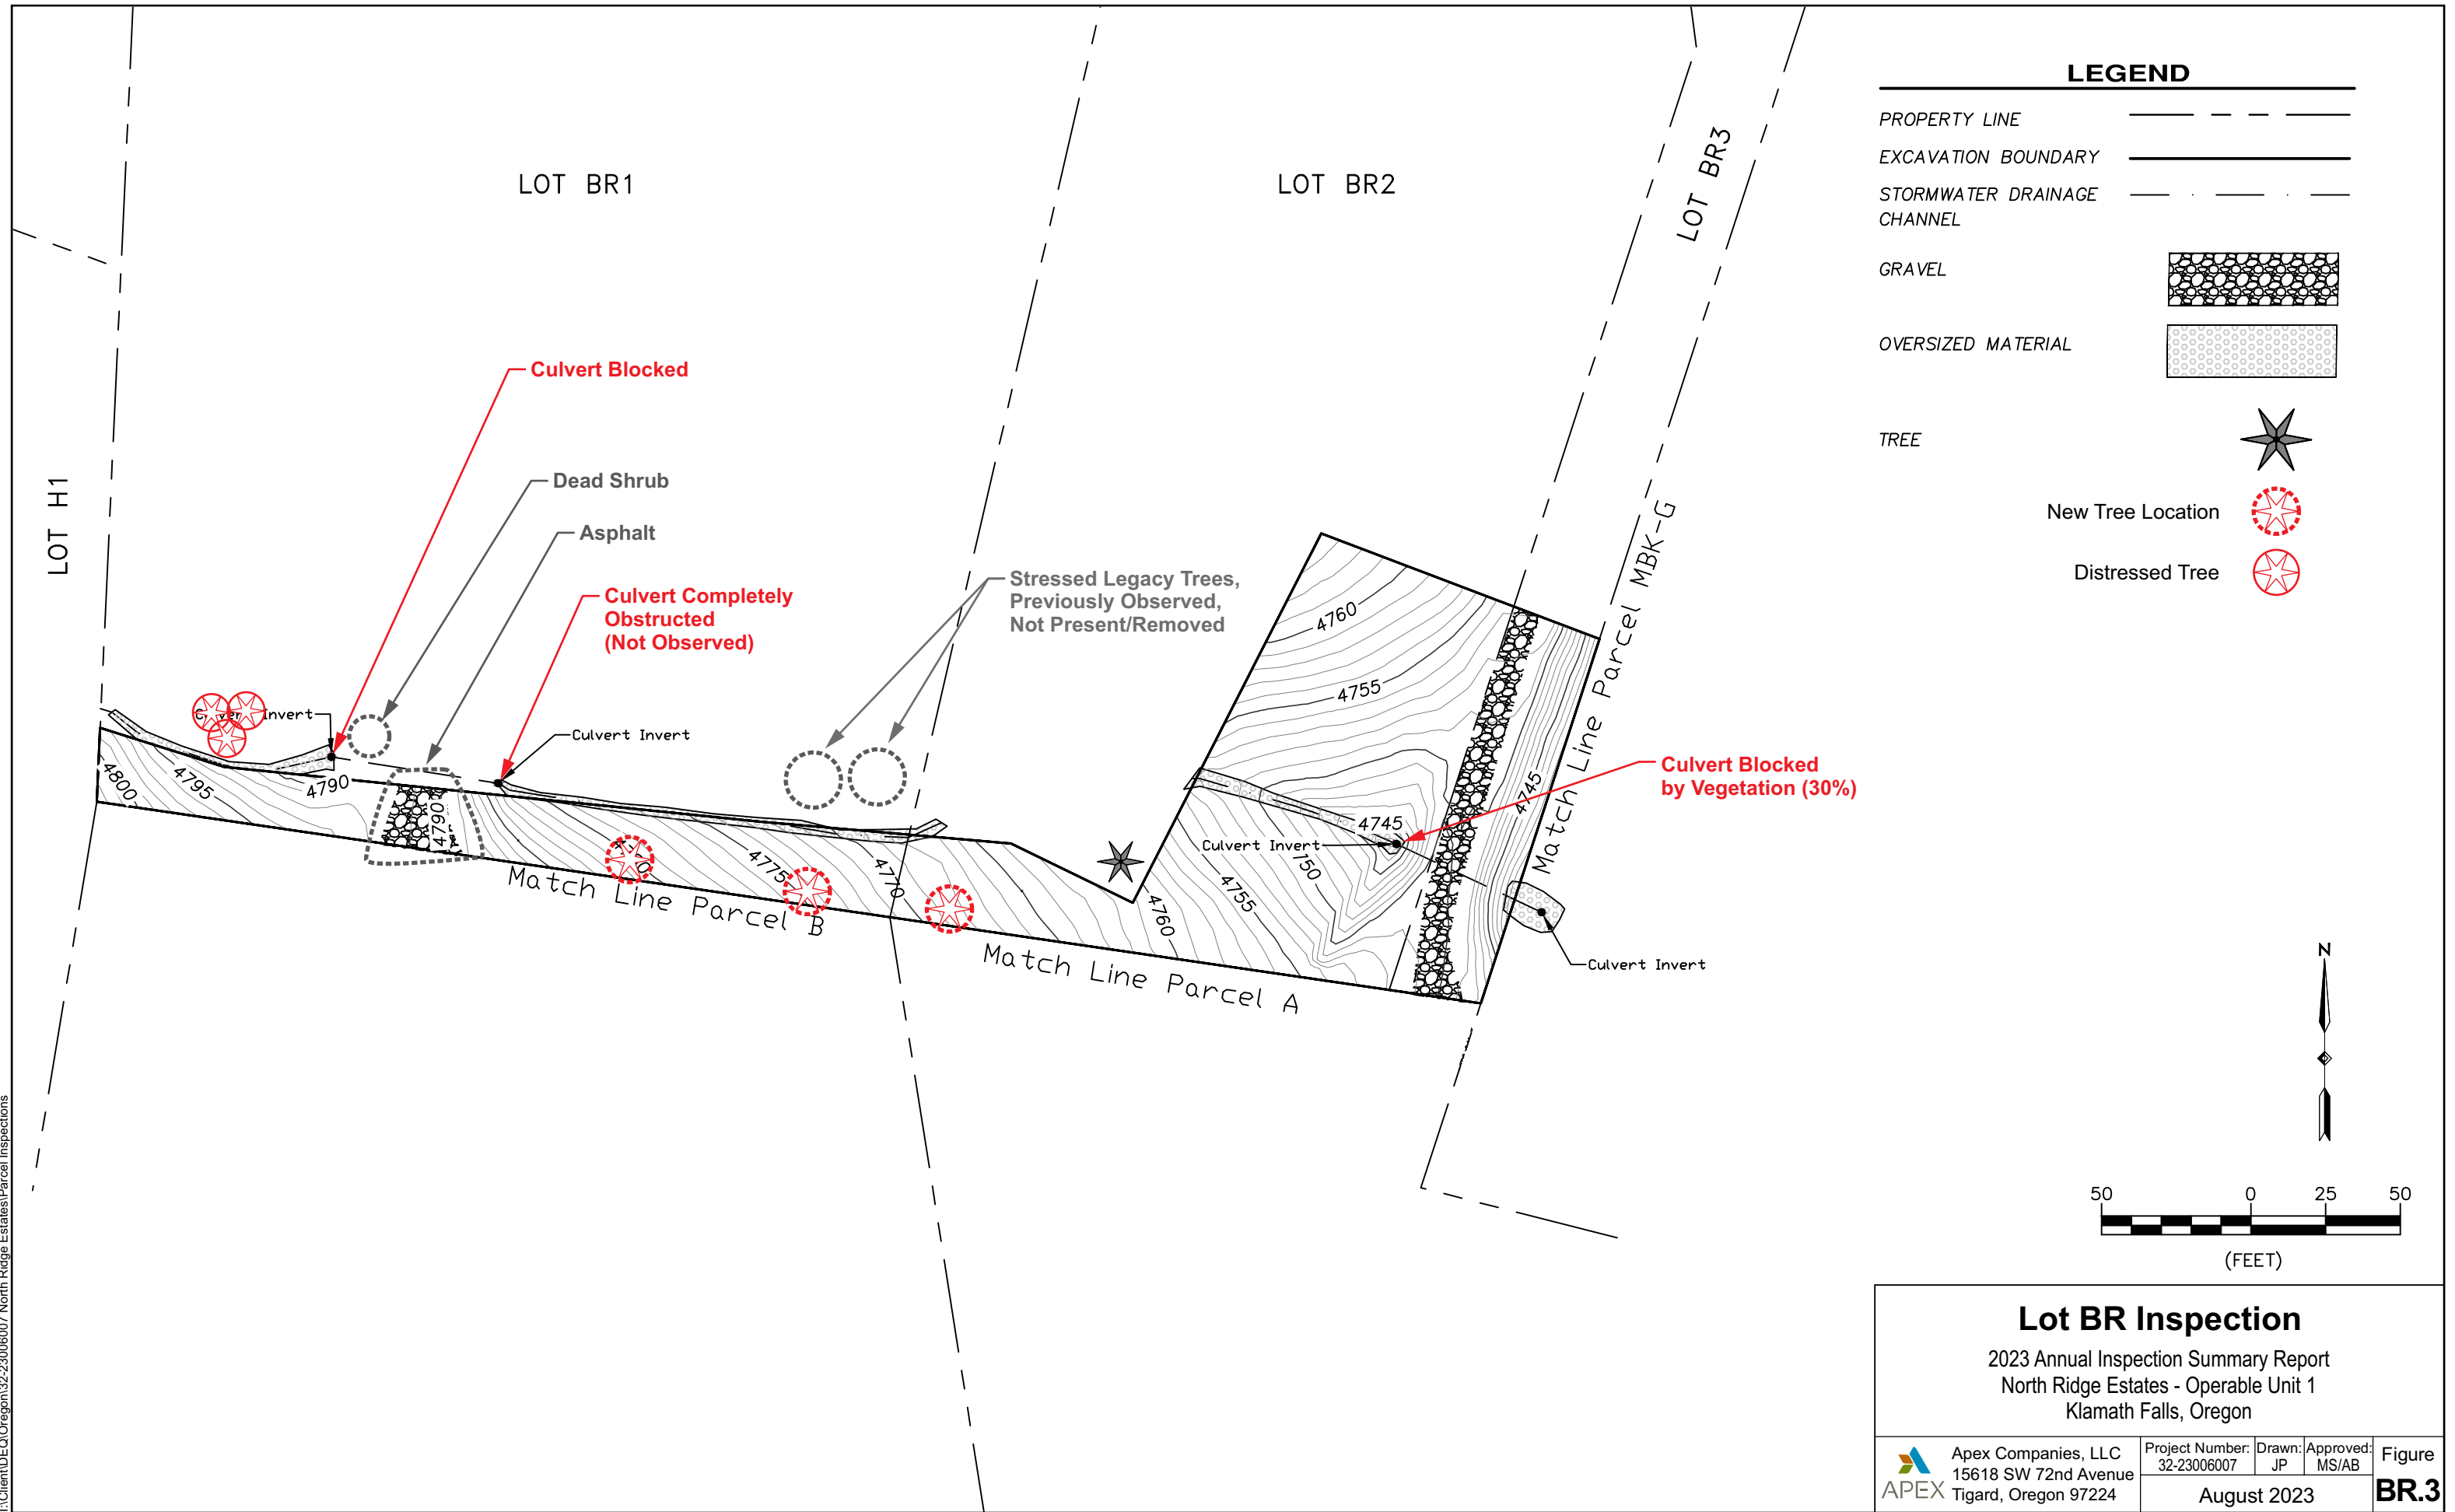
Parcel BR

1. **Blocked culvert.** The end of a culvert on your property is partially blocked by vegetation (see enclosed figure). This condition was also previously identified during the 2022 annual inspection.

Ditches and Culverts	Obstructions observed in ditches or culverts that may impede conveyance of stormwater?	<input checked="" type="checkbox"/>	<input type="checkbox"/>	<input type="checkbox"/>	<input type="checkbox"/>	All culverts on the parcel were noted as being partially or completely obstructed. (Same as 2022)	Remove obstructions from culverts.
	Damaged observed to riprap surface? Note if riprap is not intact or not effectively providing armor protection.	<input type="checkbox"/>	<input type="checkbox"/>	<input checked="" type="checkbox"/>	<input type="checkbox"/>		
	Are there any areas that show signs of excessive scour? (i.e., gullies forming along centerline of ditch)	<input type="checkbox"/>	<input type="checkbox"/>	<input checked="" type="checkbox"/>	<input type="checkbox"/>		
	Are culvert inlets and outlets damaged?	<input type="checkbox"/>	<input type="checkbox"/>	<input checked="" type="checkbox"/>	<input type="checkbox"/>

Corrective Action. Remove the material obstructing the culvert to allow the unrestricted flow of stormwater by November 12, 2023.

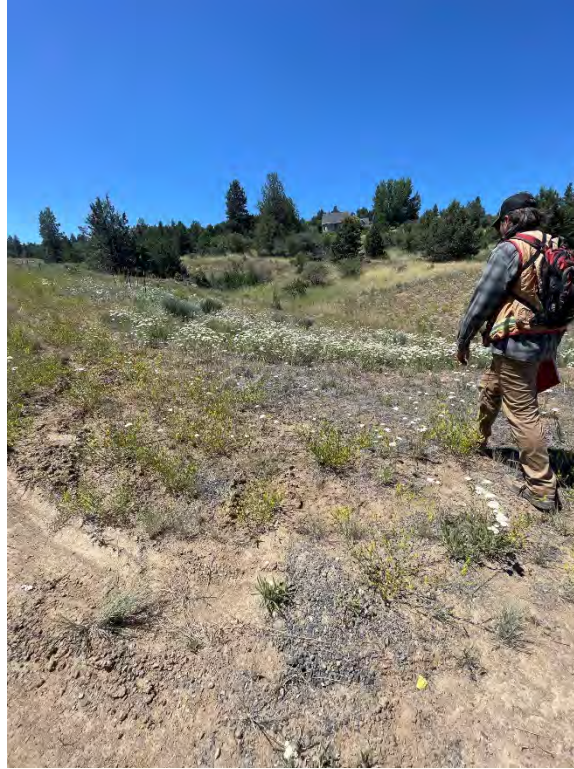
Parcel BR – Southeast corner of Parcel, facing Northwest.

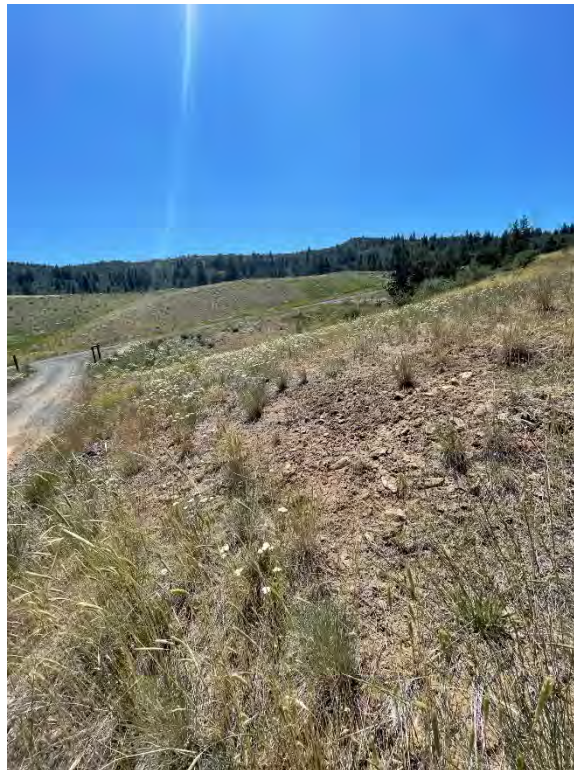
Parcel BR – Northeast corner of Parcel, facing Southeast.

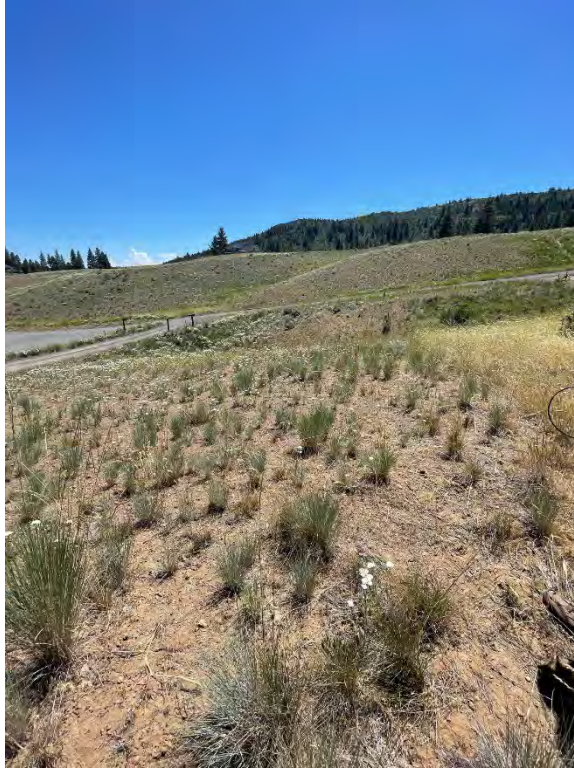
Parcel BR – North central corner of Parcel, facing Southeast.
