RE: Annual Inspection for Parcel BR (part of)
North Ridge Estates Superfund Site
ECSI No. 6018

Parcel BR

Operations and Maintenance Inspection Form

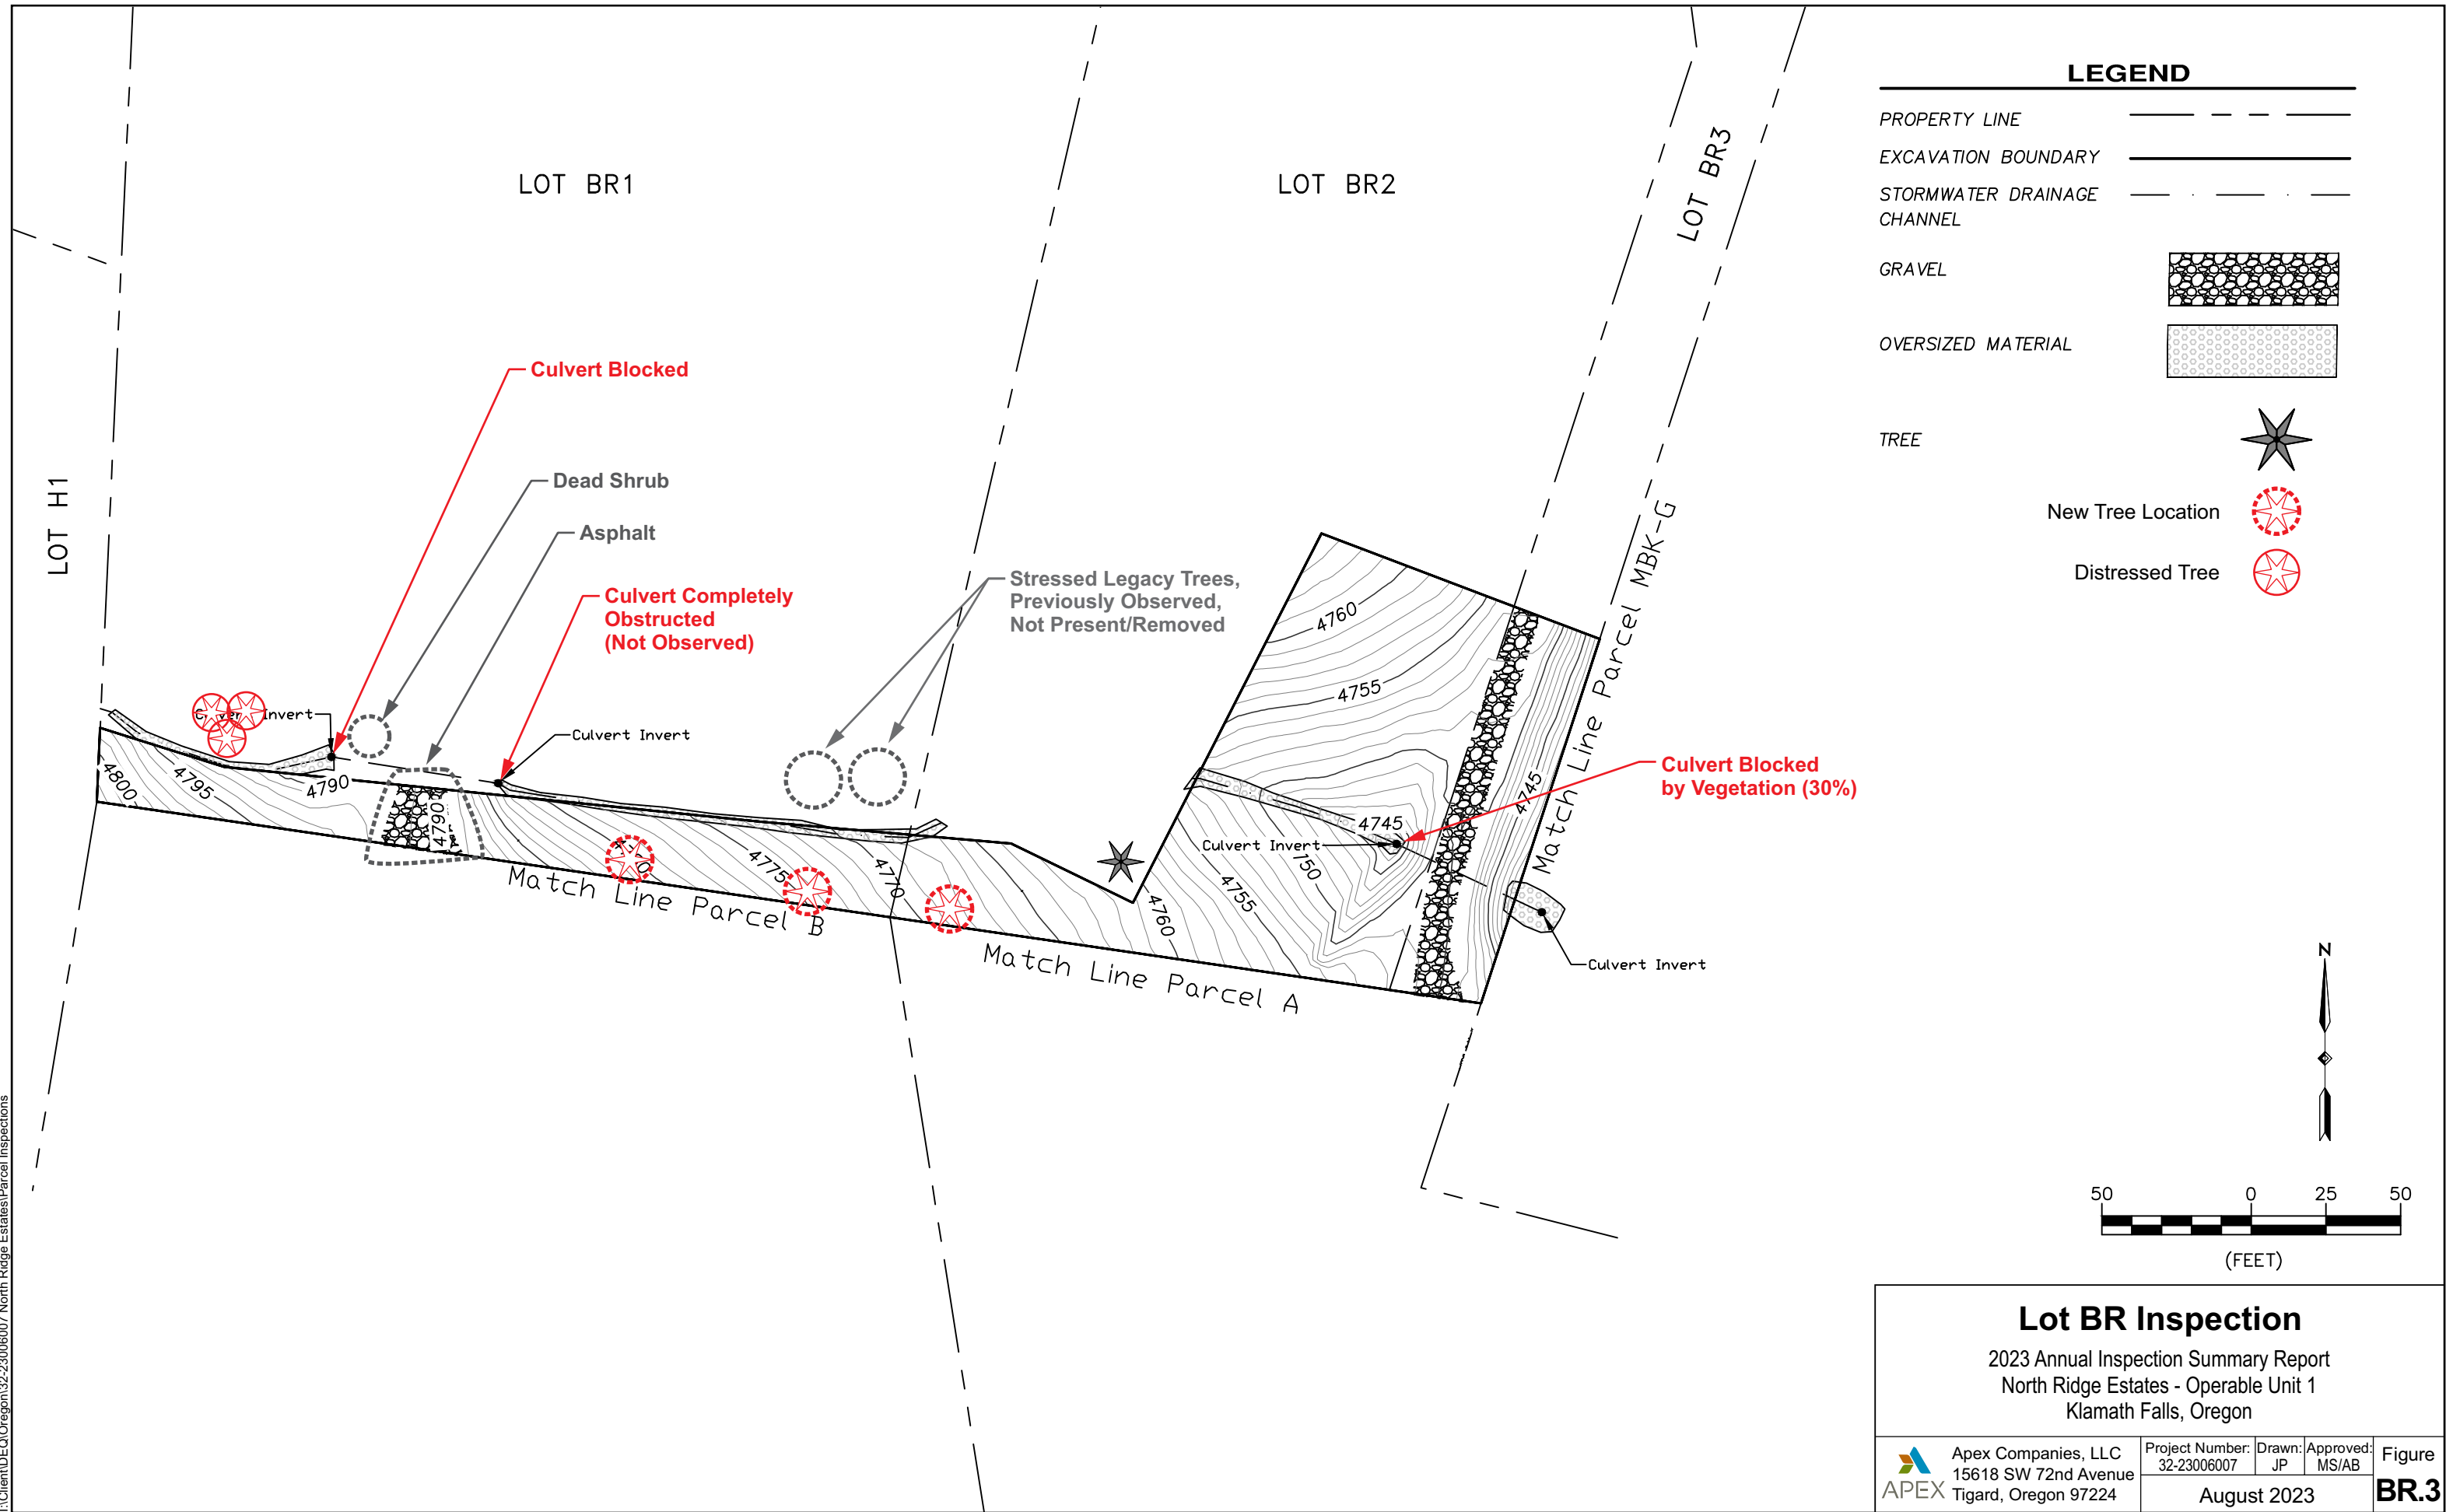
1. **Blocked culvert.** The culvert located beneath your driveway was blocked on both ends (see enclosed figure). This condition was also previously identified during the 2022 annual inspection.

Ditches and Culverts	Obstructions observed in ditches or culverts that may impede conveyance of stormwater?	<input checked="" type="checkbox"/>	<input type="checkbox"/>	<input type="checkbox"/>	<input type="checkbox"/>	All culverts on the parcel were noted as being partially or completely obstructed. (Same as 2022)	Remove obstructions from culverts.
	Damaged observed to riprap surface? Note if riprap is not intact or not effectively providing armor protection.	<input type="checkbox"/>	<input type="checkbox"/>	<input checked="" type="checkbox"/>	<input type="checkbox"/>		
	Are there any areas that show signs of excessive scour? (i.e., gullies forming along centerline of ditch)	<input type="checkbox"/>	<input type="checkbox"/>	<input checked="" type="checkbox"/>	<input type="checkbox"/>		
	Are culvert inlets and outlets damaged?	<input type="checkbox"/>	<input type="checkbox"/>	<input checked="" type="checkbox"/>	<input type="checkbox"/>

Corrective Action. Remove the material obstructing the culvert to allow the unrestricted flow of stormwater by November 12, 2023.

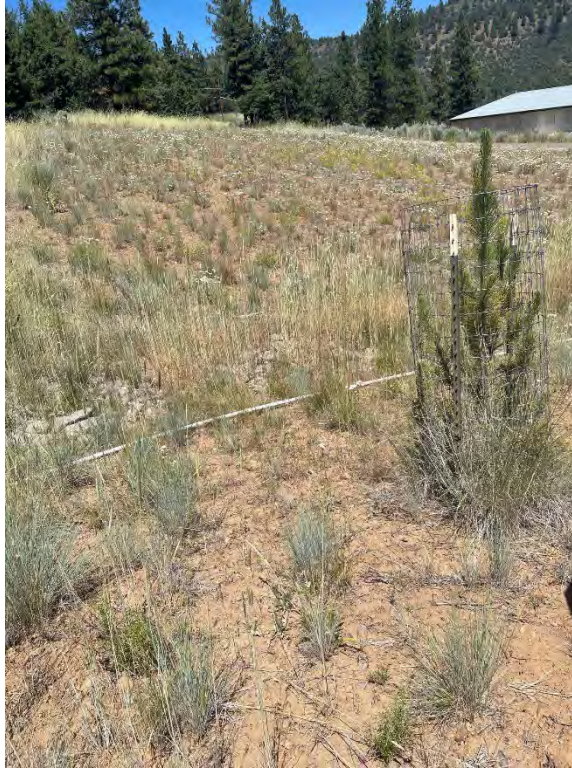
Parcel BR – Central corner of Parcel, facing Northeast.

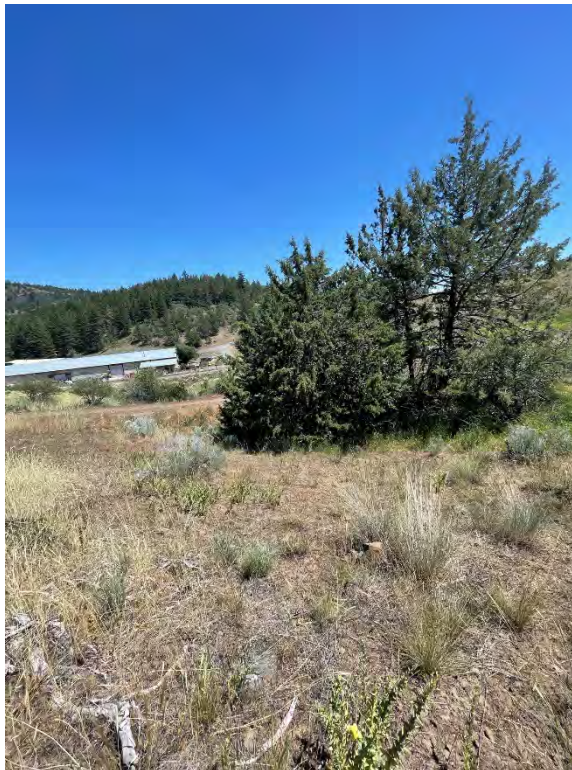
Parcel BR – Northwest Corner of Parcel, facing Southeast.
