RE: Annual Inspection for Parcel BR (part of)  
North Ridge Estates Superfund Site  
ECSI No. 6018

# North Ridge Estates Remedy Performance Assessment

**BR**

**May 30, 2024, 3:59:00 PM**

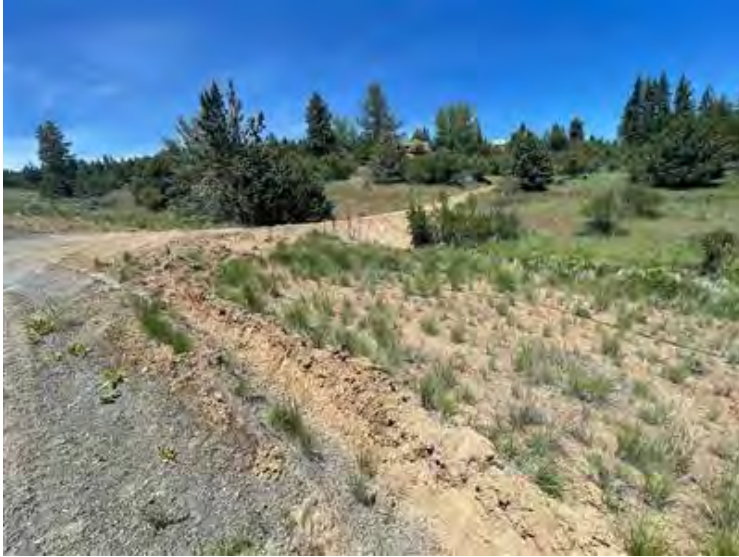
Have vehicles damaged the protective cap?

**Yes (Repair Needed)**

**Tire ruts (~6 to 8 in deep) near lot BR2 dirt/gravel road**

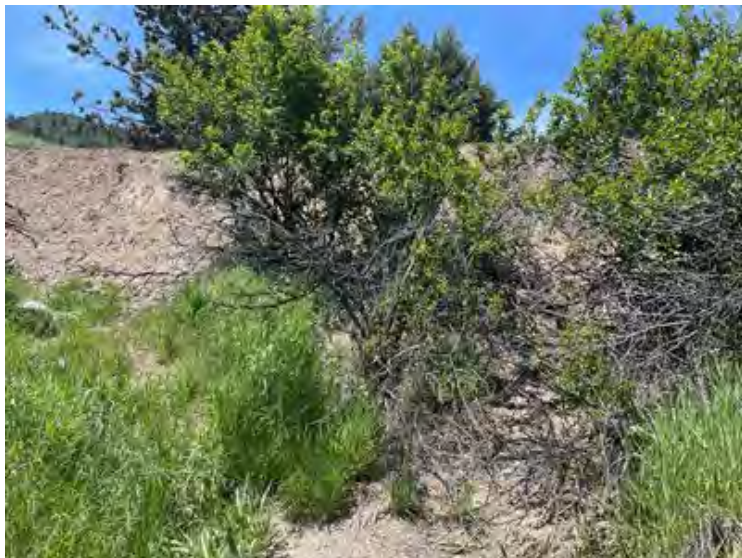
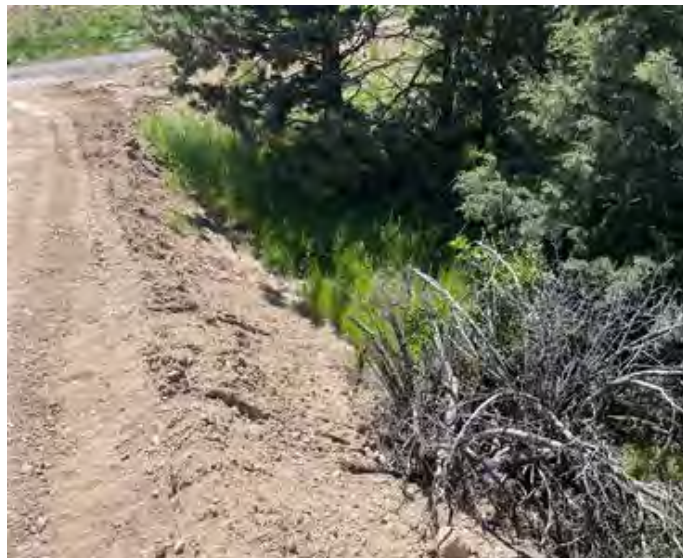
Obstructions observed in ditches or culverts that may impede conveyance of stormwater?

**Yes (Repair Needed)**

**Driveway construction impeded drainage (no culvert visible)**

**Dirt/gravel driveway at BR1/BR2 boundary does not appear to have a culvert pass through.**
