RE: Annual Inspection for Parcel BM (Apartments)  
North Ridge Estates Superfund Site  
ECSI No. 6019

Operations and Maintenance Inspection Form

2023 Annual Inspection Summary Report  
North Ridge Estates - Operable Unit 1  
Klamath Falls, Oregon

Figure  
**BM.3**

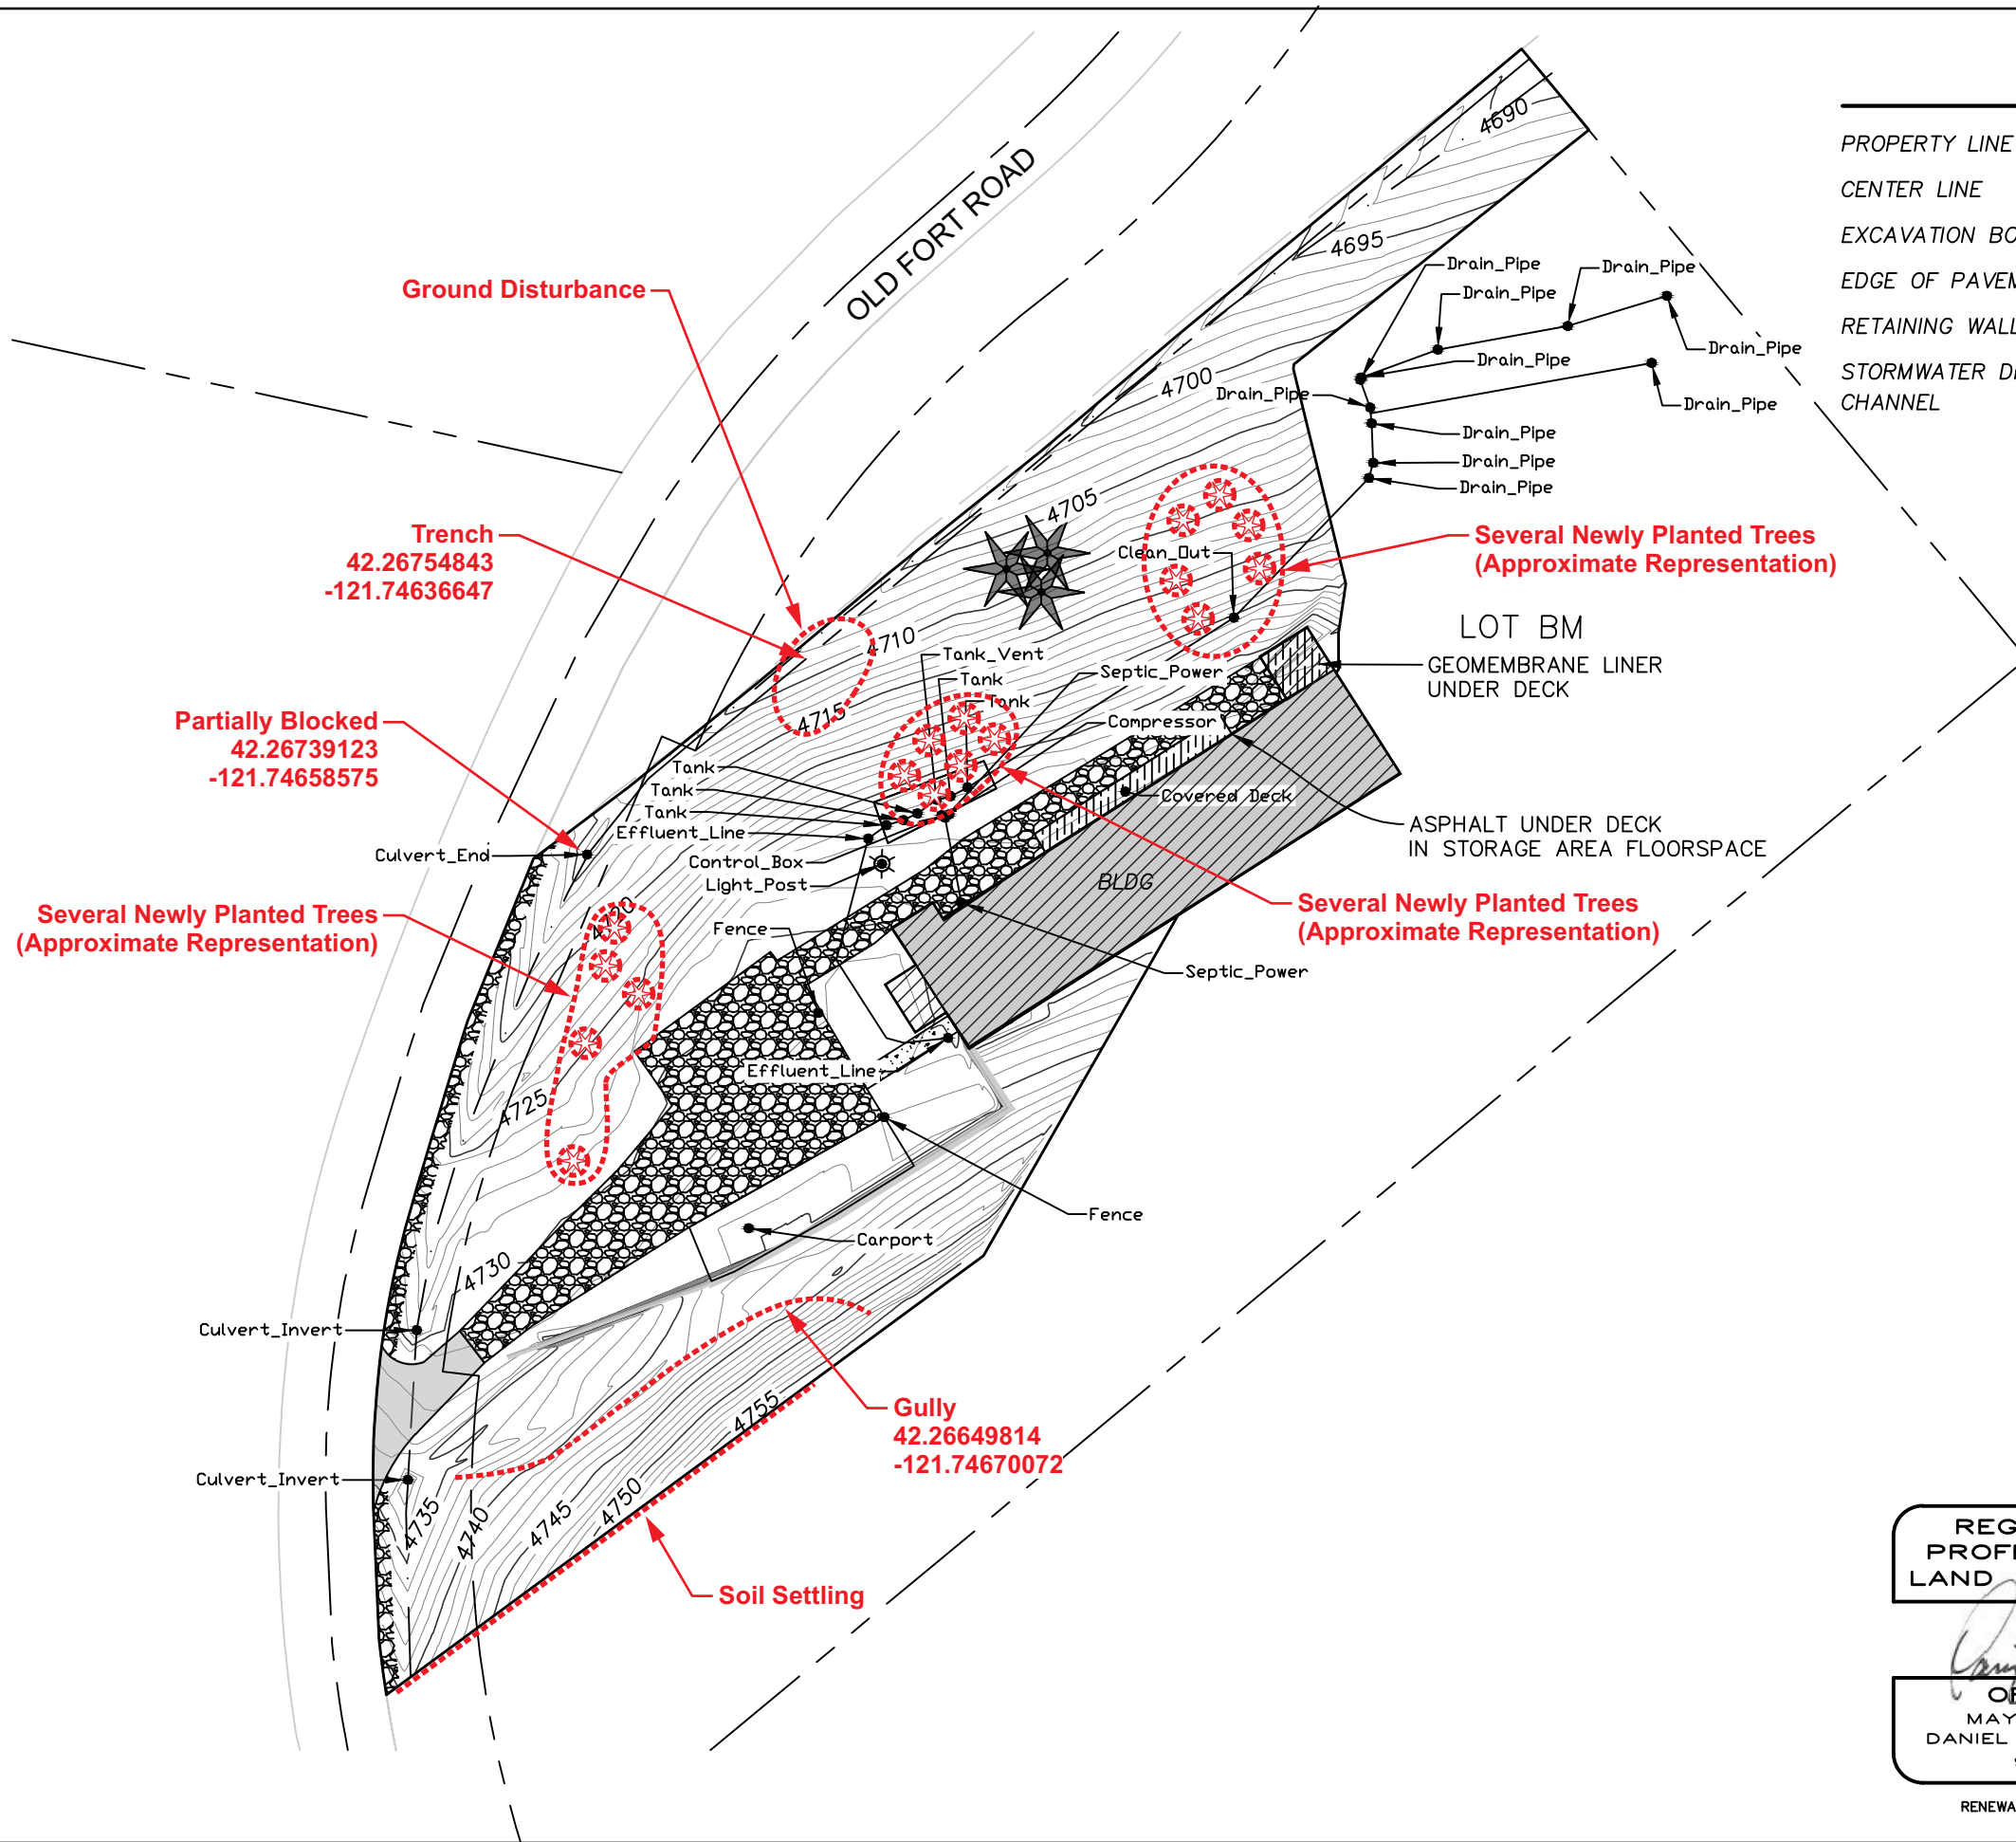
1. **Gullies.** A gully located on the upper slope and a “trench” noted at the base of the property have impacted the protective cap (see enclosed figure).

**Corrective Action.** Fill in the gully and “trench”. Armor as needed to prevent reoccurrence by November 12, 2023.

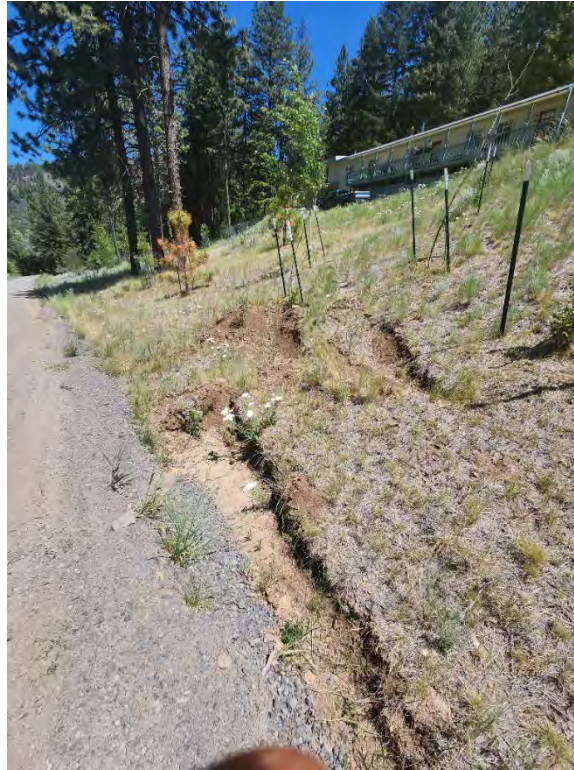
Have gullies developed deeper than 6 inches?	<input checked="" type="checkbox"/>	<input type="checkbox"/>	<input type="checkbox"/>	<input type="checkbox"/>	Continual erosion from downslope movement of stormwater likely formed trench on western portion of parcel. Gullies formed along southeast portion of parcel.	Backfill gully to prevent further erosion.
	Have animals created burrows in the protective cap?	<input type="checkbox"/>	<input type="checkbox"/>	<input checked="" type="checkbox"/>	<input type="checkbox"/>		
	Have vehicles damaged the protective cap?	<input type="checkbox"/>	<input checked="" type="checkbox"/>	<input type="checkbox"/>	<input type="checkbox"/>	Minor ground disturbance activities were noted along the northwest perimeter of the site. No apparent damage to the protective liner was noted. (Same as 2022)	
	Any evidence of ACM on Site including areas where the protective cap is less than 2 feet (see as-built drawings) or within the dripline of the legacy trees?	<input type="checkbox"/>	<input type="checkbox"/>	<input checked="" type="checkbox"/>	<input type="checkbox"/>

Parcel BM – Gully located on East side of Parcel (same as 2022).

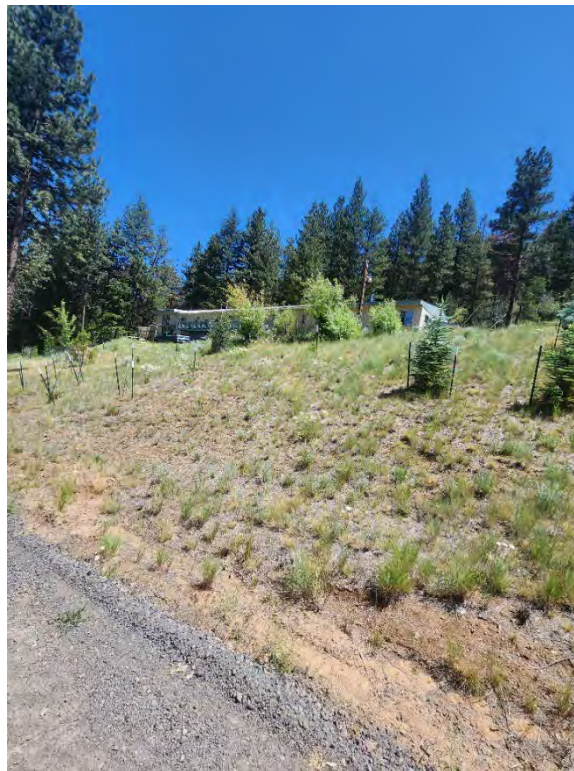
Are there areas that show evidence of unstable slopes, subsidence, or slope failure? Are there signs of active bank erosion and/or lateral cutting?	<input type="checkbox"/>	<input checked="" type="checkbox"/>	<input type="checkbox"/>	<input type="checkbox"/>	Soil along the upslope side of the cap (southeast edge of property), has settled slightly versus native grade. This settling should be monitored during future inspections to see if slope continues to move. (Same as 2022)	
	Any visible ACM along the perimeter of the Site (where applicable)?	<input type="checkbox"/>	<input type="checkbox"/>	<input checked="" type="checkbox"/>	<input type="checkbox"/>		
Vegetation	Evidence of distressed or sparse vegetation? (sparse vegetation no greater than 10 percent of area and bare areas no greater than 100 square feet)	<input type="checkbox"/>	<input checked="" type="checkbox"/>	<input type="checkbox"/>	<input type="checkbox"/>	A total of five newly planted trees located on east portion of parcel near apartment building are in distressed condition.

Parcel BM – View of distressed trees in background, facing Northeast from Southeast corner of Parcel.
