Department of Environmental Quality

RE: Annual Inspection for Parcel BK  
North Ridge Estates Superfund Site  
ECSI No.6020

Operations and Maintenance Inspection Form

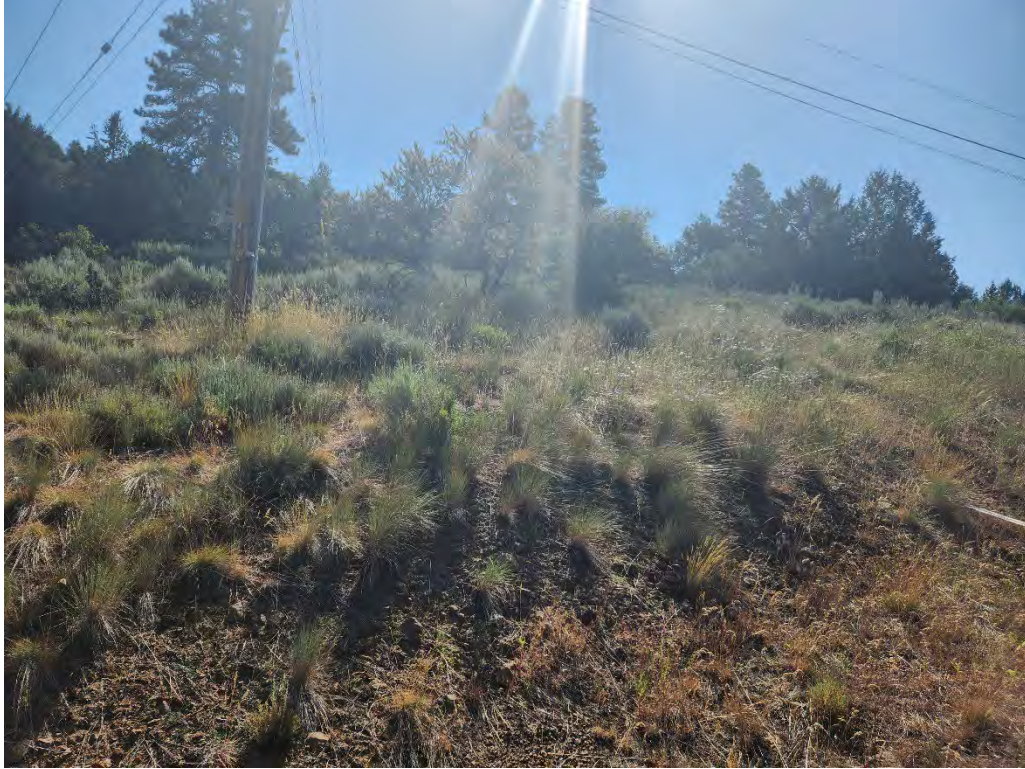
Parcel AR – View from South Central Area of Parcel.

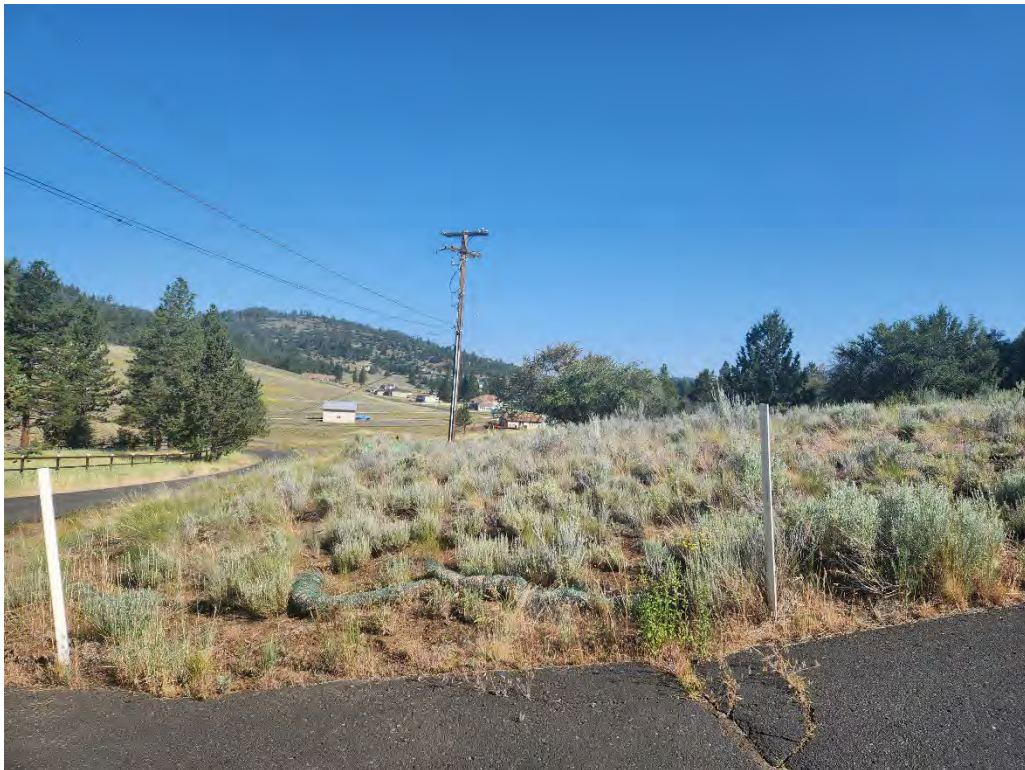
Parcel AR – View facing North from Southern corner of Parcel.
