RE: Annual Inspection for Parcel BK  
North Ridge Estates Superfund Site  
ECSI No. 6020

2024 Annual Inspection Summary Report  
North Ridge Estates - Operable Unit 1  
Klamath Falls, Oregon

# North Ridge Estates Remedy Performance Assessment

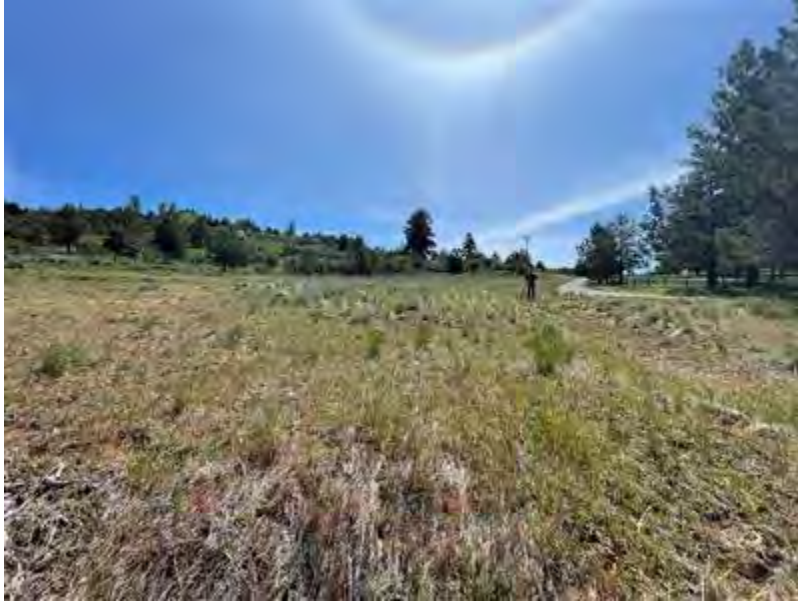
**Developing rill (~2" deep) near West edge of Parcel.**

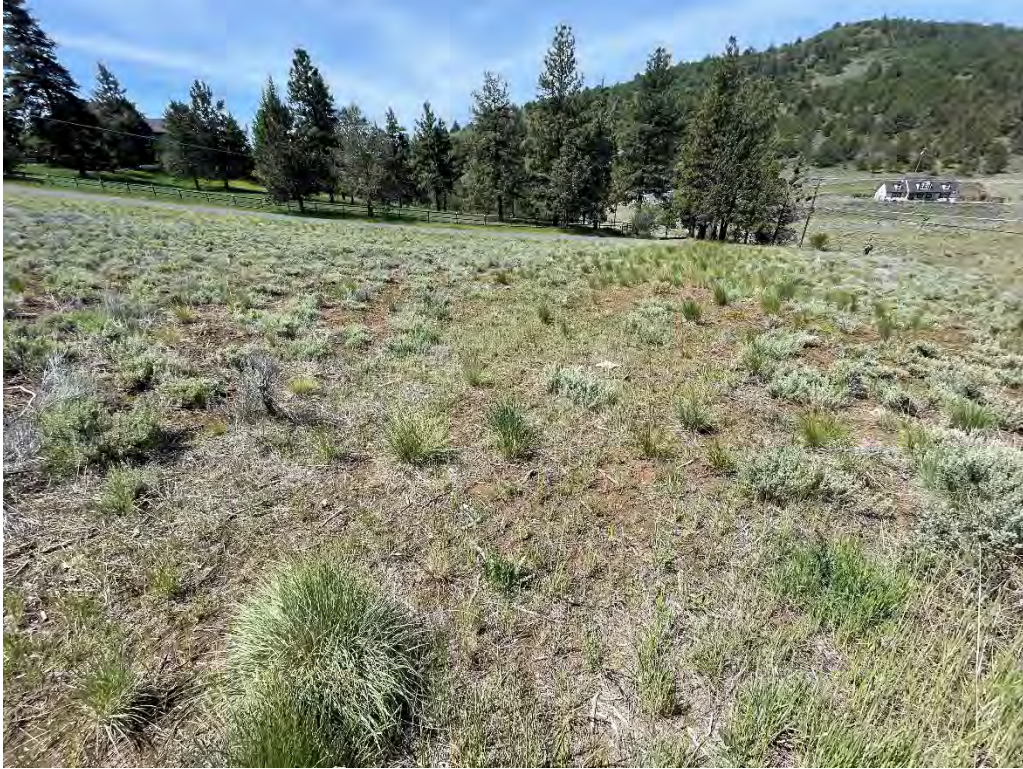
Parcel AR – North center of Parcel, facing Southwest.

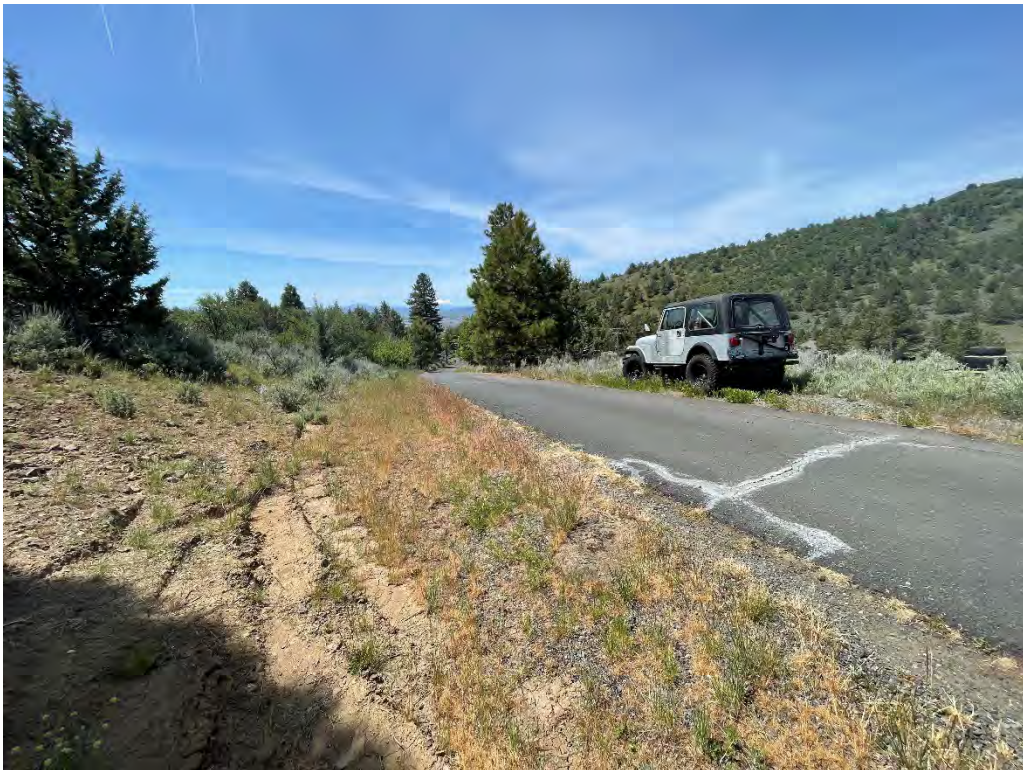
Parcel AR – Northeast corner of Parcel, facing South.

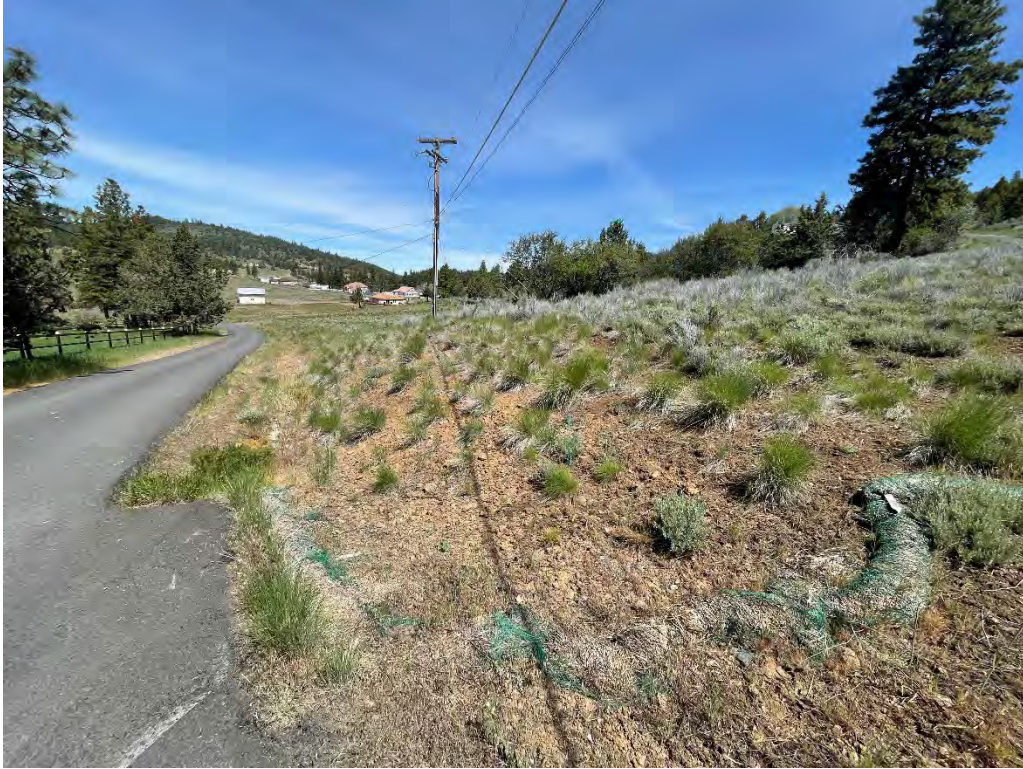
Parcel AR – South corner of Parcel, facing Northwest.

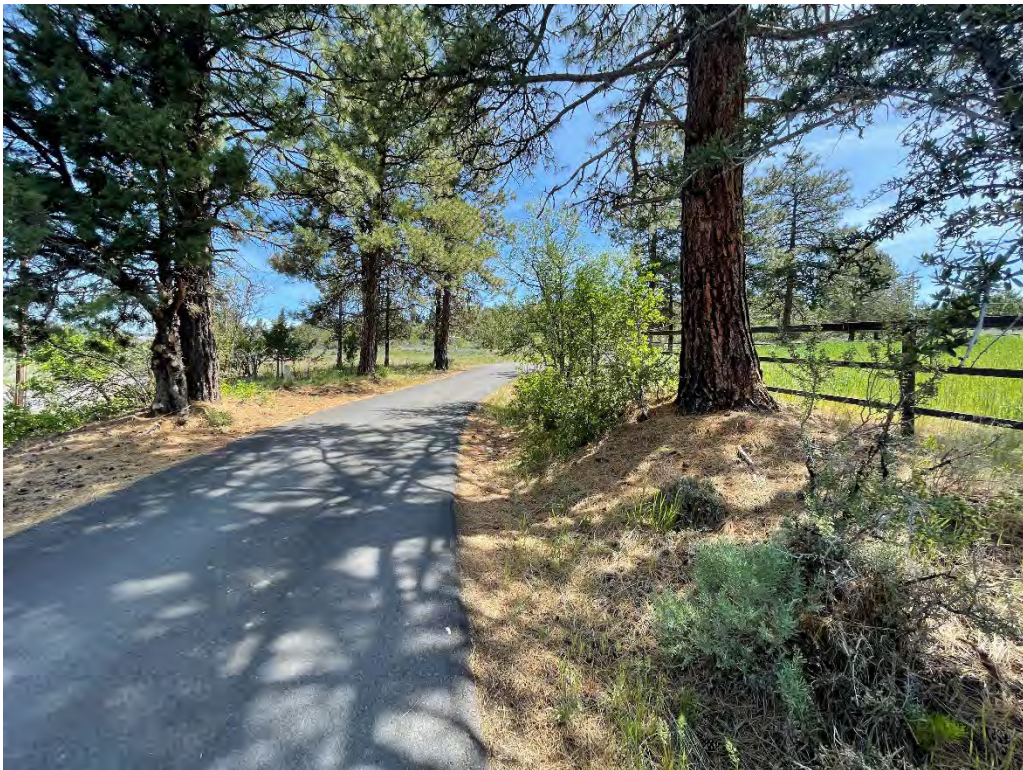
Parcel AR – Southwest corner of Parcel, facing Northeast.

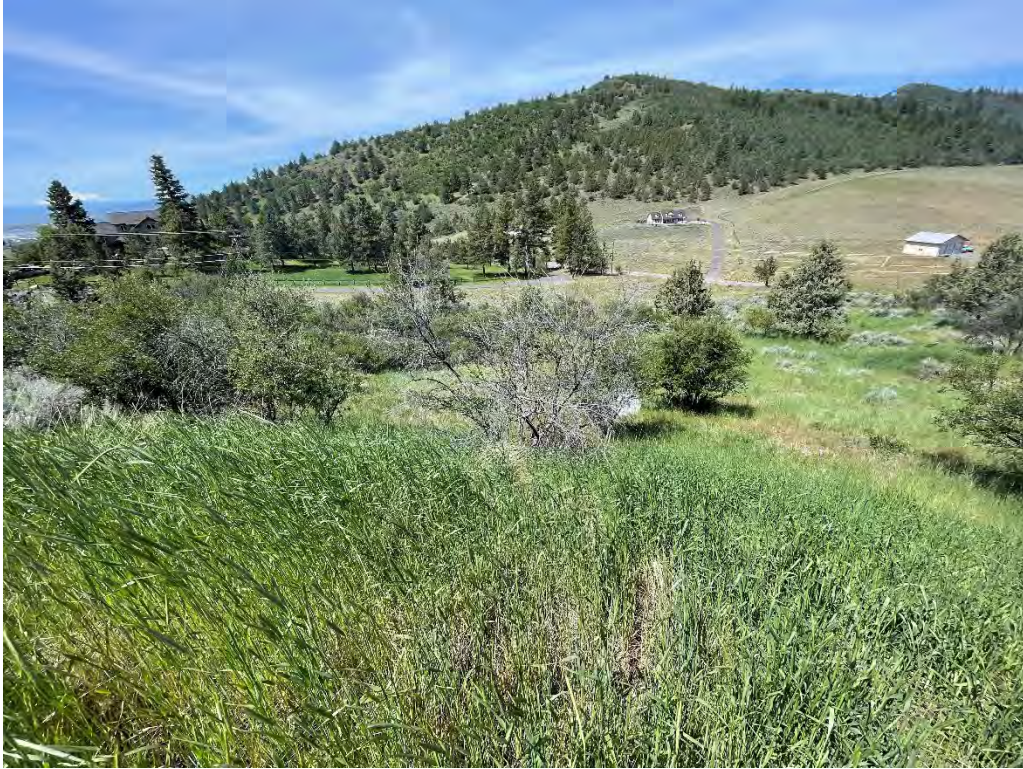
Parcel BK – Northeast corner of Parcel, facing West.

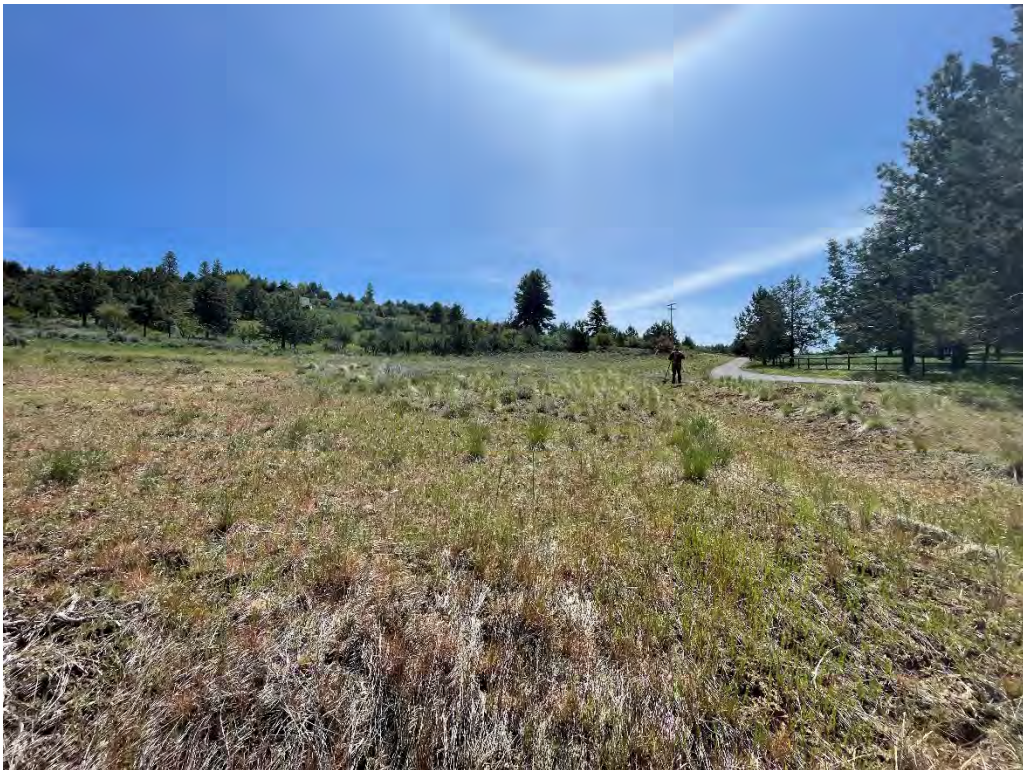
Parcel BK – Northwest corner of Parcel, facing Southeast.

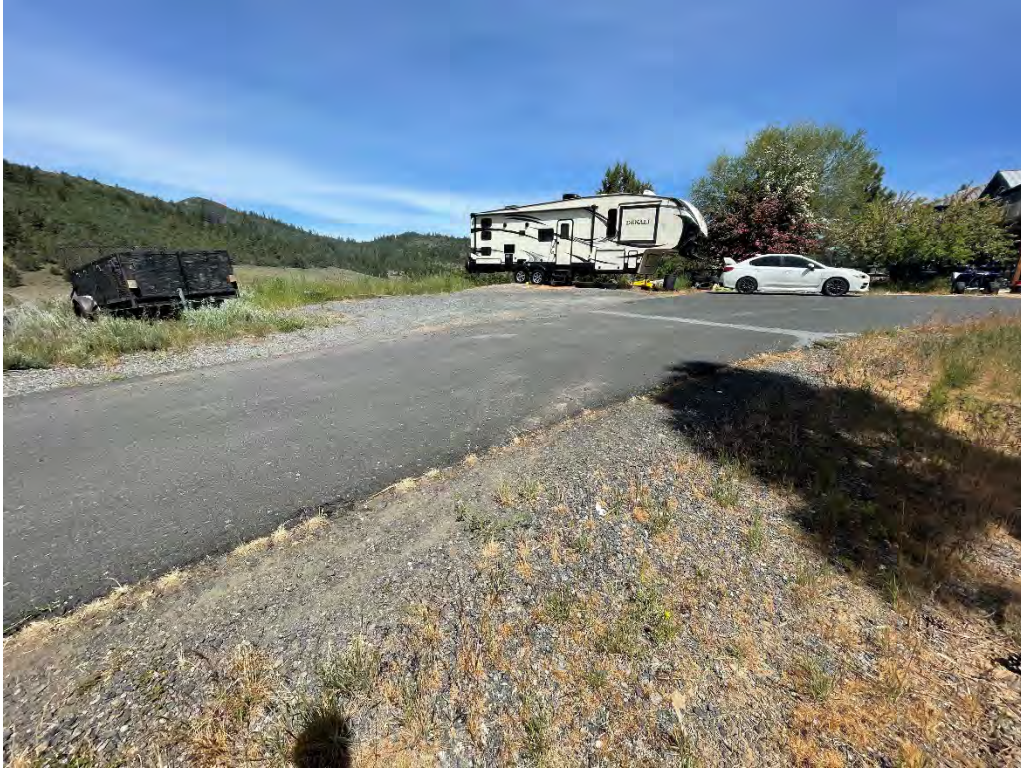
Parcel BK – Southeast corner of Parcel, facing Northwest.

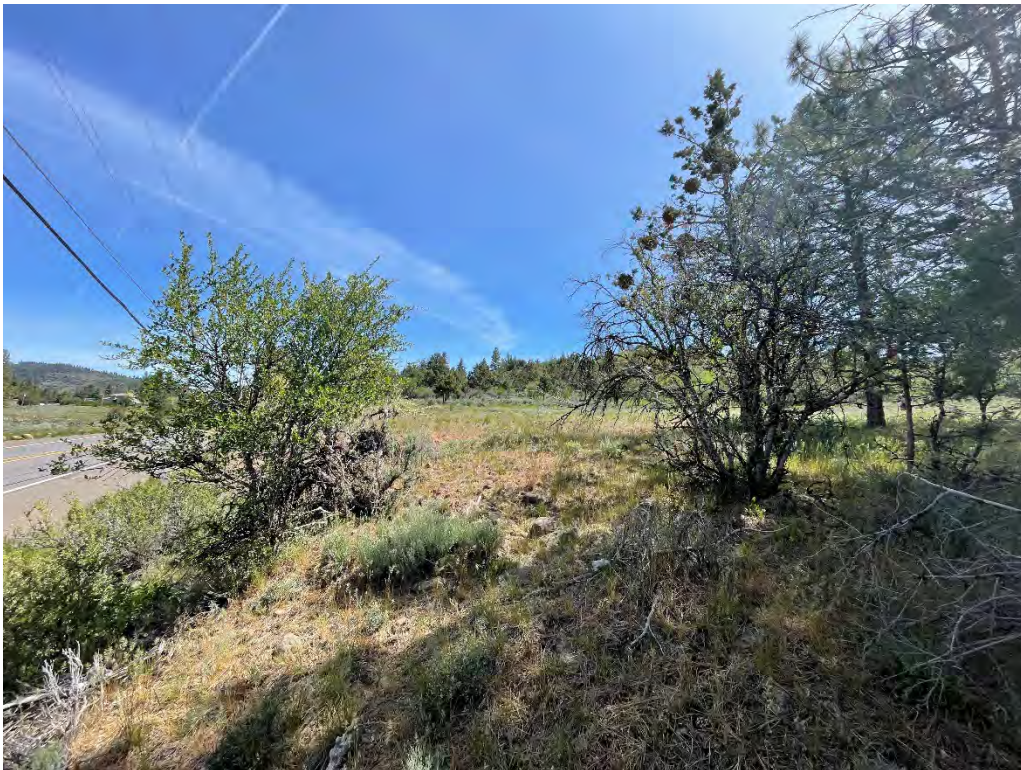
Parcel BK – Southwest corner of Parcel, facing North.
