RE: Annual Inspection for Parcel BO
North Ridge Estates Superfund Site
ECSI No.6021

Parcel BO

2023 Annual Inspection Summary Report
North Ridge Estates - Operable Unit 1
Klamath Falls, Oregon

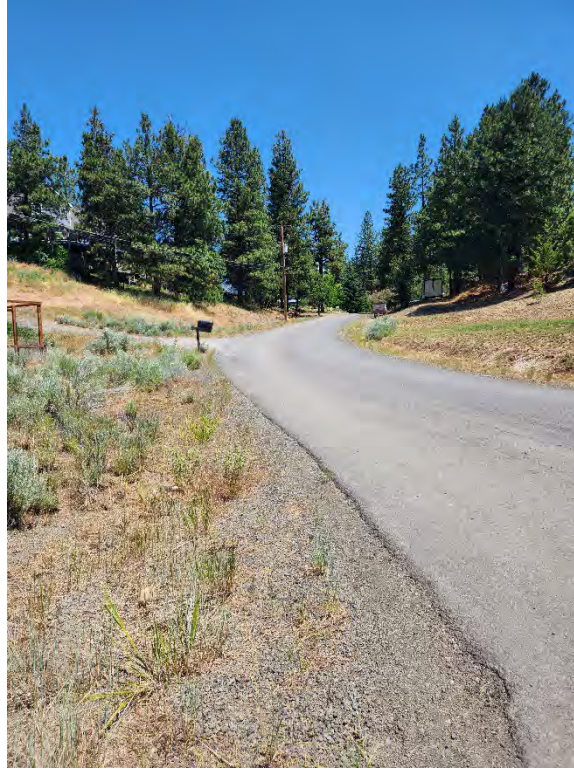
Parcel BO – View from Western corner of Parcel.

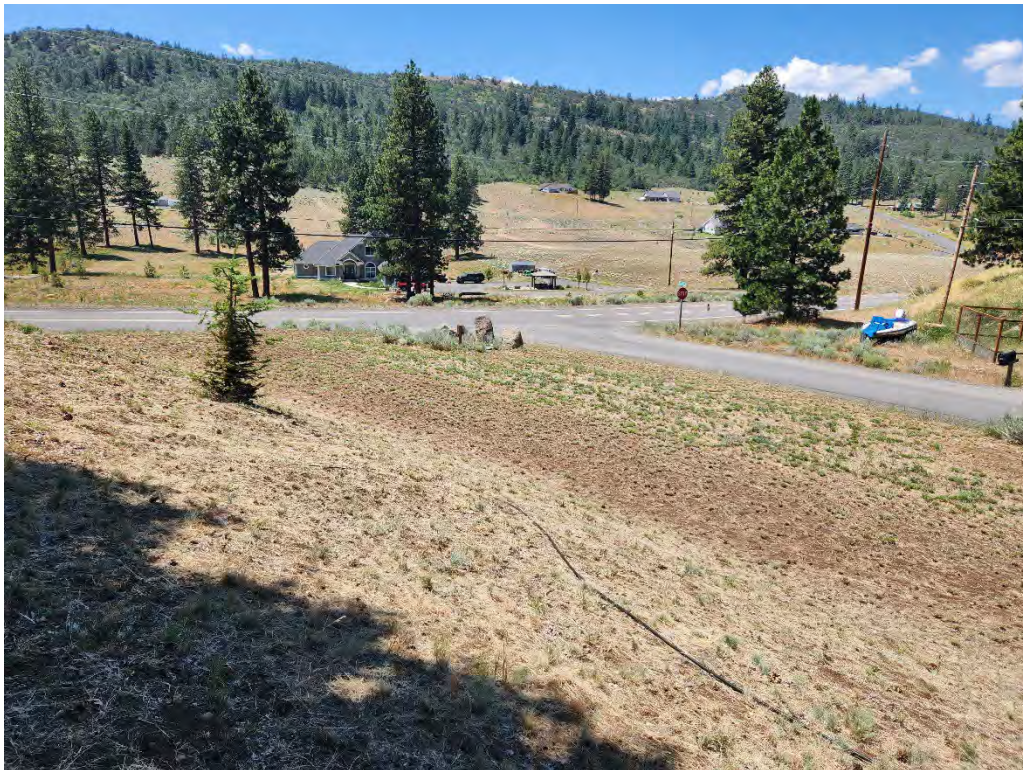
Parcel BO – View from Eastern corner of Parcel.

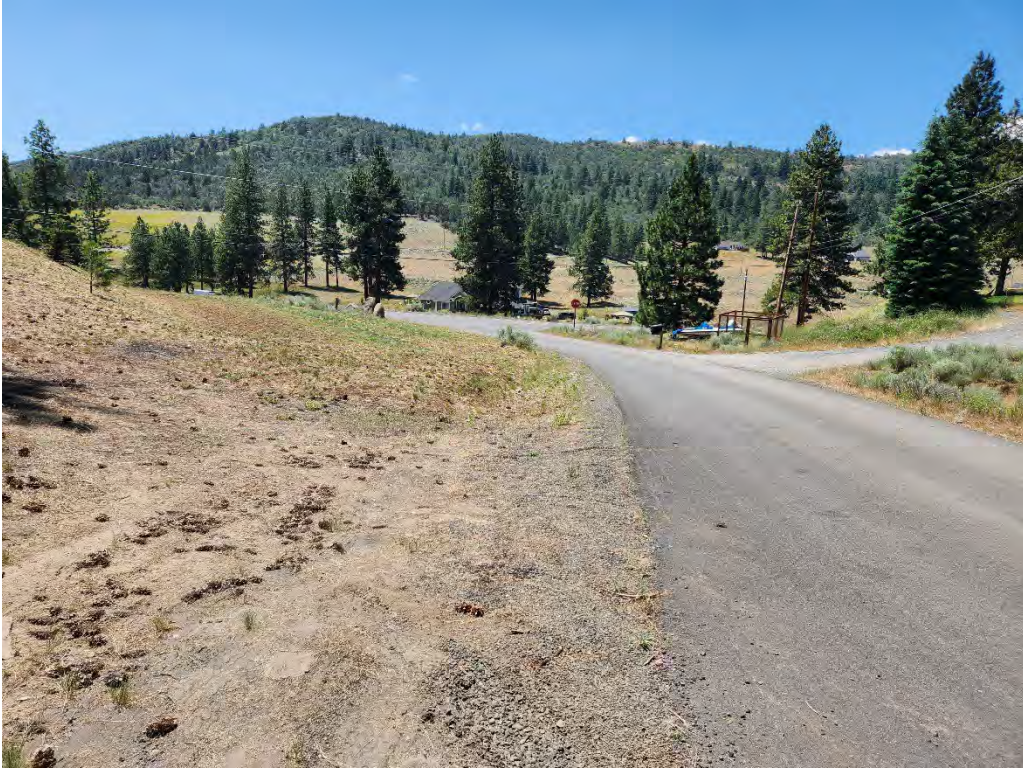
Parcel BO – View from North corner of Parcel.

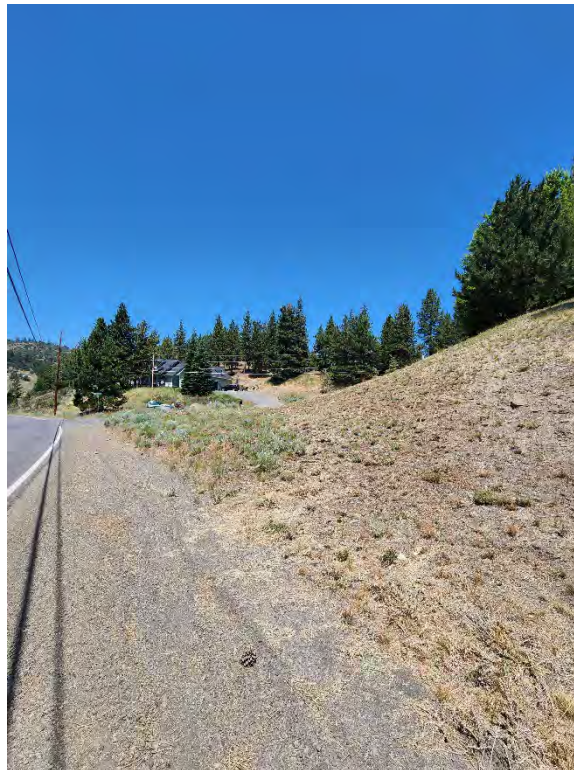
Parcel BO – View from Southern corner of Parcel.
