RE: Annual Inspection for Parcel BP  
North Ridge Estates Superfund Site  
ECSI No. 6022

Operations and Maintenance Inspection Form

**Lot BP Inspection**

2023 Annual Inspection Summary Report  
North Ridge Estates - Operable Unit 1  
Klamath Falls, Oregon

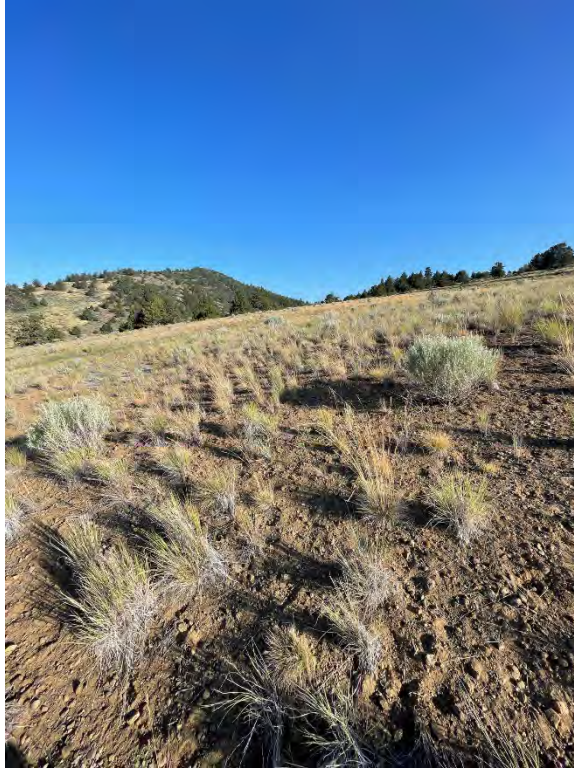
Parcel BP – Southeast corner of Parcel, facing Northwest.

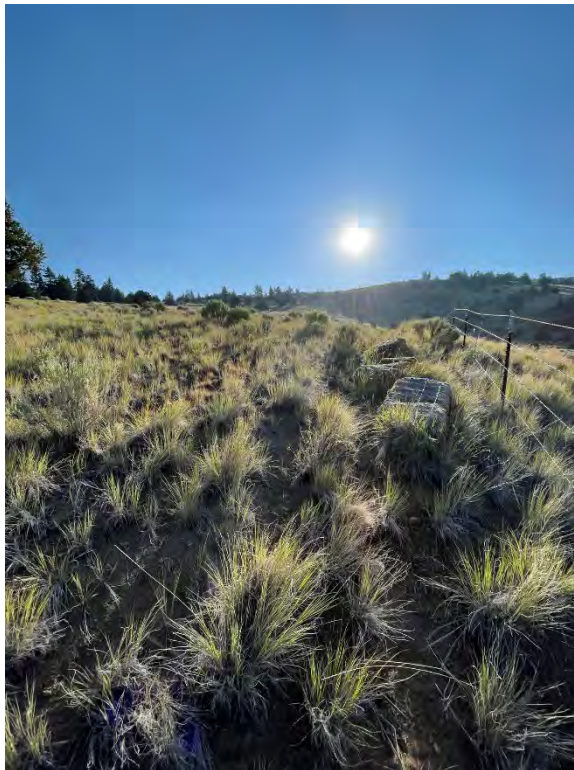
| Part I. General Site Information | | | | | | | |
|---|---|---|---|---|---|---|---|
| Protective Cap | Have rills developed deeper than 2 inches? | <input type="checkbox"/> | <input checked="" type="checkbox"/> | <input type="checkbox"/> | <input type="checkbox"/> | Multiple rills were identified in the southwest portion of the parcel. (Same as 2021) | |

Parcel BP – Southwest corner of Parcel, facing Northeast.

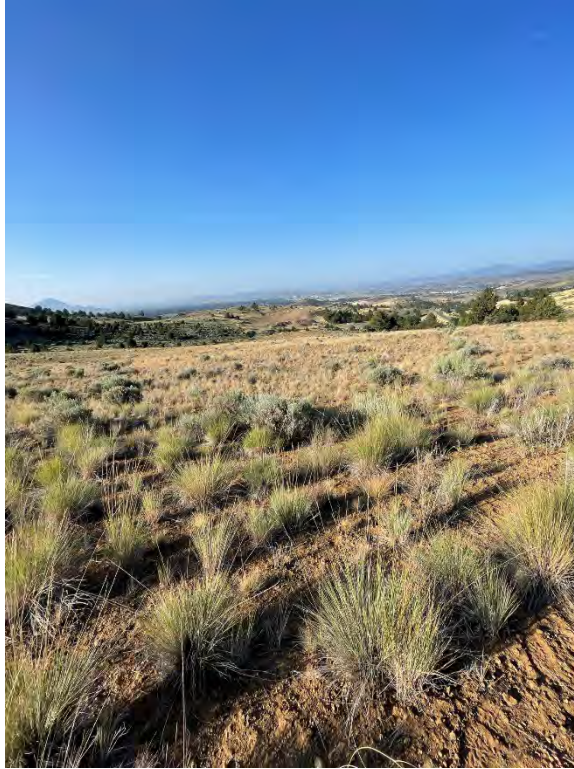
Parcel BP – North corner of Parcel, facing South.

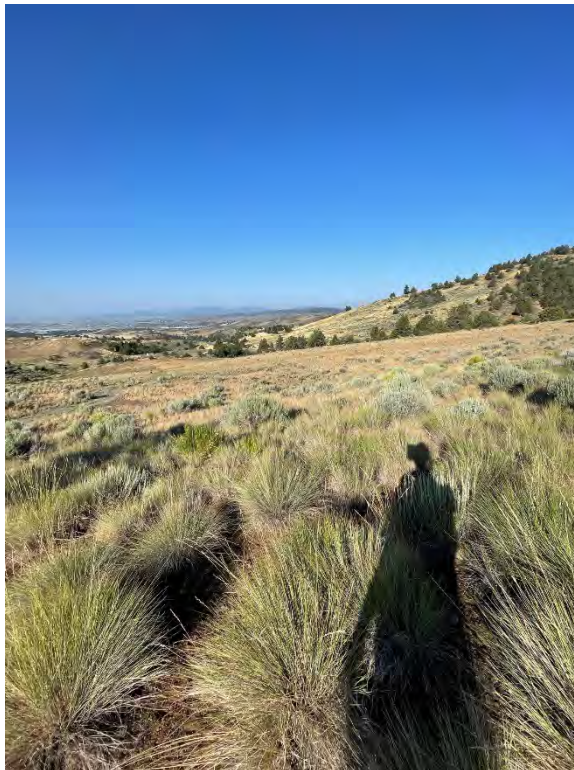
Parcel BP – Northeast corner of Parcel, facing Southwest.

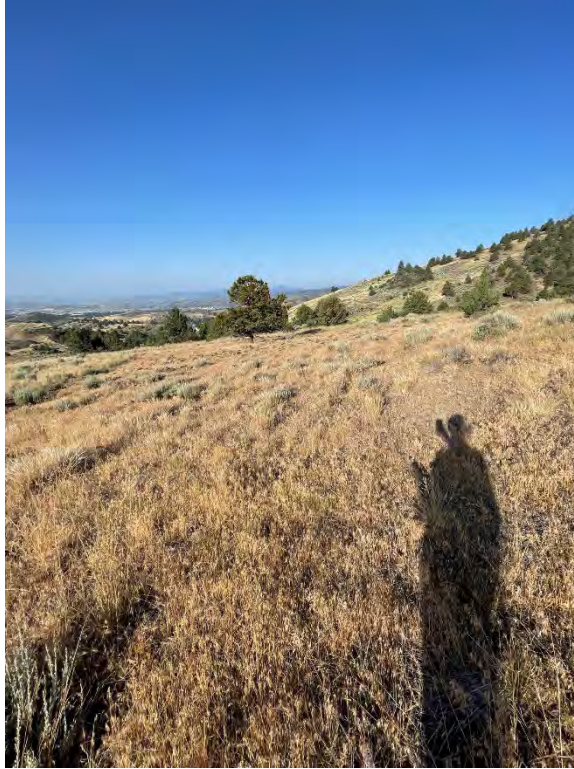
Parcel BP – Northeast corner of the Parcel, facing Southwest.

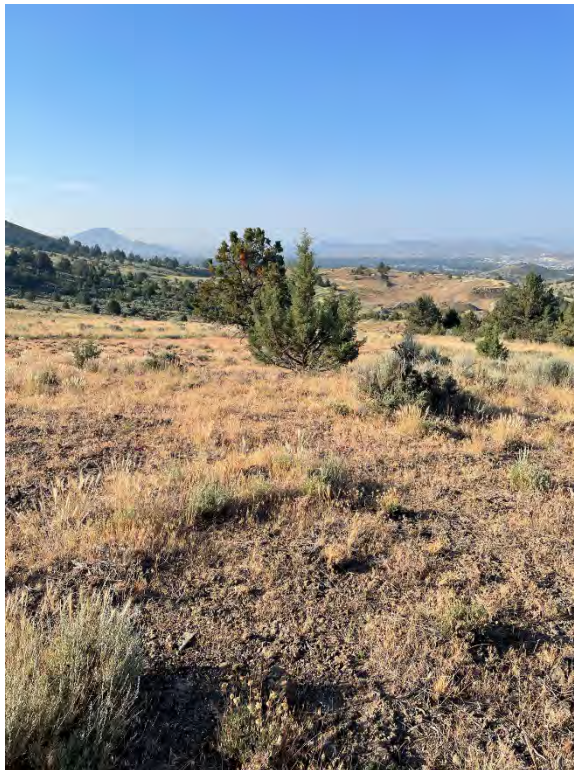
Parcel BP – Northwest corner of the Parcel, facing Southeast.

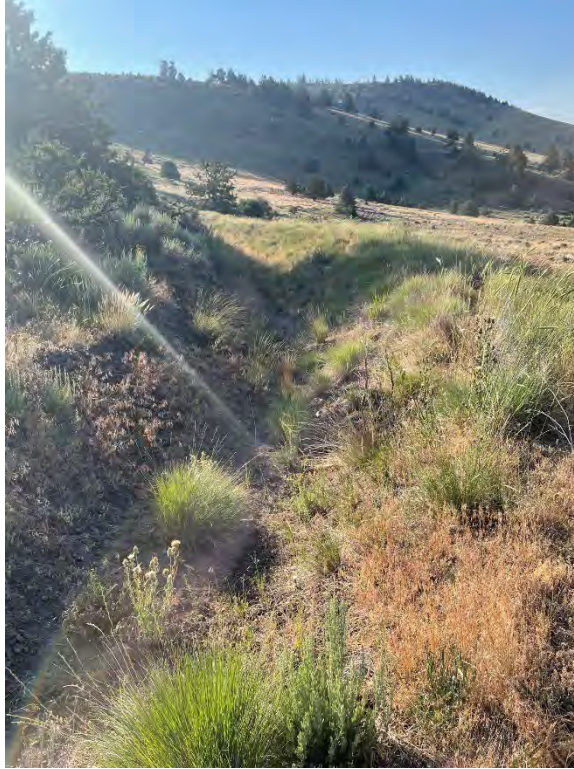
Parcel BP – West side of the ditch within the Parcel.

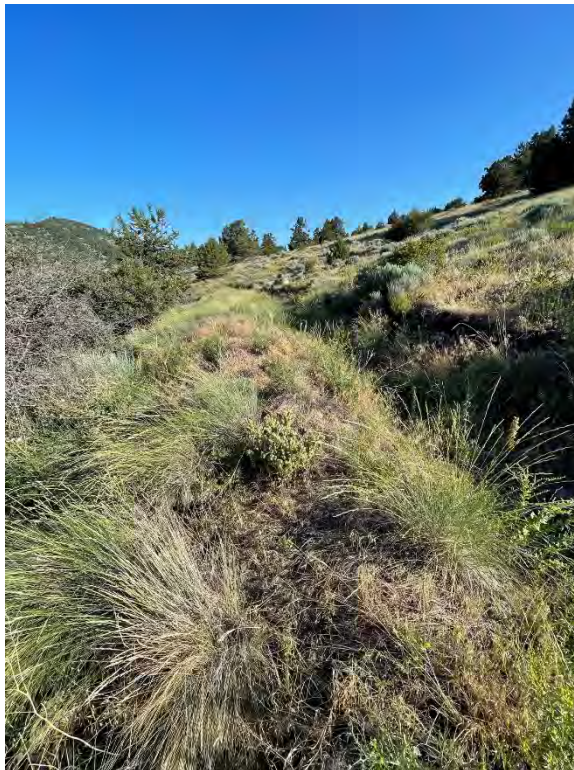
Parcel BP – East side of ditch within the parcel.

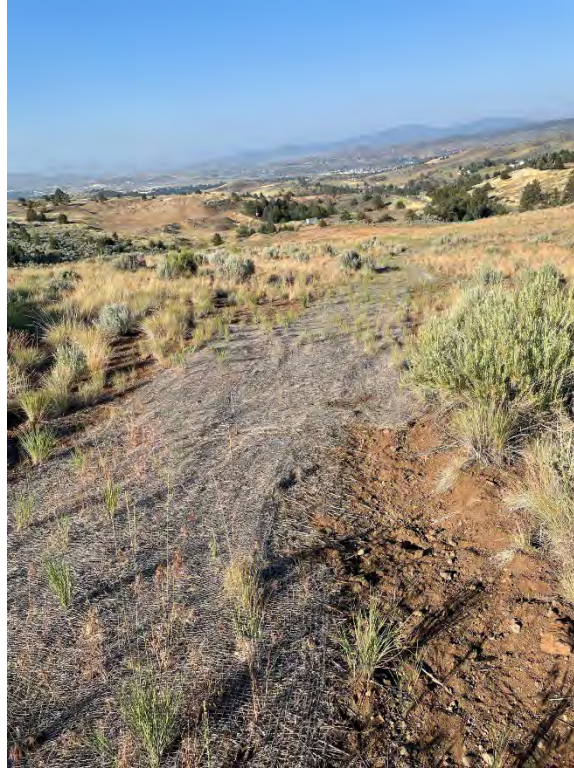
| Part I. General Site Information | | | | | | | |
|---|---|---|---|---|---|---|---|
| | Have gullies developed deeper than 6 inches? | <input checked="" type="checkbox"/> | <input type="checkbox"/> | <input type="checkbox"/> | <input type="checkbox"/> | At the top of the hill the gully was approximately 4 to 8 inches deep and at the bottom (southern) end the gully was 8 to 12 inches deep. The gully also extends into parcel BQ. (Same as 2021) | Backfill gullies with soil and/or armor with rock to prevent additional erosion. |

| | | <input type="checkbox"/> | <input type="checkbox"/> | <input type="checkbox"/> | <input type="checkbox"/> | U.S. EPA entended SW cutoff trench and repaired some rills and gullies in 2022. | |

Parcel BP – Repaired gully system through parcel on the East side.
