RE: Annual Inspection for Parcel BQ  
North Ridge Estates Superfund Site  
ECSI No. 6012

## Lot BQ Inspection

2023 Annual Inspection Summary Report  
North Ridge Estates - Operable Unit 1  
Klamath Falls, Oregon

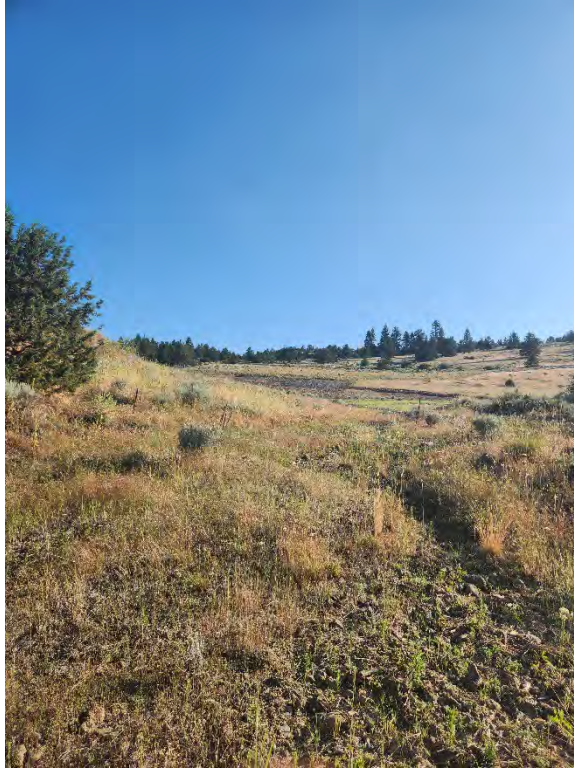
Parcel BQ – View of Parcel from Central corner.

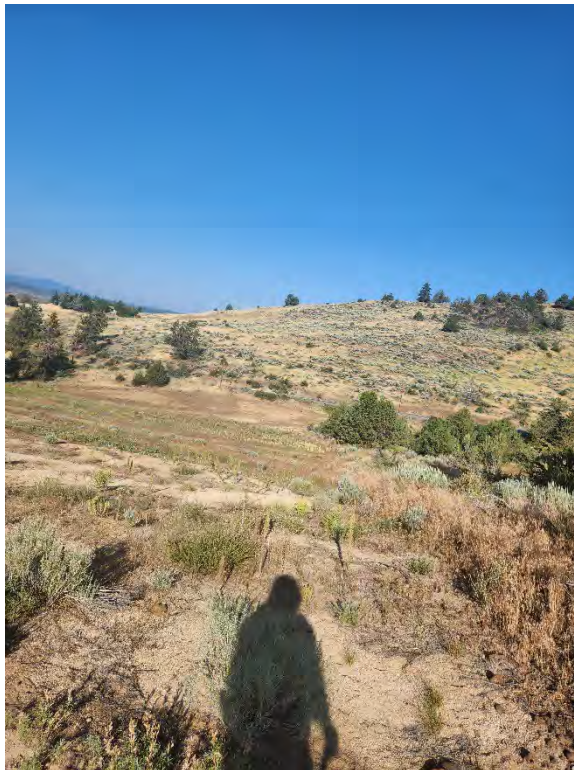
Parcel BQ – View of Parcel Excavation Limits.

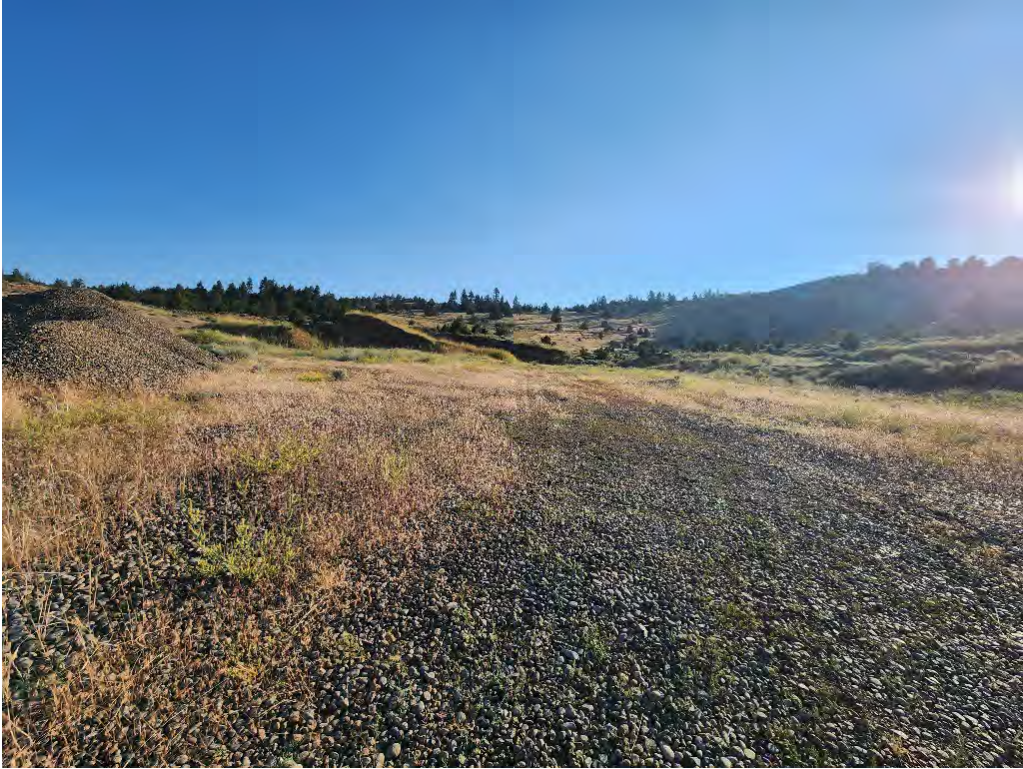
Parcel BQ – Rock piles originally stored have moved since 2022.

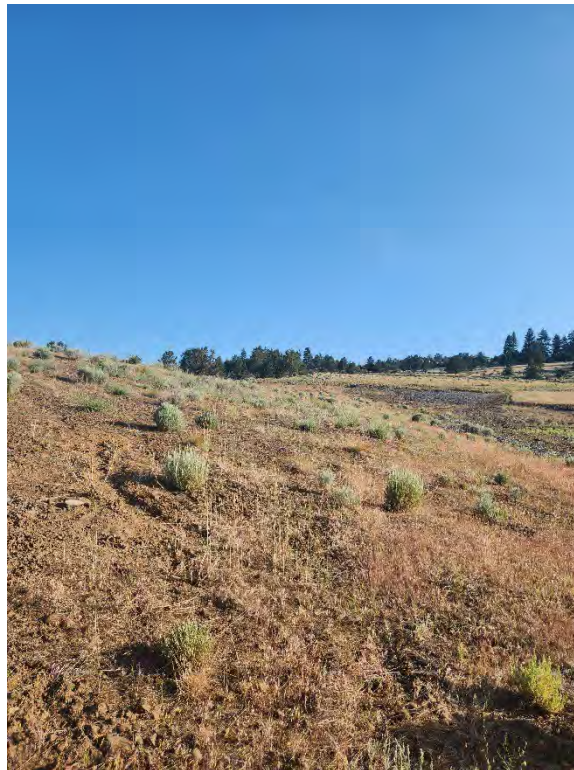
Parcel BQ – Additional view of Parcel Excavation Limits.

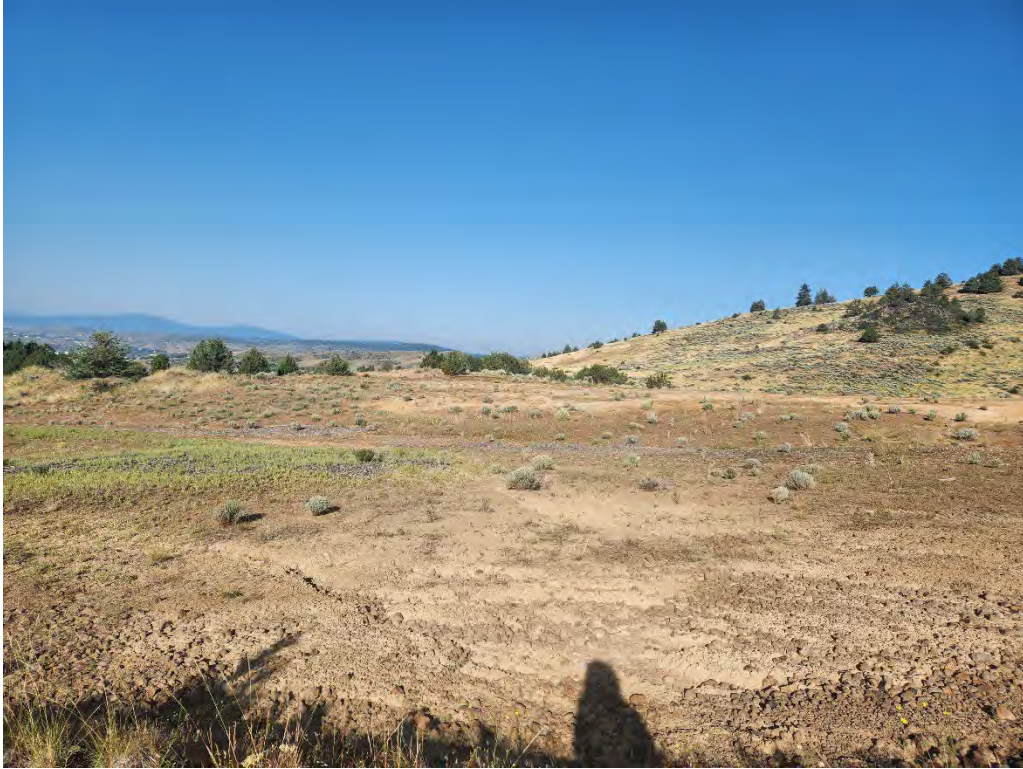
Parcel BQ – View of East corner.

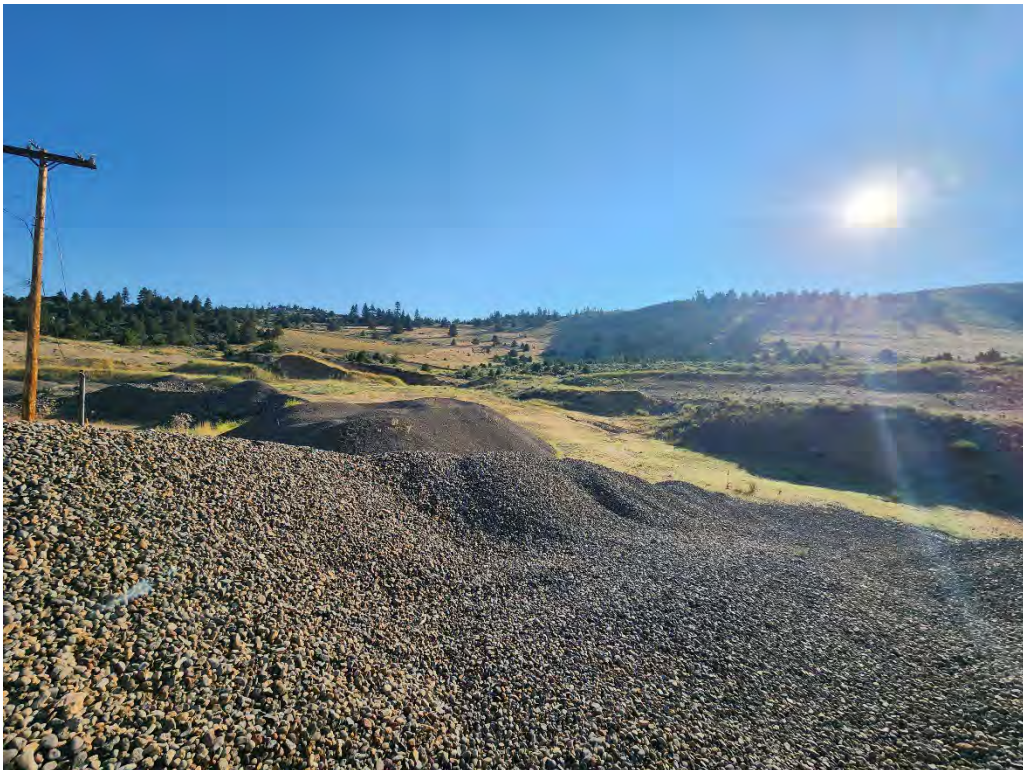
Parcel BQ – Elevated view of Parcel from Southeast corner.

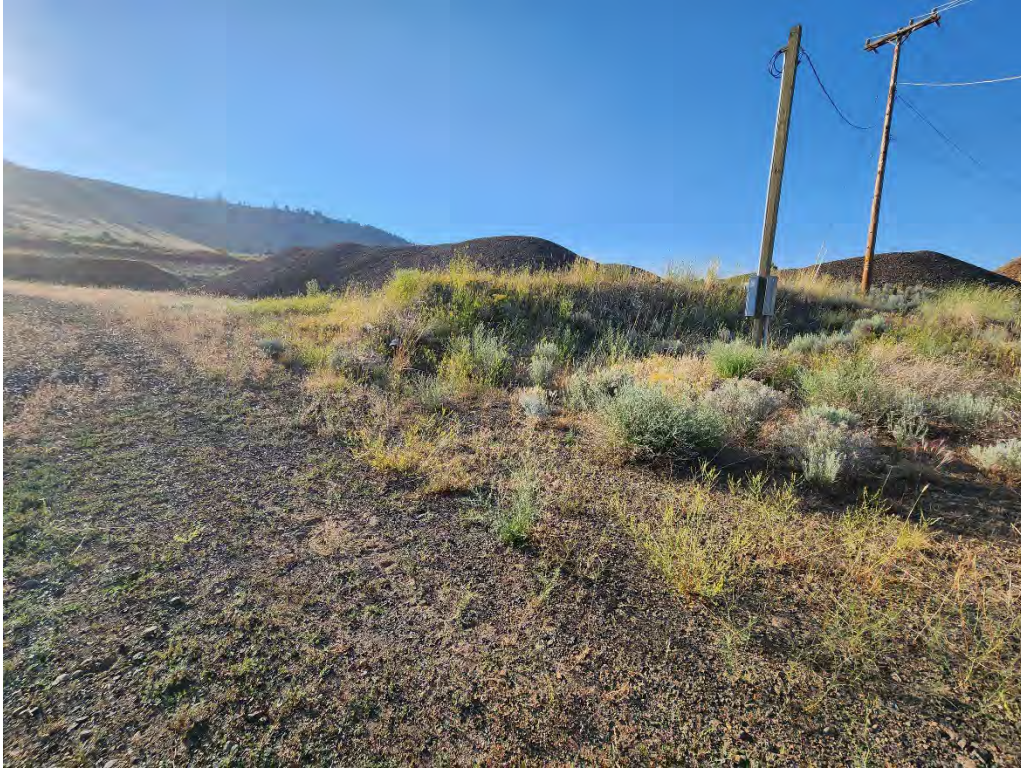
Parcel BQ – View of Parcel and Excavation Limits.

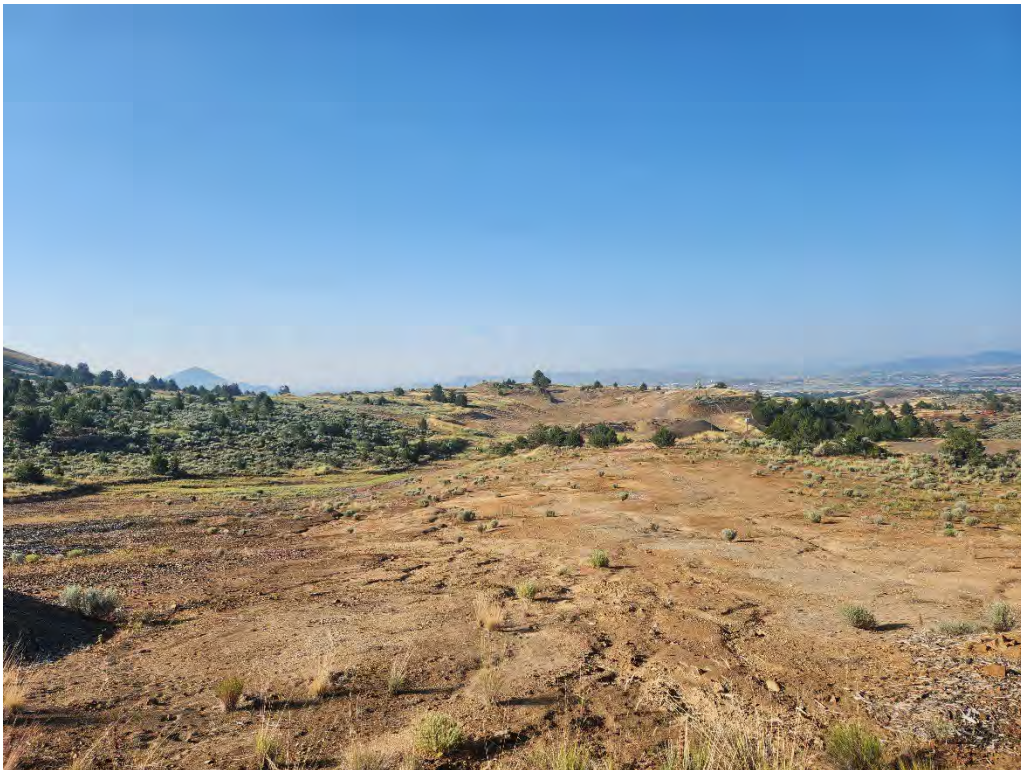
Parcel BQ – View facing South from North corner of Parcel.

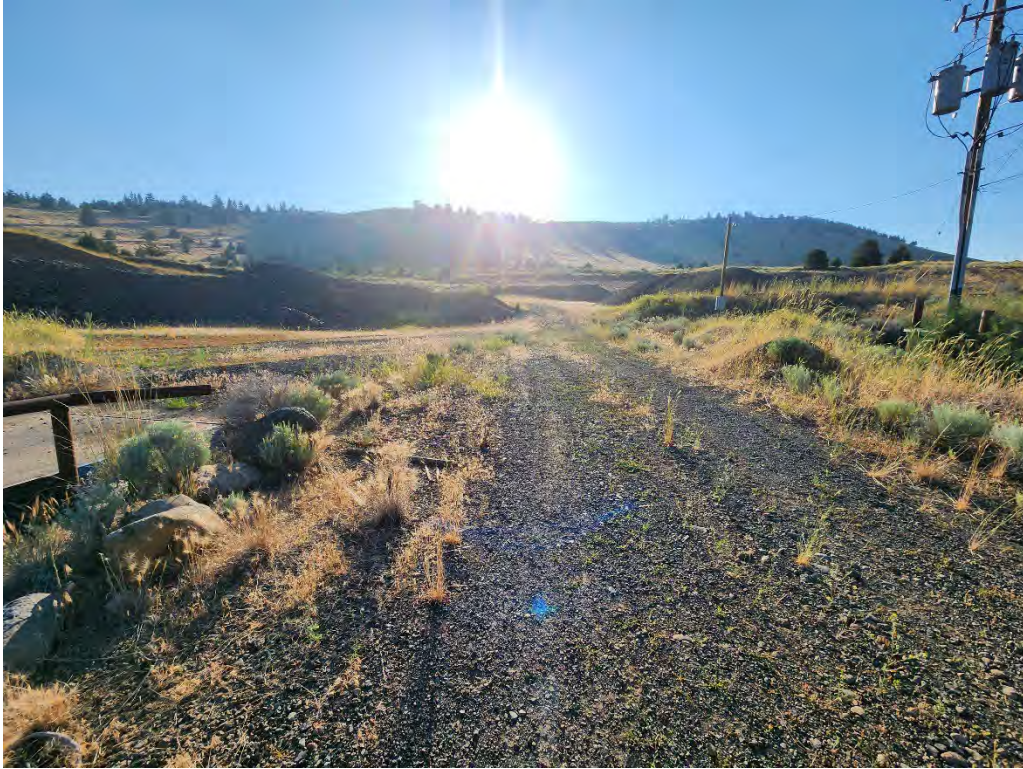
Parcel BQ – View facing East from Southwest corner of Parcel.

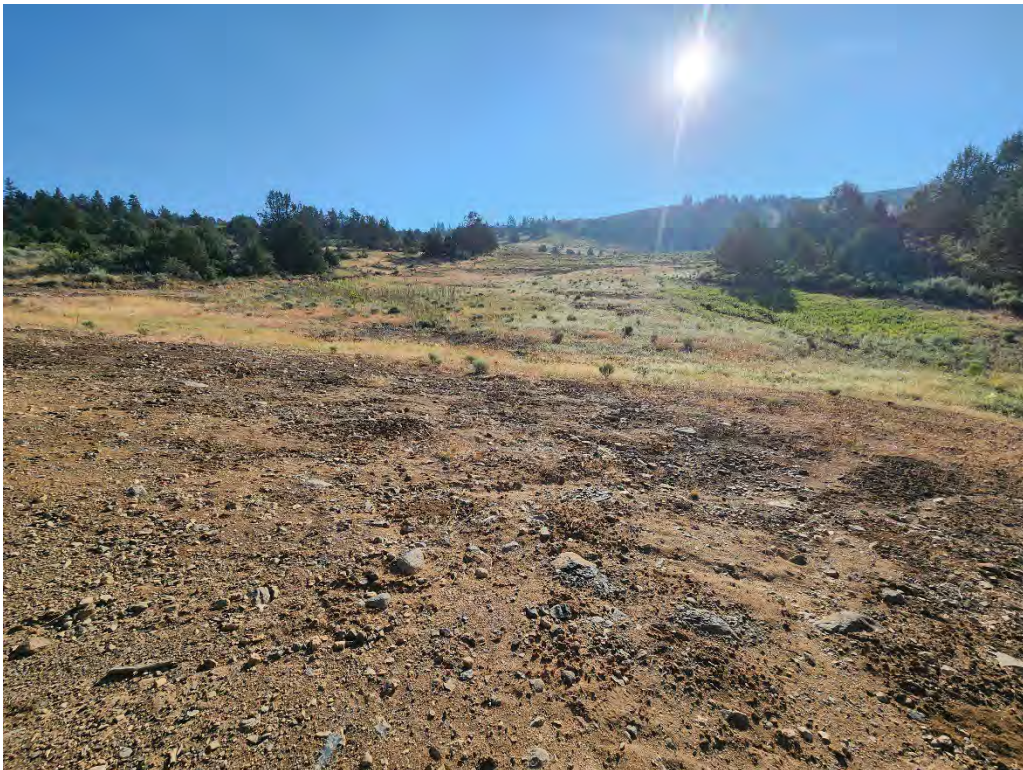
Parcel BQ – View of SW Cutoff Trench (foreground) facing East from West corner of Parcel.
