RE: Annual Inspection for Parcel WWTP
North Ridge Estates Superfund Site
ECSI No. 6024

Parcel WWTP

Operations and Maintenance Inspection Form

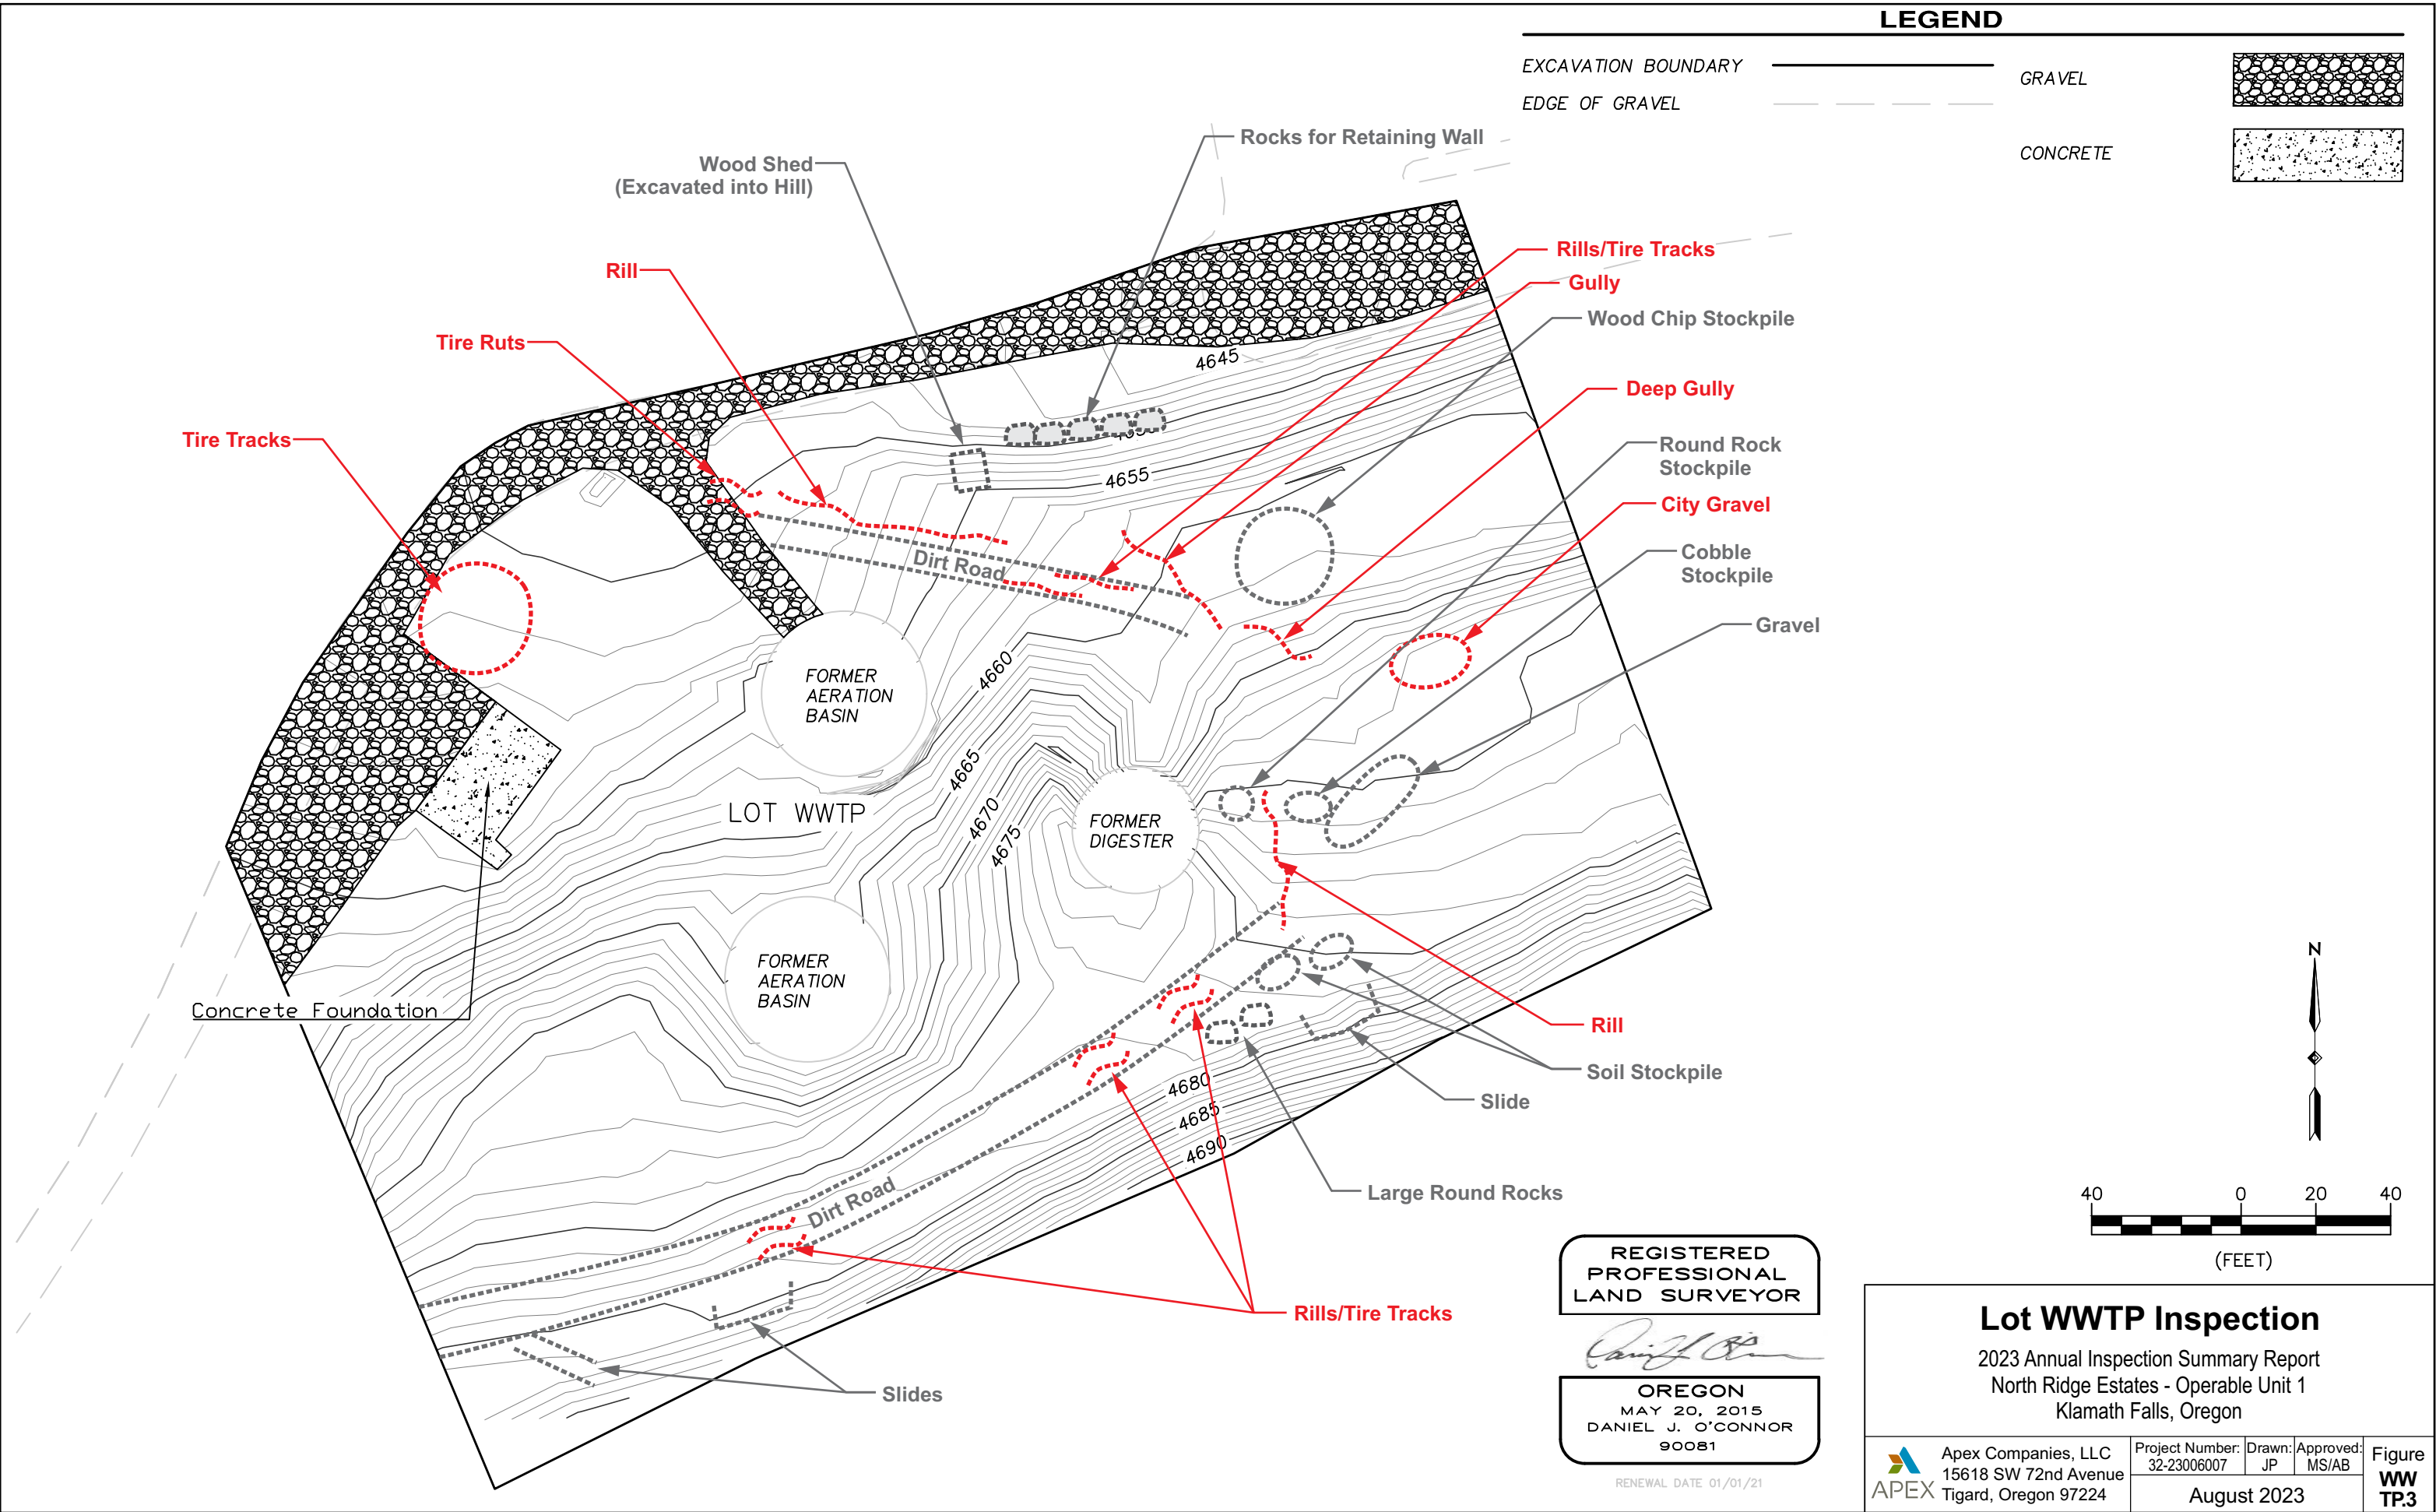
Parcel WWTP

1. **Cap Damage.** Slides/soil sloughing on steep slope, rills, tire tracks, and gullies were noted during the inspection consistent with previous years (see enclosed figure).

Corrective Action. Fill in the damaged areas to restore the 2 foot soil cap and vegetate. Armor as needed to prevent reoccurrence by November 12, 2023.

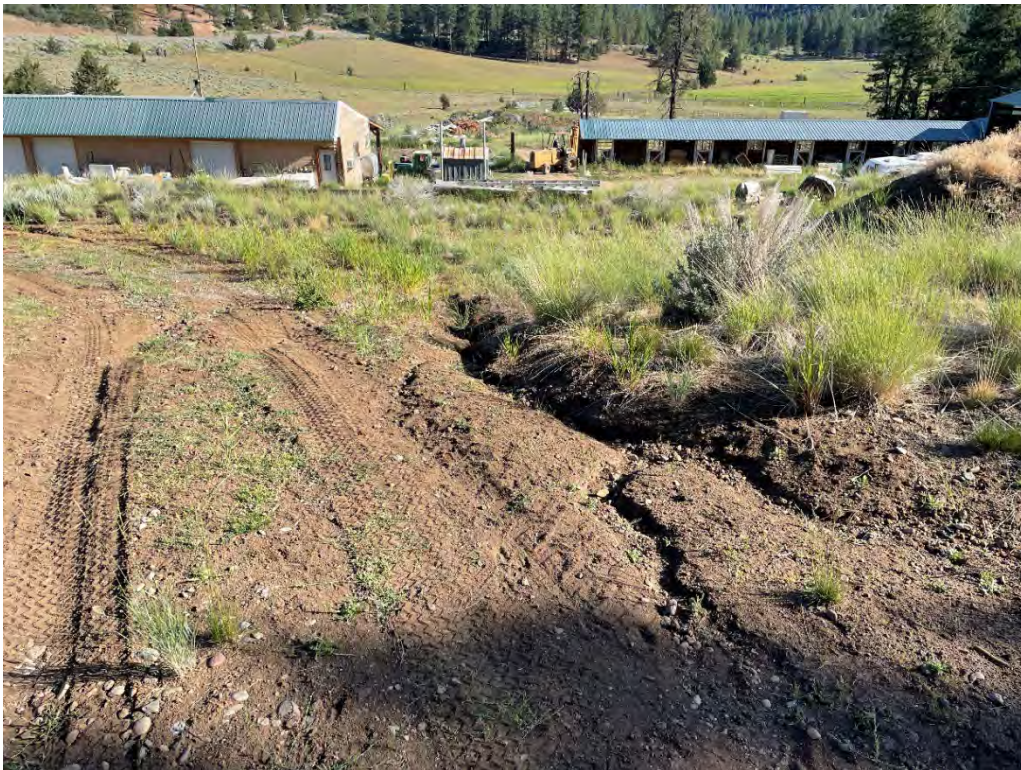
Have gullies developed deeper than 6 inches?	<input checked="" type="checkbox"/>	<input type="checkbox"/>	<input type="checkbox"/>	<input type="checkbox"/>	A gully was identified near the dirt road and woodchip stockpile in the NE quadrant of the parcel.	Backfill gully to prevent further erosion.
	Have animals created burrows in the protective cap?	<input type="checkbox"/>	<input type="checkbox"/>	<input checked="" type="checkbox"/>	<input type="checkbox"/>		
	Have vehicles damaged the protective cap?	<input type="checkbox"/>	<input checked="" type="checkbox"/>	<input type="checkbox"/>	<input type="checkbox"/>	Tire ruts were noted at the base of the dirt road at the north central area of the parcel (Same as 2022).	
	Any evidence of ACM on Site including areas where the protective cap is less than 2 feet (see as-built drawings) or within the dripline of the legacy trees?	<input type="checkbox"/>	<input type="checkbox"/>	<input checked="" type="checkbox"/>	<input type="checkbox"/>

Parcel WWTP – View of new downslope Gully alongside dirt road.

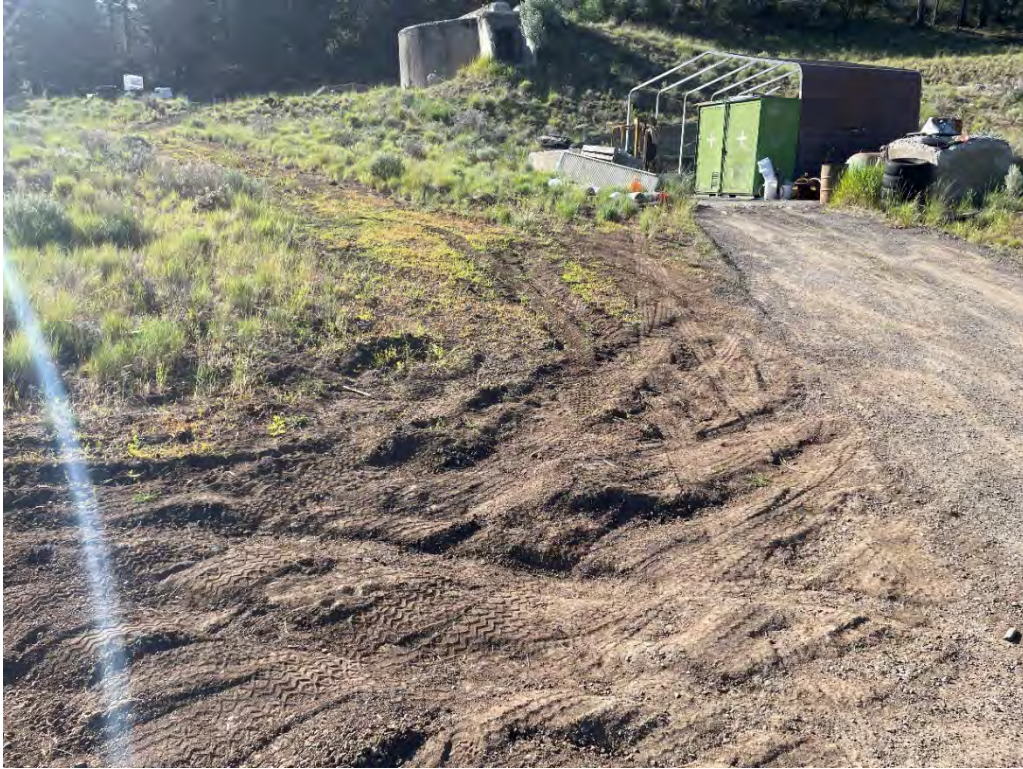
Parcel WWTP – View of new Tire Ruts at base of dirt road.

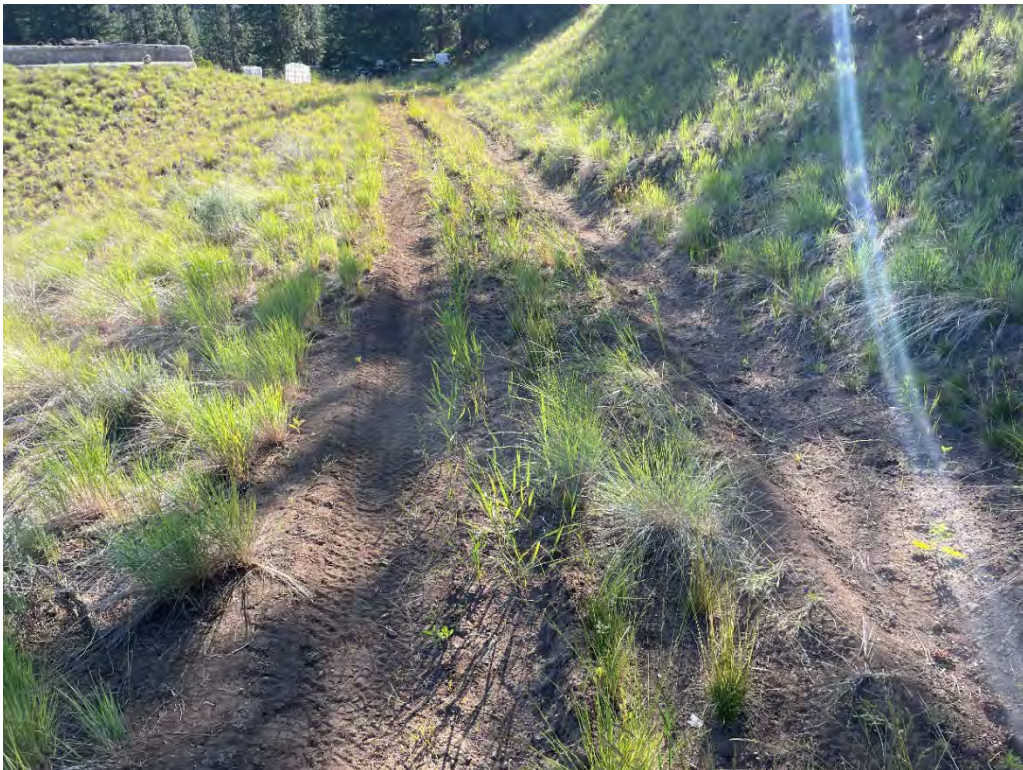
Parcel WWTP – View of new Tire Tracks on dirt road (Former Aeration Basin visible in background).

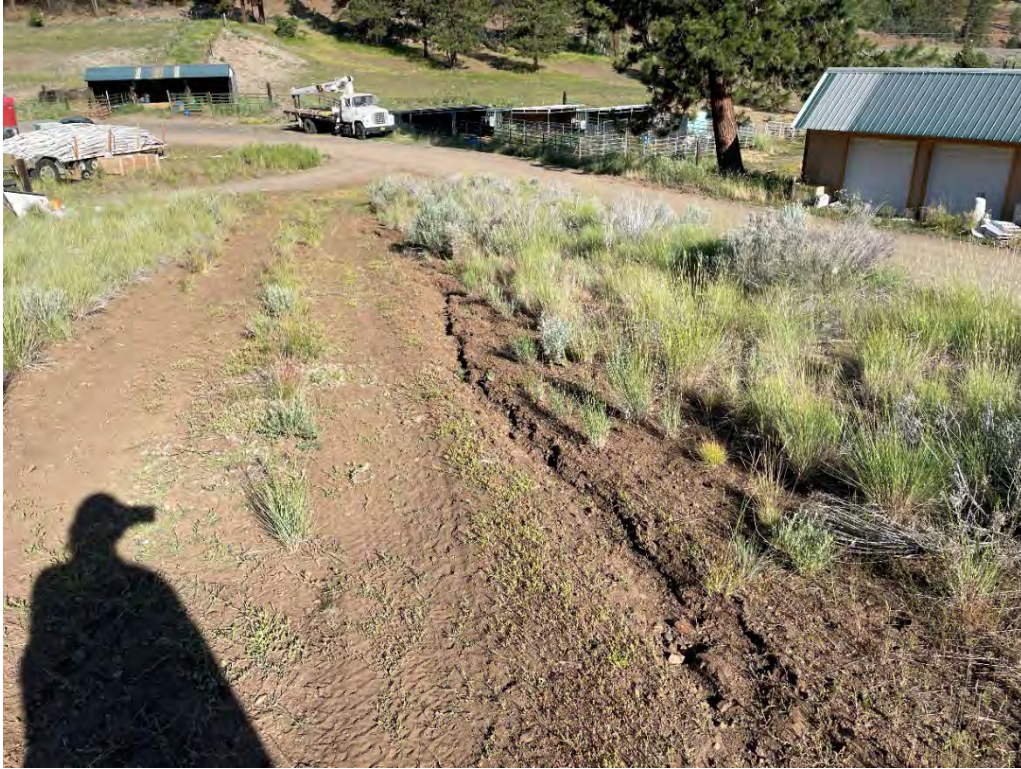
Parcel WWTP – View of new Rill alongside the dirt road.

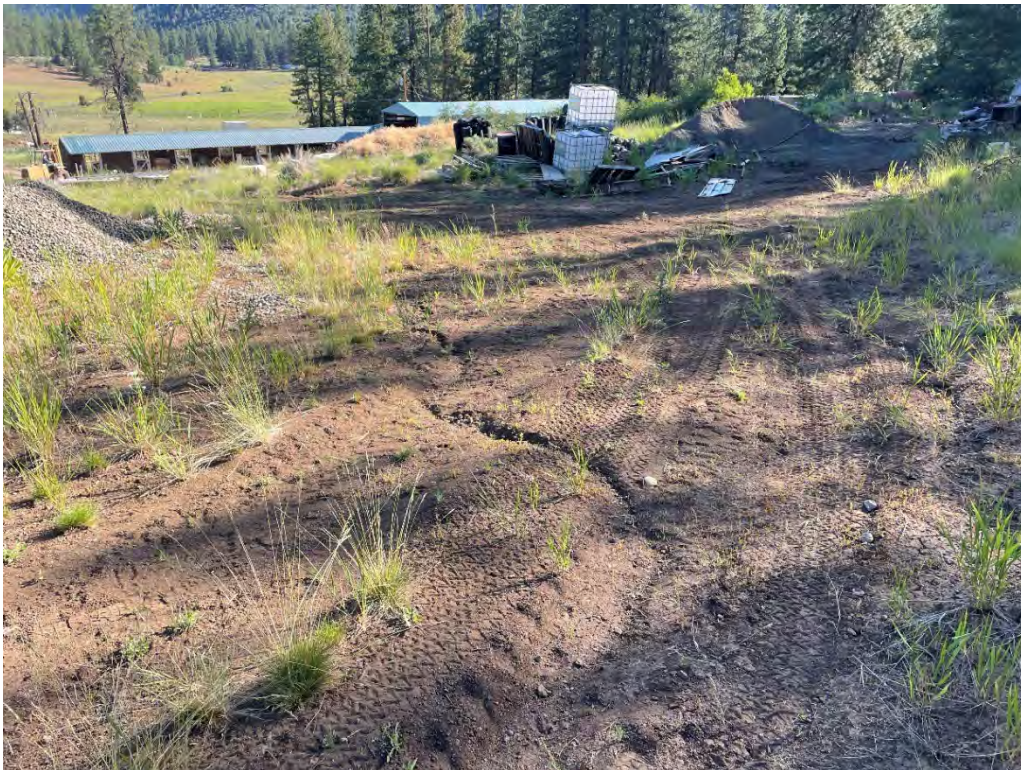
Parcel WWTP – View of new Rill near Former Digester.
