RE: Annual Inspection for Parcel MBK-G (Warehouse)
North Ridge Estates Superfund Site
ECSI No. 6025

Parcel MBK-G

Operations and Maintenance Inspection Form

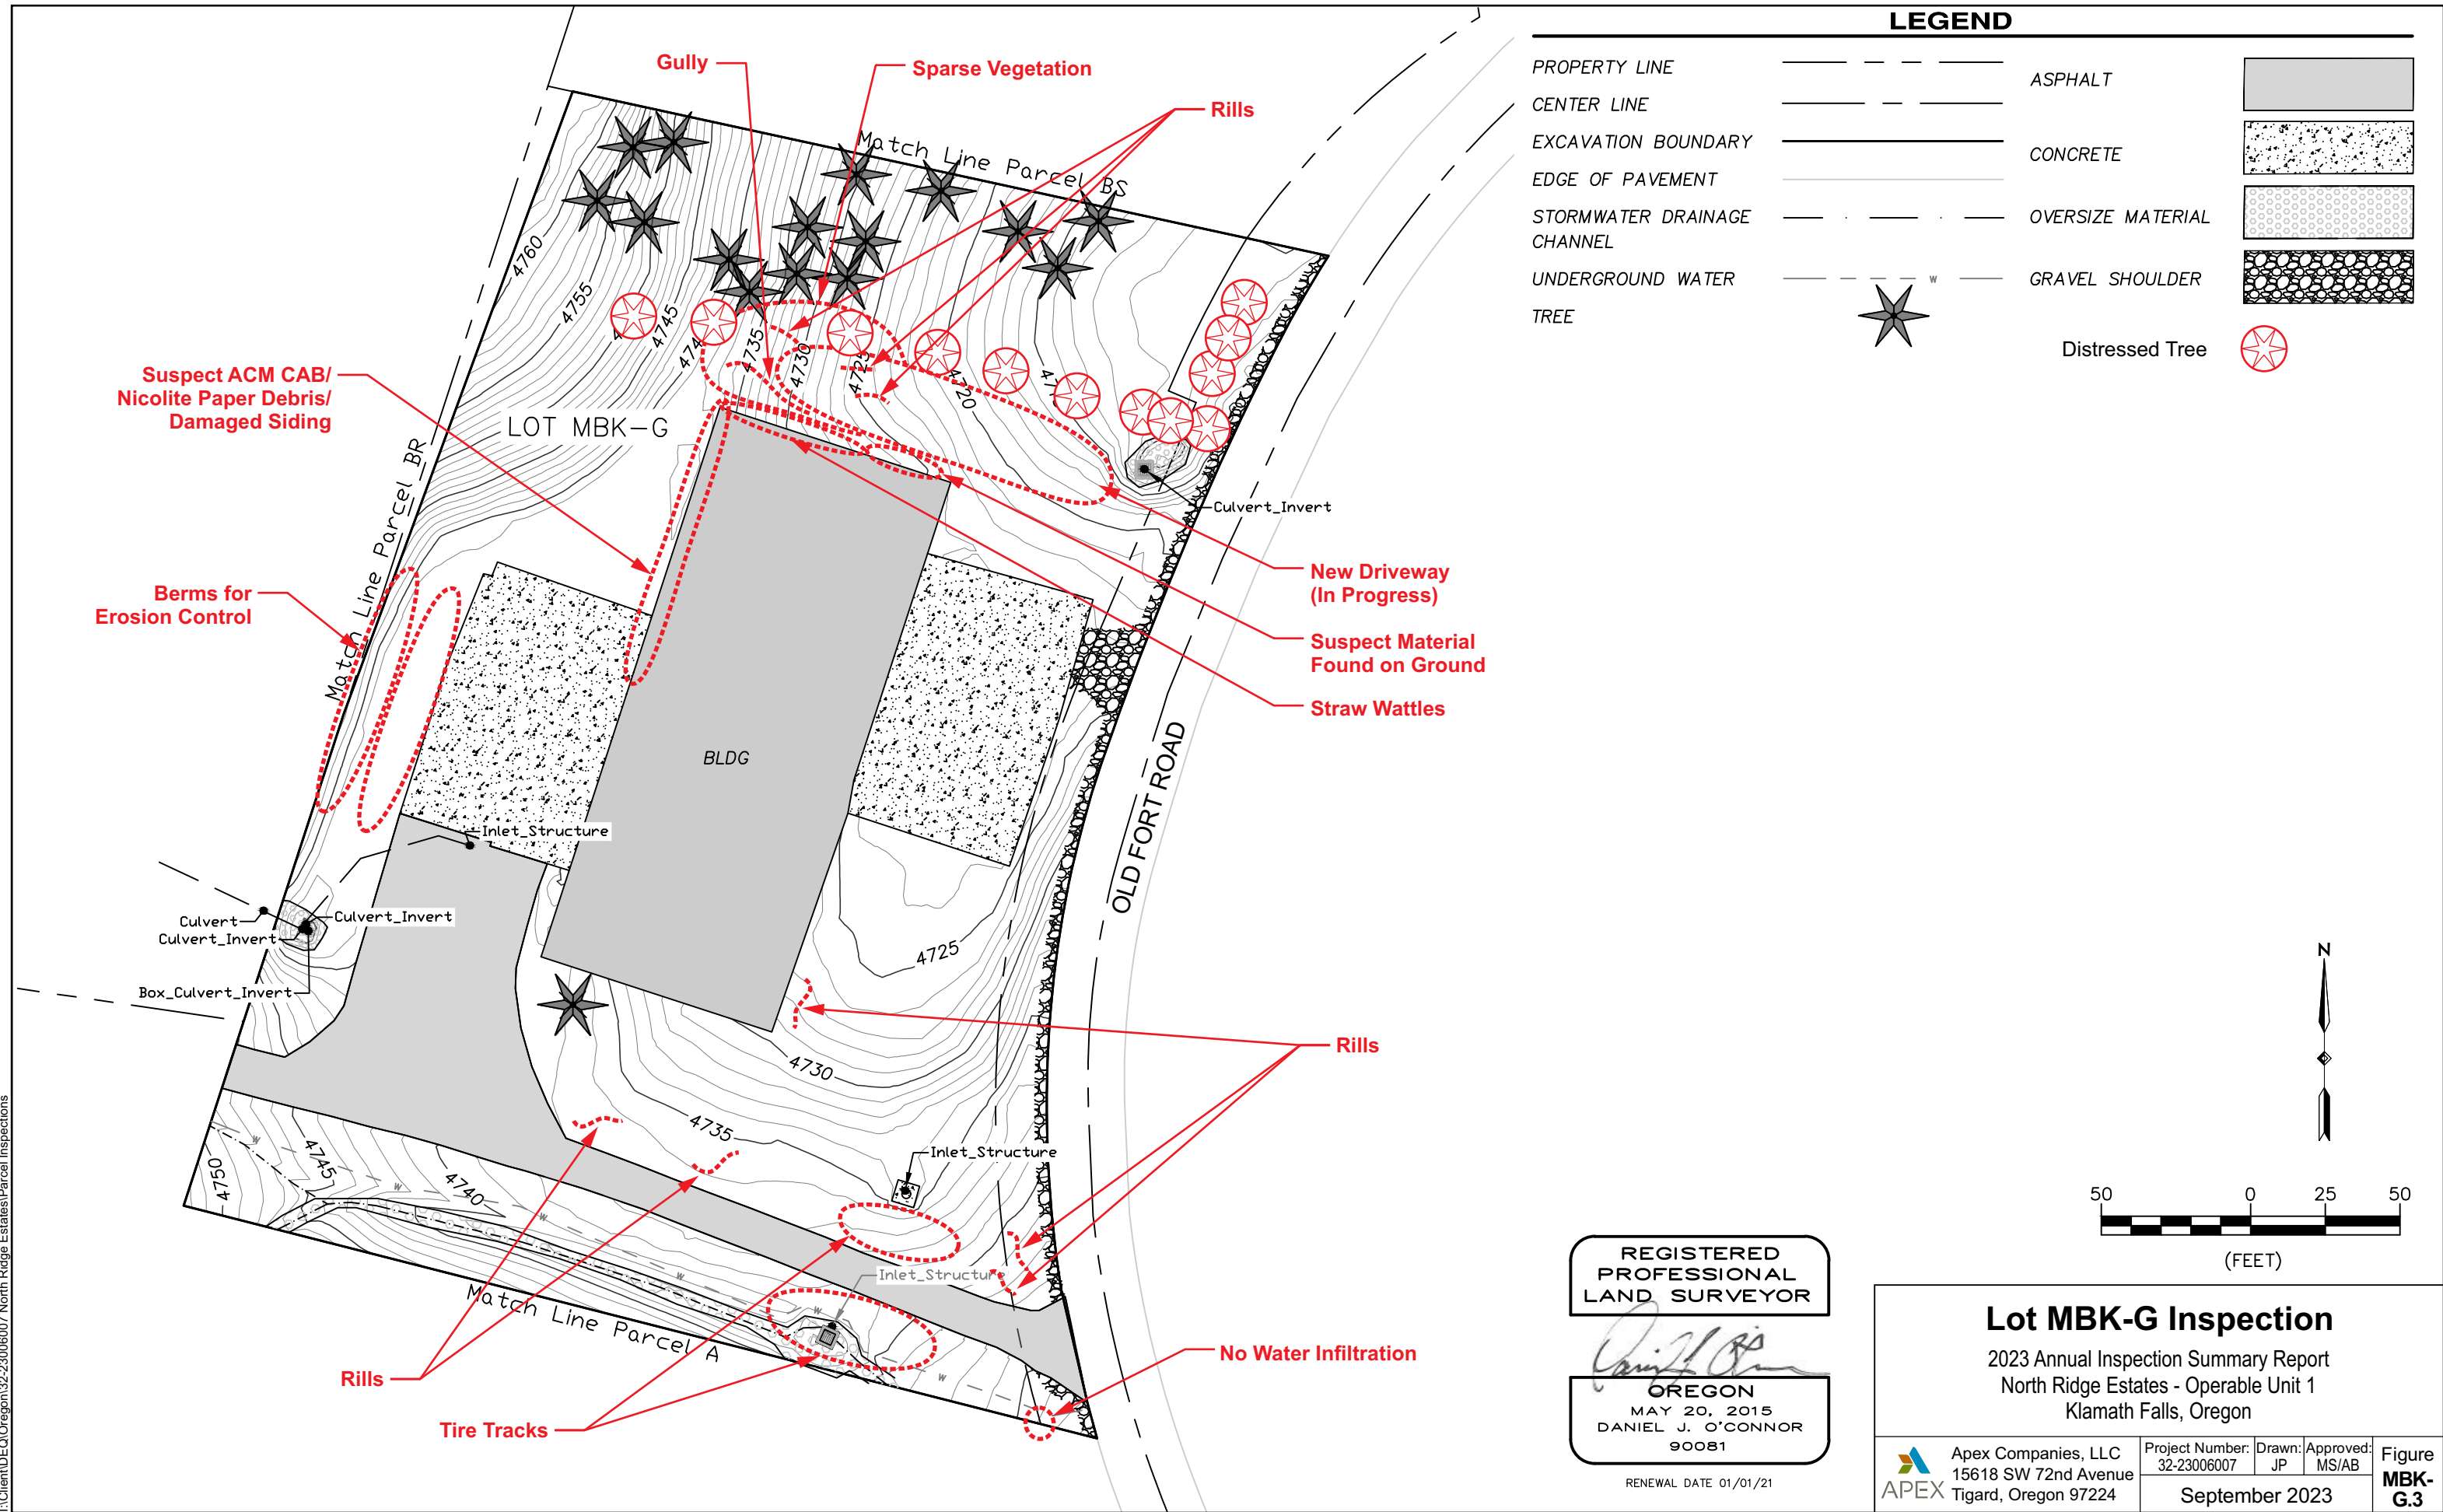
Parcel MBK-G

1. **Cap Damage.** Significant areas of damage to the soil protective cap have been repeatedly noted primarily on the north side of the building (see enclosed figure).

Have gullies developed deeper than 6 inches?	<input checked="" type="checkbox"/>	<input type="checkbox"/>	<input type="checkbox"/>	<input type="checkbox"/>	Gullies were noted along the north side of the warehouse. (Same as 2021)	Owner onsite at time of inspection indicated intention of backfilling rills.
	Have animals created burrows in the protective cap?	<input type="checkbox"/>	<input type="checkbox"/>	<input checked="" type="checkbox"/>	<input type="checkbox"/>		
	Have vehicles damaged the protective cap?	<input type="checkbox"/>	<input checked="" type="checkbox"/>	<input type="checkbox"/>	<input type="checkbox"/>	No damage to cap, but tire tracks were noted on the southeast corner of the parcel. (Same as 2022)	
	Any evidence of ACM on Site including areas where the protective cap is less than 2 feet (see as-built drawings) or within the dripline of the legacy trees?	<input type="checkbox"/>	<input checked="" type="checkbox"/>	<input type="checkbox"/>	<input type="checkbox"/>	Suspect cement asbestos board (CAB) siding observed on all exterior sides of warehouse.

Corrective Action. Fill in the damaged areas to restore the protective cap. Armor as needed to prevent reoccurrence by November 12, 2023.

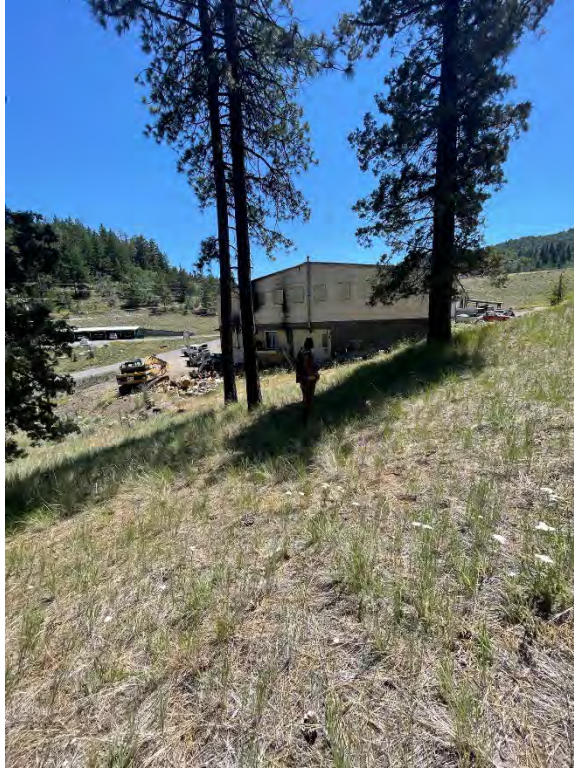
Parcel MBK-G – Northwest Corner of Parcel; Owner reportedly adding Driveway North of Warehouse.

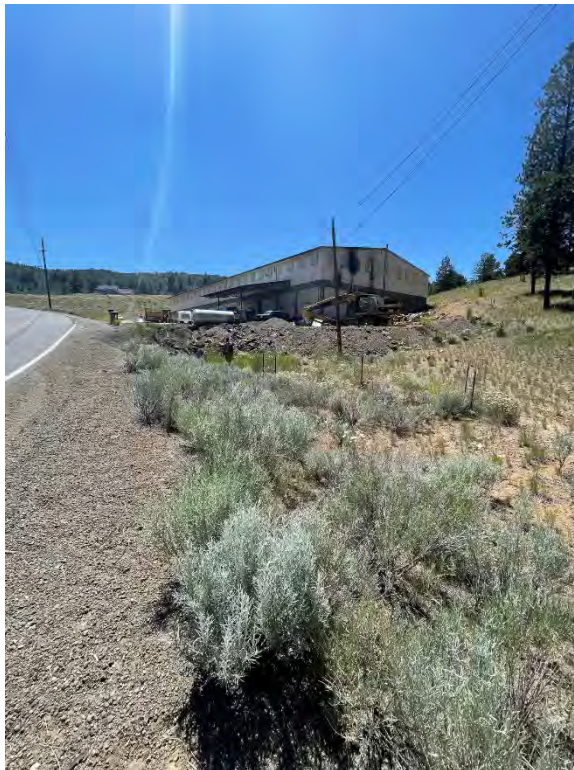
Parcel MBK-G – Northeast Corner of Parcel, facing Southwest.

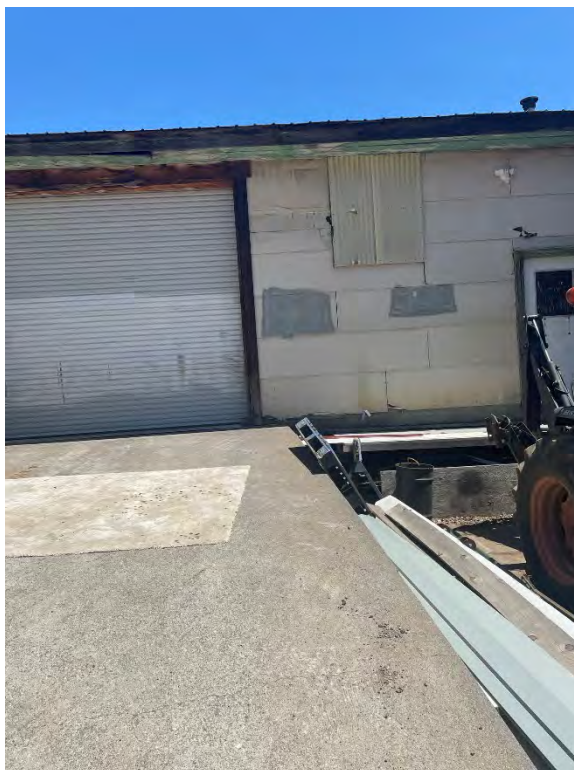
2. **Damaged Siding.** The building's cement asbestos board (CAB) siding is continuing to deteriorate. Multiple pieces of this asbestos containing material (ACM) were observe and pose a risk of contaminating the protective cap.

Parcel MBK-G – Suspect cement asbestos board (CAB) siding on West exterior of Warehouse.

Recommendation. Remove or seal the deterorating siding in accordance with applicable local, state, and federal regulations.

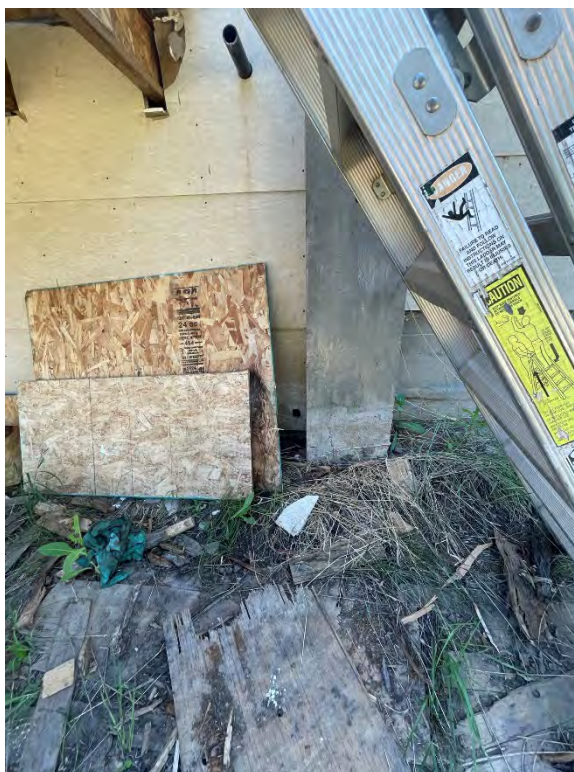
Suspect CAB debris on ground.	<input checked="" type="checkbox"/>	<input type="checkbox"/>	<input type="checkbox"/>	<input type="checkbox"/>	Suspect CAB siding observed to be damaged and deteriorating on all exterior sides of warehouse structure. Suspect CAB siding debris observed on ground on north side of warehouse struture.	Remove and properly dispose of suspect CAB debris following local, state and federal regulations.
		<input type="checkbox"/>	<input type="checkbox"/>	<input type="checkbox"/>	<input type="checkbox"/>		
		<input type="checkbox"/>	<input type="checkbox"/>	<input type="checkbox"/>	<input type="checkbox"/>		
		<input type="checkbox"/>	<input type="checkbox"/>	<input type="checkbox"/>	<input type="checkbox"/>

Parcel MBK-G – Suspect CAB observed on the ground on the North side of the Warehouse.

Corrective Action. Remove and properly dispose of CAB material on the ground by November 12, 2023. Perform reguard inspections of siding and remove and properly dispose of CAB material on the ground promptly.

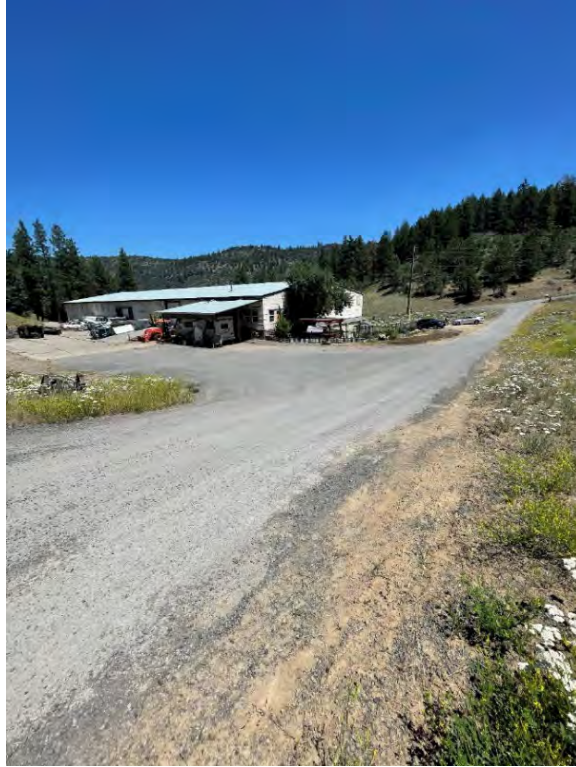
Parcel MBK-G – Southwest corner of Parcel, facing Northeast.

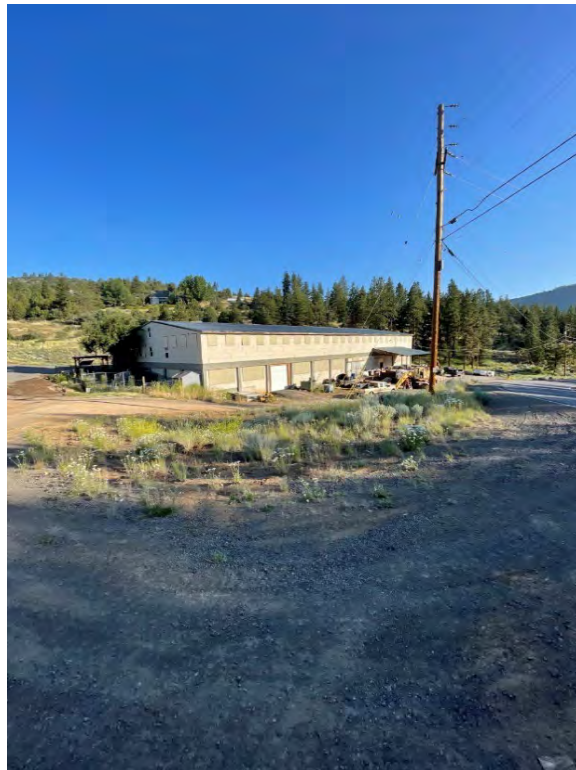
Parcel MBK-G – Northwest corner of Parcel, facing Southeast.
