RE: Annual Inspection for parts of Parcels C, E, & F
North Ridge Estates Superfund Site
ECSI No. 6029

Operations and Maintenance Inspection Form

Lot LAM Inspection
2023 Annual Inspection Summary Report
North Ridge Estates - Operable Unit 1
Klamath Falls, Oregon

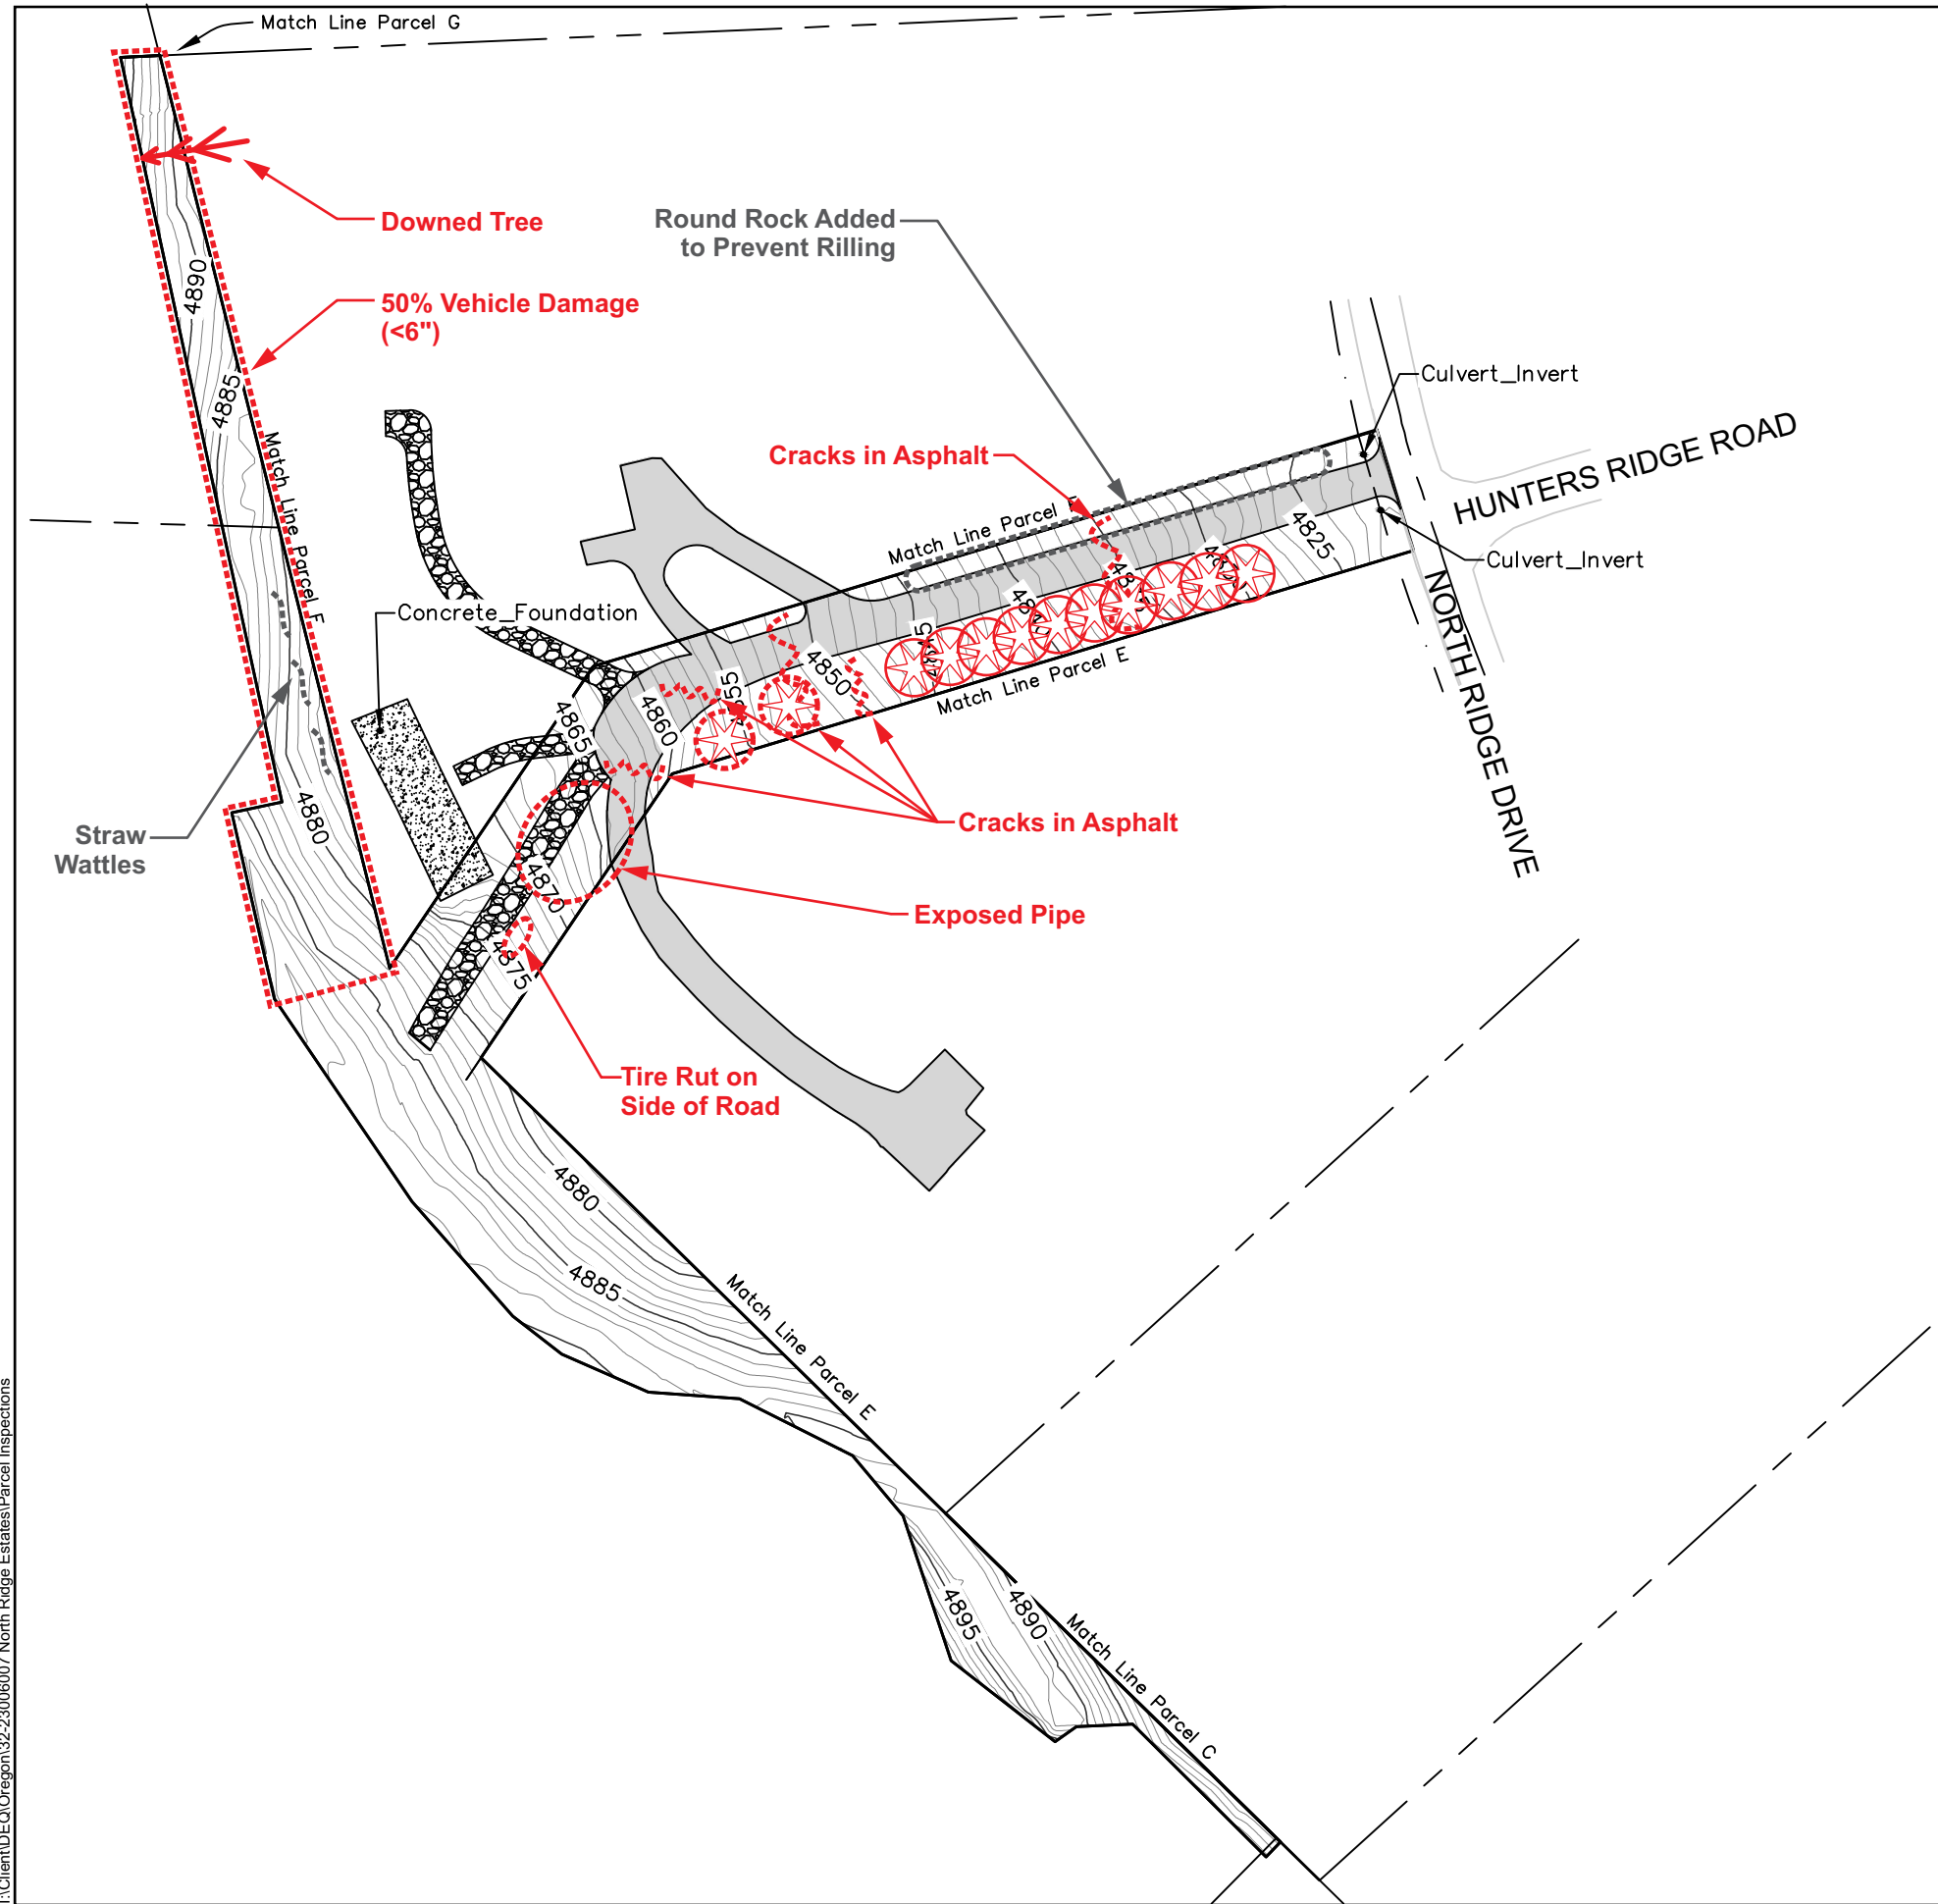
Apex Companies, LLC 15618 SW 72nd Avenue Tigard, Oregon 97224	Project Number: 32-23006007	Drawn: JP	Approved: MS/AB	Figure LAM.3
September 2023

1. **Cap Damage.** Areas of damage to the soil protective cap by vehicles have been noted (see enclosed figure).

Corrective Action. Fill in the damaged areas. Armor as needed to prevent reoccurrence by November 12, 2023.
2. **Recommendations.** 1) Cover the exposed water line. 2) Seal cracks in the asphalt drive.

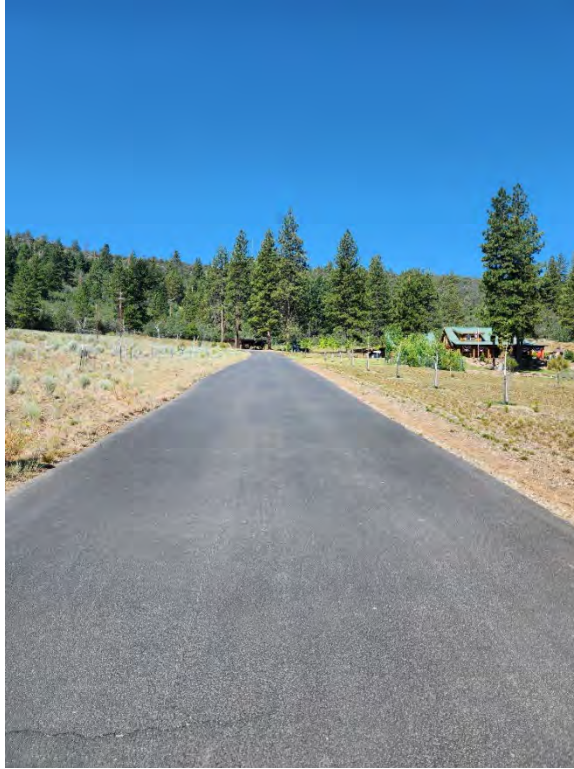
Parcel LAM – View of distressed trees, road cracks from corner looking West from East corner of Parcel.

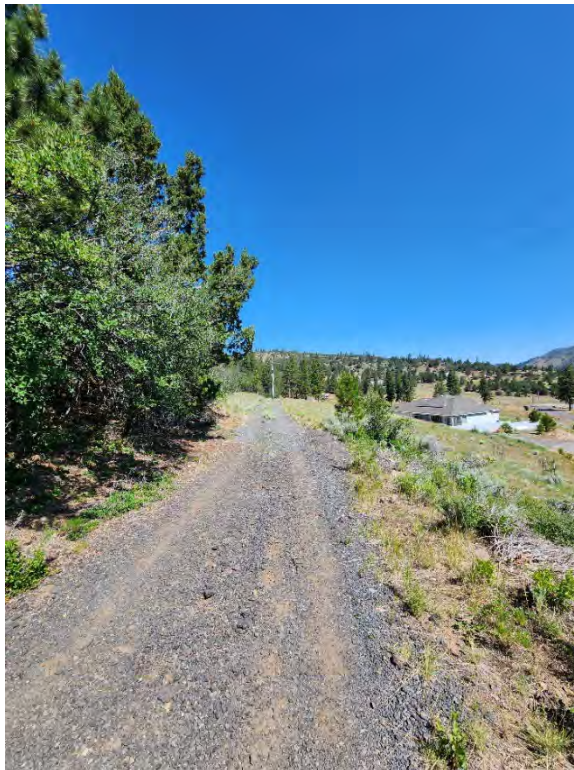
Parcel LAM – View of Parcel from Southern Corner.

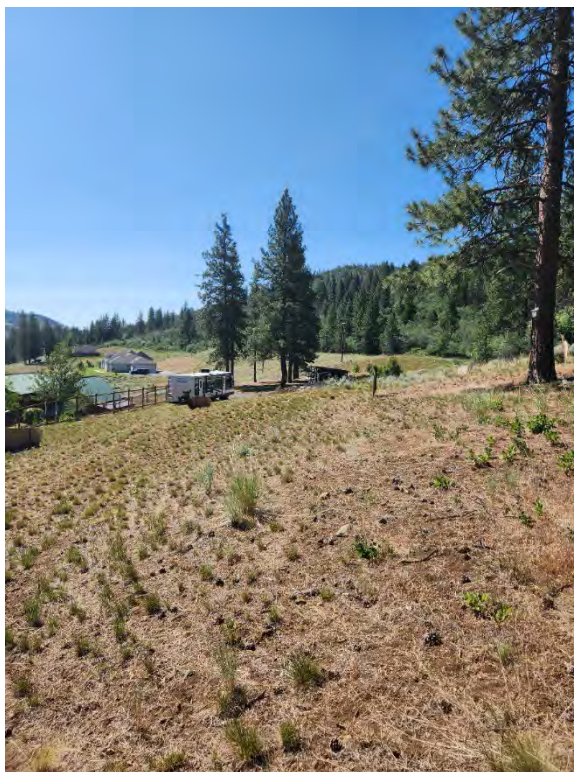
Parcel LAM – View of Parcel from Northern Corner.
