RE: 2023 Annual Inspection for Roads
North Ridge Estates Superfund Site
ECSI No. 6376

2023 Annual Inspection Summary Report
North Ridge Estates - Operable Unit 1
Klamath Falls, Oregon

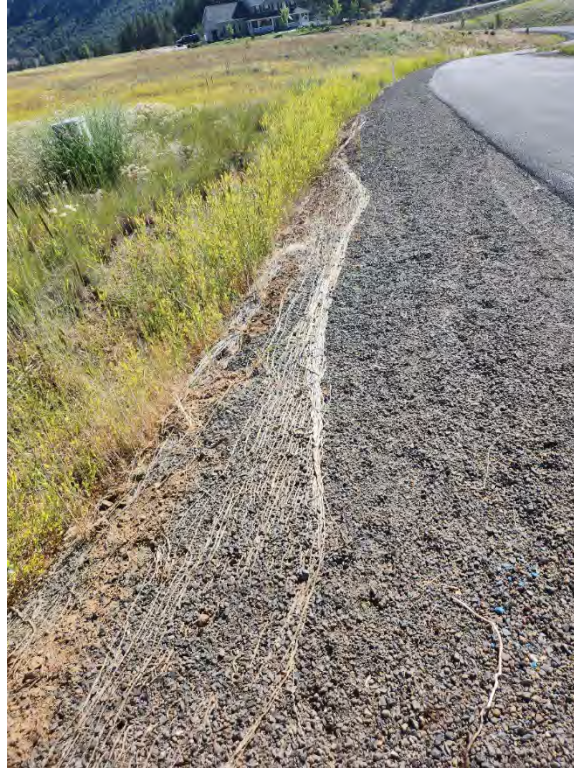
Hunter's Ridge Road – View of exposed Coconut Fiber Mat on North shoulder of road.

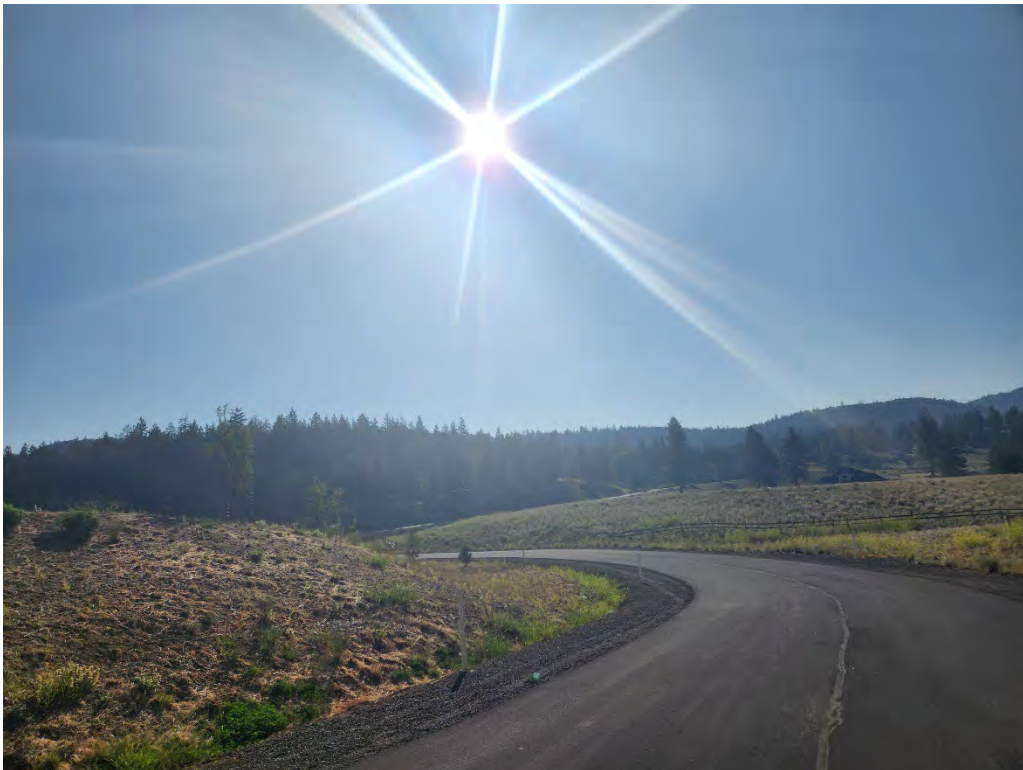
| Part I. General Site Information | | | | | | | |
|--|--|---|---|---|---|--|---|
| | Have vehicles damaged the protective cap? | <input type="checkbox"/> | <input checked="" type="checkbox"/> | <input type="checkbox"/> | <input type="checkbox"/> | Approximately 4 inch deep tire tracks on southwest corner of Old Fort Road and Hunter's Ridge Road. No apparent damage to protective cap. (Same as 2022) Additional tracks found along the dirt shoulder of the road. | |

Hunter's Ridge Road – View looking East of Tire Tracks on North gravel road shoulder.

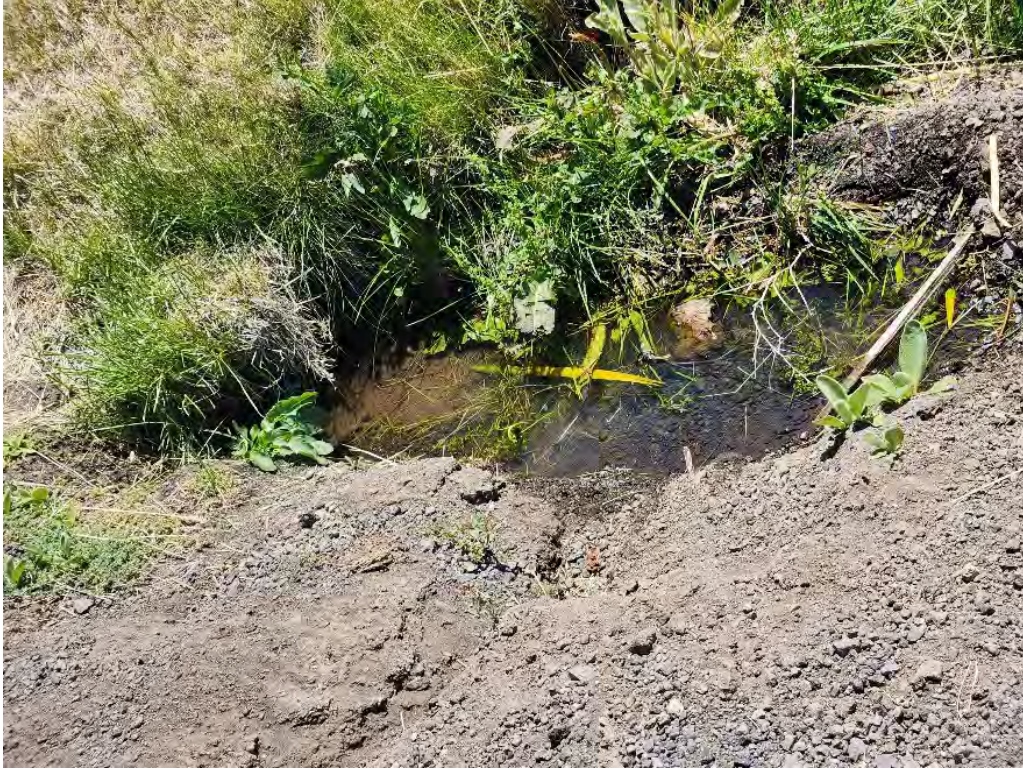
| Ditches and Culverts | Obstructions observed in ditches or culverts that may impede conveyance of stormwater? | <input checked="" type="checkbox"/> | <input type="checkbox"/> | <input type="checkbox"/> | <input type="checkbox"/> | Several culverts were noted to have some level of obstruction on Scott Valley Drive. | Remove obstructions from culverts to enable stormwater flow. |

Scott Valley Drive – Standing Water located on the Southern side of the road, result of blocked culvert.

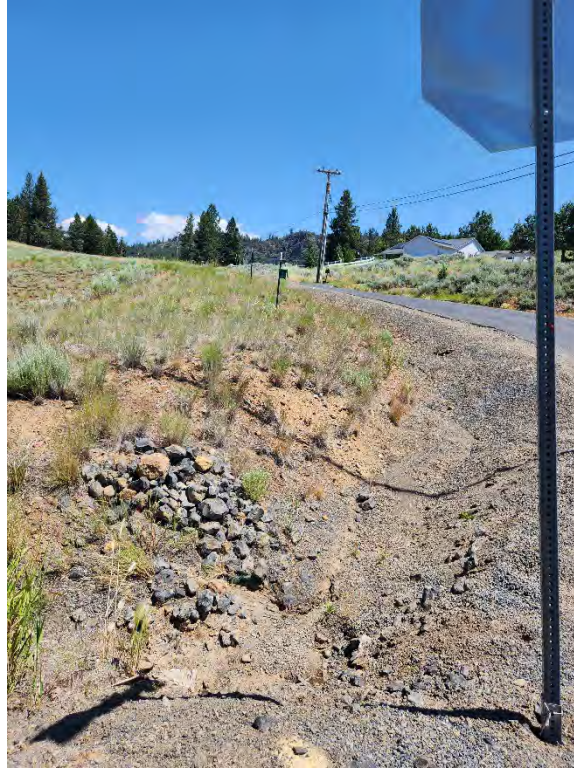
| | Are there any areas that show signs of excessive scour? (i.e., gullies forming along centerline of ditch) | <input type="checkbox"/> | <input checked="" type="checkbox"/> | <input type="checkbox"/> | <input type="checkbox"/> | Scouring was noted at multiple locations along the southeast side of Scott Valley Drive. (Same as 2022) | |

Scott Valley Drive – View from Southwest corner of road where erosion in ditch is present (same as 2022).

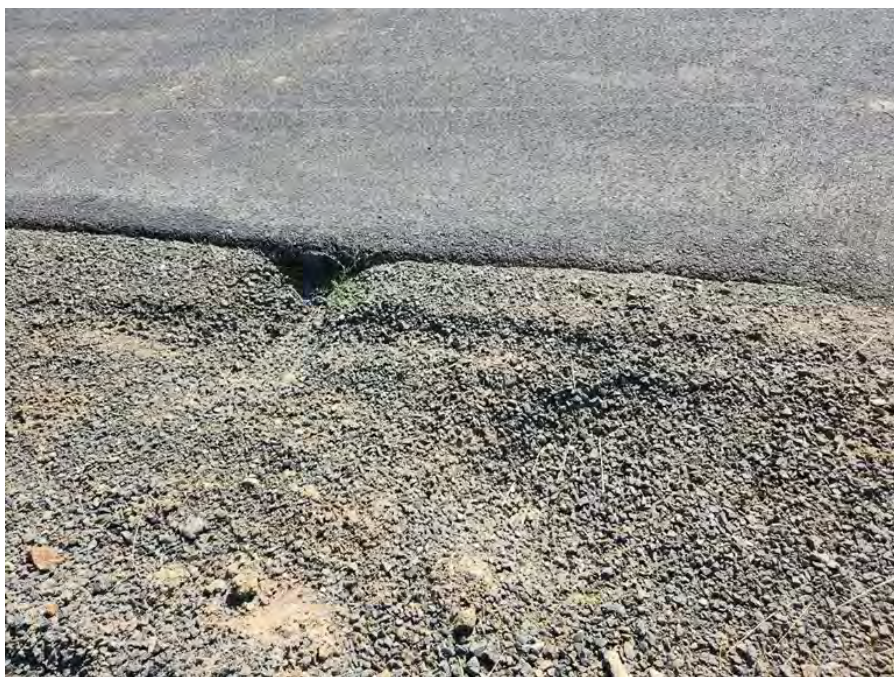
| Part I. General Site Information | | | | | | | | |
|--|--|---|---|---|---|--|--|---|
| | Are there areas that show evidence of unstable slopes, subsidence, or slope failure? Are there signs of active bank erosion and/or lateral cutting? | <input type="checkbox"/> | <input type="checkbox"/> | <input checked="" type="checkbox"/> | <input type="checkbox"/> | Depressions observed near Parcel LAM. | | |

North Ridge Drive – View of depressions in gravel shoulder.

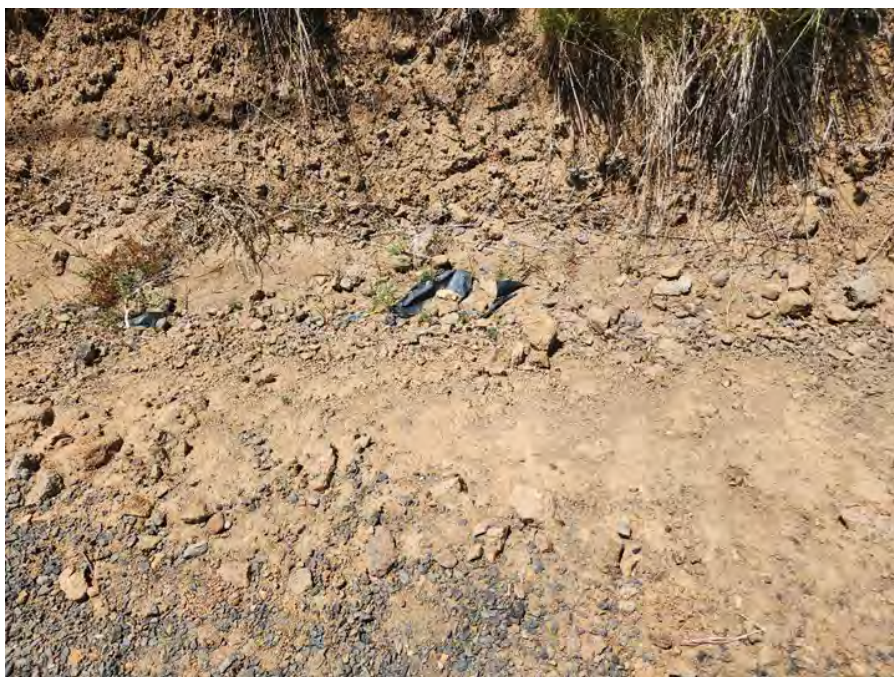
| Part I. General Site Information | | | | | | | | |
|--|--|---|---|---|---|--|--|---|
| | Have gullies developed deeper than 6 inches? | <input checked="" type="checkbox"/> | <input type="checkbox"/> | <input type="checkbox"/> | <input type="checkbox"/> | Gullies were noted along North Ridge Drive adjacent to Parcel D. | Backfill gullies to prevent further erosion. | |

North Ridge Drive – Black Geomembrane exposed along shoulder near Parcel D.

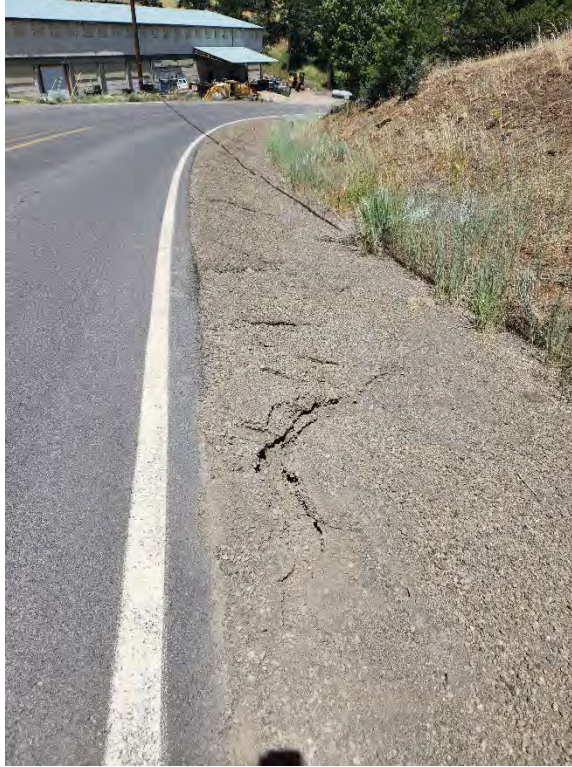
| Part I. General Site Information | | | | | | | |
|--|--|---|---|---|---|--|--|
| | Have gullies developed deeper than 6 inches? | <input checked="" type="checkbox"/> | <input type="checkbox"/> | <input type="checkbox"/> | <input type="checkbox"/> | Rills and gullies were noted in several locations in the ditches along Old Fort Road (Parcels AK, AP, AQ, BM, MBK-G, WWTP). (Same as 2022) | Backfill gullies to prevent further erosion. |

Old Fort Road – View of Gully along gravel shoulder of road.

1. The gullies located at Scott Valley Road and Old Fort Road as well as along Old Fort Road by the apartments just past Hunters Ridge Road need to be repaired and armored as needed to prevent continued erosion. These conditions were previously noted in 2022.
2. Many of the culverts were partially to mostly obstructed and need to be cleared to contain stormwater runoff and prevent damage to the protective caps.

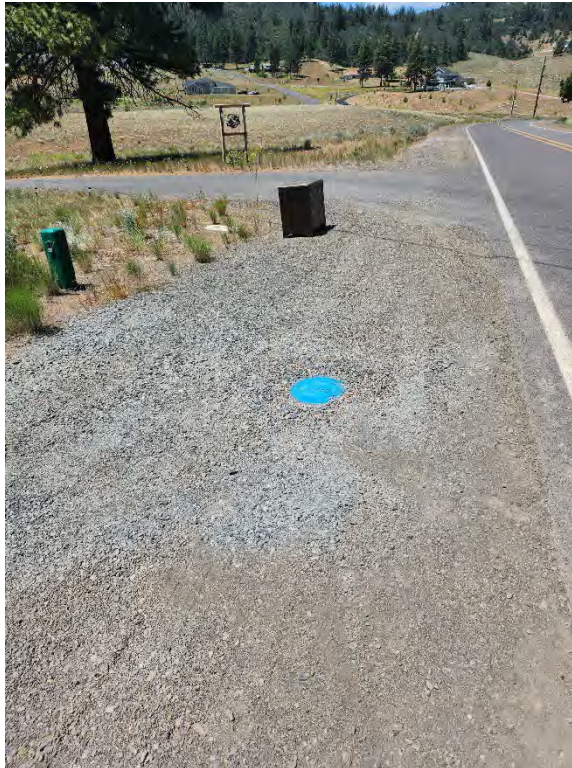
Old Fort Road – View of recently repaired area of gravel shoulder.

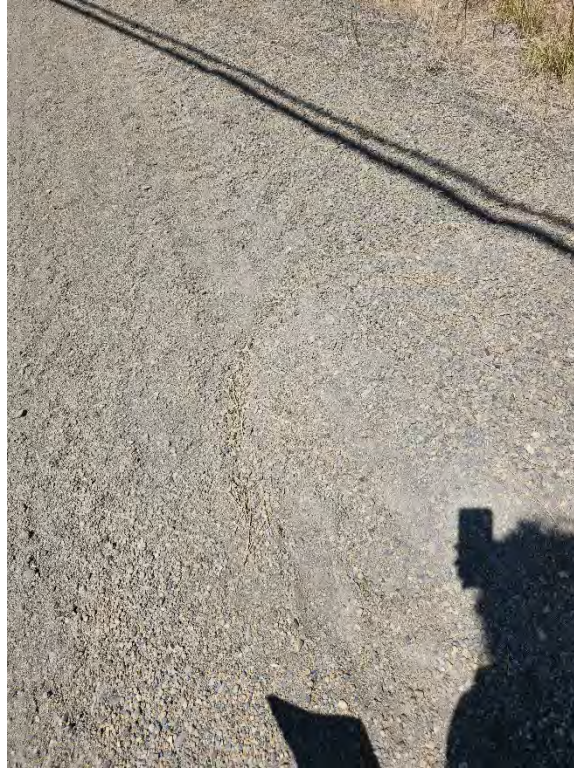
| Part I. General Site Information | | | | | | | |
|--|--|---|---|---|---|--|--|
| Protective Cap | Have rills developed deeper than 2 inches? | <input checked="" type="checkbox"/> | <input type="checkbox"/> | <input type="checkbox"/> | <input type="checkbox"/> | Rills and gullies were noted in several locations in the ditches along Old Fort Road (Parcels AK, AP, AQ, BM, MBK-G, WWTP). (Same as 2022) | Backfill gullies to prevent further erosion. |

Old Fort Road – View of Rills observed on gravel shoulder.

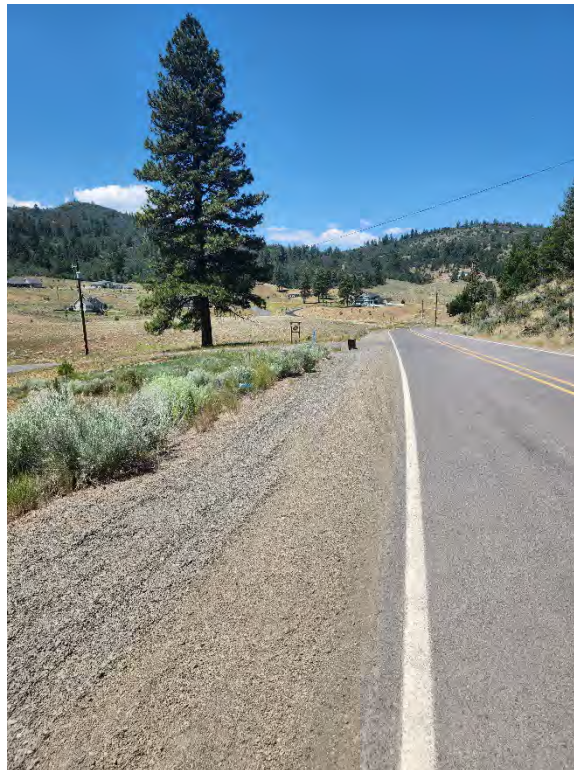
| Part I. General Site Information | | | | | | | |
|--|--|---|---|---|---|--|--|
| | Have vehicles damaged the protective cap? | <input type="checkbox"/> | <input checked="" type="checkbox"/> | <input type="checkbox"/> | <input type="checkbox"/> | Tire tracks were observed on the northeast corner of Parcel A and along Parcel MBK-D. | |

Old Fort Road – View of Tire Tracks observed along gravel shoulder.
