***Thicket Court***

## Operations and Maintenance Inspection Form

| Part I. General Site Information | | | | | | | |
|---|---|---|---|---|---|---|---|
| Site Name: | North Ridge Estates | State/County: | Oregon (Klamath County) | Parcel/Tax ID: | Thicket Court | | |
| Inspection Date: | 10/12/2021 | Person(s) Performing Inspection: | Saul Montes (Apex Companies, LLC) | Person(s) Performing Inspection: | | | |

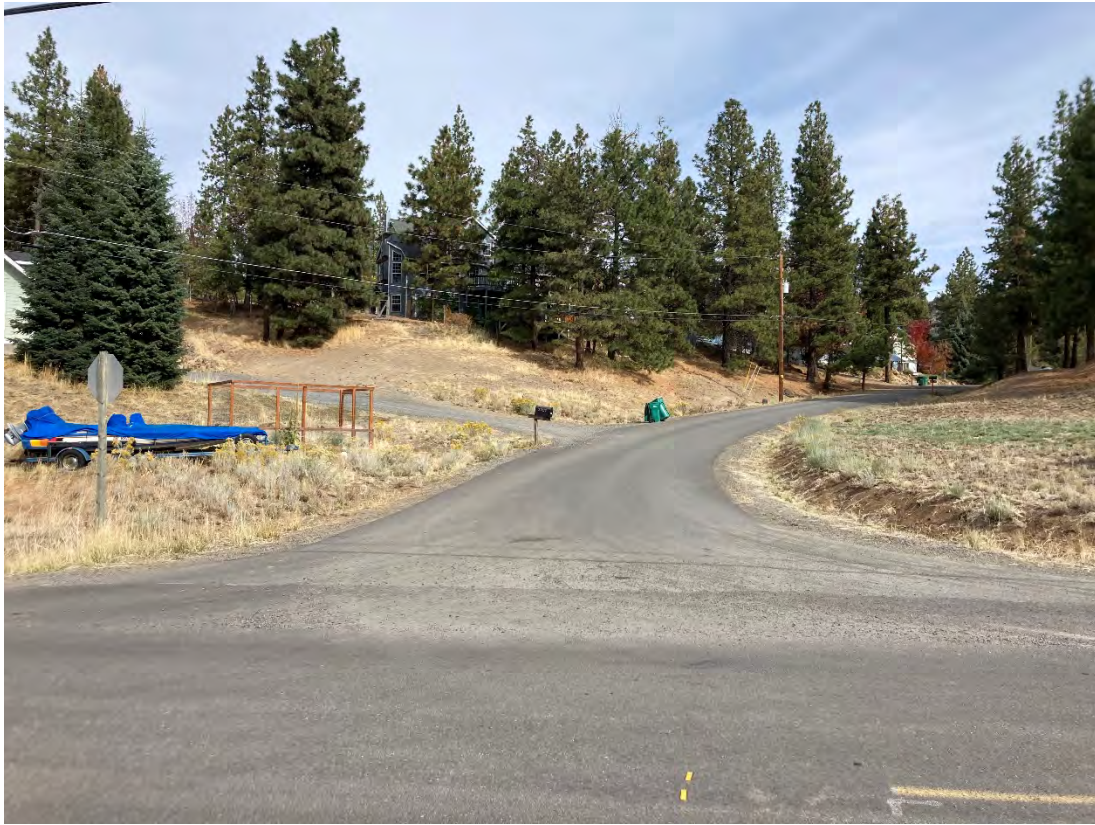
View of Thicket Court, looking north from Old Fort Road.

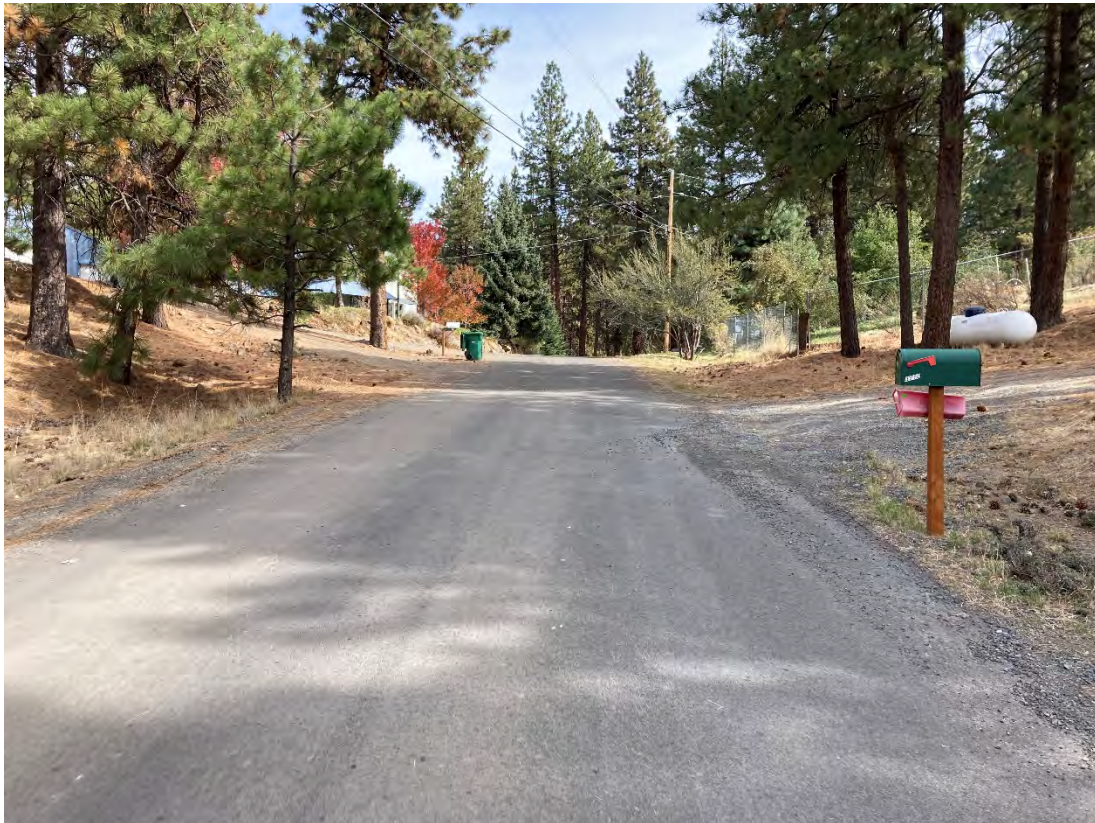
The southern end of the Thicket Court is still in better condition than the northern portion.

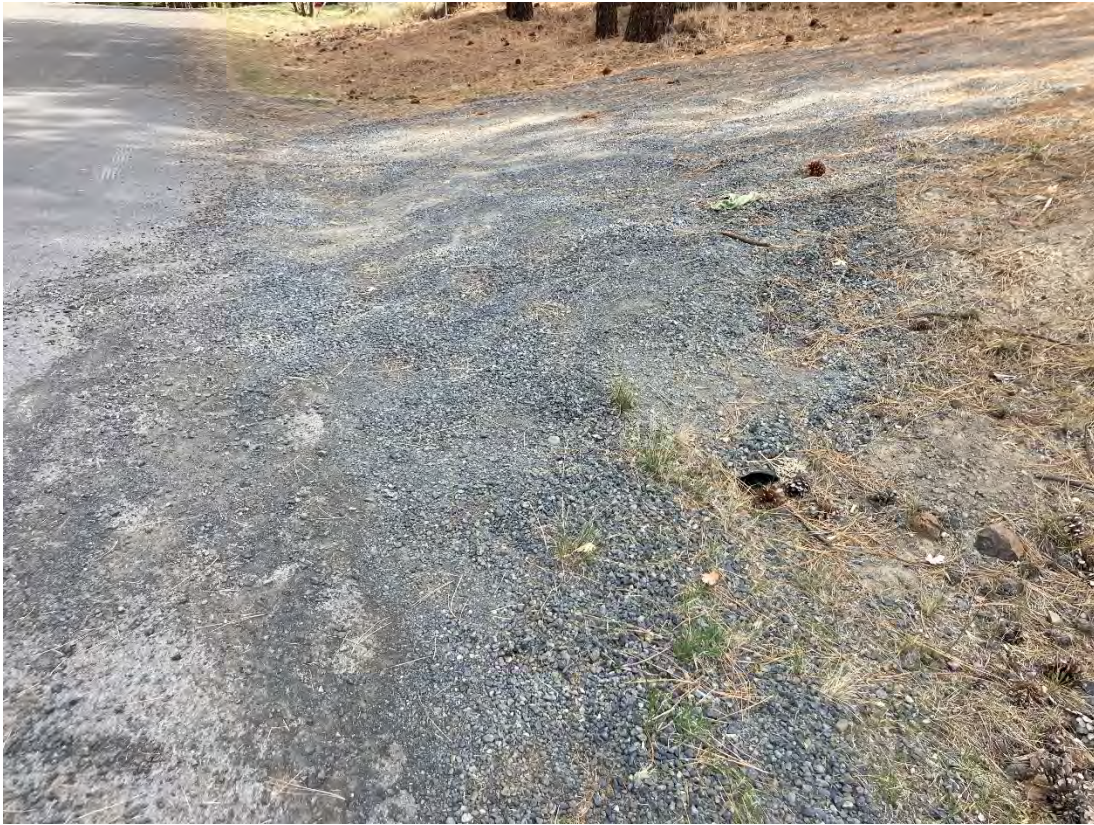
| Ditches and Culverts | Obstructions observed in ditches or culverts that may impede conveyance of stormwater? | <input checked="" type="checkbox"/> | <input type="checkbox"/> | <input type="checkbox"/> | <input type="checkbox"/> | Several of the culverts are obstructed. (Same as 2020) | Culverts are expected in current condition but cleaning/obstruction removal will be required in the future. Obstructions not removed are unlikely to be cleared 'naturally'. Cracks should be repaired using a crack sealant to prevent further damage during freeze/thaw cycles. |

Several of the driveways on the southern end of Thicket Court have culverts that are obstructed.

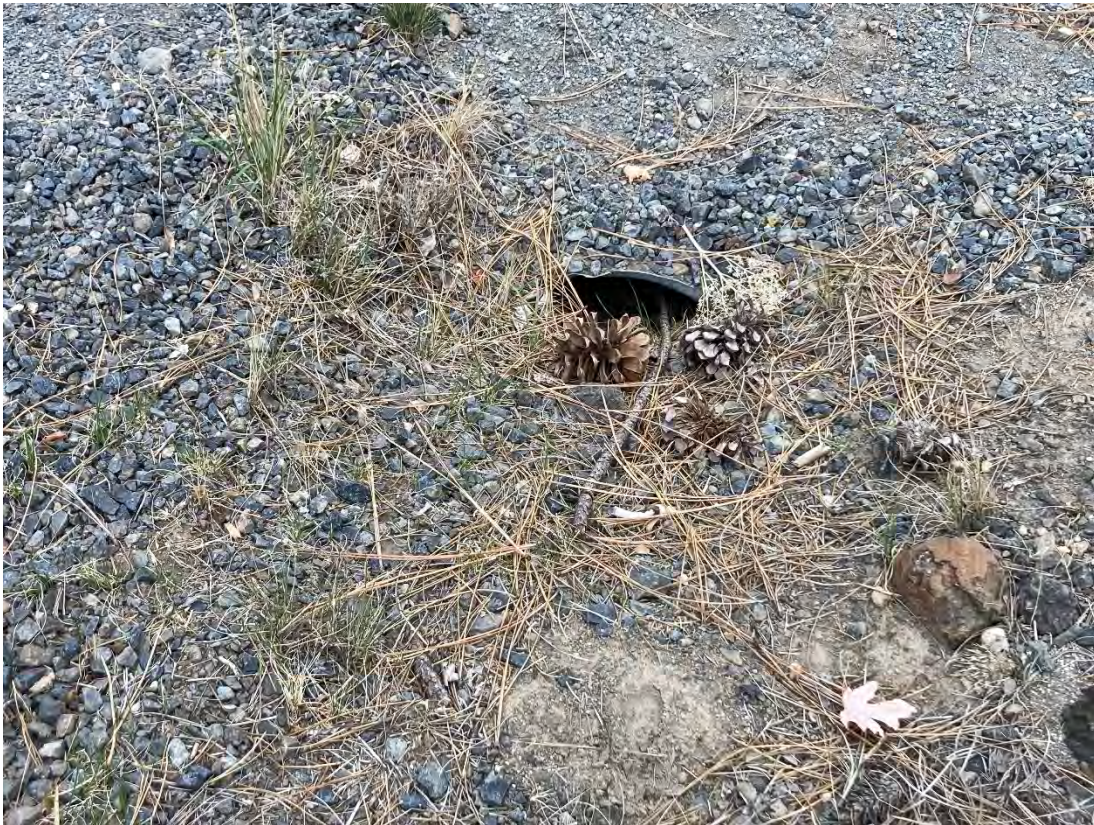
Majority of the culverts on the southern end of Thicket Court are obstructed by debris and soil.

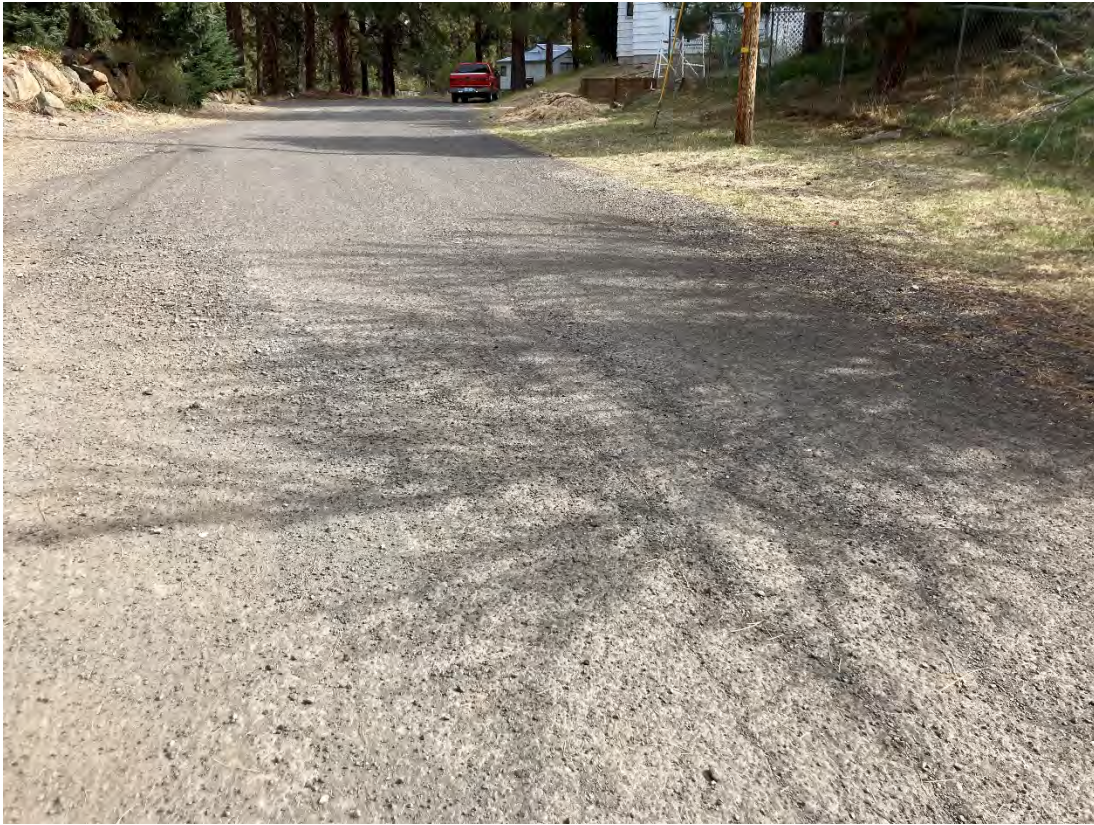
| Driveways and Walkways | Are the driveways showing signs are failure? (i.e., alligator cracking) | <input type="checkbox"/> | <input type="checkbox"/> | <input type="checkbox"/> | <input checked="" type="checkbox"/> | Cracking is evident in Thicket Court the further north traveled. (Same as 2020) | |

Several cracks were located on Thicket Court after proceeding north, away from Old Fort Road.

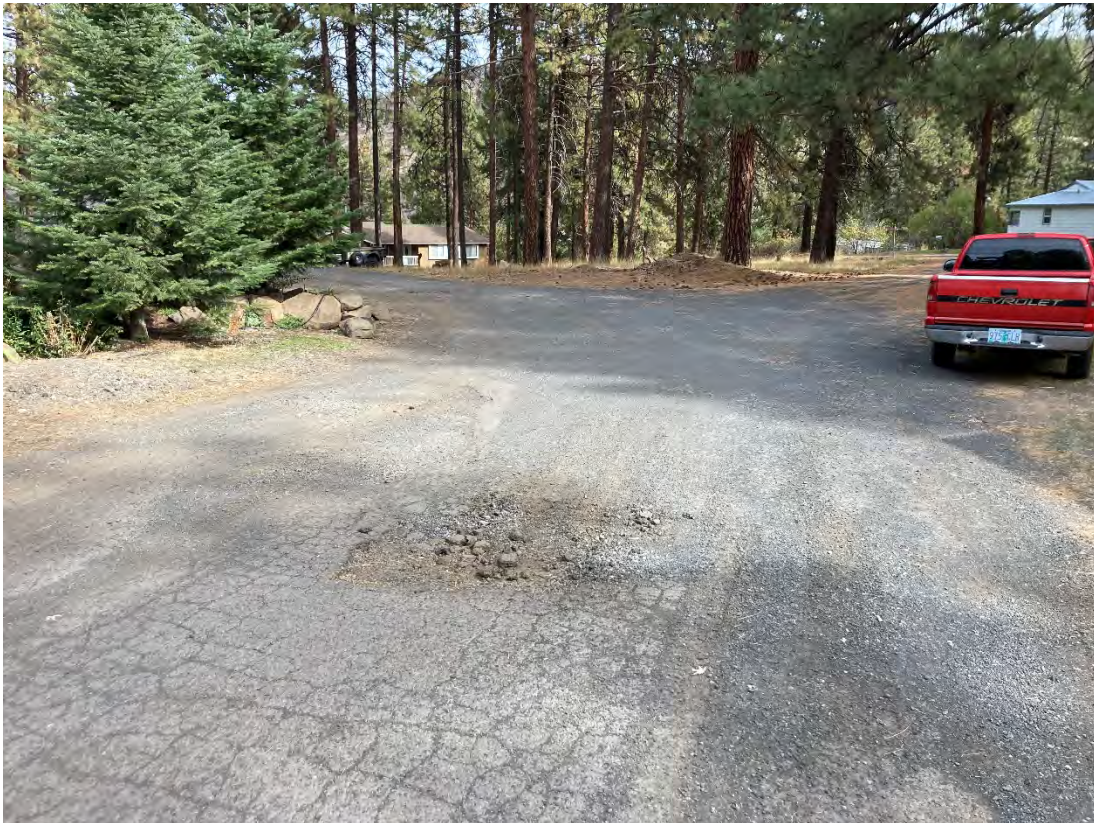
| | Are there any other signs of considerable damage to paved surfaces, other than normal wear and use? | <input type="checkbox"/> | <input type="checkbox"/> | <input type="checkbox"/> | <input checked="" type="checkbox"/> | Potholes and crumbling pavement are evident as the loop is entered at the northern end of the road. (Same as 2020) | |

Potholes were evident further north toward the loop at the northern end of the road.

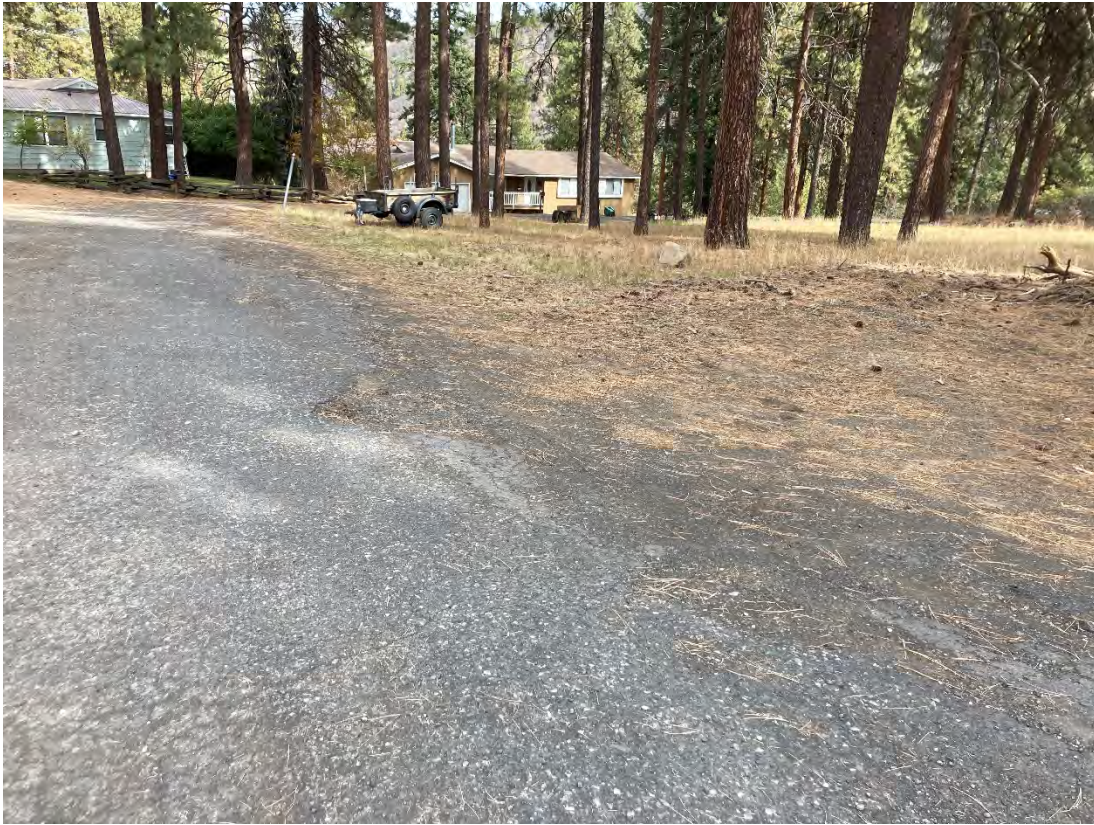
On the loop at the northern end, the pavement was worn away on the outside edge.

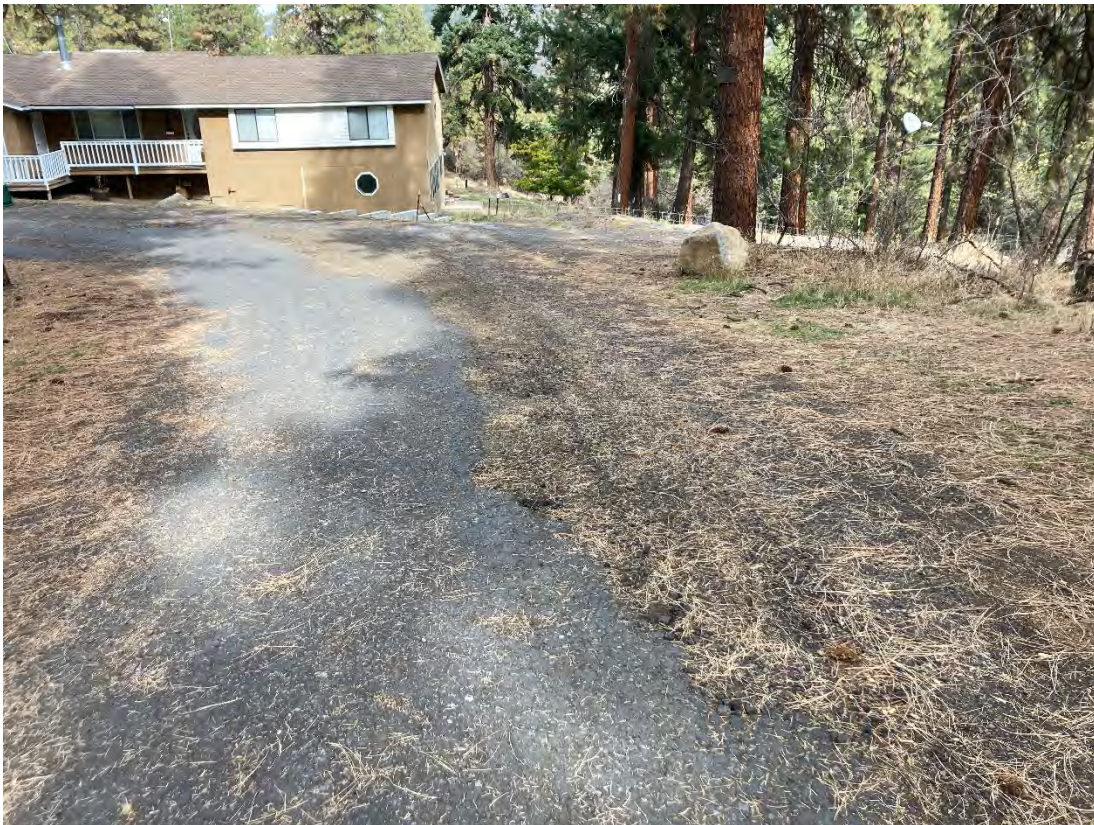
More of the worn pavement in the northern loop of Thicket Court.
