Technical Memorandum

To:	Mark Pugh, RG Oregon Department of Environmental Quality	Date:	October 9, 2024
From:	Meaghan Pollock, RG	Project No.:	M0785.29.001
Re:	Former Astoria Marine Construction Company-	-Visual Monitoring a	nd Bathymetric Survey

Figure 2 Photograph Locations for Visual Monitoring

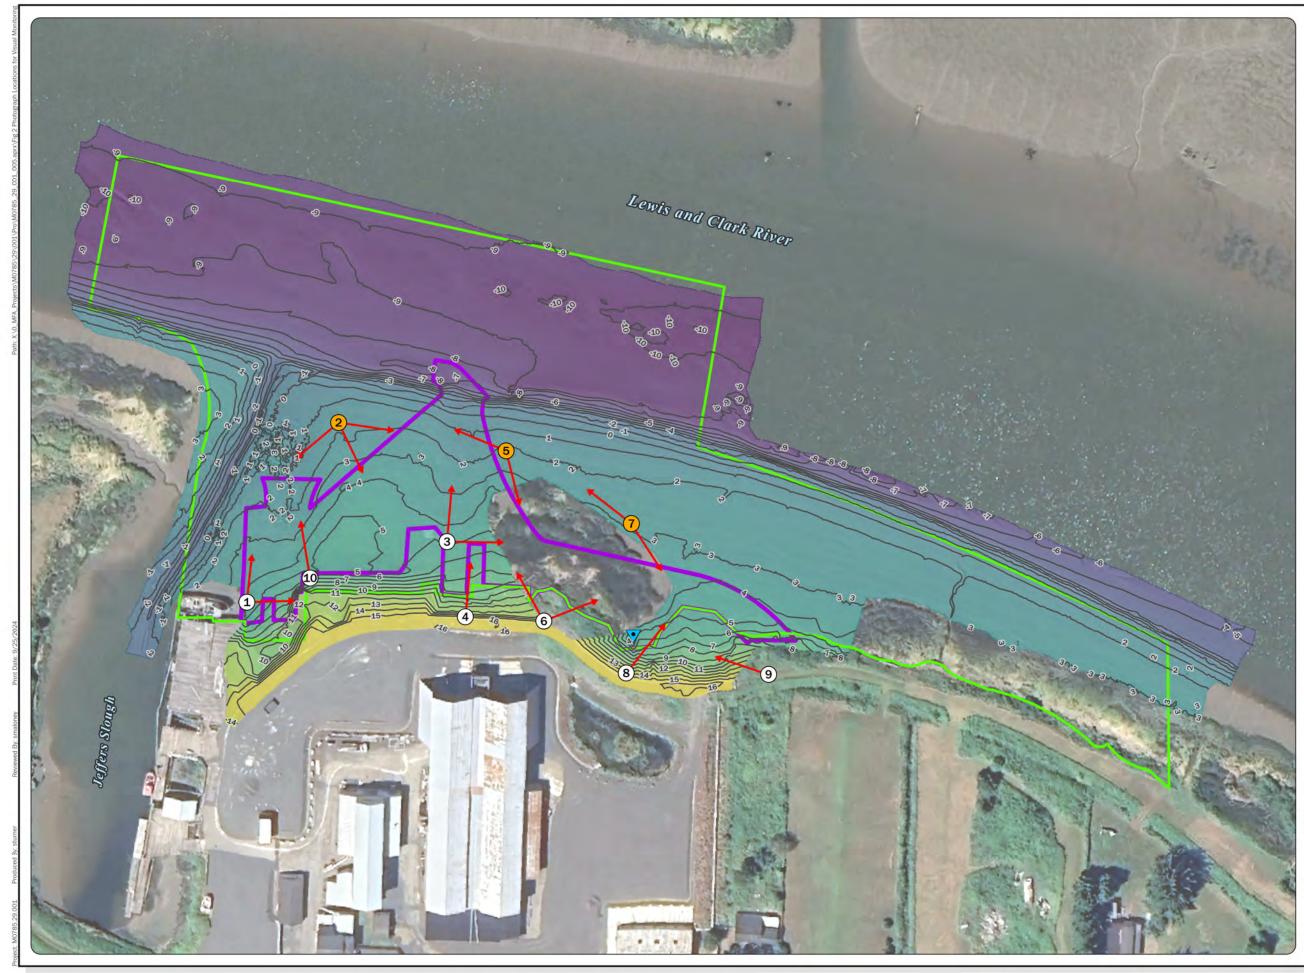
On August 20, 2024, MFA conducted visual monitoring of accessible portions of the EMNR sand layer and MNR area (see Figure 2; Appendices A and B). MFA was unable to access photograph locations 2, 5, or 7 due to soft sediment that resulted in unsafe walking conditions even using Mudder Boots. The remaining photograph locations were adjusted based on conditions encountered in the field. An additional photograph location (location 10) was added to the visual monitoring program to provide coverage of the southern portion of the EMNR sand layer.

- Visible sand appeared generally smooth. Rounded dimples associated with mollusk activity were observed in the intertidal zone.
- Vegetation on the EMNR sand layer was healthy and dense.
- No areas of significant sediment deposition were observed on the EMNR sand layer.
- Minor drainage channels were observed on the EMNR sand layer, consistent with those previously observed. No areas of significant sediment loss were noted.
- No significant debris were observed on the EMNR sand layer or sediment surface.
- No other visible indicators of potential contamination were observed (e.g., sheen or staining) on surface sediment.

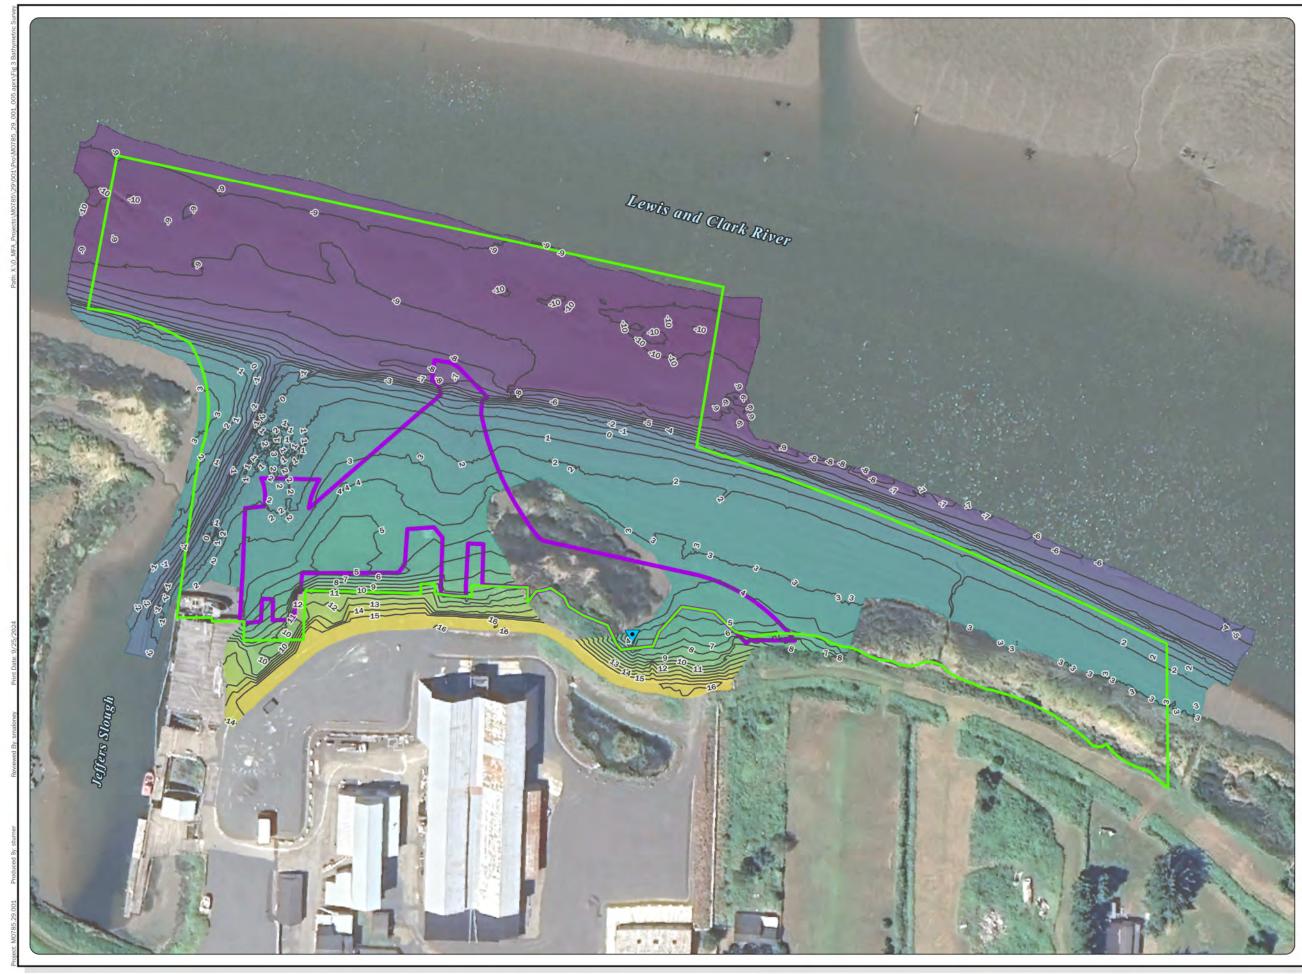
Figure 3 Bathymetric Survey

Between August 20 and 22, 2024, eTrac Inc., a surveyor licensed in the State of Oregon, conducted a survey of accessible portions of the EMNR sand layer and MNR area. MFA conducted oversight during the survey which included a multibeam bathymetric survey and land-based topographic surveying of areas inaccessible by water. The survey results are provided in Figure 3 and Appendix C.

The survey could not be conducted on a portion of the EMNR sand layer and MNR area due to dense vegetation. Minor drainage channels are noted across the EMNR sand layer and MNR area, consistent with visual monitoring observations. No areas of significant sediment disturbance were identified during the survey.

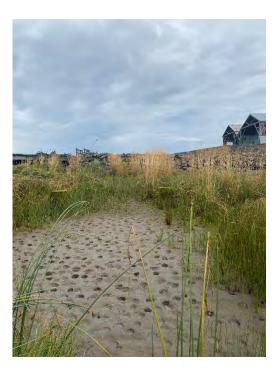
Photo No. 1.

Photograph location 1, facing north.

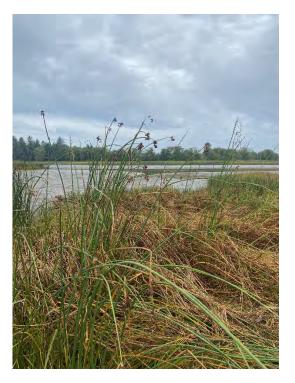
Photo No. 2.

Photograph location 1, facing west.

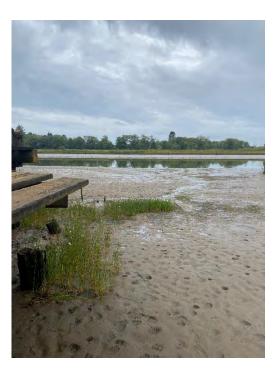
Photo No. 3.

Photograph location 3, facing west.

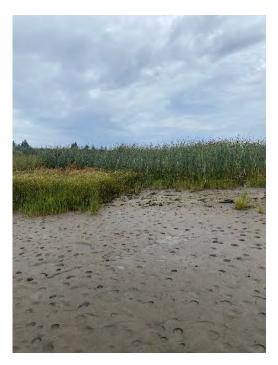
Photo No. 4. Description

Photograph location 3, facing north.

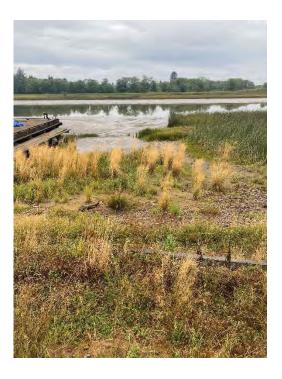
Photo No. 5.

Photograph location 4, facing west.

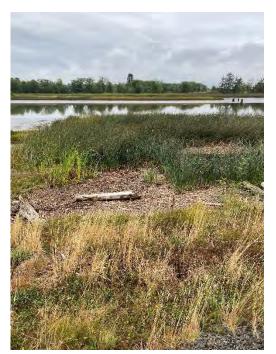
Photo No. 6.

Photograph location 6, facing northwest.

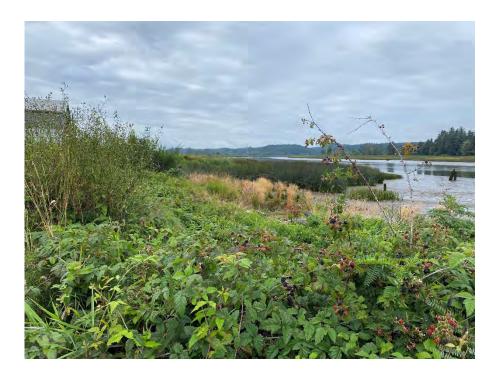
Photo No. 7.

Photograph location 6, facing southwest.

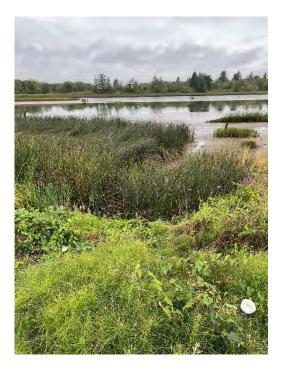
Photo No. 8.

Photograph location 8, facing northwest.

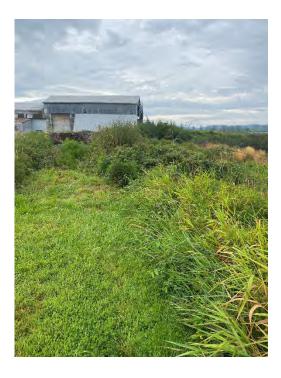
Photo No. 9.

Photograph location 9, facing south-southwest.

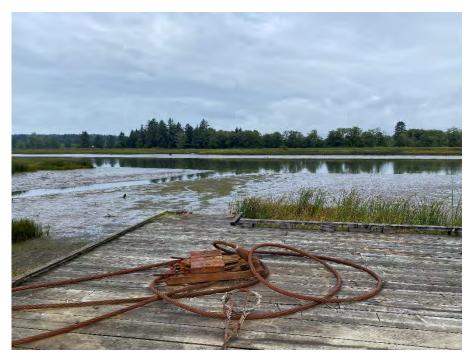
Photo No. 10.

Photograph location 10, facing west-southwest.
